Monitoring Report
OCTOBER
2010

*American Airlines 331
Accident Site and Landfarm*

**MONITORING REPORT – OCTOBER 2010
AMERICAN AIRLINES 331 ACCIDENT SITE AND
LANDFARM**

Prepared by:
CL ENVIRONMENTAL
22 Fort George Heights
Kingston 9

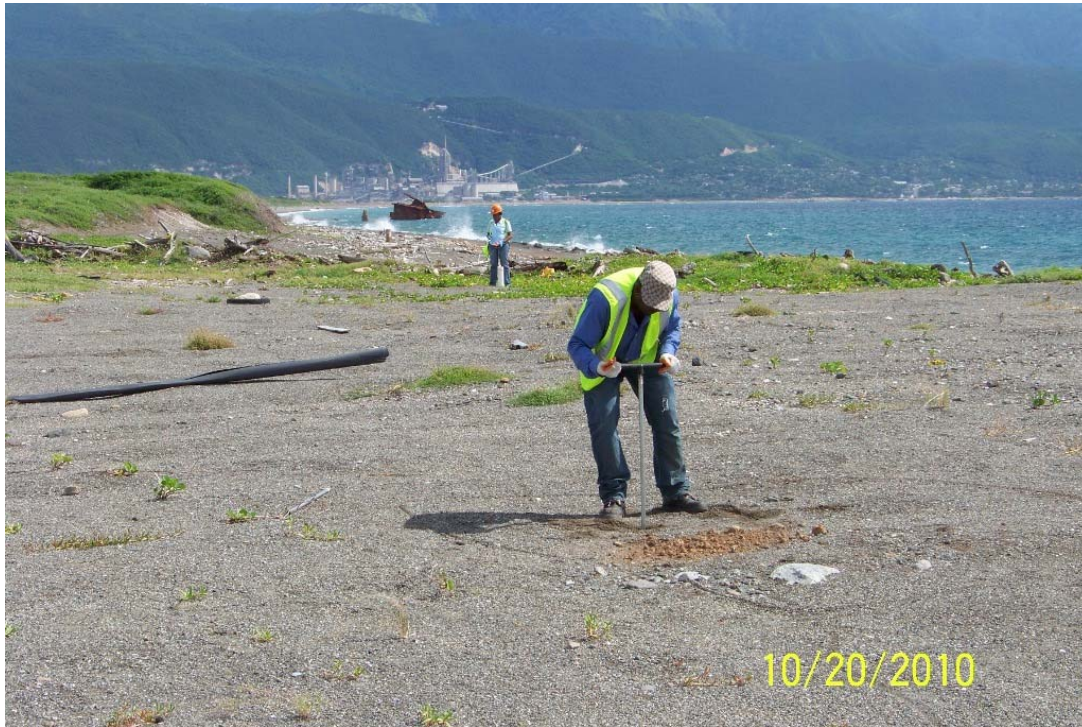
Plate 3 Photo showing soil sampling with auger at accident site

DRO traces were detected in four out of five of the sampled grid sections at the accident site. These locations coincided with where visible spills of jet fuel were. However, all values were well within the standards.

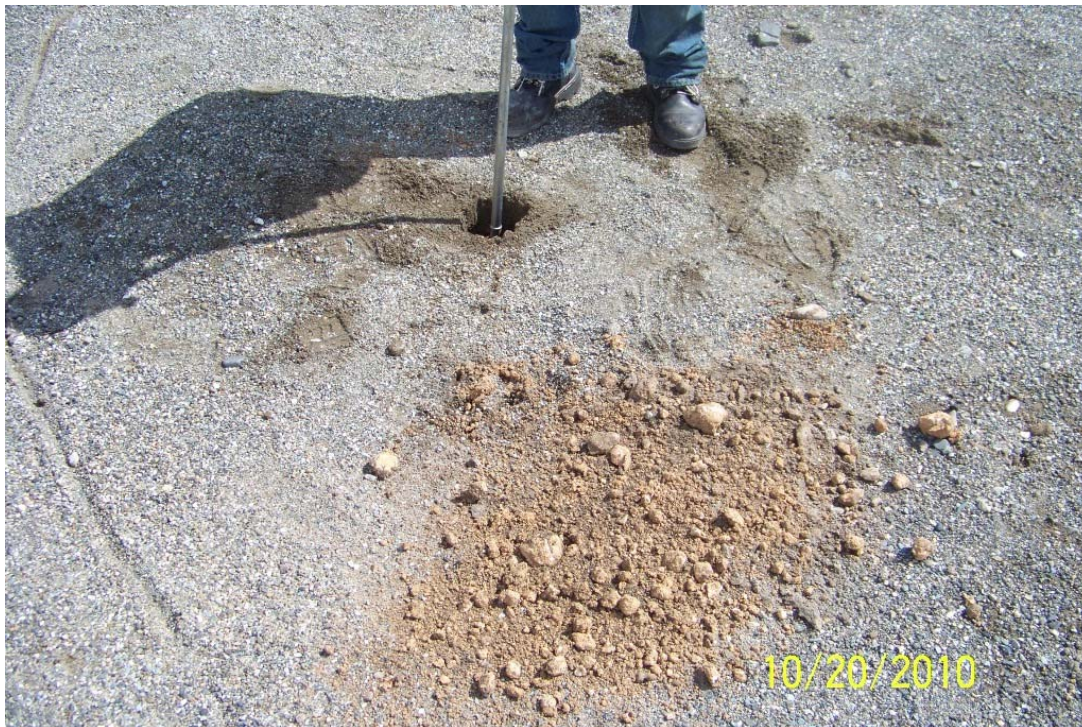
Plate 4 Photo showing soil sampling with auger at accident site

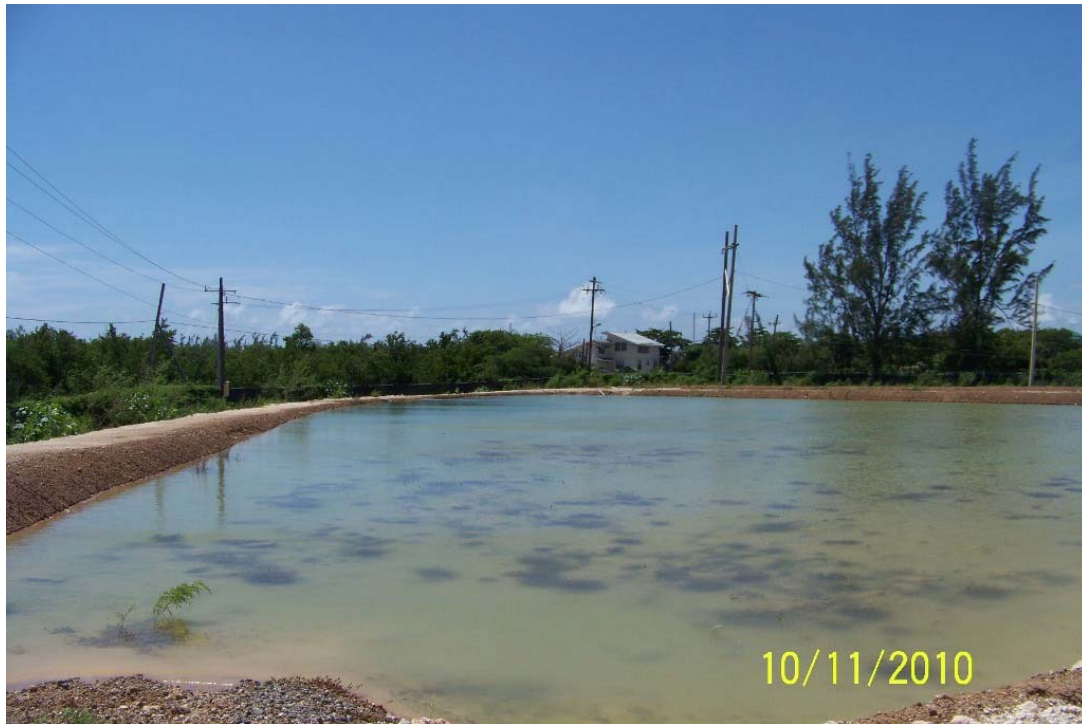
Soil samples were unable to be taken from the landfarm as it was still flooded due to heavy rainfall in the previous month.

Plate 5 Photo showing flooded treatment area of landfarm

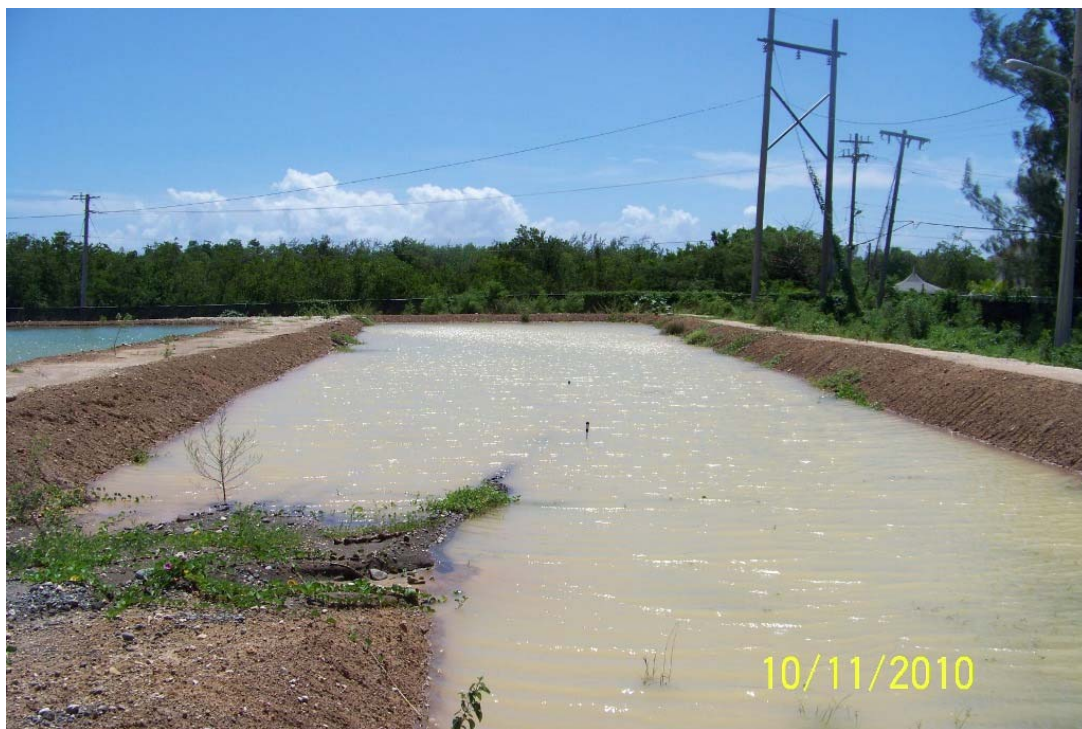
Plate 6 Photo showing flooded storage area of landfarm

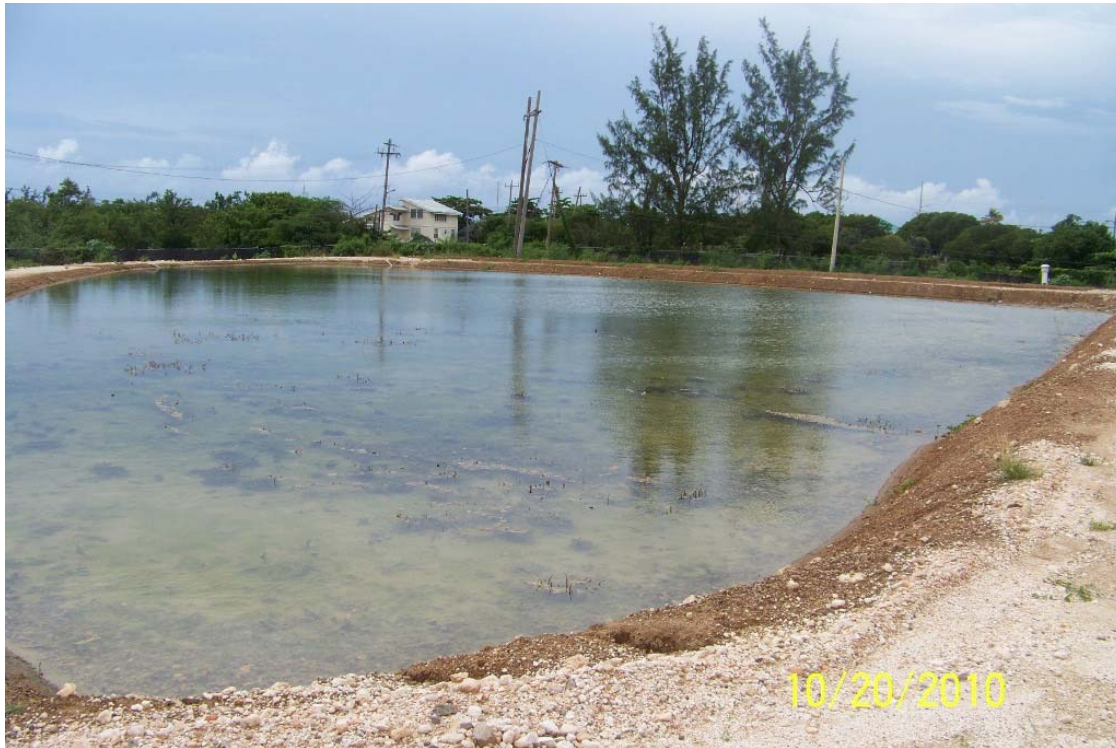
Plate 7 Photo flooded treatment area of landfarm

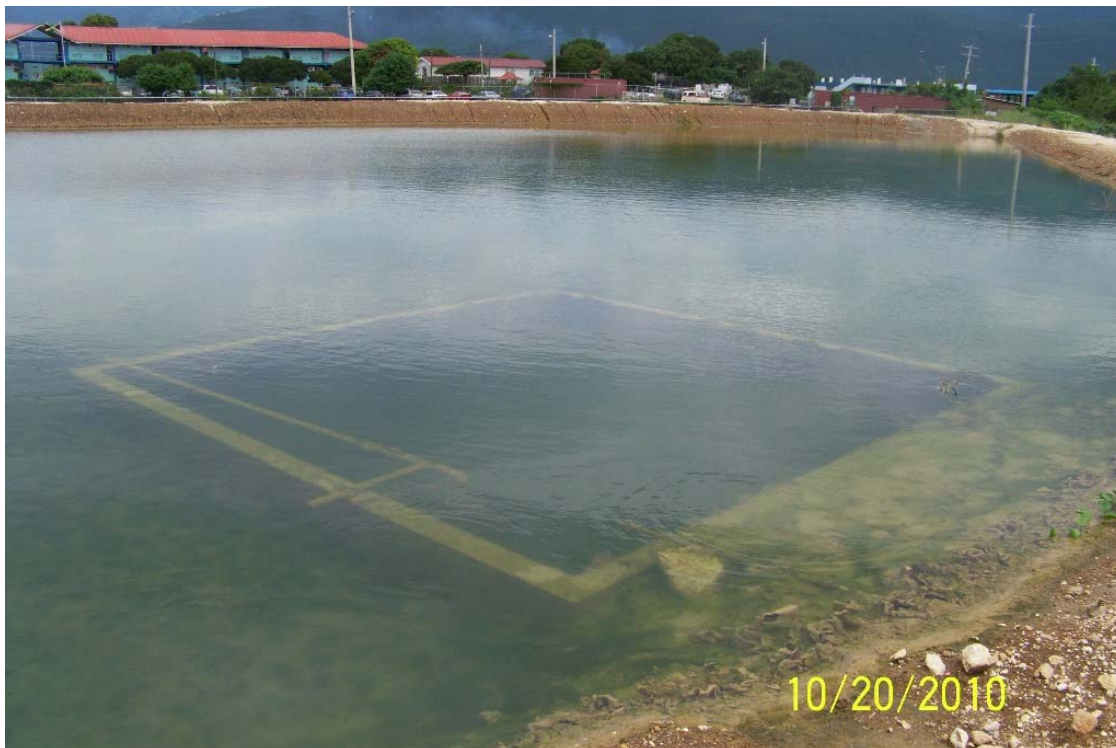
Plate 8 Photo showing leachate sample point

DRO values were detected in the leachate sample, due to the treatment of the contaminated sand in this section of the landfarm. Water from the sprinkler system and rainfall percolate through the contaminated sand and rocks, and upon reaching the final clay layer, flows toward the leachate containment area where it is stored until it evaporates. DRO values in the leachate sample have also decreased compared to last month's values. There were also minor traces of DRO in monitoring Wells 3 and 5.

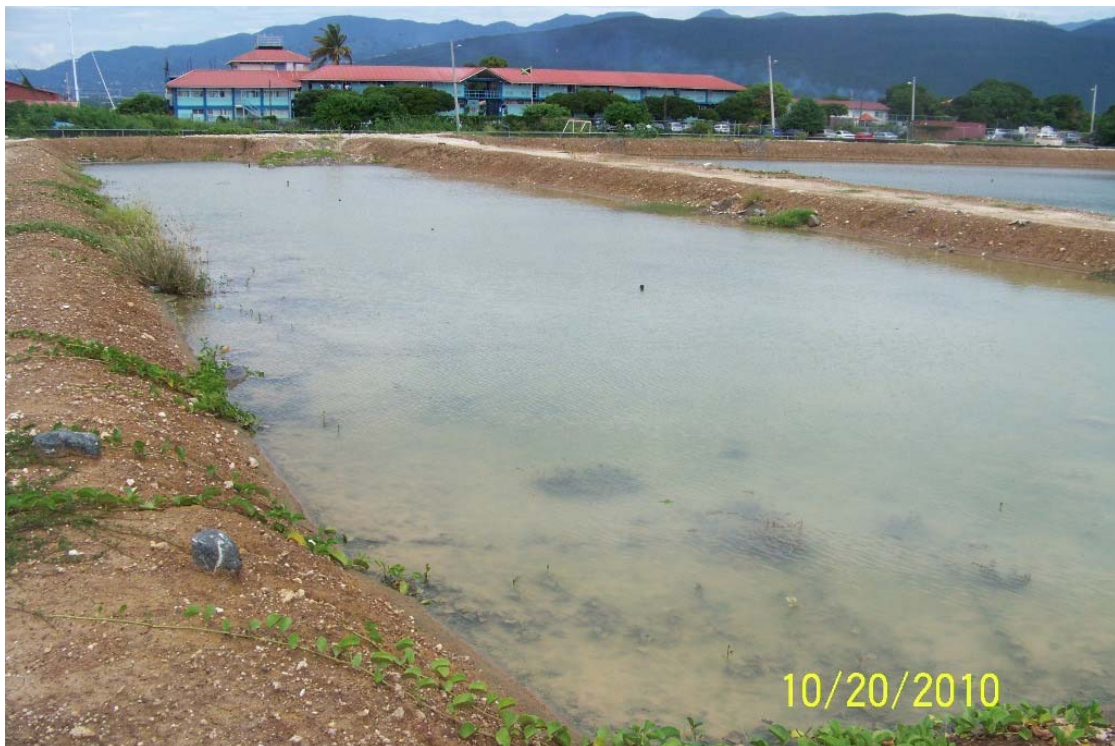
Plate 10 Photo showing flooded storage area at landfarm
