DUNE RESTORATION MONITORING REPORT 2
FOR
AMERICAN AIRLINES 331 ACCIDENT SITE

Submitted to:
AMERICAN AIRLINES

Prepared by:
C.L. ENVIRONMENTAL CO. LTD.
22 Fort George Heights
Kingston 9
Jamaica, WI

DECEMBER 2010

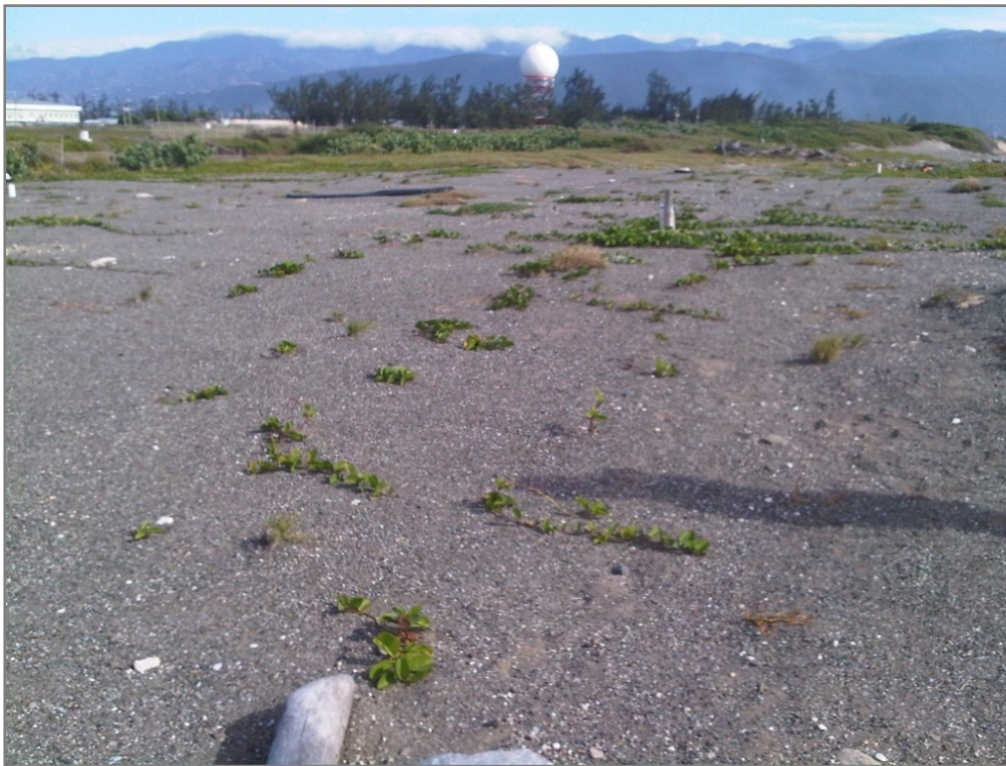
Plate 1 shows the Dune Restoration site after four months.

Plate 1 American Airlines Dune Restoration Site-December (Month 4)

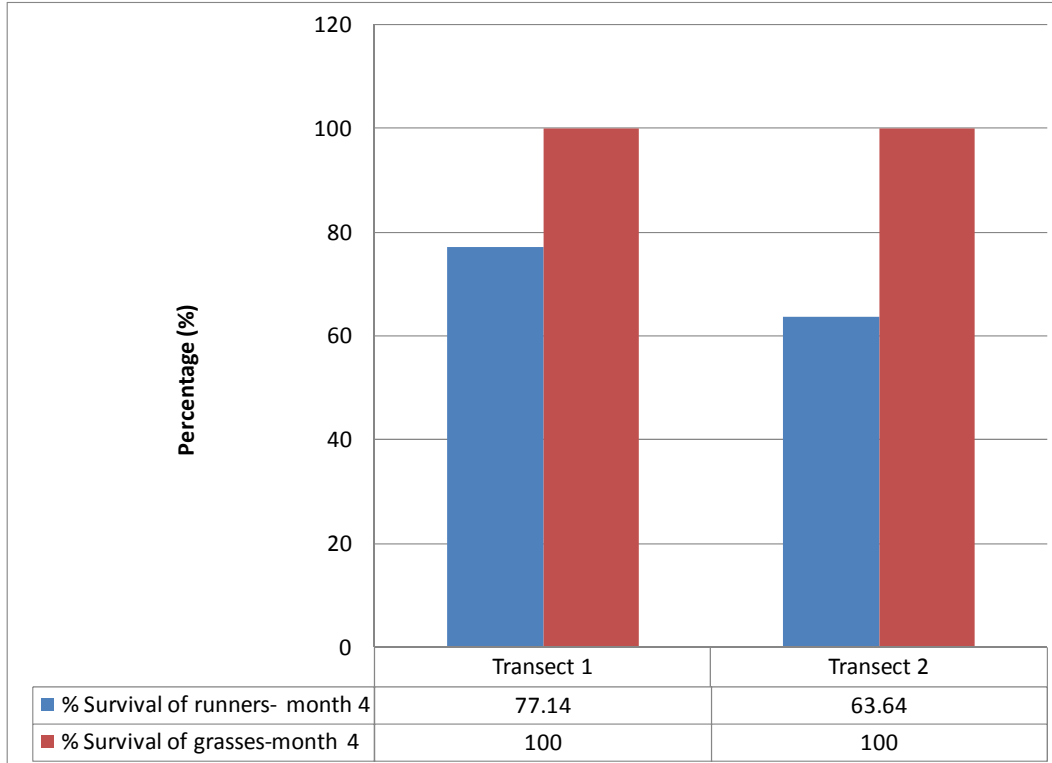
There was 100% survival of the grass (*Sporobolus*) in both transects. Survival for the runners (*Ipomea* and *Sessuvium*) in both transects was not as impressive, with an average survival of 70.39% (Table 1, Figure 2).

Figure 2 Percentage survival of runners and grasses in each transect

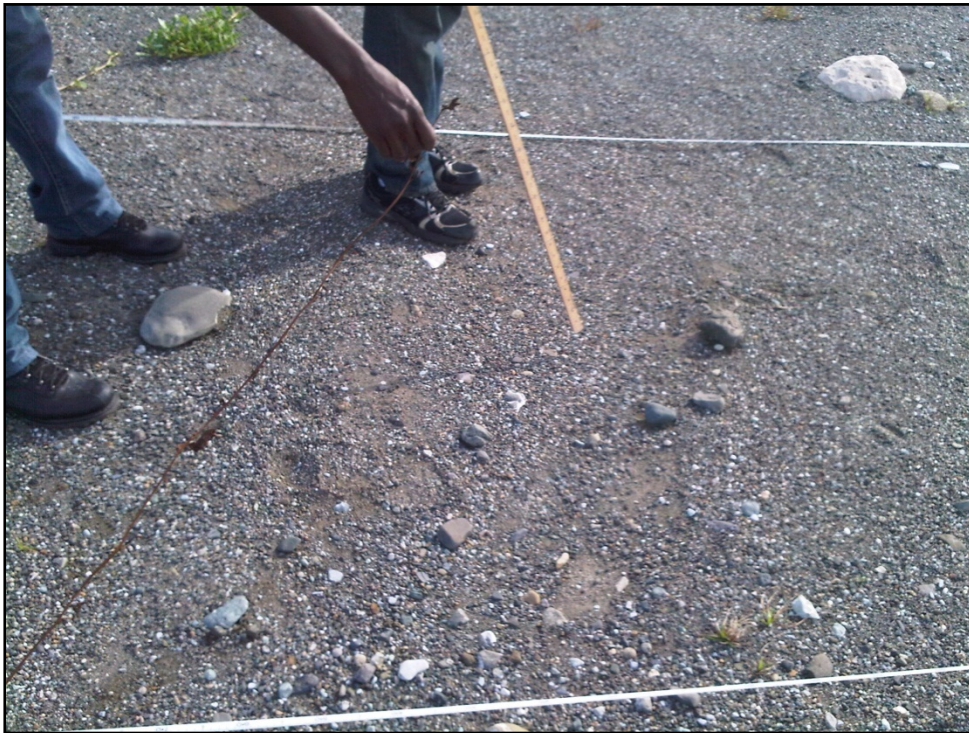
In the previous report a noticeable mortality in the northern end of transect 1 was discussed. This area was theorized to be affected directly by the heat exhaust from departing airplanes from the NMIA runway. However, observations this period show survival of plants closer to the jet-blast. The area referred to seems to be more affected by the drainage of the sand dune. Drainage grooves were noticed in this area, which indicate that the plants are being affected by a surplus of water during heavy rains (Plate 4).

Plate 4 Drainage grooves in area of plant mortality in Transect 1

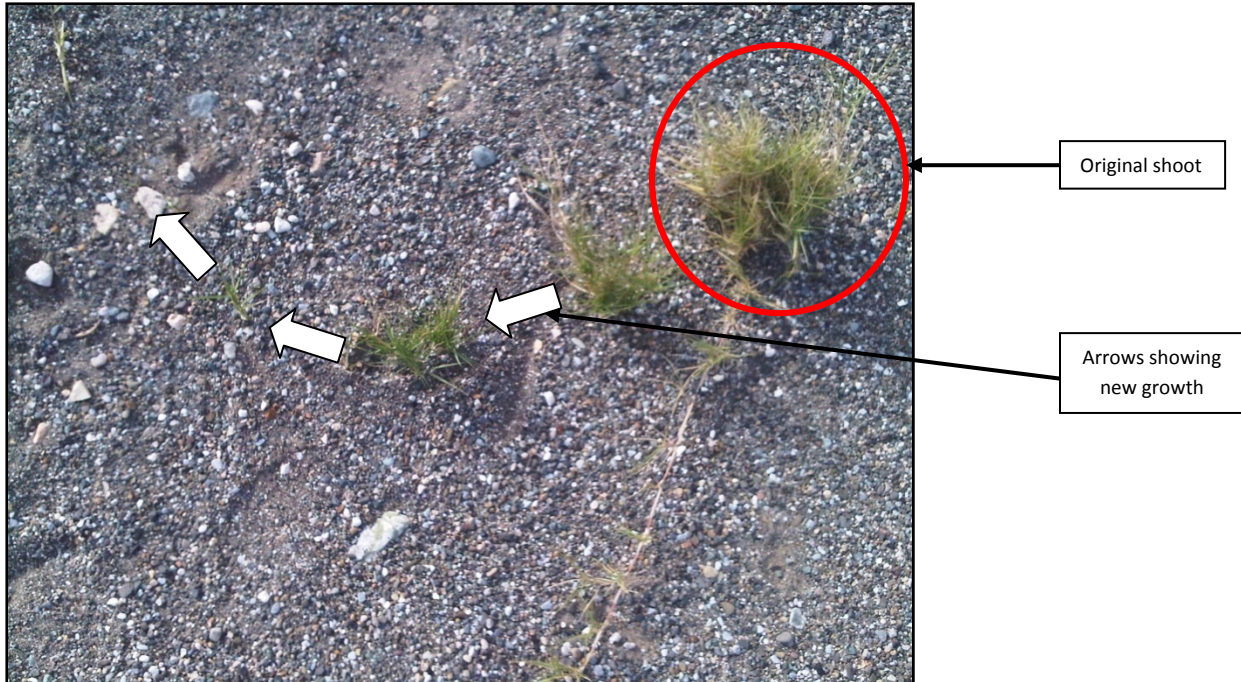
The majority of *Sporobolus* individuals exhibited an increase in percentage cover over the four (4) month period. These grasses are showing positive growth, despite a small increase in leaf cover. A few individuals are showing impressive root extension from which new shoots are emerging (Plate 5).

Plate 5 *Sporobolus* showing positive growth of root and shoot

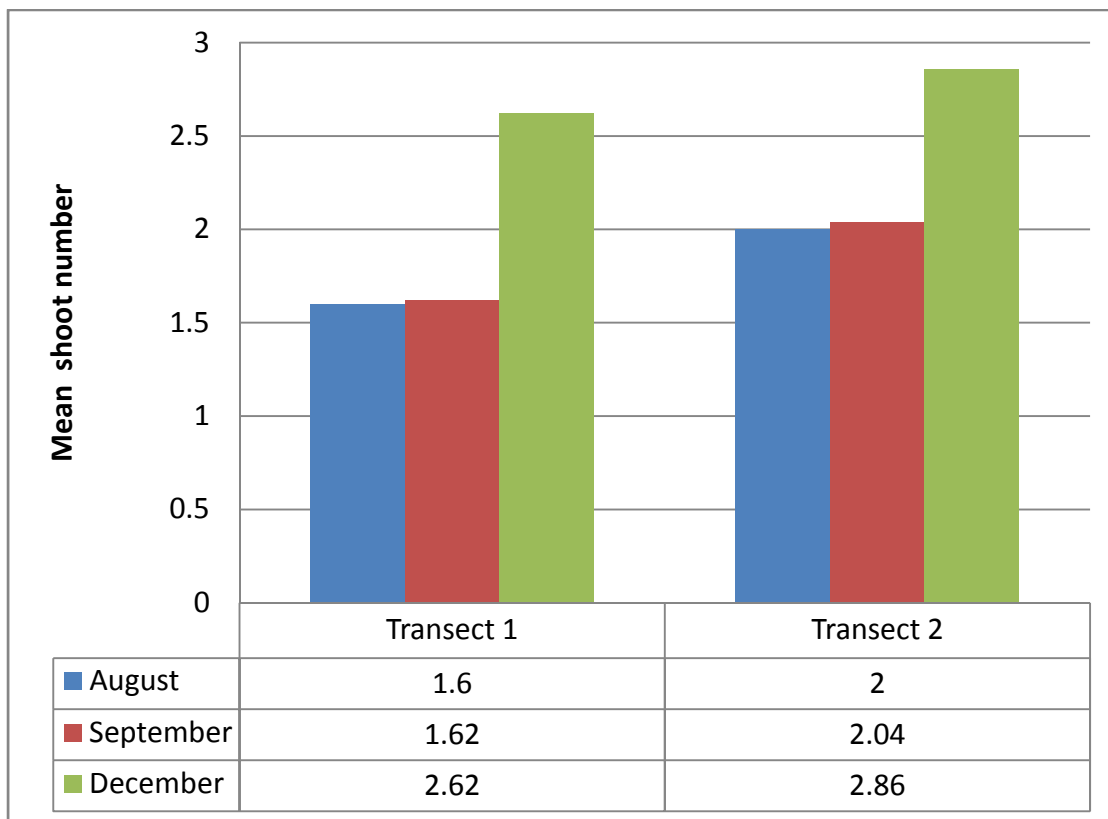
Plant growth within the restoration area is showing a positive increase in comparison to recovery period in September 2010 (Table 2, Figure 3). Despite the majority of runners having no net increase in shoot numbers, the average shoot number increased by 0.66 shoots per plant in transect 1 and 0.86 per plant in transect 2. This new growth is important to the runners colonizing the area.

Figure 3 Mean shoot number for both transects

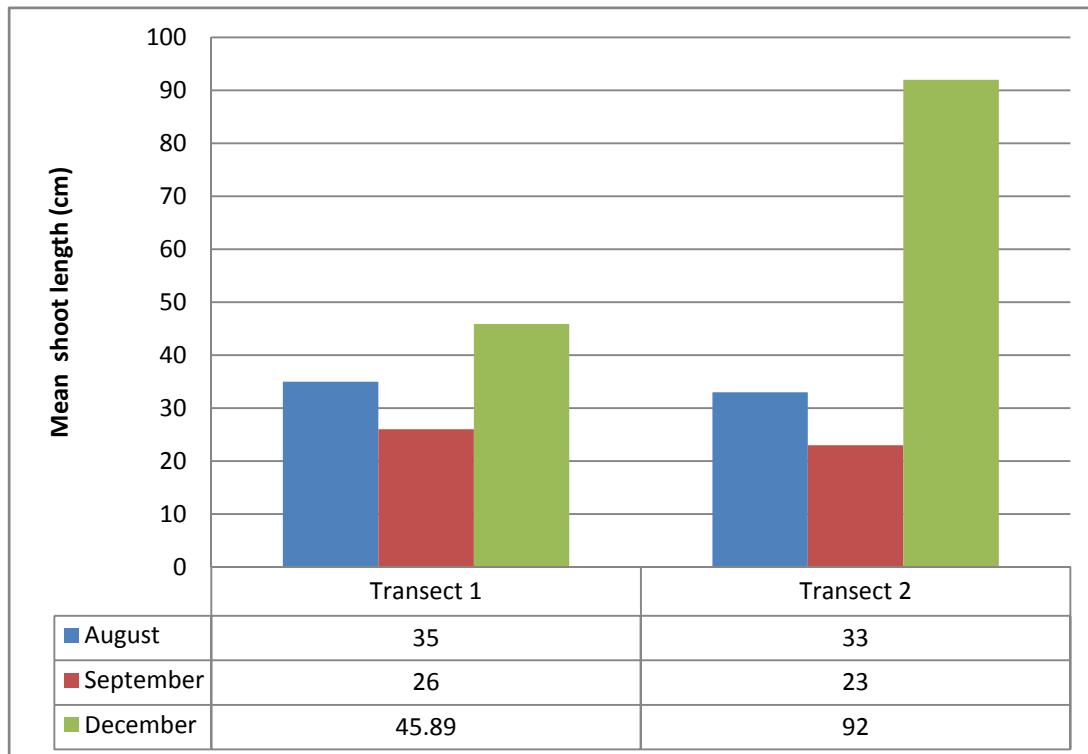
The increase in growth of shoots for the restoration site was impressive. Both transects had approximately 200% increase in average shoot length for shoots measured (Plate 6). This is indicative of a growth spurt following the plant’s post-transplant recovery (Table 3, Figure 4).

Figure 4 Mean shoot length for both transects

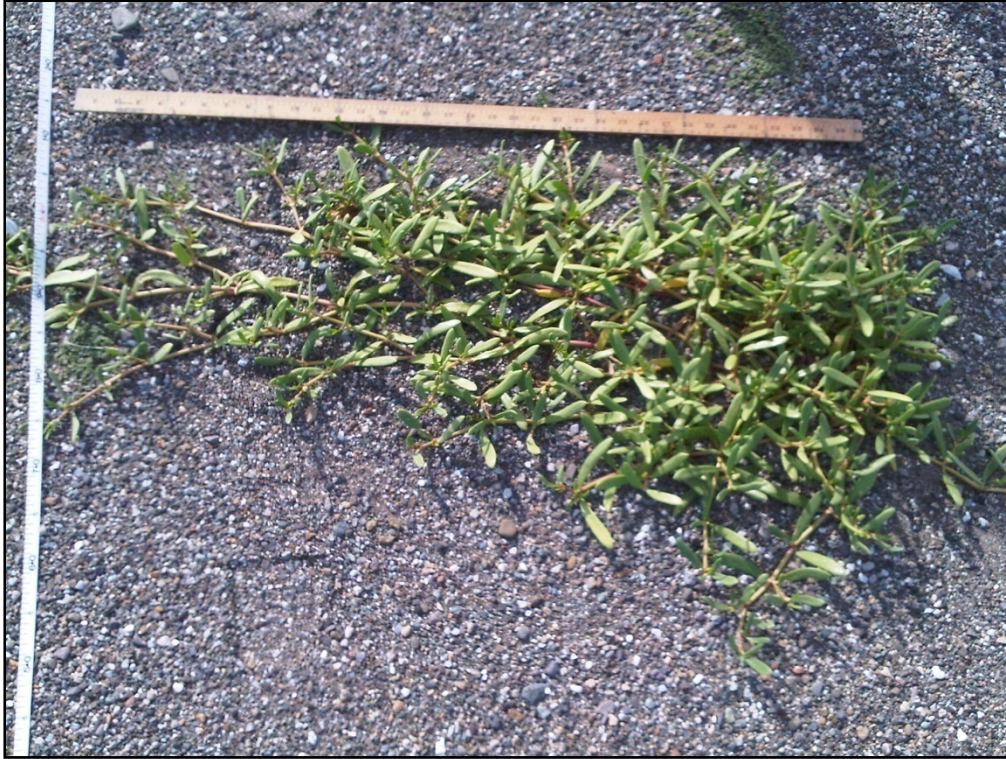
Plate 6 *Sesuvium* plant showing over 200% increase in shoot length
