DUNE RESTORATION MONITORING REPORT 1
FOR
AMERICAN AIRLINES 331 ACCIDENT SITE

Submitted to:
AMERICAN AIRLINES

SEPTEMBER 2010

Prepared by:
C.L. ENVIRONMENTAL CO. LTD.
22 Fort George Heights
Kingston 9
Jamaica, WI

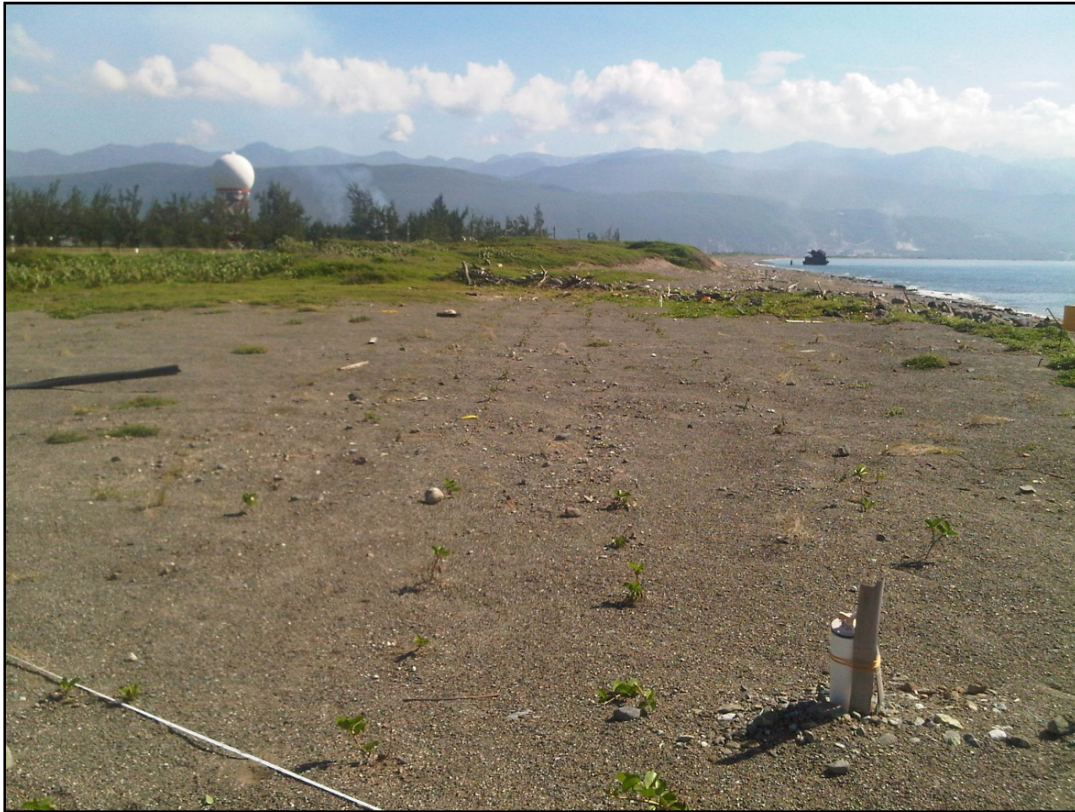
Plate 1 shows the Dune Restoration site during the first month.

Plate 1 Dune restoration site (facing east), September (month 1)

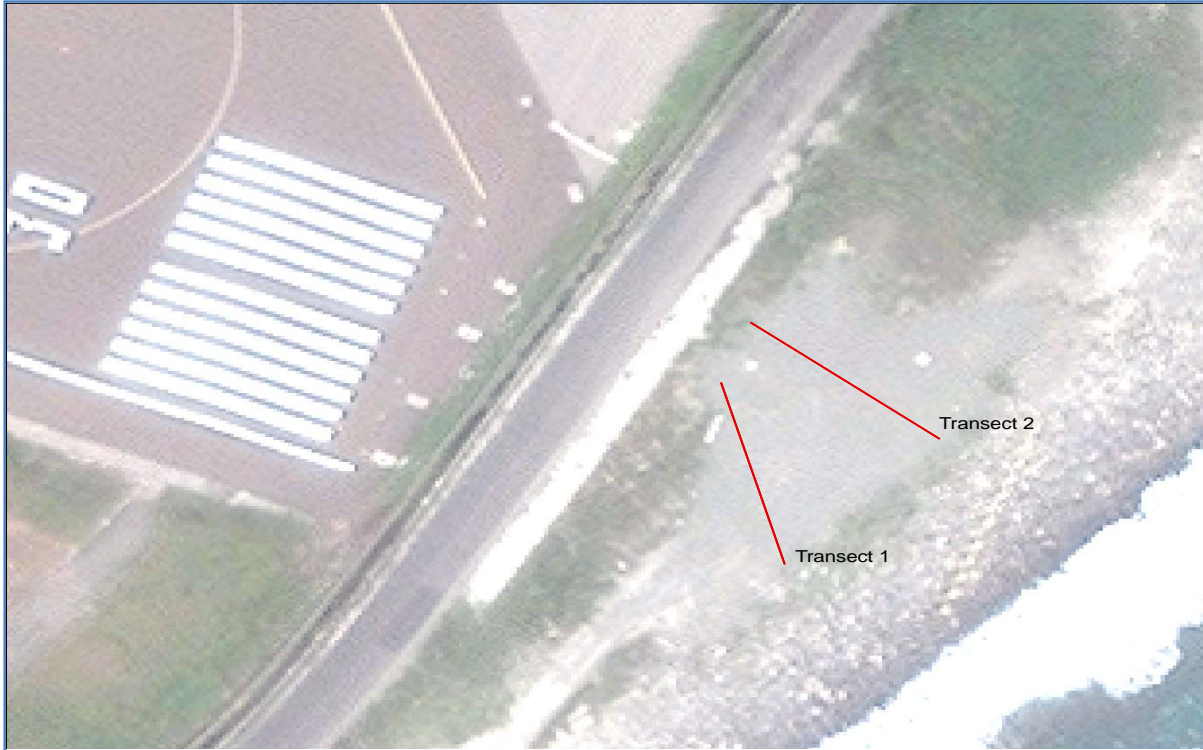
During post planting monitoring, two belt transects which were two meters wide by thirty-two meters long, previously established at the restoration site, were used to determine both growth and survivorship. The transect began at the southern end (seaward) of the area at the edges of the replanted site and ran diagonally across the area ending at the western edges of man-holes close to the roadway (Figure 1).

Figure 1 Map showing locations of belt transects at dune restoration site

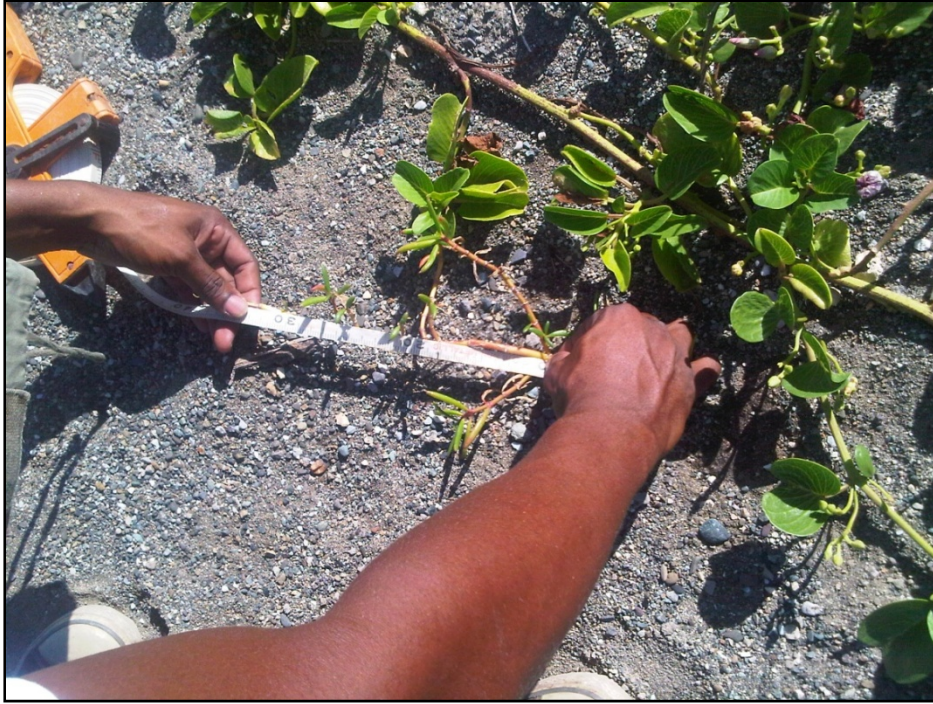
Data was then collected along the transect using 2m x 2m quadrats. Plant growth was measured in terms of three parameters: percentage cover (grasses), shoot length and shoot numbers (runners) (Plates 2-3). Species position, type and general health were also noted.

Plate 2 Photo showing measurement of shoot lengths

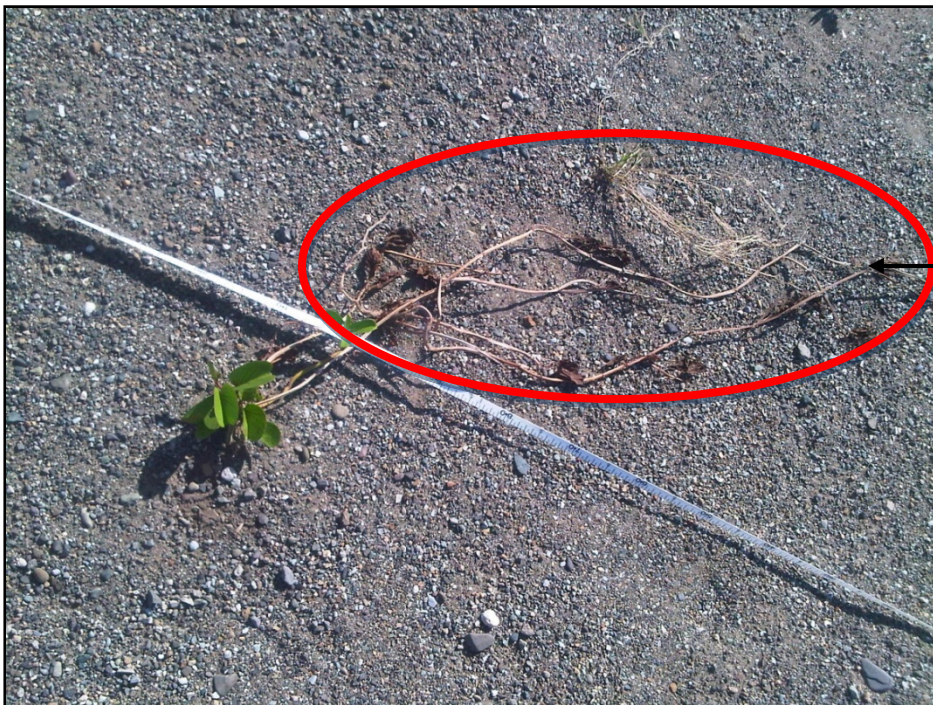
Plate 3 Photo showing method for shoot measurements of runners

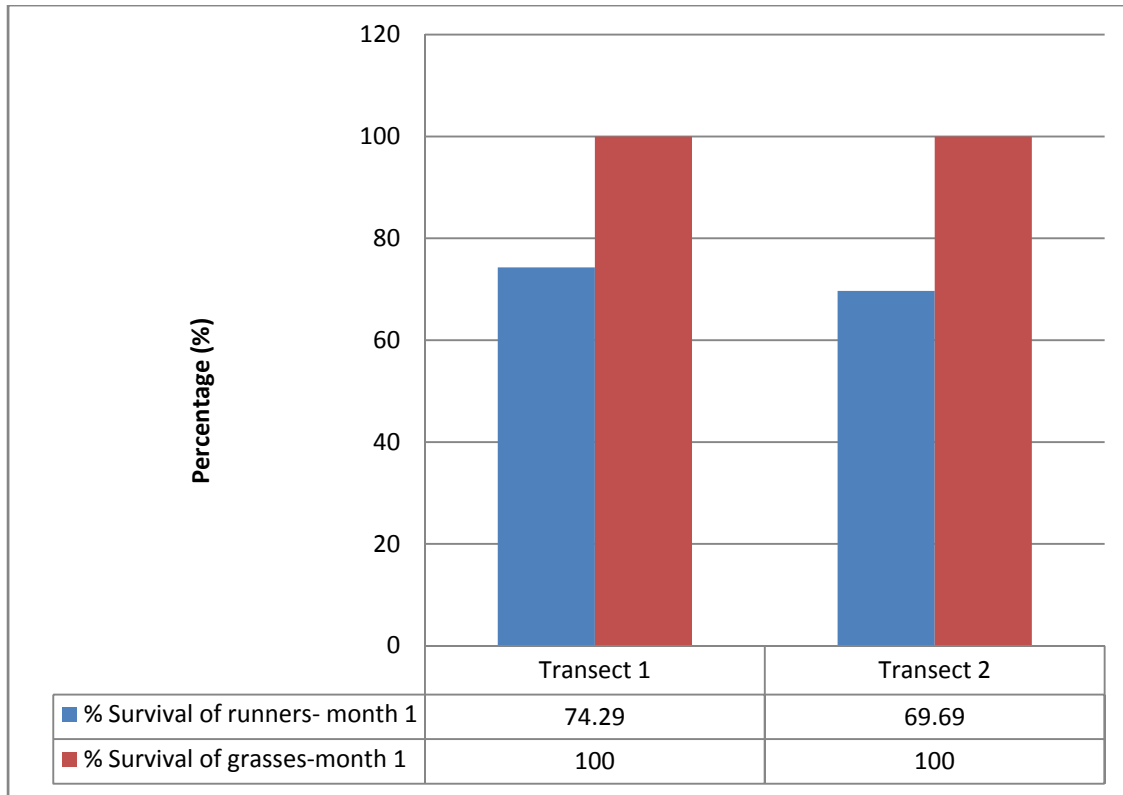
There was 100% survival of the grass (*Sporobolus*) in both transects. Survival for the runners (*Ipomea* and *Sessuvium*) were lower in both transects, with an average survival of 71.9% (Table 1, Figure 2).

Figure 2 Percentage survival of runners and grasses in each transect

It must be noted that there was a noticeable mortality at the northern end of Transect 1 which is situated closer to the main road. This area is theorized to be affected directly by the heat from jet blast exhaust from departing airplanes from the NMIA runway.
