**National Environment
and Planning Agency**

POLLUTION INCIDENT INVESTIGATION REPORT

**NOXIOUS FUMES POLLUTION INCIDENT,
PORTMORE TOLL PLAZA, ST. CATHERINE
28-30 JUNE 2012**

Prepared by National Environment and Planning Agency
27 November 2012

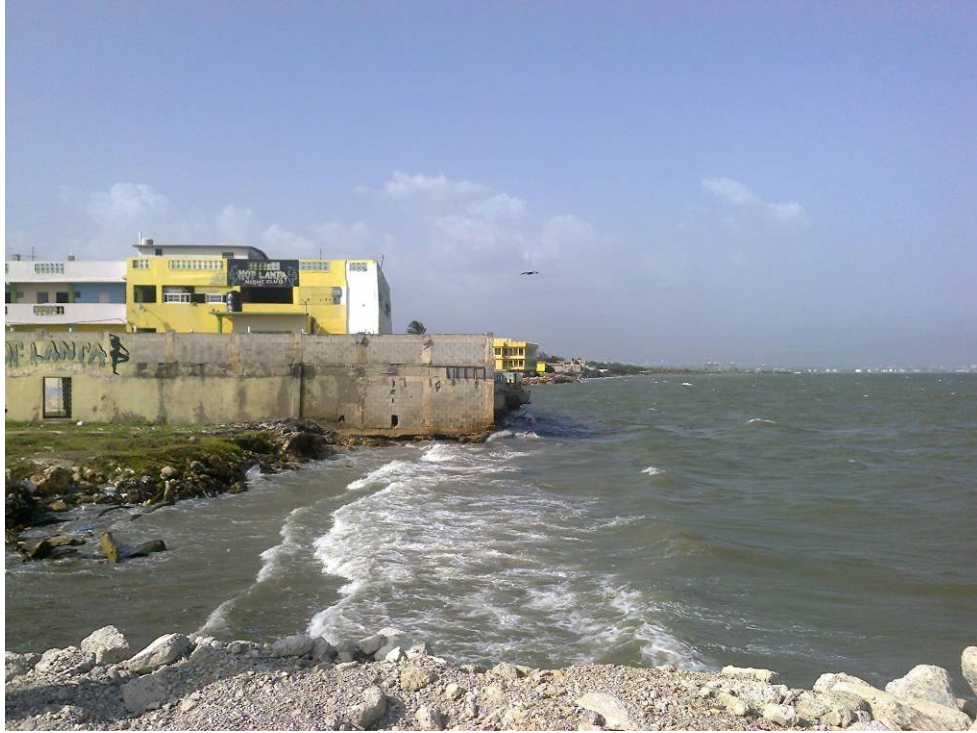
Picture 1: Coastal Water Eastward along Port Henderson Road on 2012-06-28

McMaster's property and the areas around the bridge at the opening to Dawkins Pond were assessed. No odour was detected (see Picture 1).

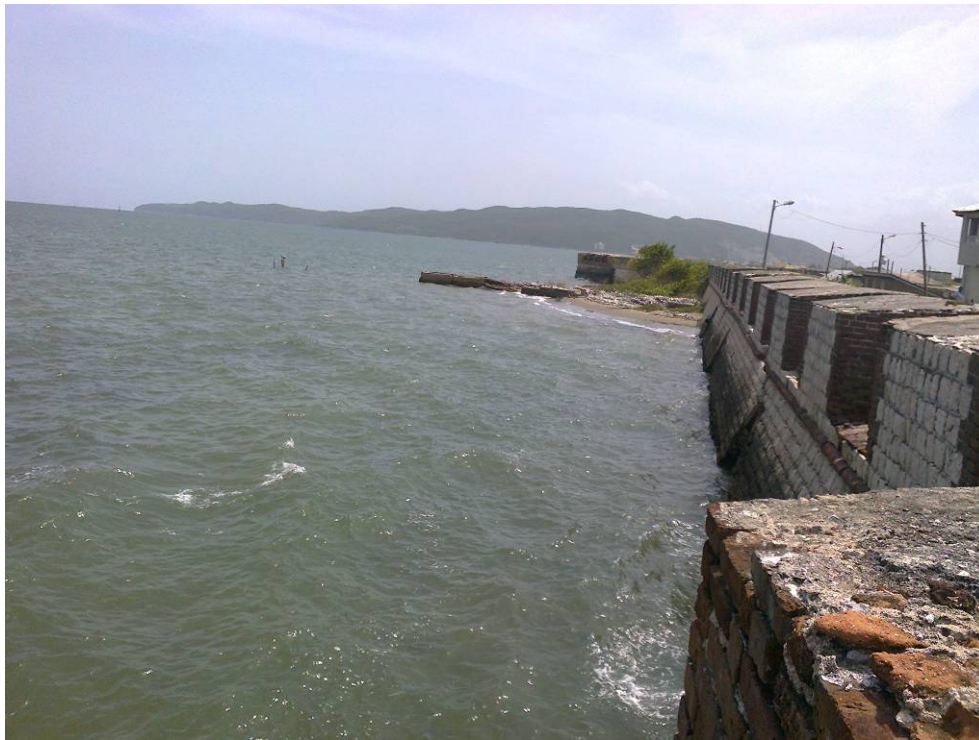
Picture 2: Coastal Water at Fort Augusta Prison on 2012-06-29

The Fort Augusta Prison compound (see Picture 2) was assessed on June 28. At that time no kerosene oil scent was detected. The Liquefied Petroleum Gas (LPG) Storage and Diesel Oil Tank on the compound was found to be in a satisfactory condition. No oil sheen was observed on the water. The persons interviewed were not affected by any noxious fumes. Two persons reported irritation of the sinuses. No one sought medical attention.

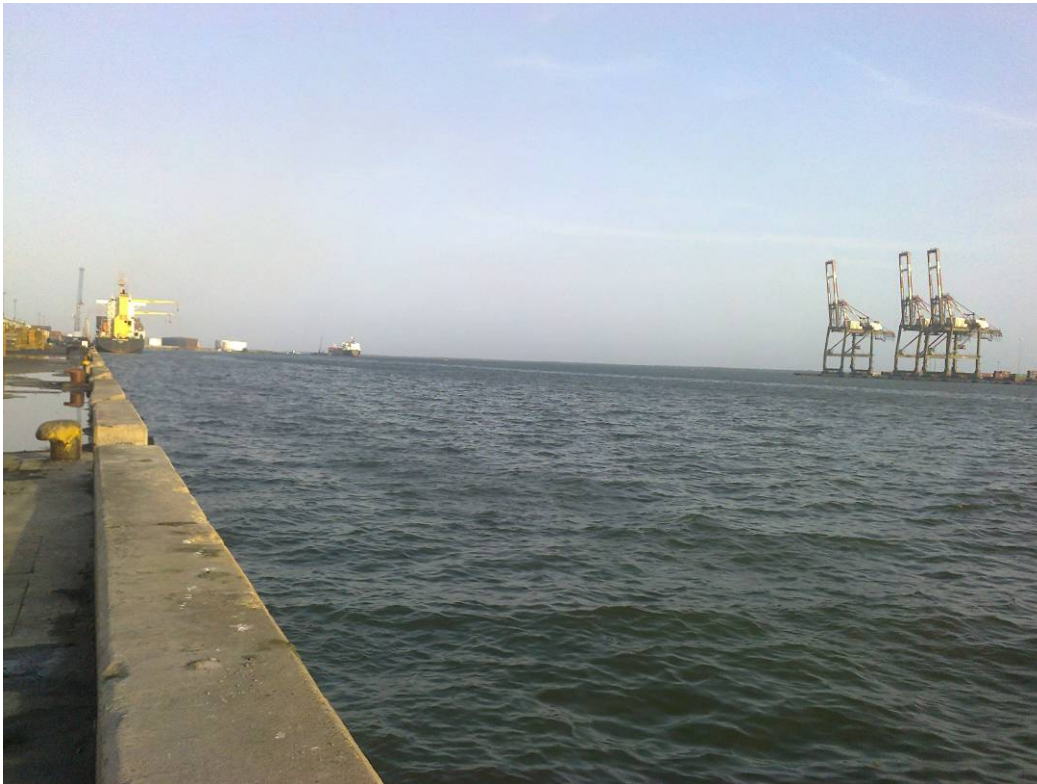
Picture 3: Coastal Water along Wharves on 2012-06-29

These areas were inspected on the June 29 and two isolated containers containing a pesticide and spilt chemicals were assessed. The containers were emanating odours dissimilar to that experienced at the Toll Plaza, Fun City Beach and the Portmore area. A puddle of oil - that was determined to be lubricating oil was observed at Newport West. There was no major spillage observed. No oil sheen was observed on around the coastal waters associated with Gordon Cay and along the Berths. These waters were of normal appearance (see Picture 3).

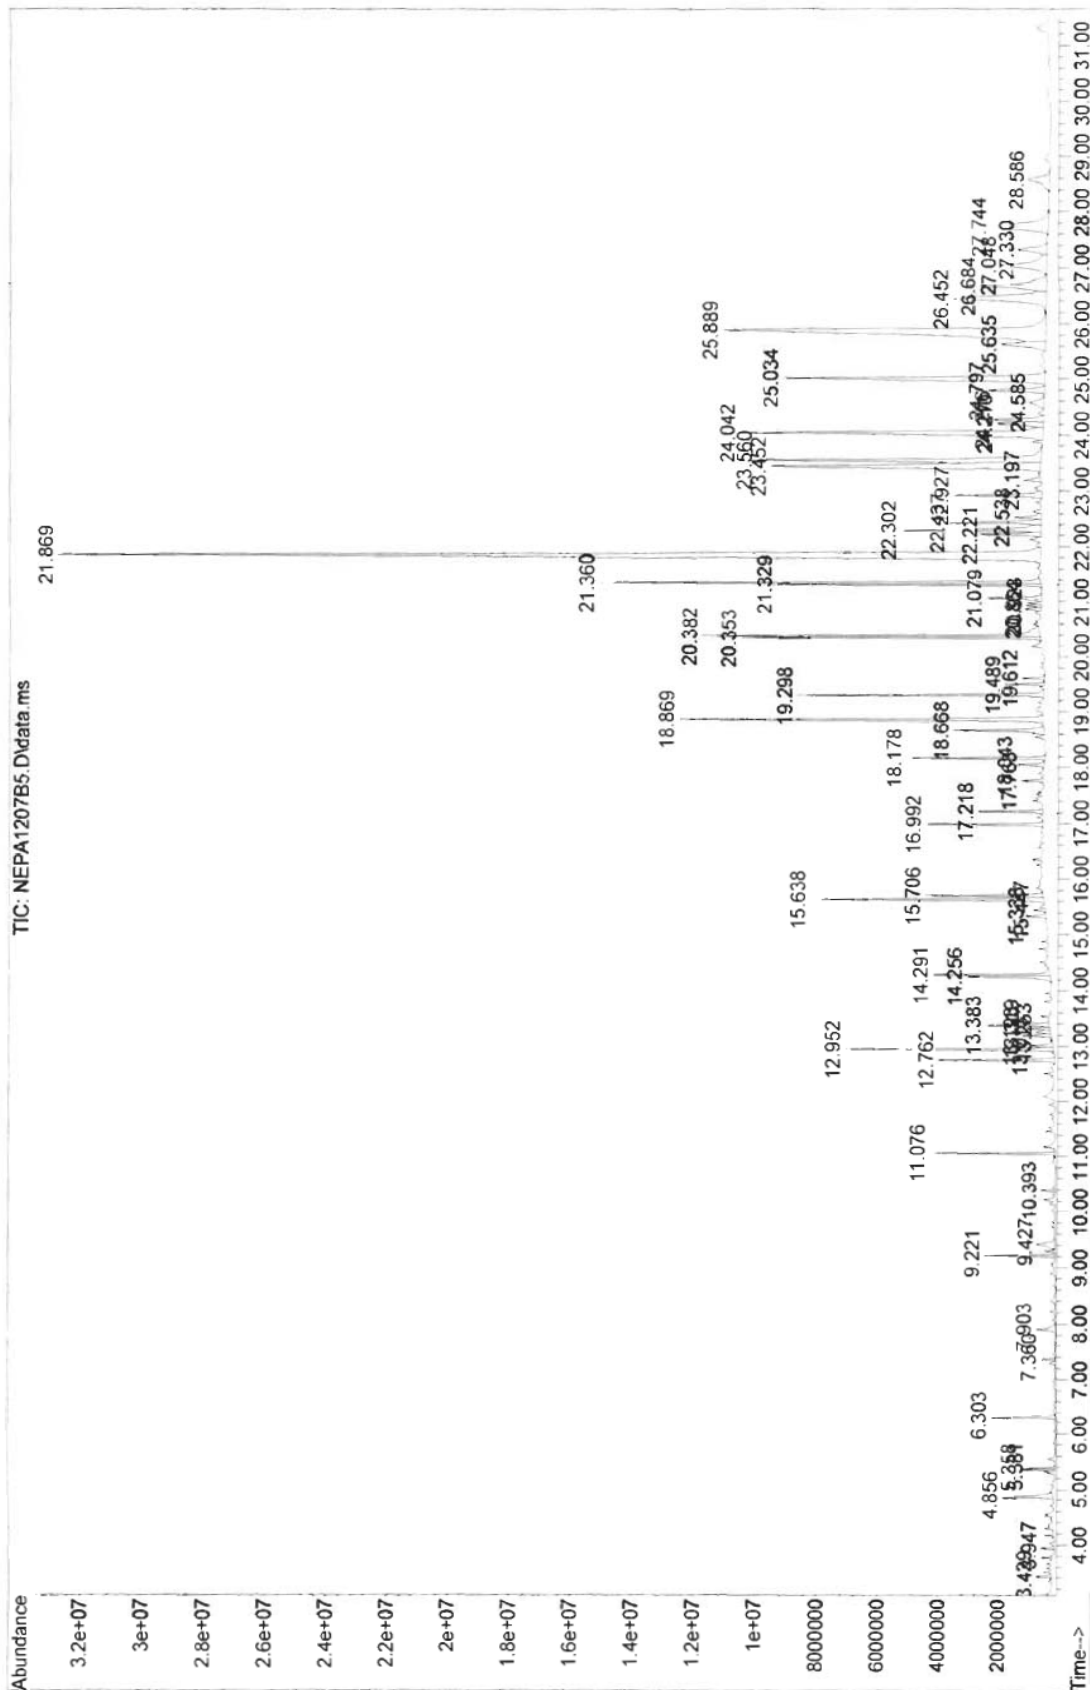
File : C:\msdchem\1\data\PRL\NEPA\NEPA1207B5.D
 Operator : SOPHIA
 Acquired : 7 Jul 2012 16:47 using AcqMethod COFFEE1.M
 Instrument : GCMSD1
 Sample Name : control plant material
 Misc Info : Port. side of toll rd
 Vial Number: 2

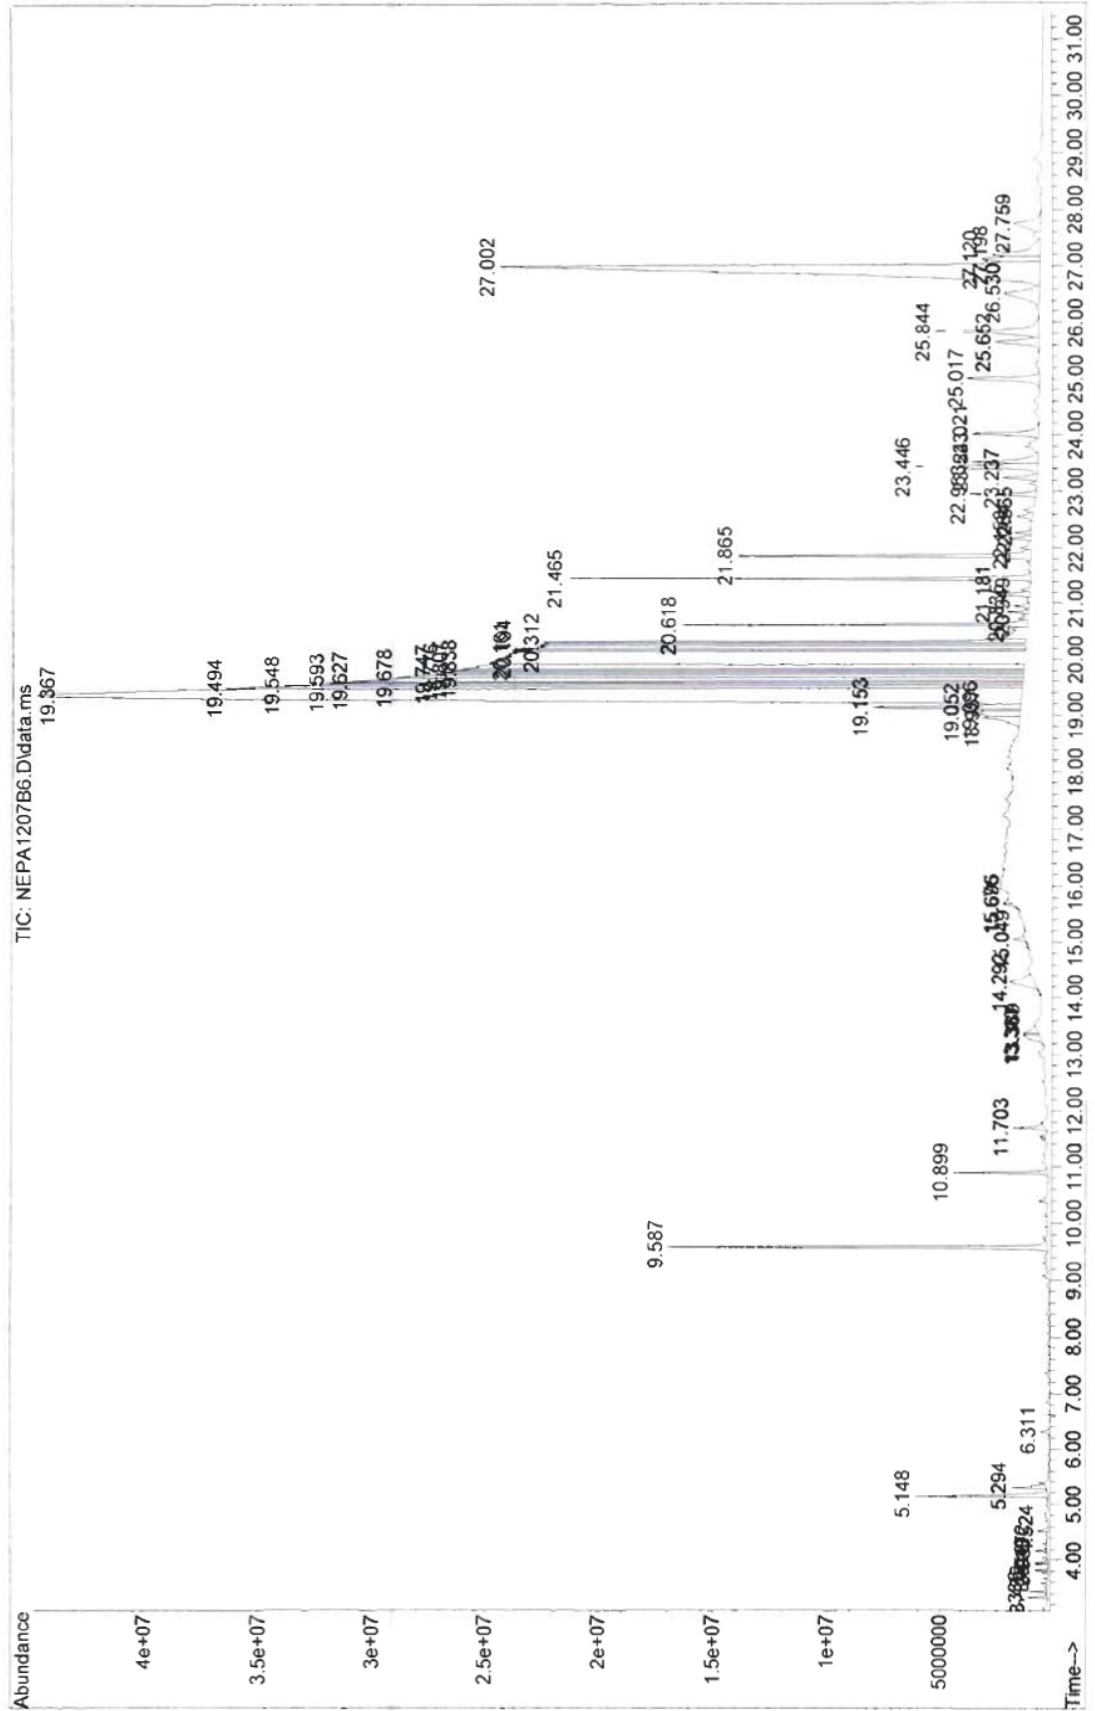
File : C:\msdchem\1\data\PRL\NEPA\NEPA1207B6.D
 Operator : SOPHIA
 Acquired : 7 Jul 2012 17:26 using AcqMethod COFFEE1.M
 Instrument : GCMSD1
 Sample Name : port. toll plaza plant material
 Misc Info : oyster, mangrove plant
 Vial Number : 3

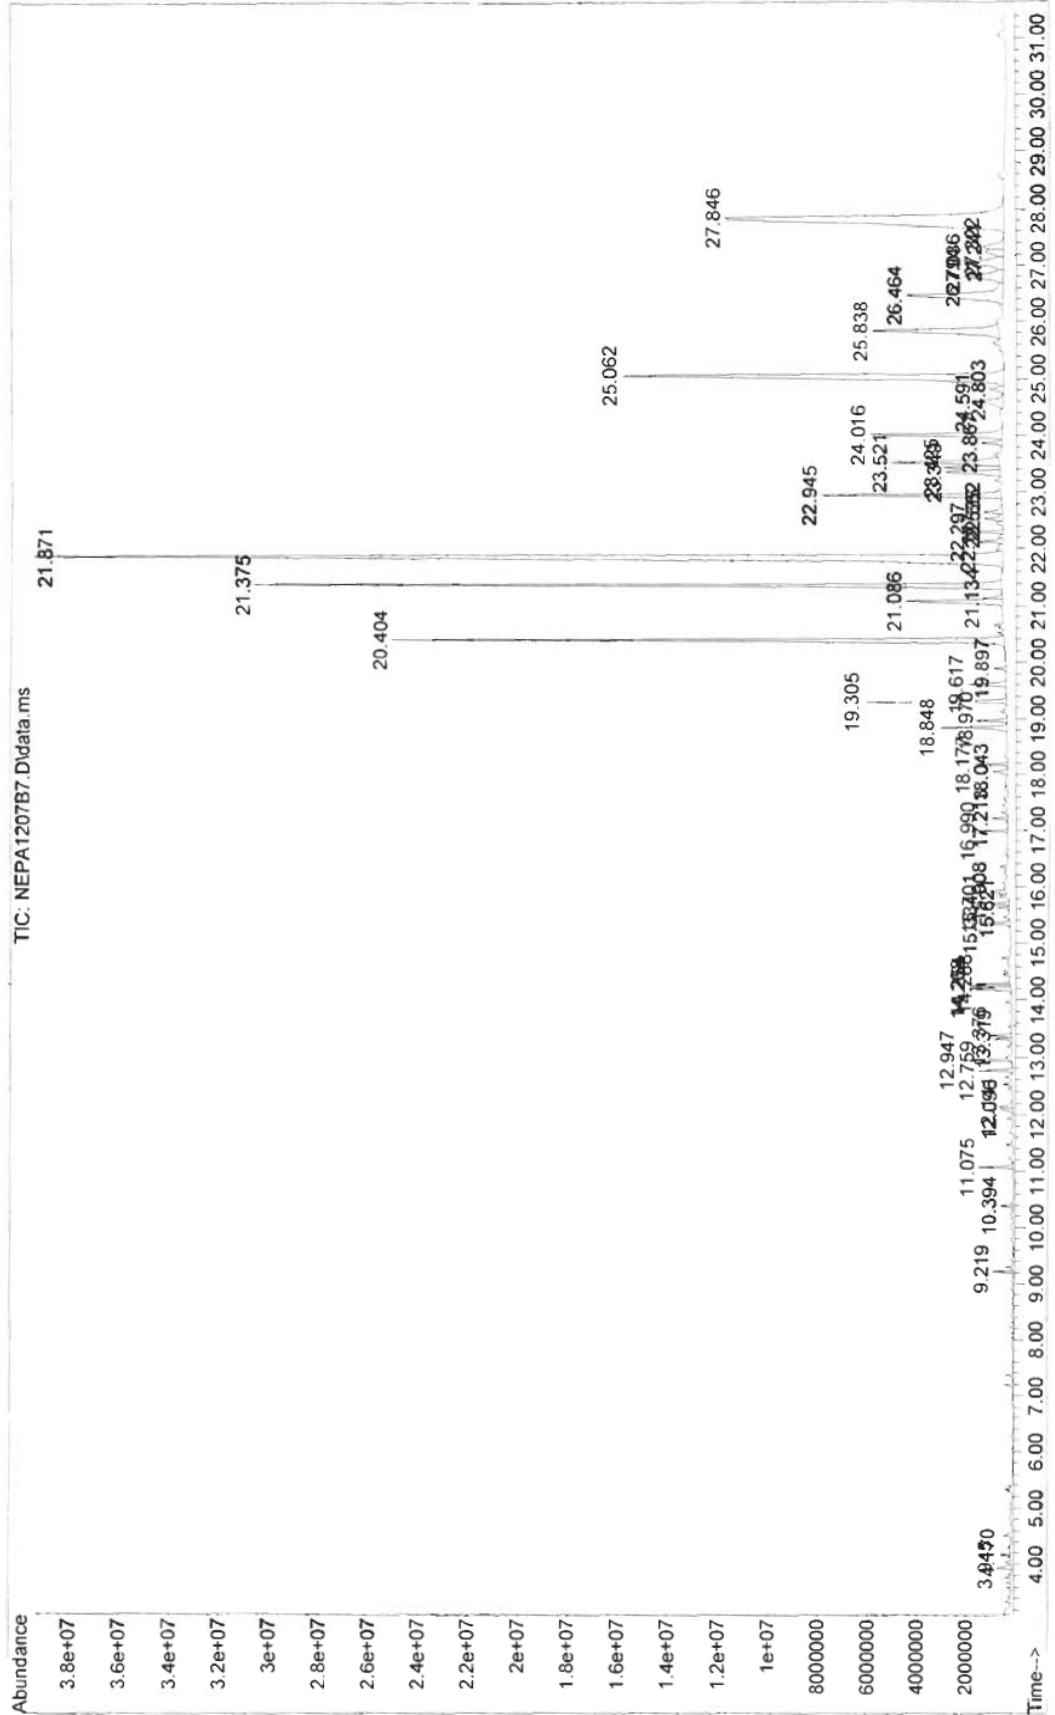
File : C:\msdchem\1\data\PRL\NEPA\NEPA1207B7.D
 Operator : SOPHIA
 Acquired : 7 Jul 2012 18:06 using AcqMethod COFFEE1.M
 Instrument : GCMSDI
 Sample Name: cranes on port. plant material
 Misc Info :
 Vial Number: 4
