**CLOSURE PLAN FOR THE AMERICAN
AIRLINESLANDFARM
IN THE PARISH OF KINGSTON, JAMAICA**

FEBRUARY 2011

CL ENVIRONMENTAL
22 FortGeorgeHeights
Kingston9

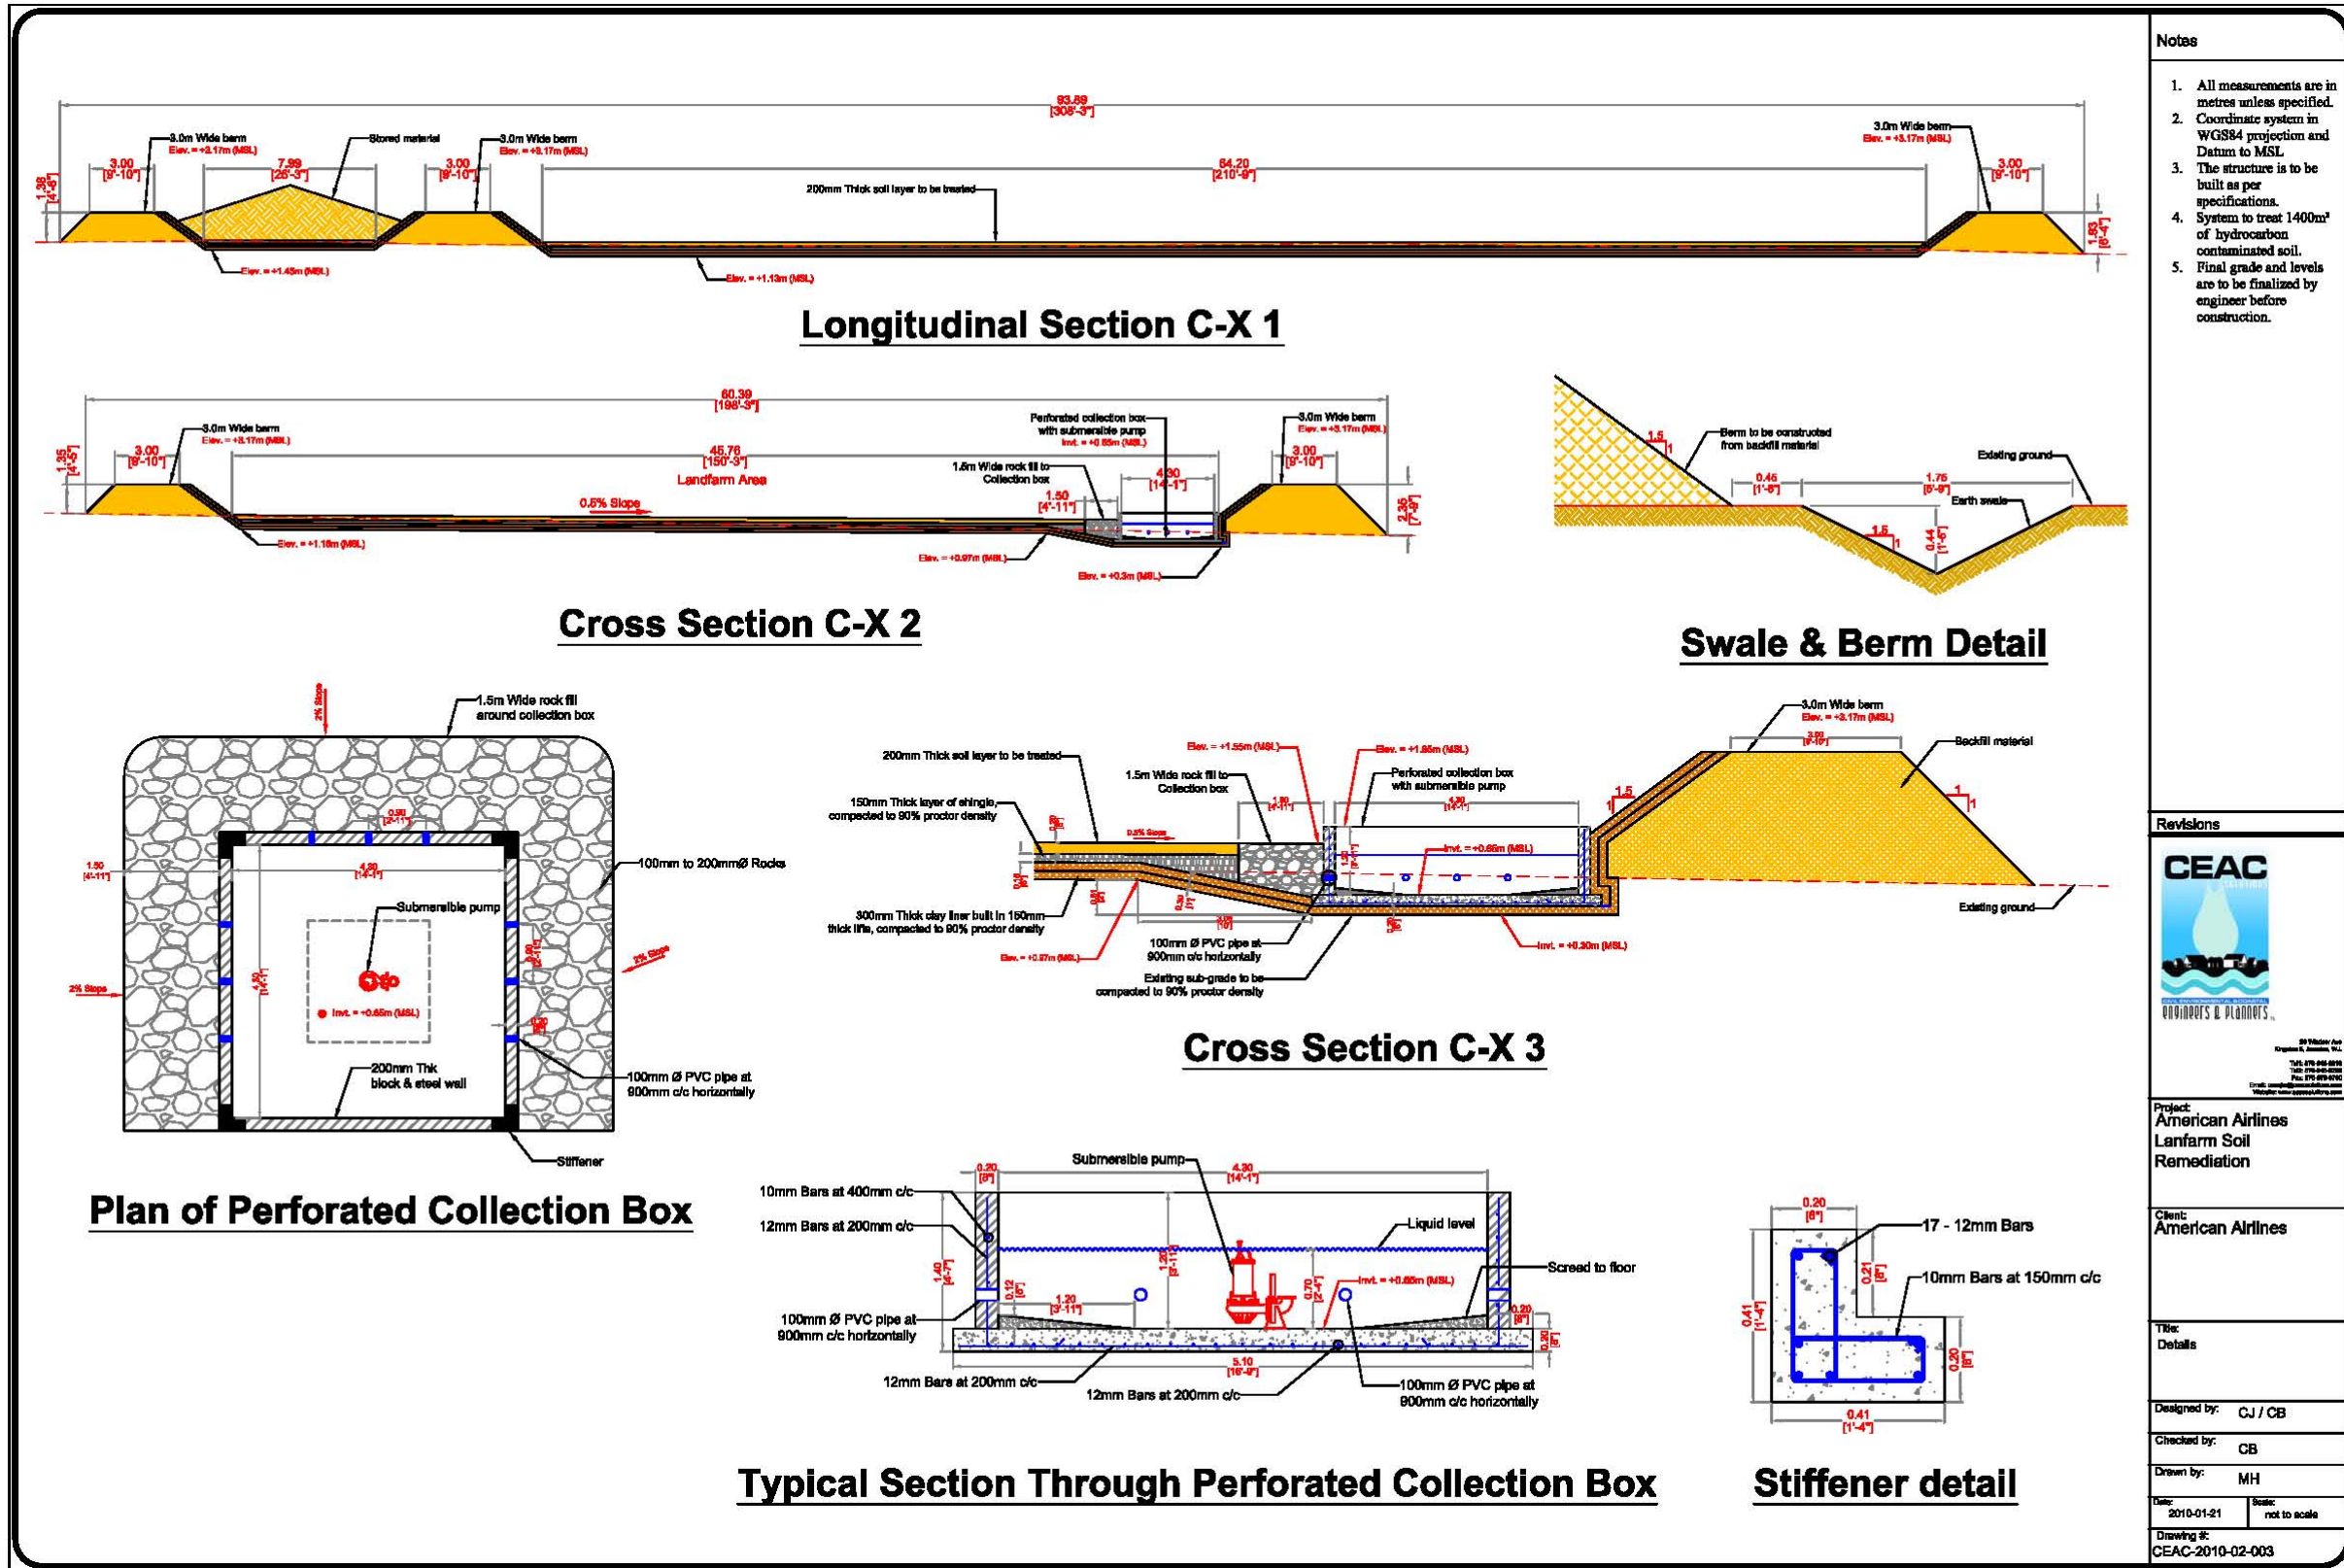
Figure 3 Cross Sections of the Landfarm structures
 American Airlines Lanfarm
 Closure Plan

It is surrounded by a berm 3m (\approx 9.84 ft.) wide and a varying height (\approx 1.38m - 1.93m) (4.52 ft. - 6.33 ft.) above existing elevation. The varying height of the berms resulted in the height of all being 3.17 m (\approx 0.97) above mean sea level (Figure 3).

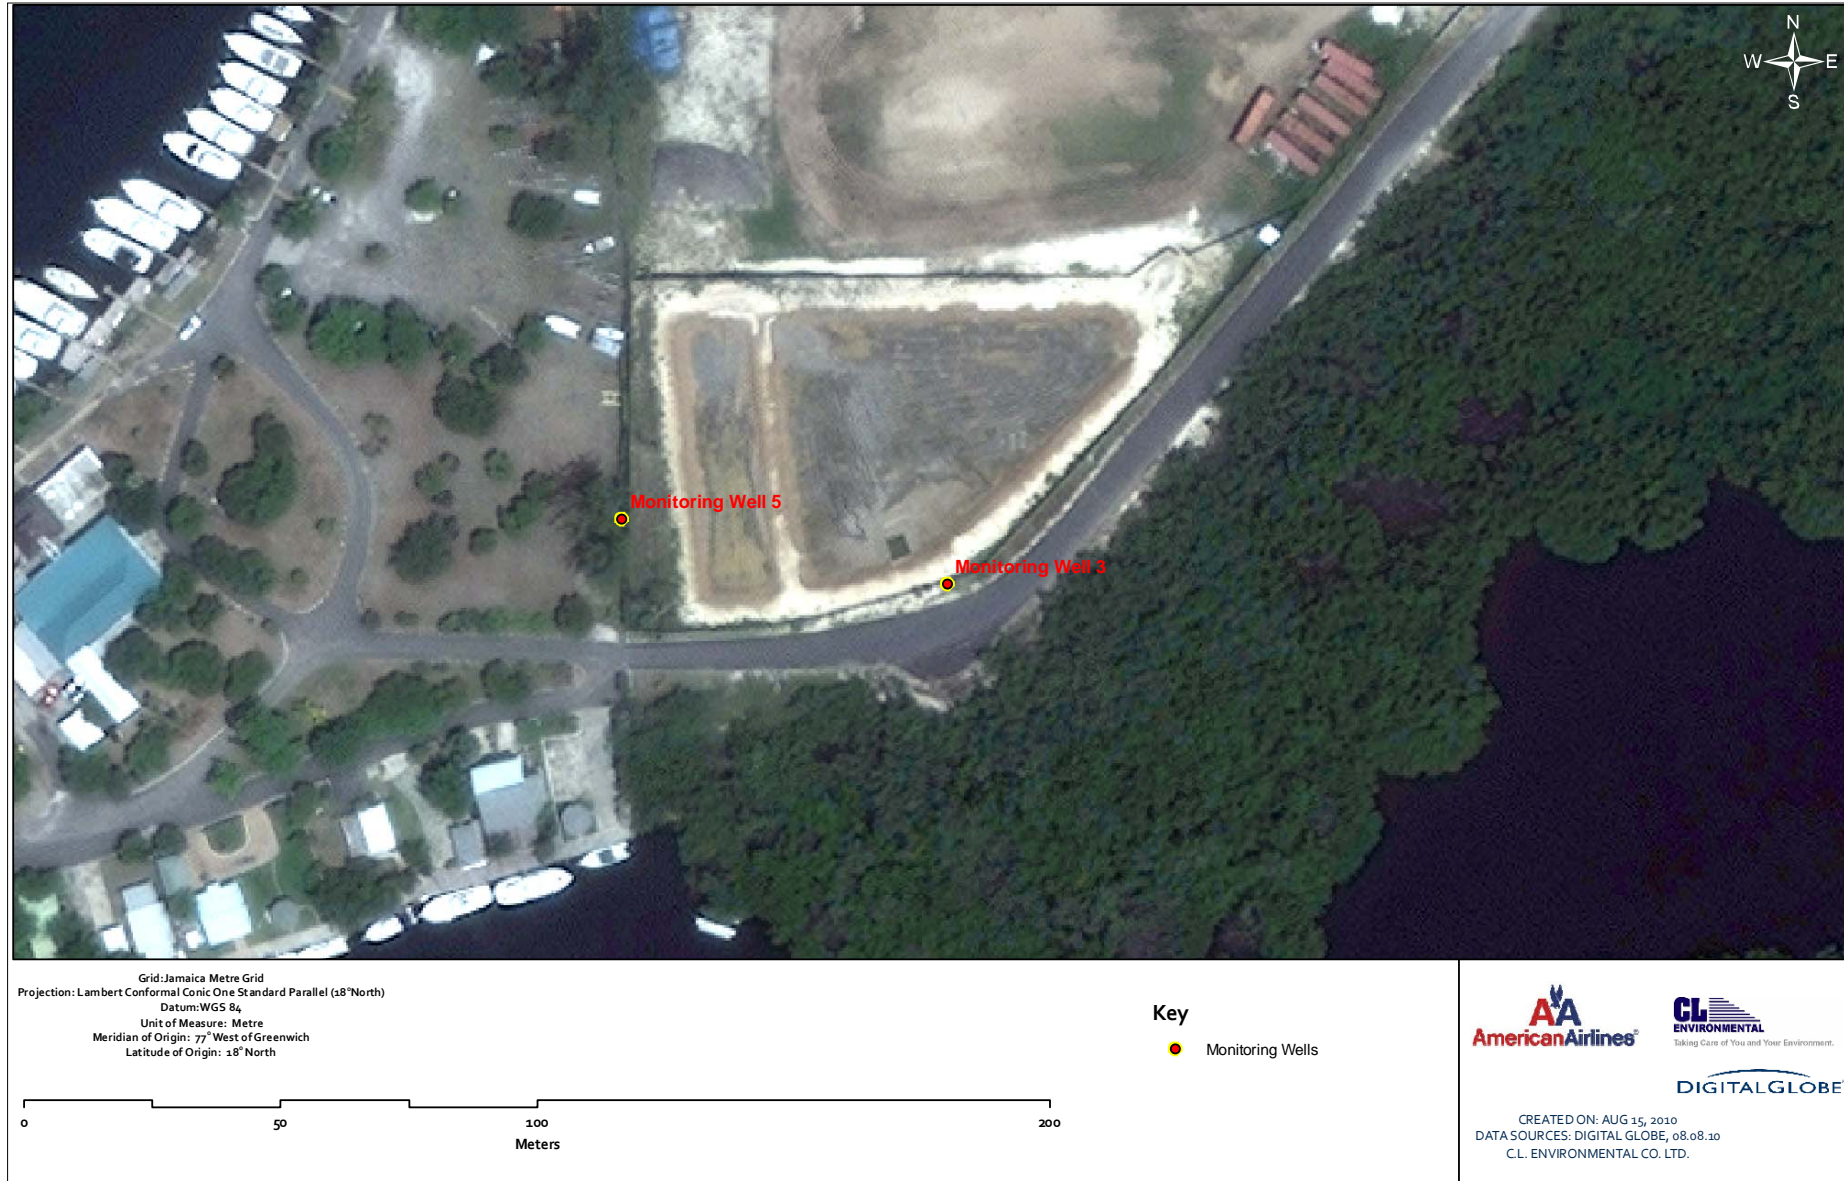
Figure 6 Wells within 1km of the landfarm
American Airlines Landfarm
Closure Plan

There are only two wells and no springs within 1km of the Landfarm area. These were developed as monitoring wells for the Landfarm activities (Figure 6).

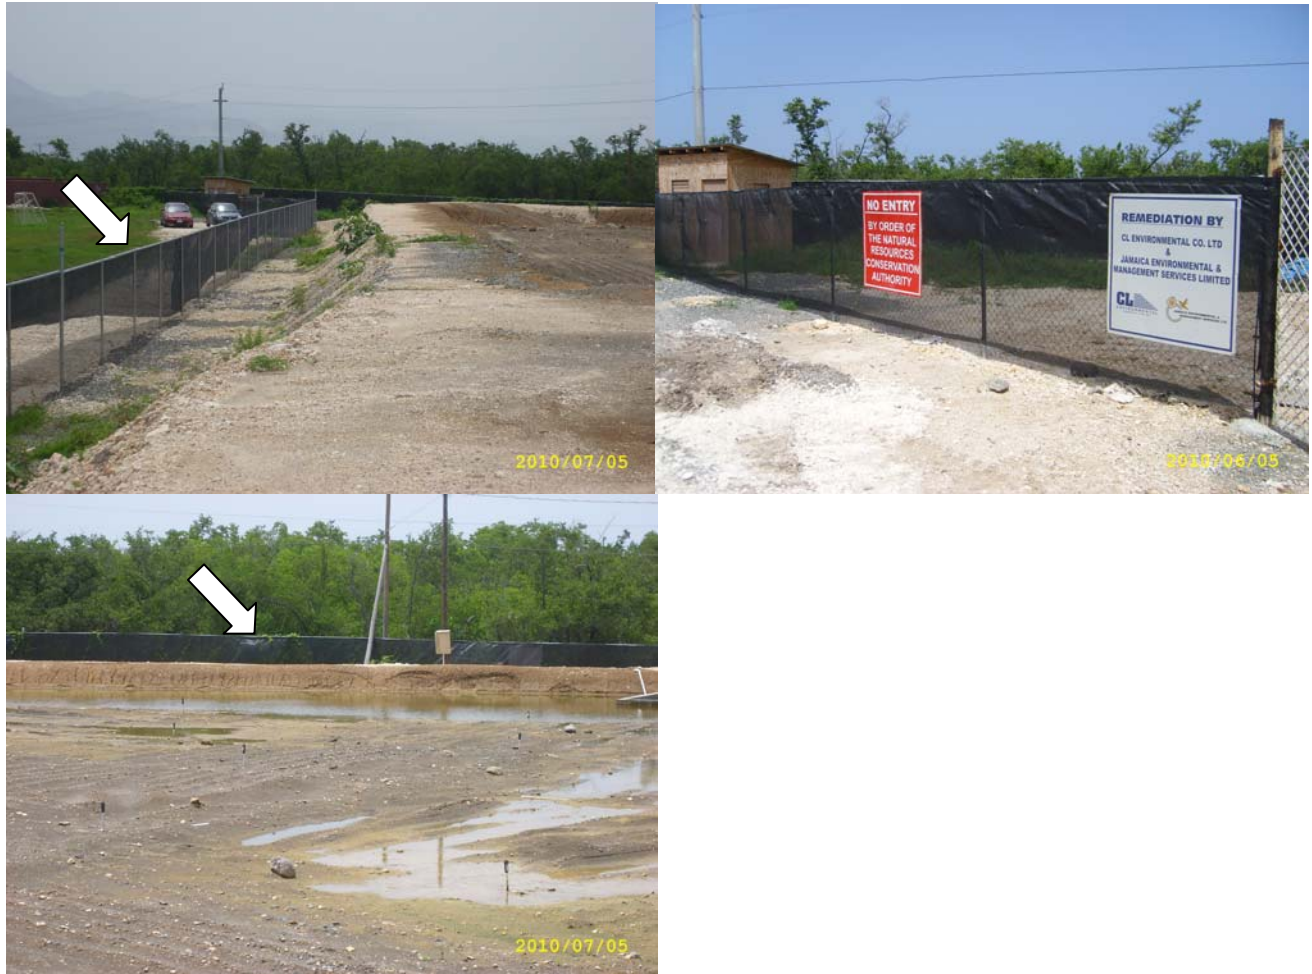
Plate 1 Photos depicting chain link fence with signage and shade cloth around the Landfarm

The site presently has a perimeter chain link fence with appropriate signage and is secure (Plate 1).

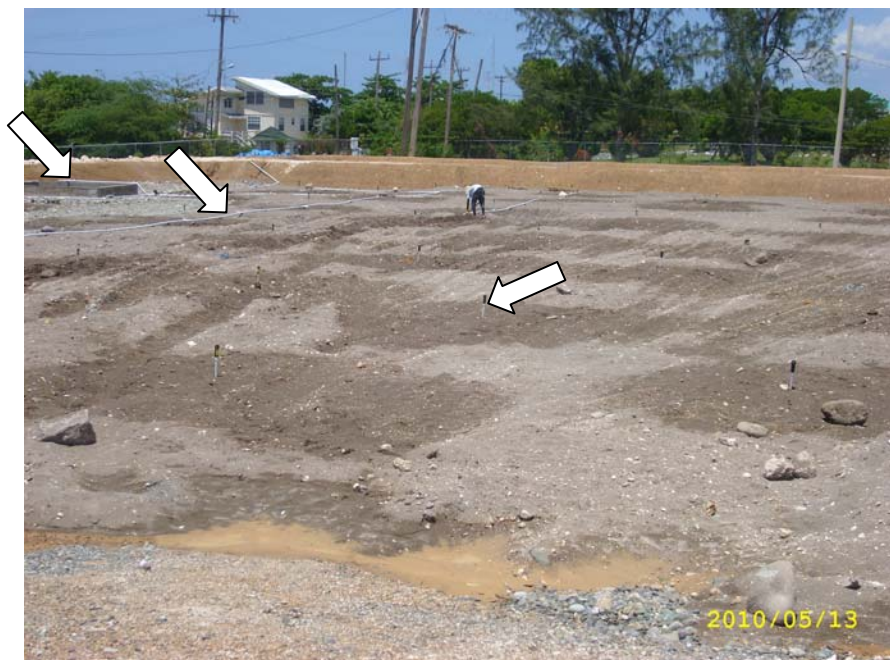
Plate 2 Photo showing irrigation pipes and sprinklers

Next will be the removal of the submersible pump, irrigation pipes and sprinklers (Plate 2). The submersible pump, PVC pipes and sprinklers will be kept and reused during the re-vegetation activity for the watering of the area.

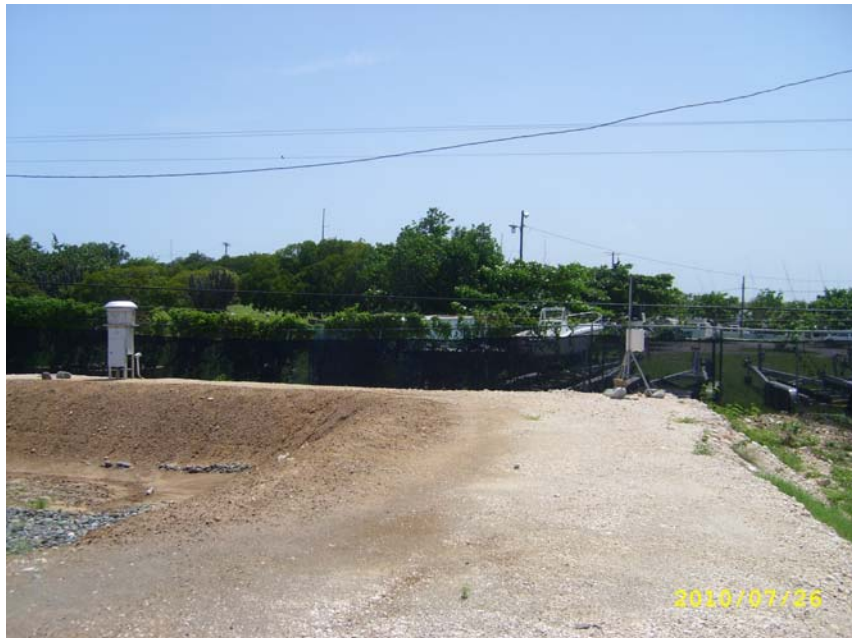
Plate 3 Photo showing weather station and high volume air sampler

These instruments will be relocated to outside of the work area when the marl base of the north western corner of the storage area is being removed (Plate 3).

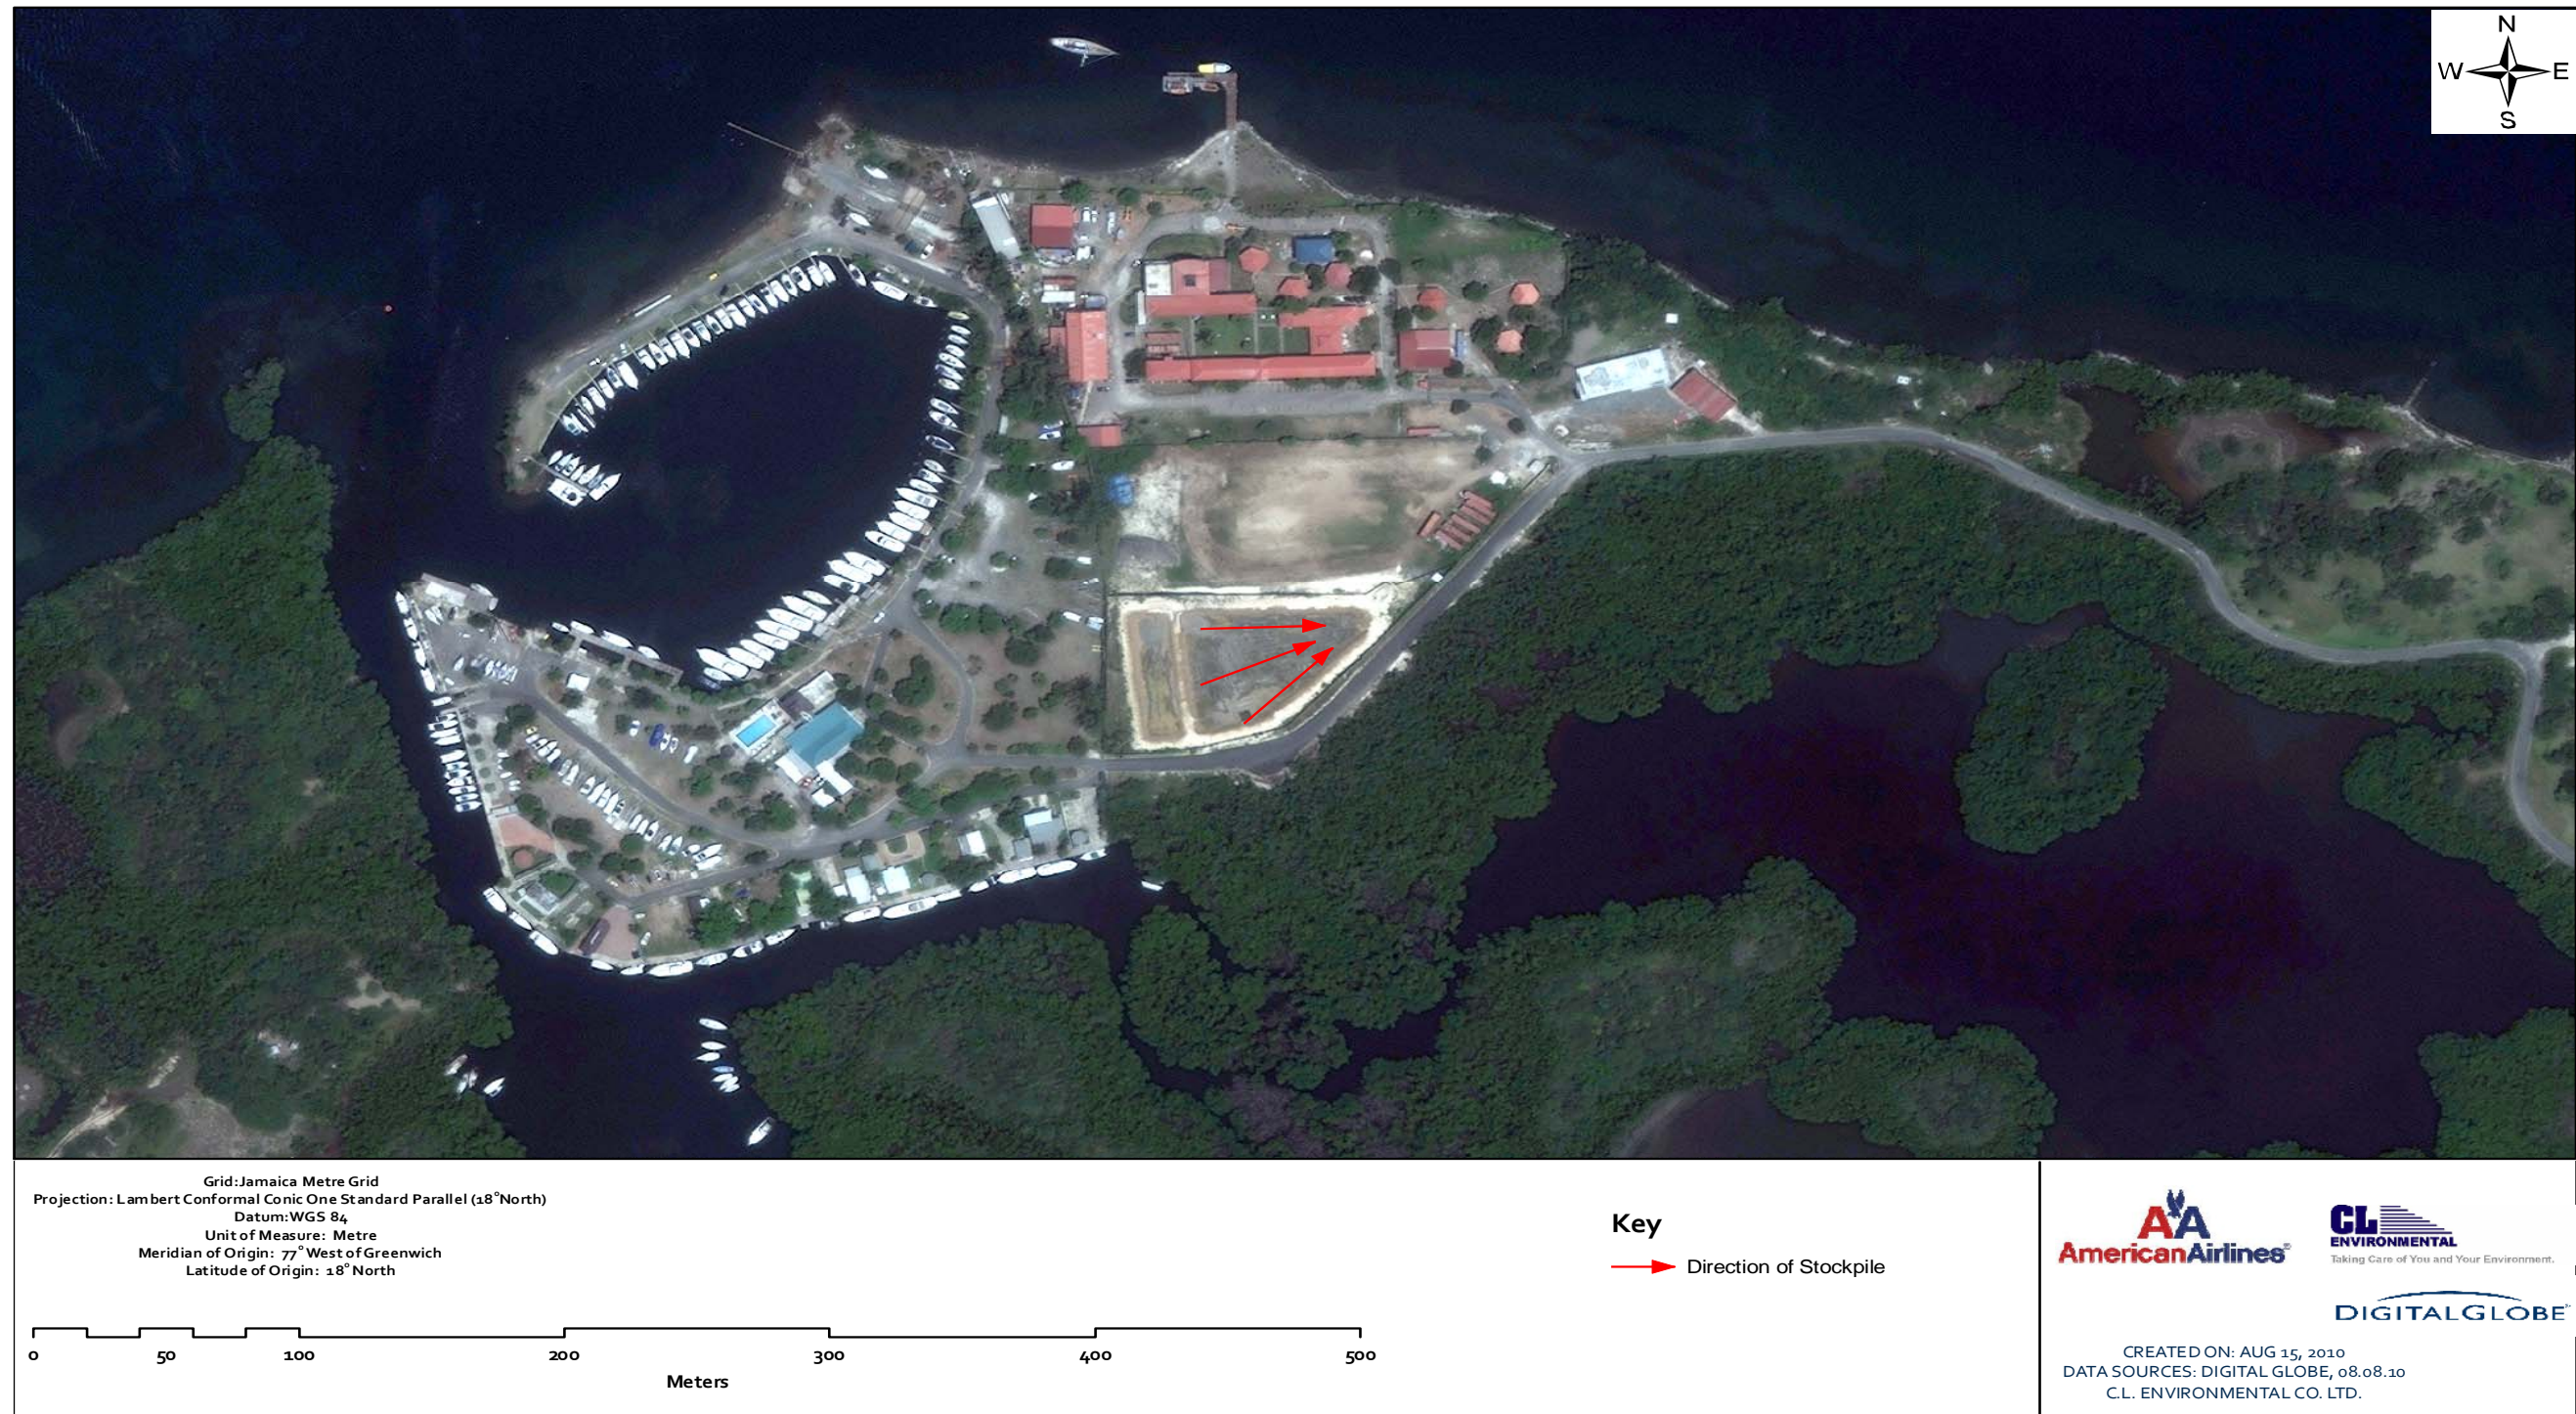
Figure 8 Map showing direction in which impacted material will be moved and loaded into trucks

- i. The remediated material and shingle will be pushed up towards the north eastern corner where it will be loaded into the trucks which will park on the ramp for loading (Figure 8). This is estimated to be **one hundred (100)** truck loads.

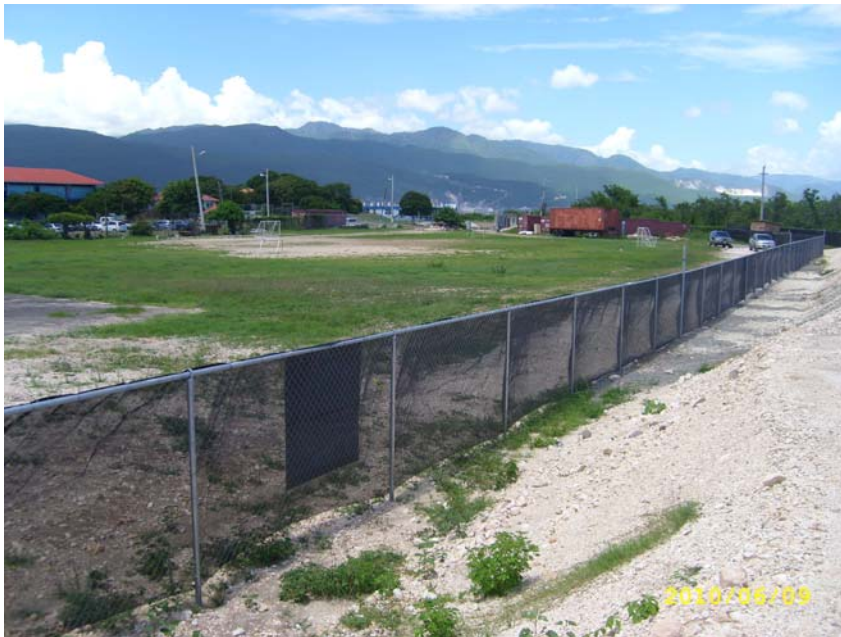
Plate 4 Photo showing chain link fence and shade cloth

The chain link fence and the shade cloth on the northern boundary will be removed and stored. Approximately **133m (≈ 436ft)** of fence and shade cloth will be removed.

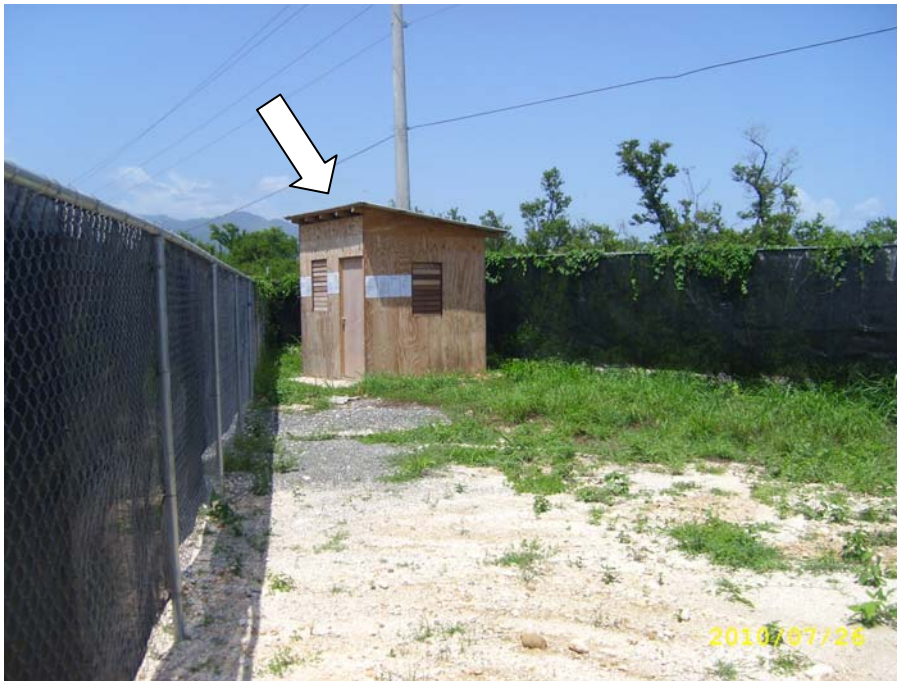
Plate 5 Photo showing storage shed

The storage shed will be removed at the end of the re vegetation exercise and either donated to the CMI or some other Institution (Plate 5). Failure to find a recipient then it will be dismantled and sent to Riverton landfill.
