Environmental Assessment

MIXED-USE DEVELOPMENT AT READING PEN, ST. JAMES

Date: June 2022

ENVIRONMENTAL ASSESSMENT FOR MIXED-USE DEVELOPMENT AT READING PEN, ST. JAMES

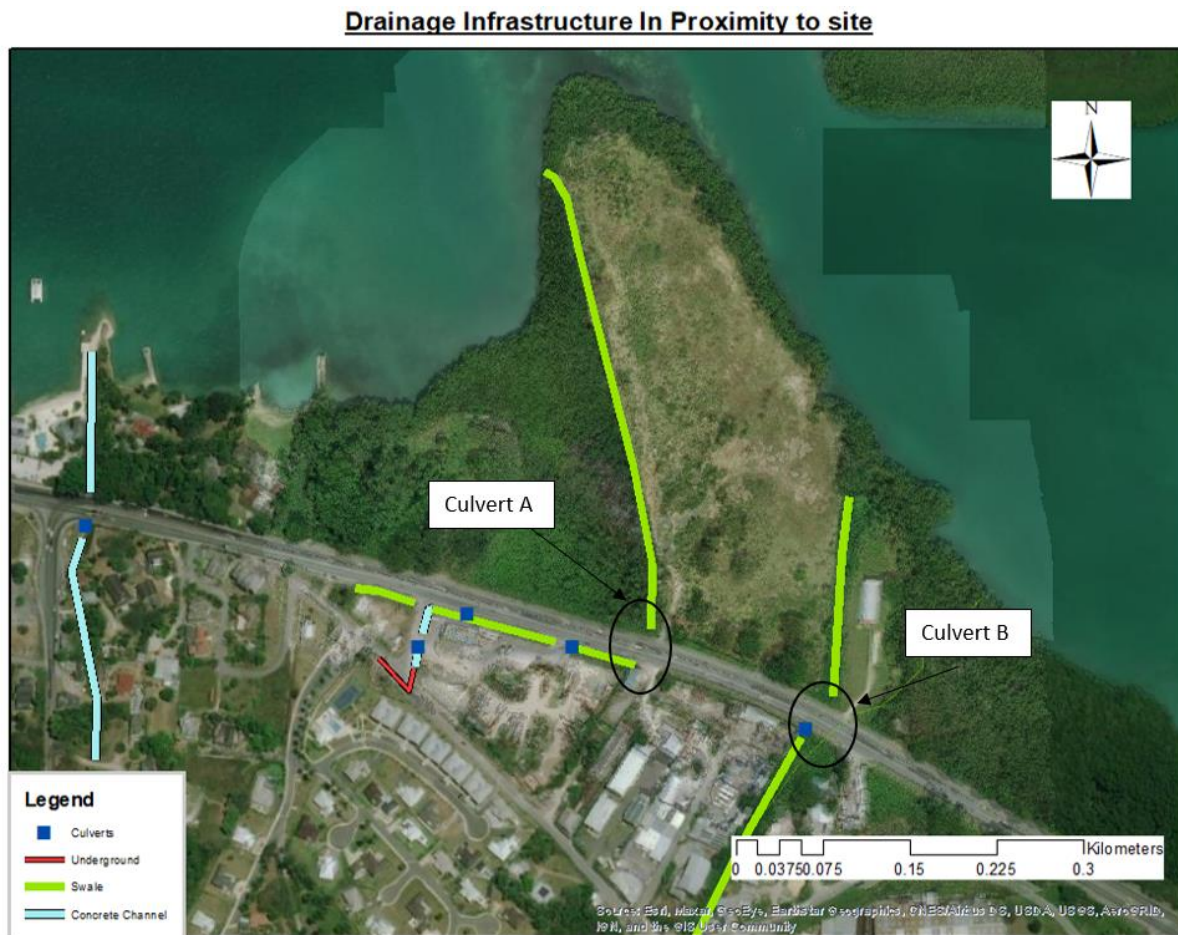
Figure 4-16 Layout of visible drainage infrastructure from the field survey

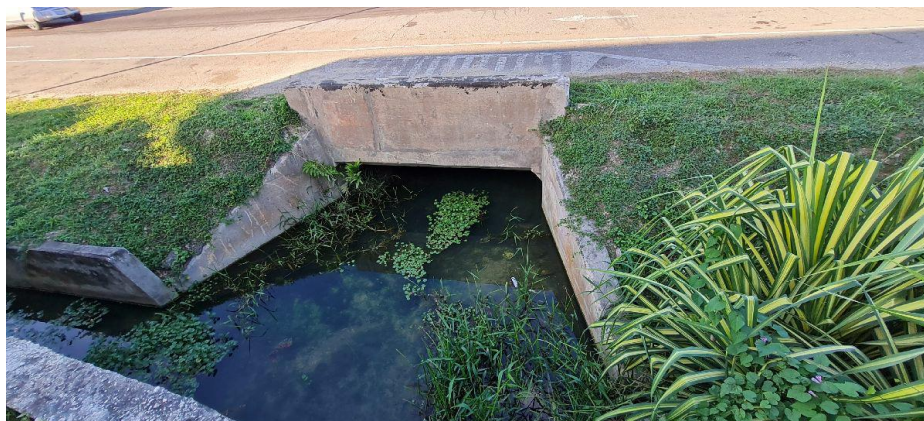
Figure 4-17 4.5x2m culvert from Gas Station to the channel west of The Peninsula

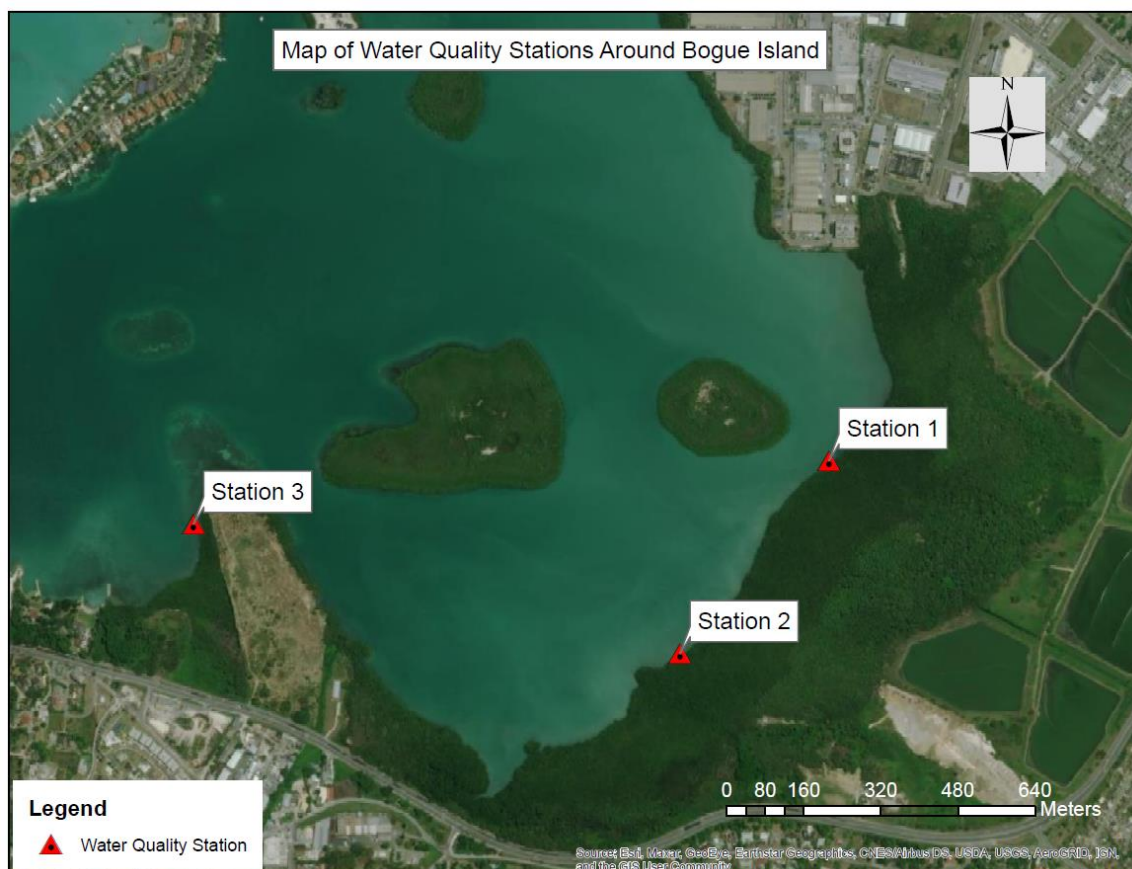
Figure 4-20 Water Quality Stations around Bogue Island, used in stormwater discharge analysis

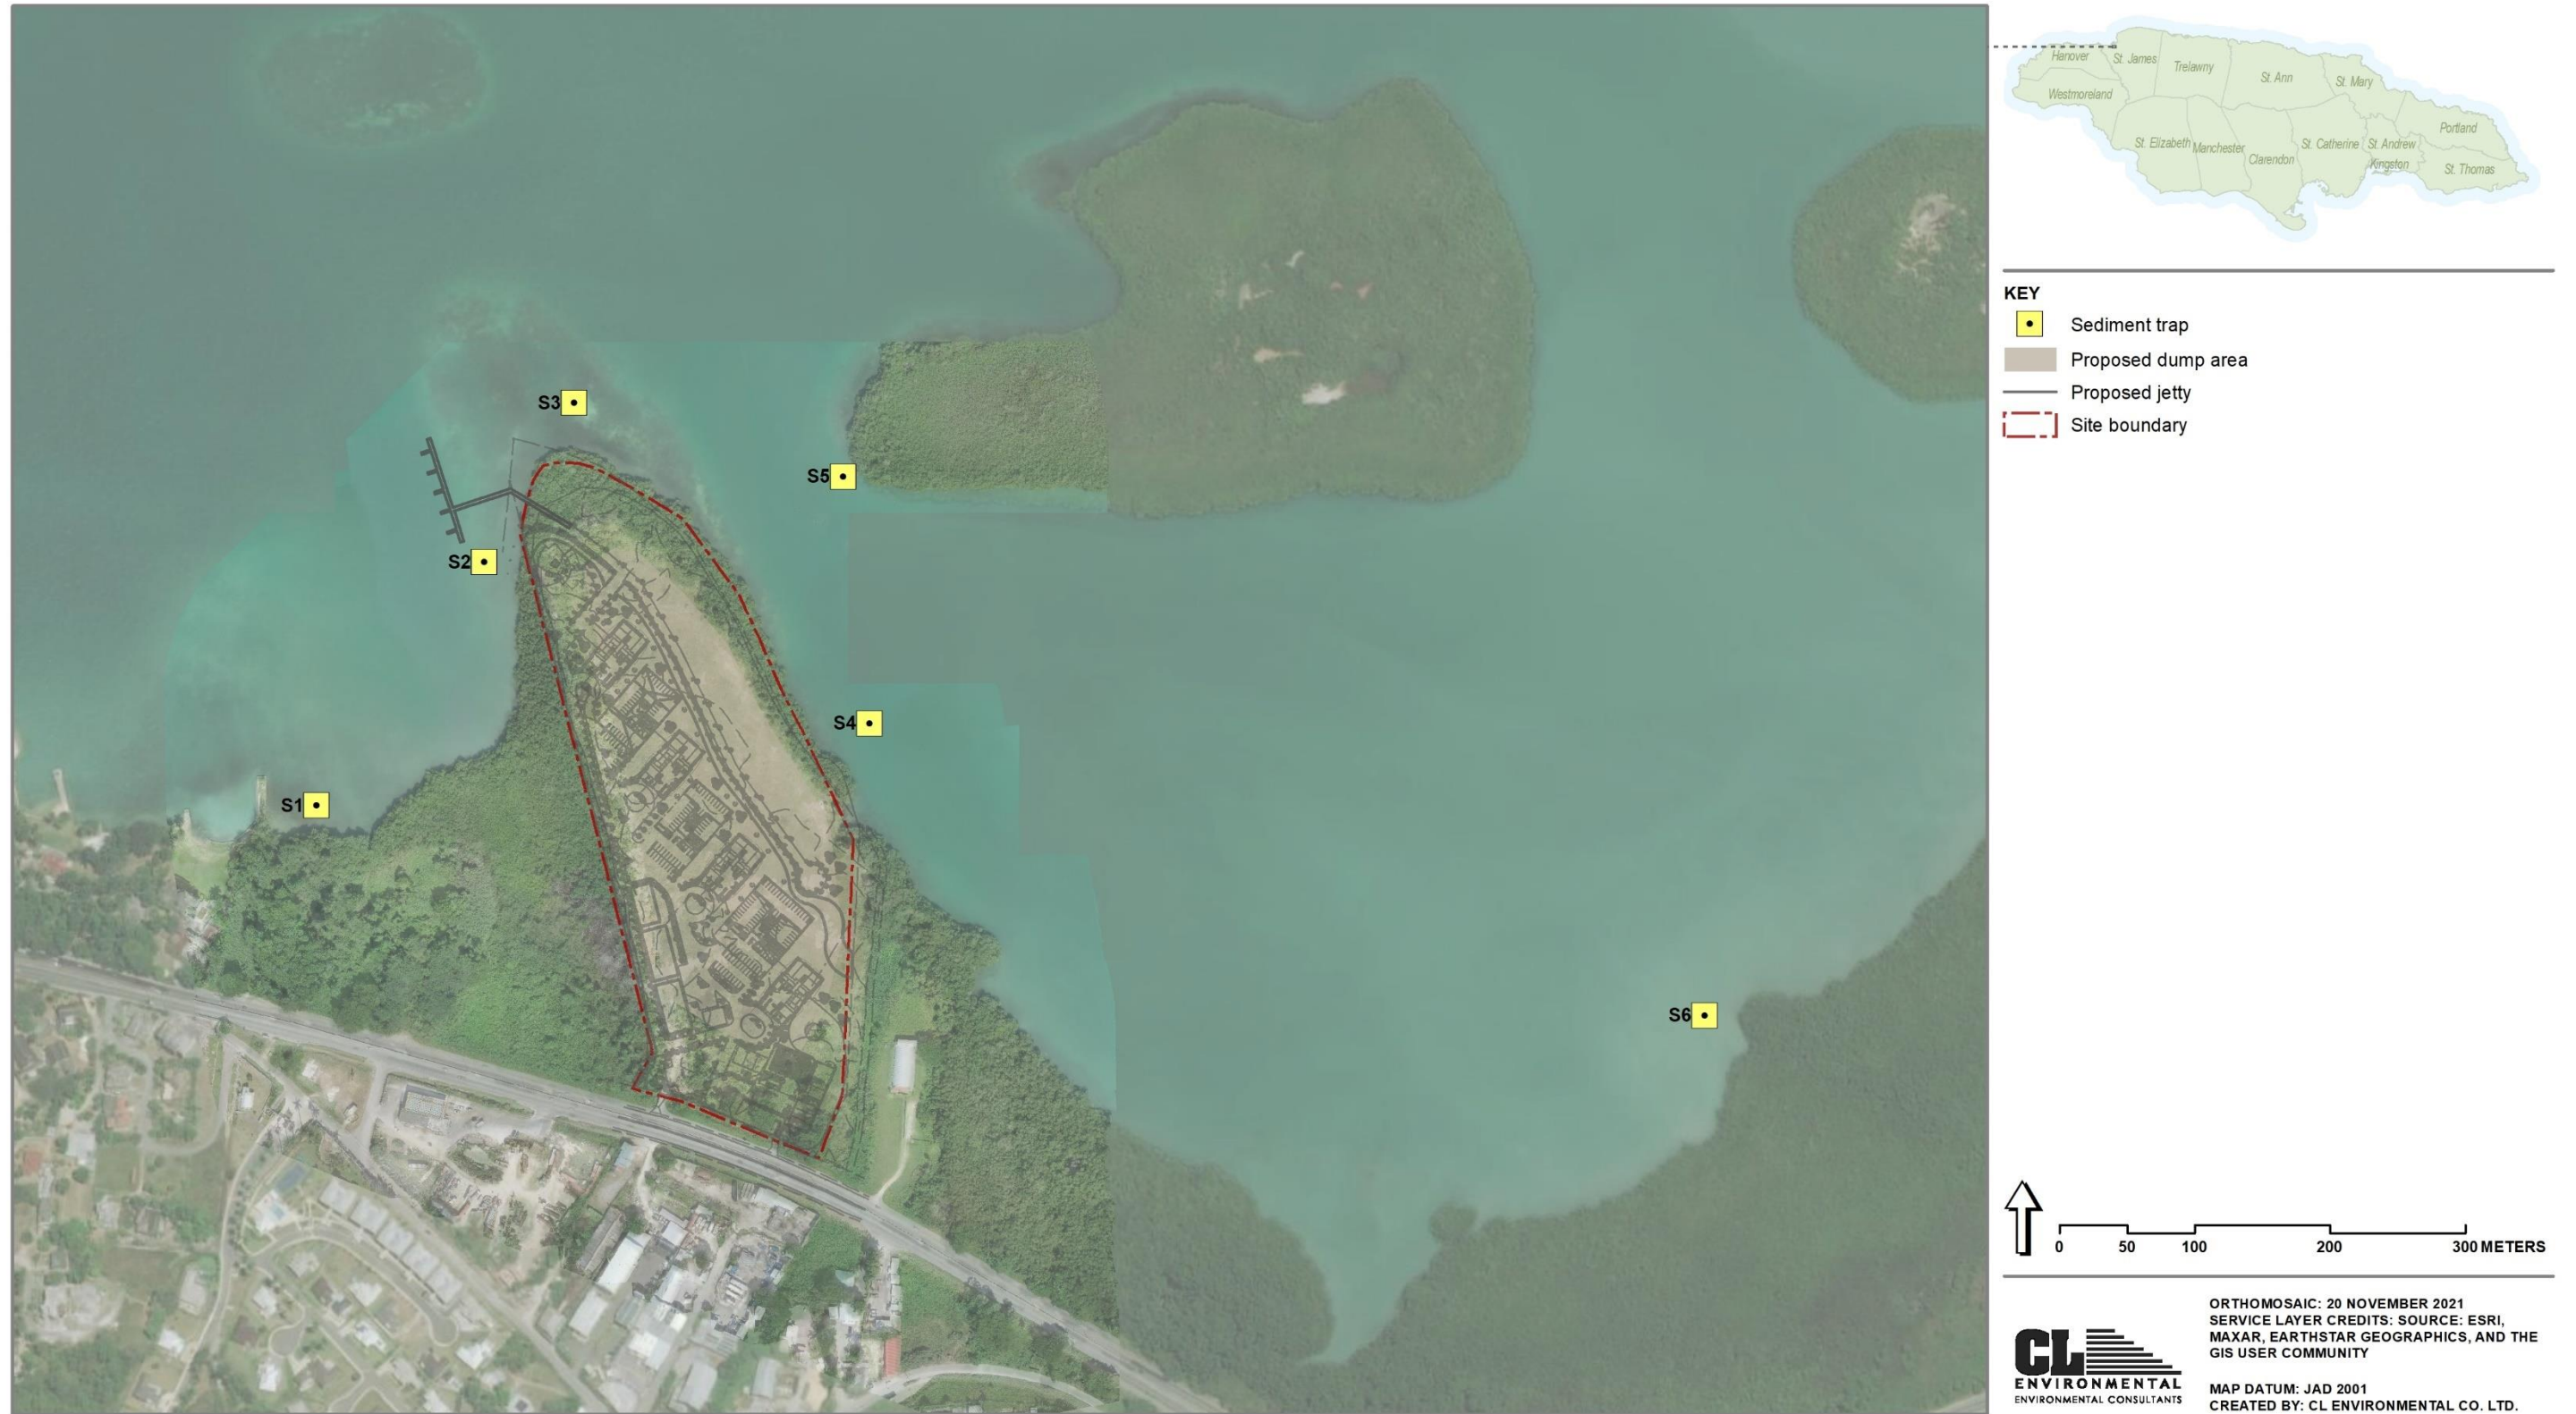
Figure 4-39 Map showing sediment trap and benthic sediment sampling locations

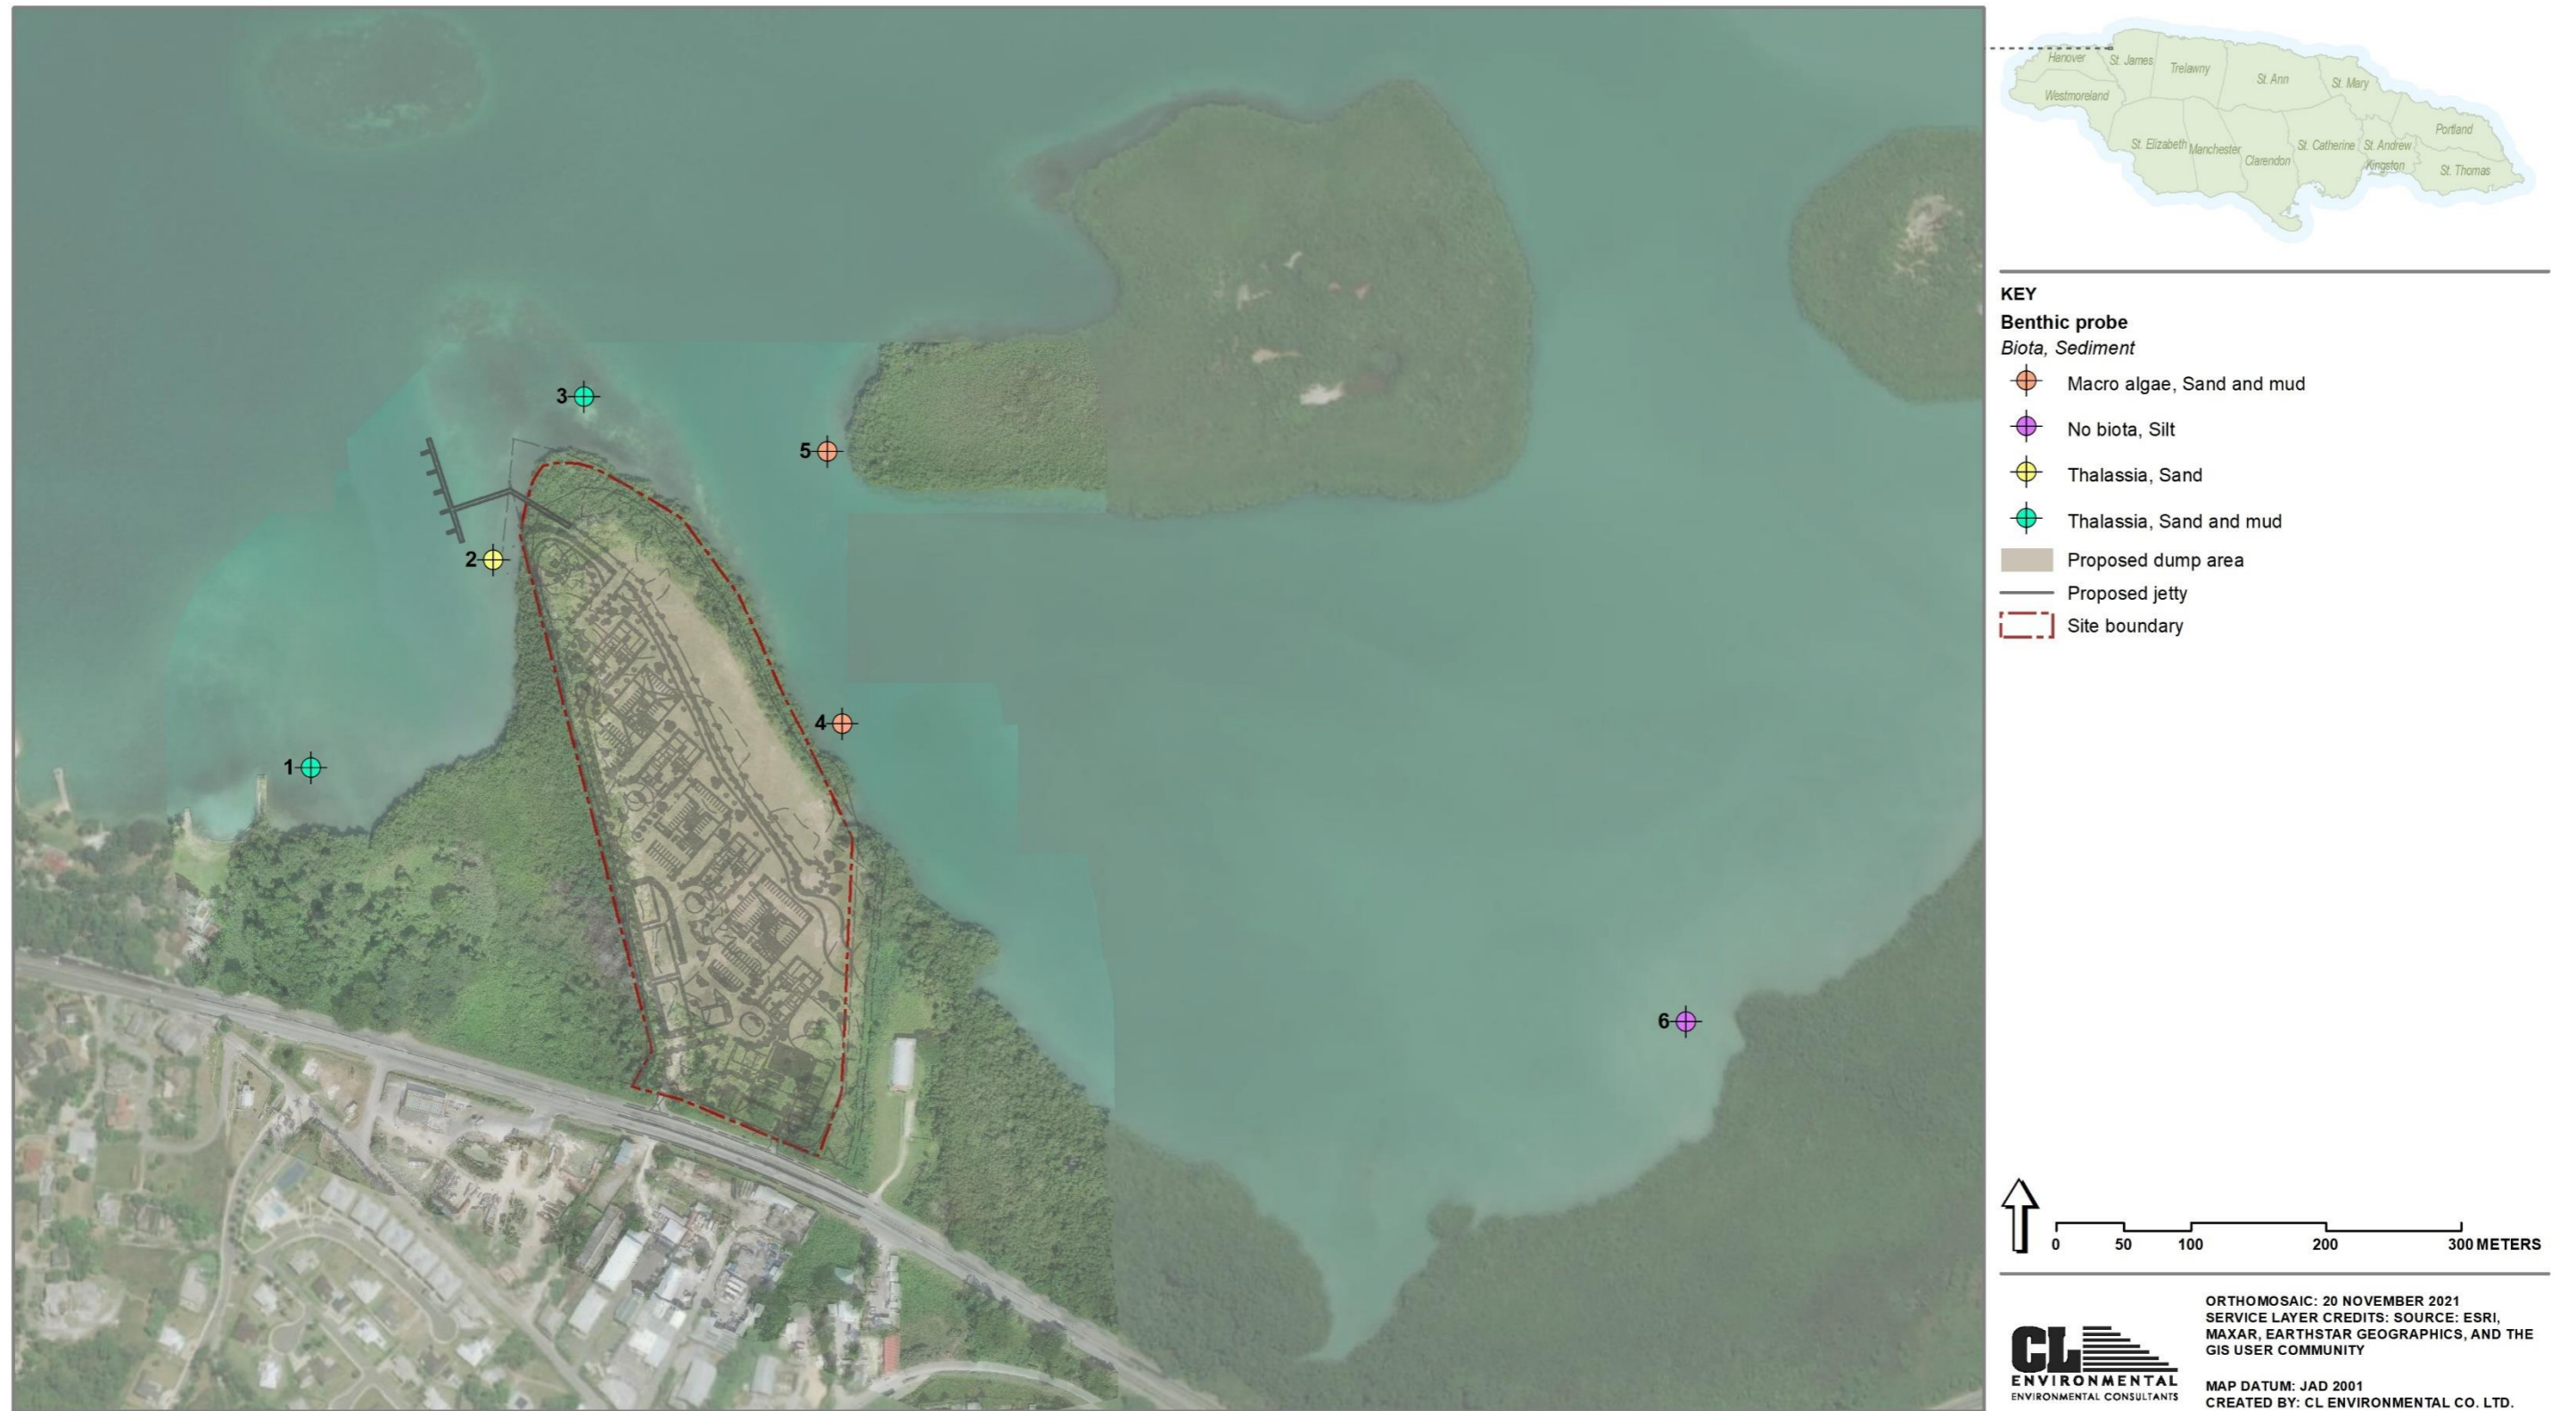
Figure 4-57 Benthos Map via probes conducted
