ENVIRONMENTAL IMPACT ASSESSMENT
For Proposed Beach Nourishment and
Installation of Six (6) Groynes
at
Sandals Negril, Norman Manley Boulevard
Hanover

FINAL REPORT

October 2019

Environmental Solutions Ltd.
7 Hillview Avenue
Kingston 10
Jamaica

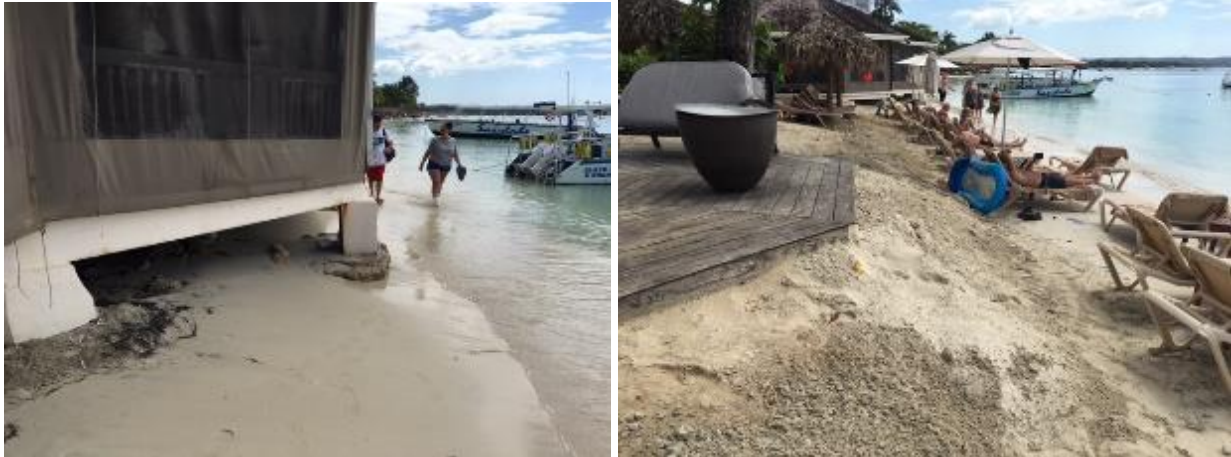
Figure 1-3: Examples of beach erosion occurring at Sandals Negril property (Source: SWIL, 2011)

The shoreline of Sandals Negril has receded with an average of 0.21m/year over 50 years (1968–2018), (SWIL, 2018). Although over the 50-year time span the shoreline has shown signs of both accretion and erosion, there has been a net loss of 30–40m of shoreline in Negril and Figure 1.3 provides examples of beach erosion occurring at the Sandals Negril property (SWIL, 2007). Specifically, between 1980–2010, the shoreline at Sandals Negril retreated by approximately 15–20m, with this retreat being much more evident over the northern half of the property (SWIL, 2011).

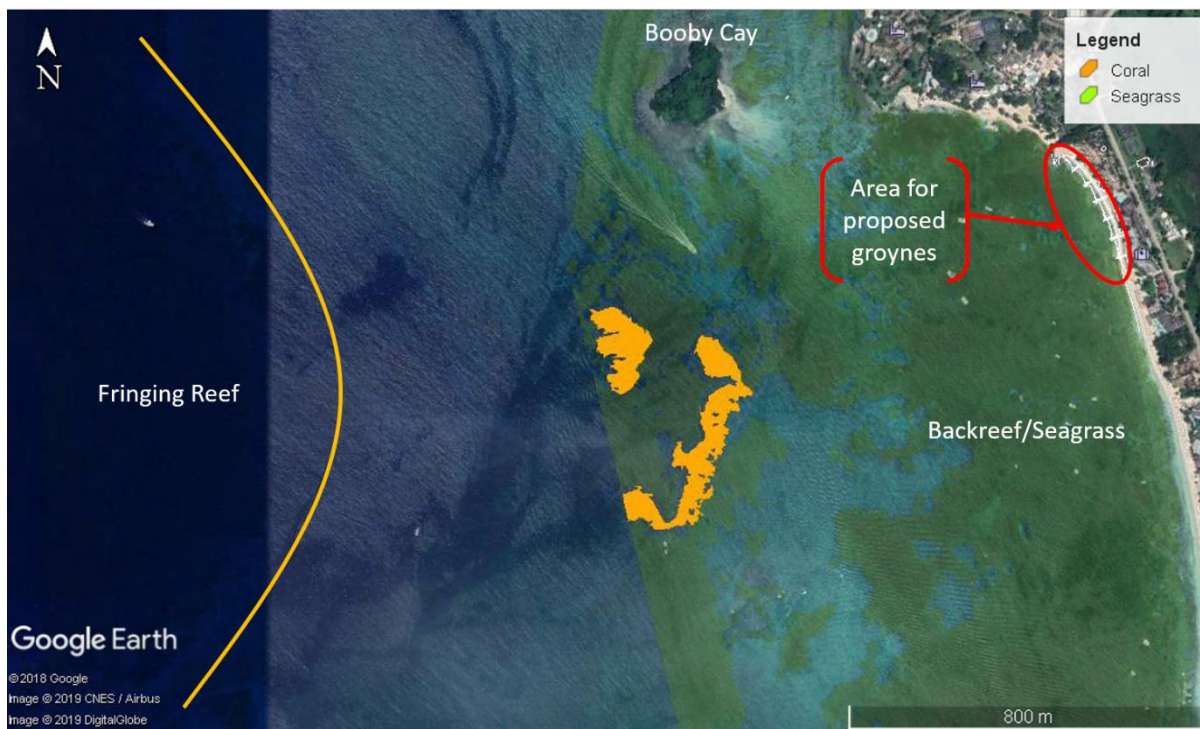
Figure 3-4 is an aerial image showing a shallow fringing coral reef system, located 2–3km offshore with a depth of 20–50m, as well as a small patch reef just over 1km from the beach. Given the distance of these systems away from the site of the proposed groynes, an assessment of these reef zones was not included in the scope of this EIA. Environmental Solutions Ltd. conducted a previous assessment of the reef for an alternative beach stabilisation design for Sandals Negril; the description of the reefs surveyed can be found in Appendix 12.8.

Figure 3-4: Aerial image showing distance of fringing reef (orange line) and patch reef (shaded orange) from the proposed project site (red) at Sandals Negril

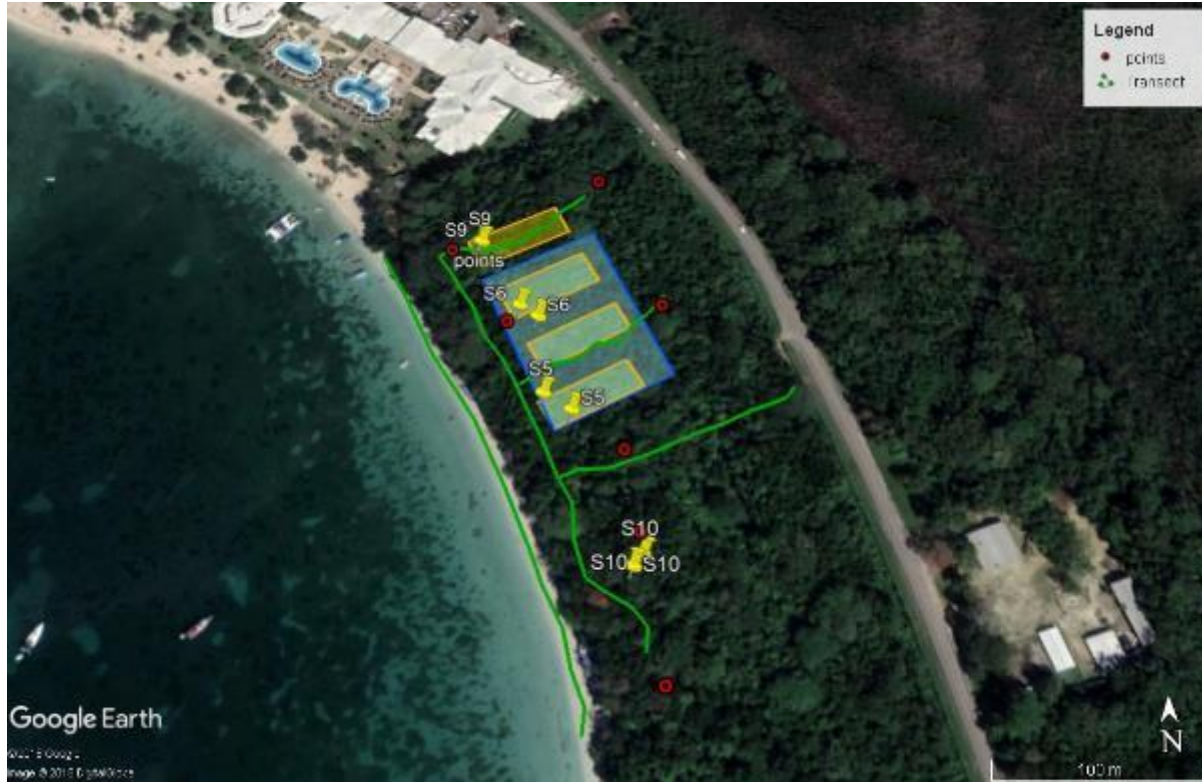
Figure 3-8: The location of the “transects” and points used to generate the fauna list for the study. (Modified from SWIL, 2018)

Line transect – Due to the road network on the property, the line transect method was selected for the nocturnal avian survey. The line transect method entails walking at a steady pace along a selected path for a given distance, while recording all bird species seen or heard (Bibby et al., 1998). The “transects” were located within the areas for the proposed development activity (see Figure 3-8).

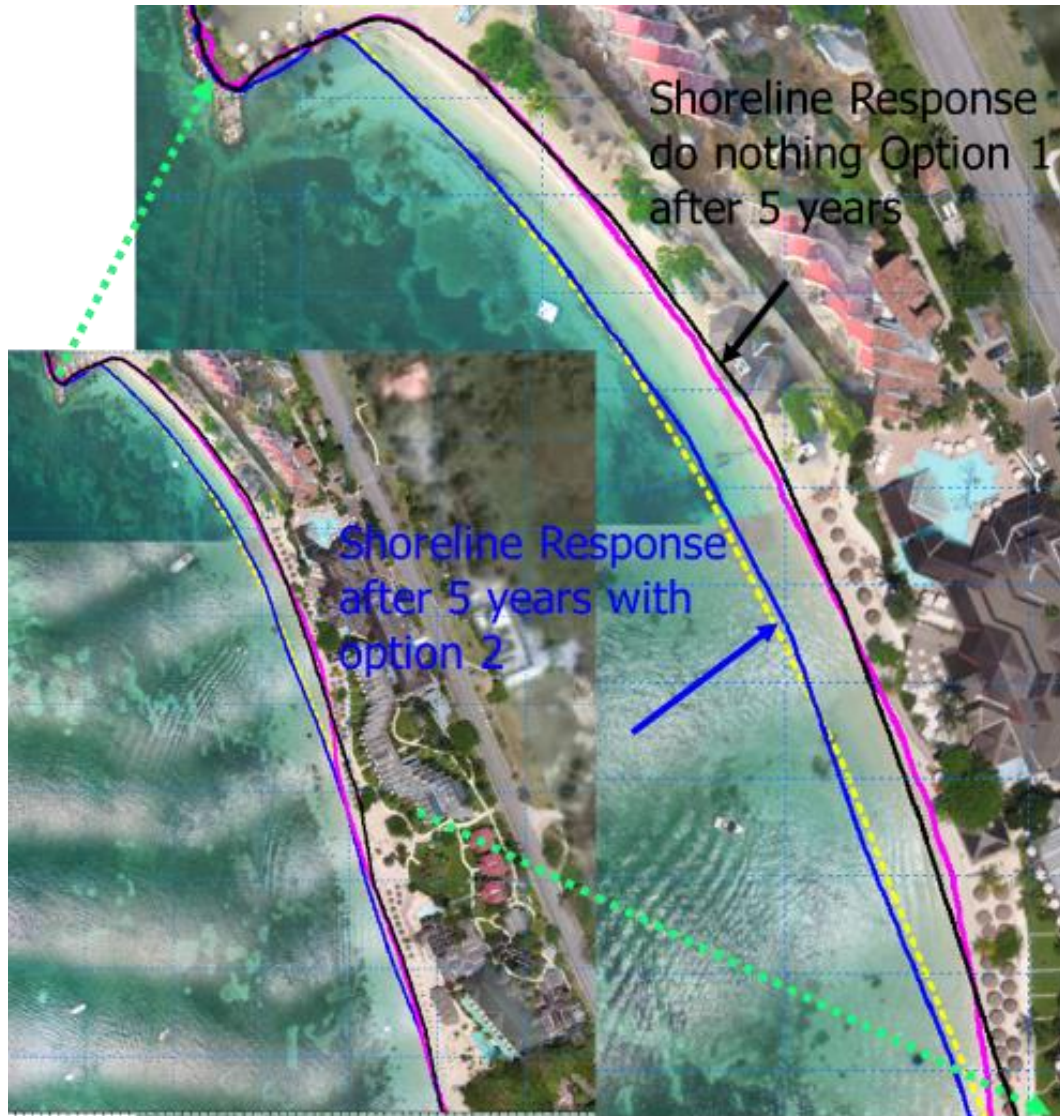
Figure 4-1: Model results comparing the “Do Nothing” Alternative to “Nourishment Alone” (SWIL, 2018)

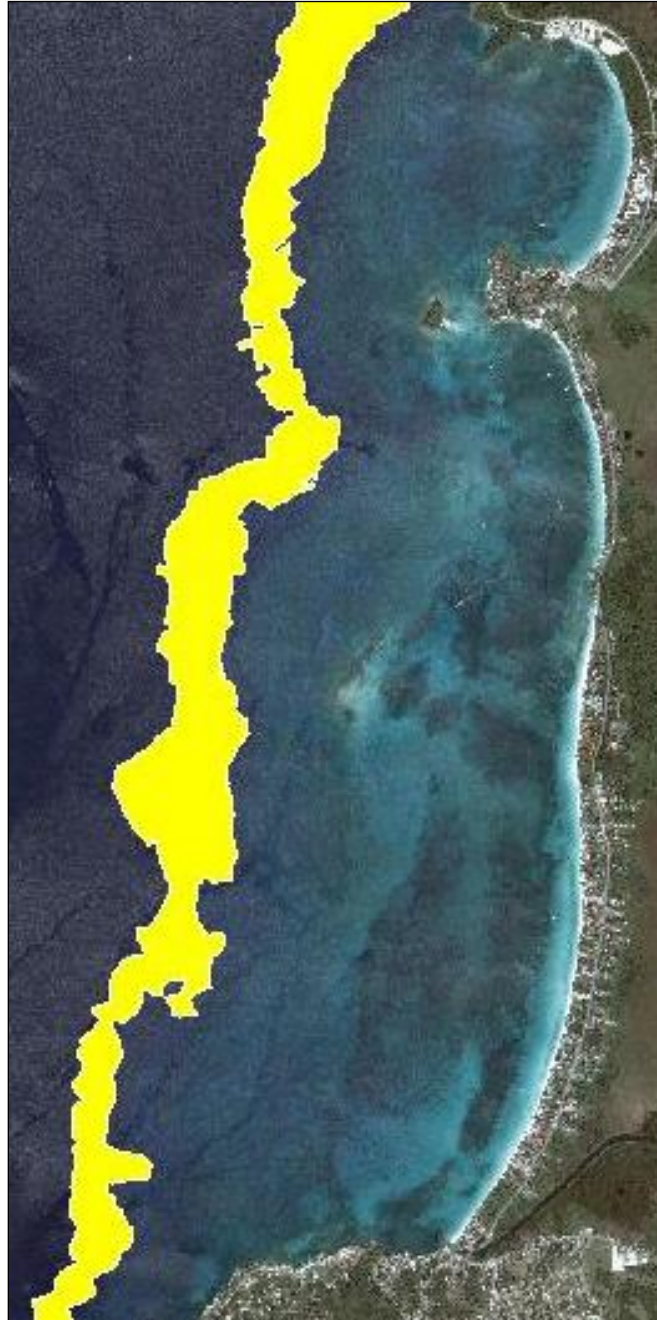
Figure 4-5: Potential sand source along outer reef, within the 20 to 50m contour (SWIL, 2007).

In a 2007 study commissioned by the Negril Coral Reef Protection Society (NCRPS), it has been suggested that thick layers of sand exist between the 20 and 50m depth contours off of the outer shelf of Long Bay and Bloody Bay. The area under consideration is approximately 7km long and 200–600 m wide (Figure 4-5). It is therefore expected that more than enough sand is situated along the outer shelf of Negril to use for beach nourishment. However, no actual assessments have been conducted to determine the availability and thickness of the sand layers and quality of sediments, as well as the economic feasibility of pumping the sand from offshore. It is also not anticipated that this sort of investment could be borne solely by Sandals, but would have to be a Negril-wide initiative. If this material were to be used, several management plans would have to be prepared including a management plan to ensure that there is limited impact on corals and seagrass beds.

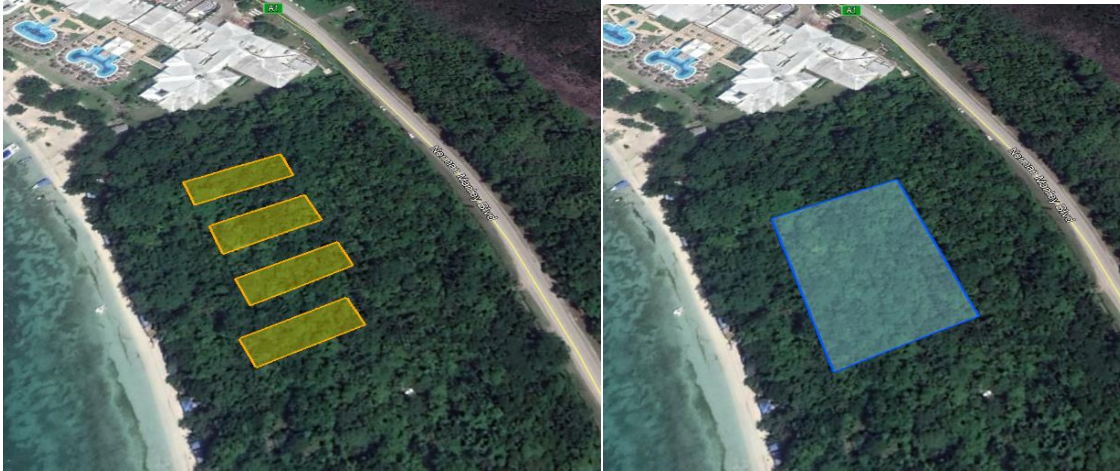
- Option 1 – approx. 8,860m² of vegetation would need to be cleared at minimum. Additional clearance will be required for vehicular access paths, storage areas, etc. This option will require excavation to about 2m deep which is reportedly below the water table;
- Option 2 – approx. 14,650m² and a much larger area. However, excavation would be to 1m depth which is above the water table.

Figure 5-5: Left – Option 1 (combined area of 8,860m²); Right – Option 2 (approx. 14,650 m²)

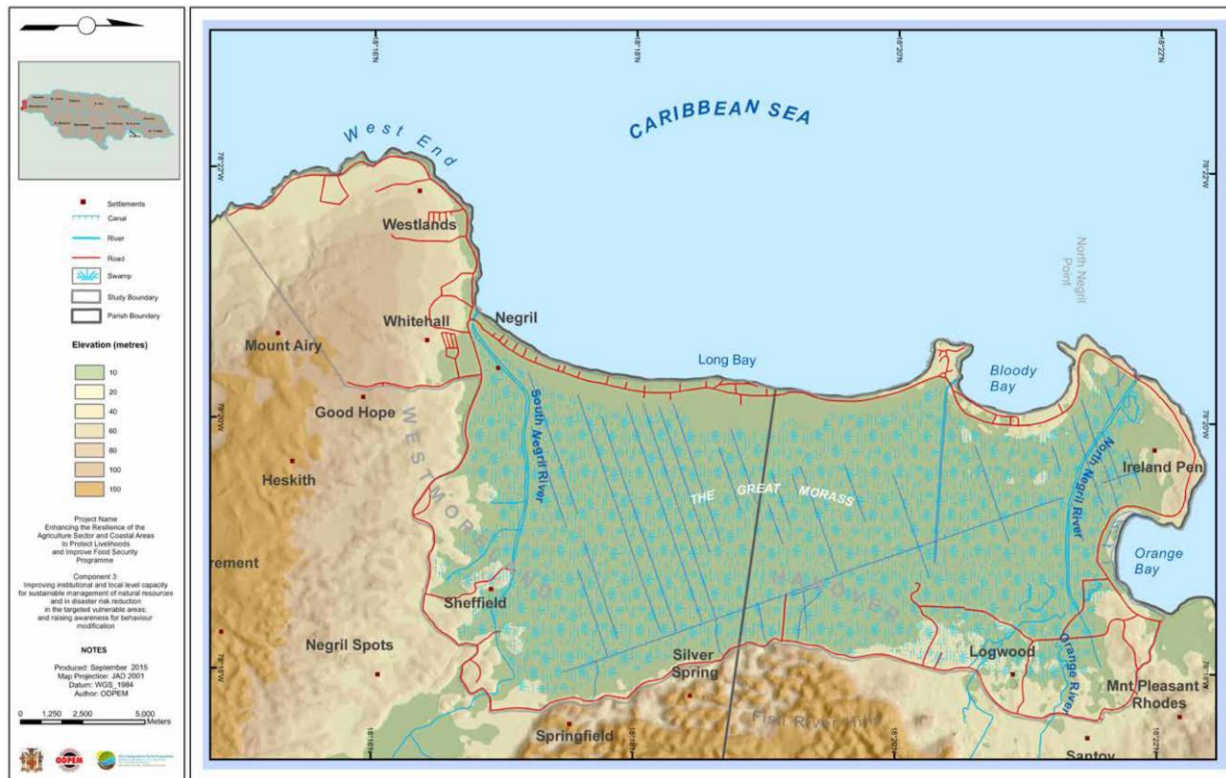
The Negril coastal system comprises a wetland called The Great Morass; the shorelines of Long Bay, Bloody Bay, Orange Bay to the north; and an offshore shelf containing seagrass and reef habitats, drowned cliffs and former river valleys (Figure 6-1). Understanding the relationship between these components and the processes that helped to create them provide valuable insight on the potential shoreline response at the Sandals Negril property to future climate change, coastal hazards and man-made interventions.

Figure 6-1: Profile of Negril (Climate Risk Atlas of Coastal Hazards and Risk in Negril)

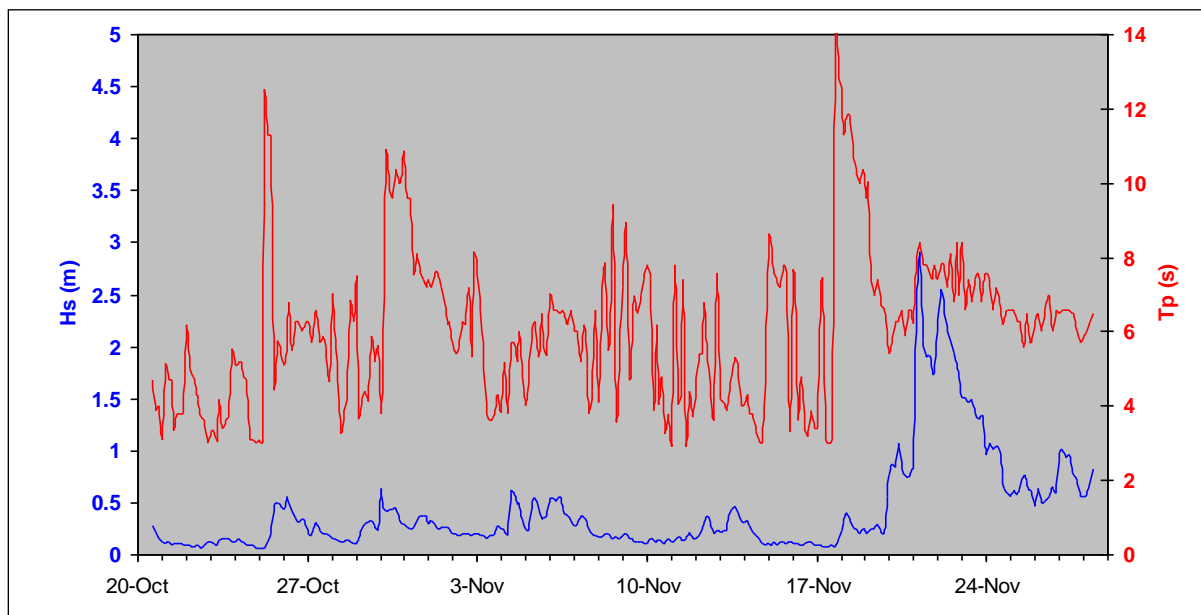
Figure 6-4: Time series of wave conditions measured in Negril (October 20 to November 28, 2007). From SWIL, 2007, Figure 5.2.

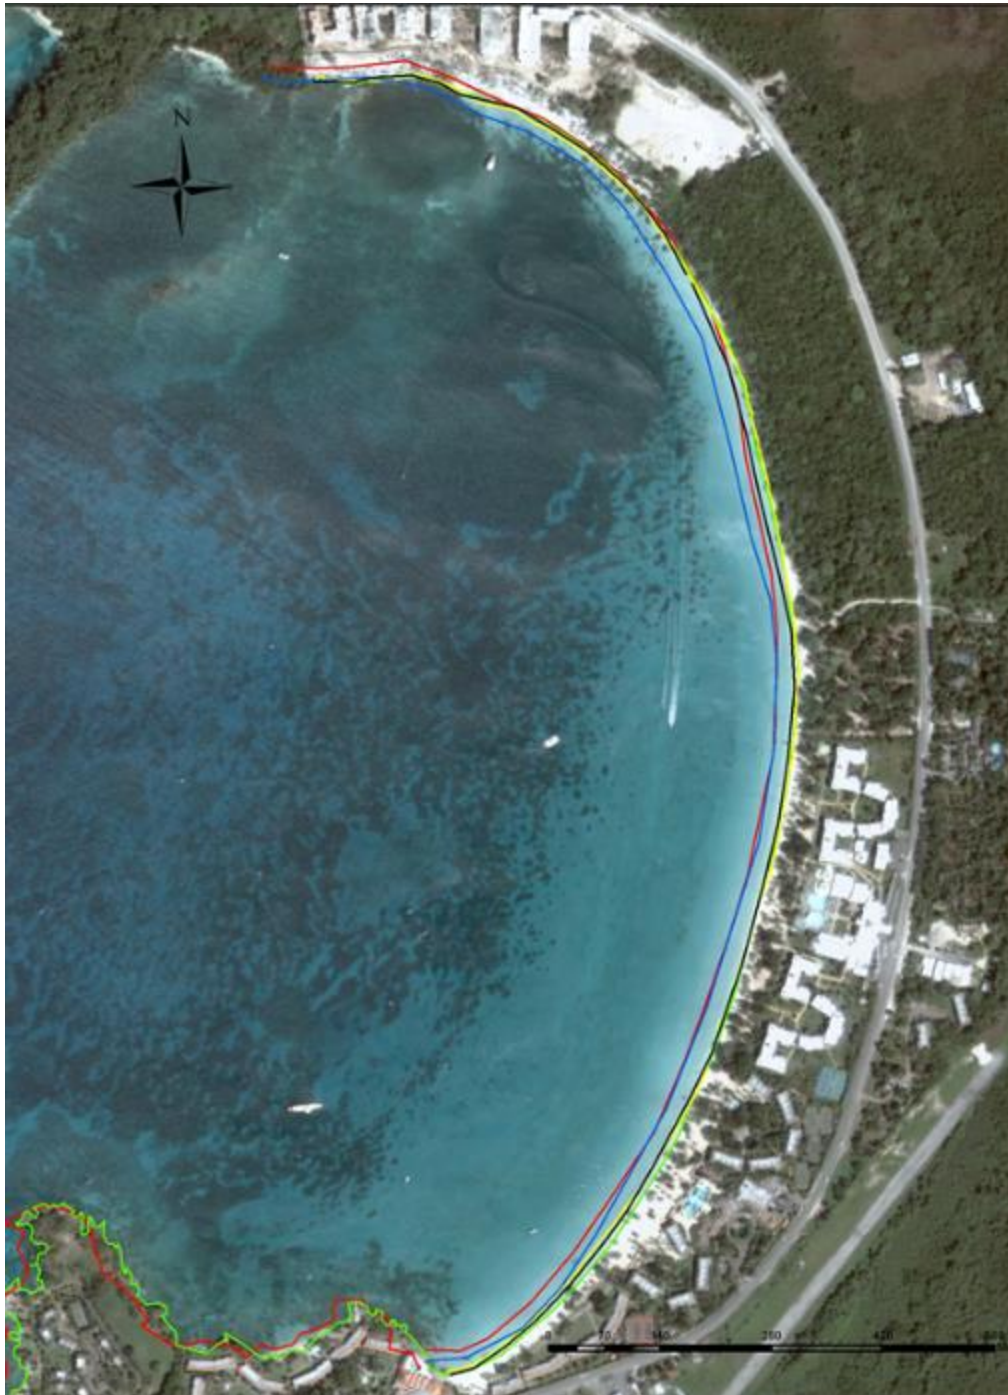
Figure 6-7: Comparative shoreline positions, Bloody Bay (from SWIL, 2007). The scale bar suggests approximately 40–50 metres of land loss between 1968 and 2006.

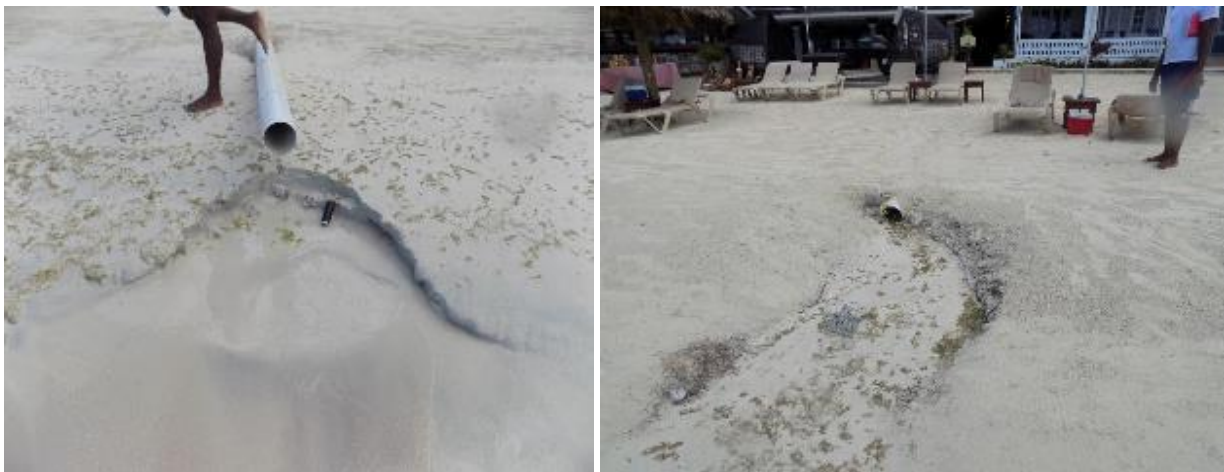
Figure 6-8: Drain pipes emptying into the beach at Sandals Negril

Along the beach at Sandals Negril, there are drain pipes that take water from the storm drains that run along the walkway on the beach as well as from the showers which are located ~100m apart (see Figure 6-8).

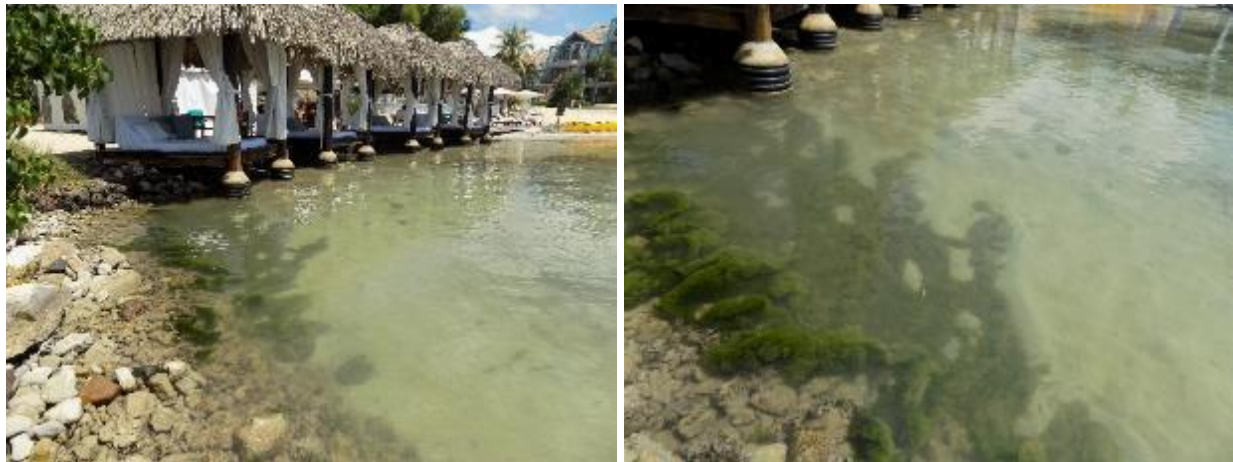
Algae were also observed at various points along the beach, especially in the bay marking the beginning of the Sandals property, as seen in the images below:

Figure 6-9: Algae in the bay marking the beginning of Sandals Property, Negril, October 3, 2018

The algal growth seen along the shoreline may be as a result of the water being discharged from pipes along the beach. These pipes carry grey water from the shower areas and surface runoff from the lawns to the sea. Fertilisers used on the lawn and soap/body wash used for bathing may contain nutrients (both phosphates and nitrates). These nutrients are critical to the growth and proliferation of algae.

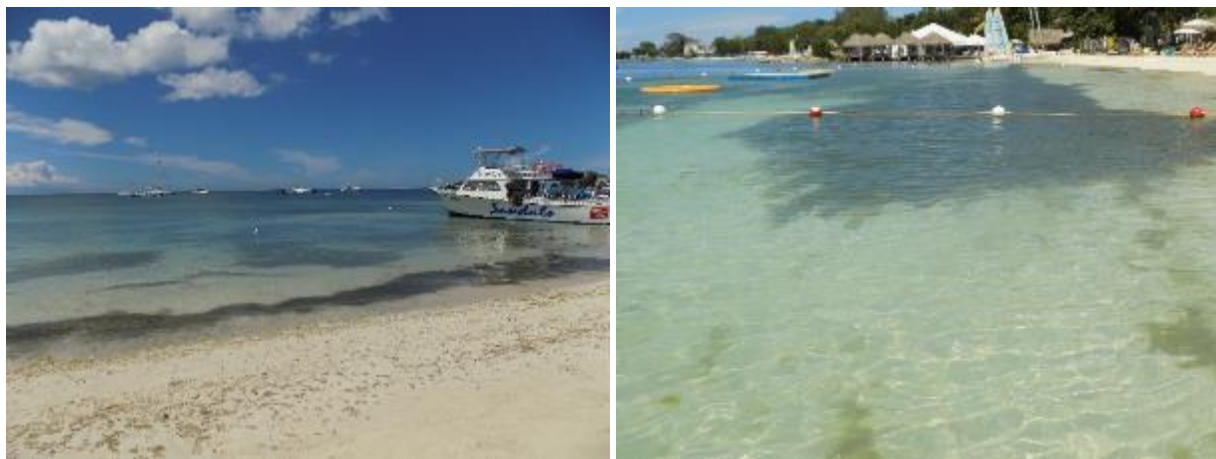
Figure 6-10: Algae at other points along the beach of Sandals Negril, October 3, 2018

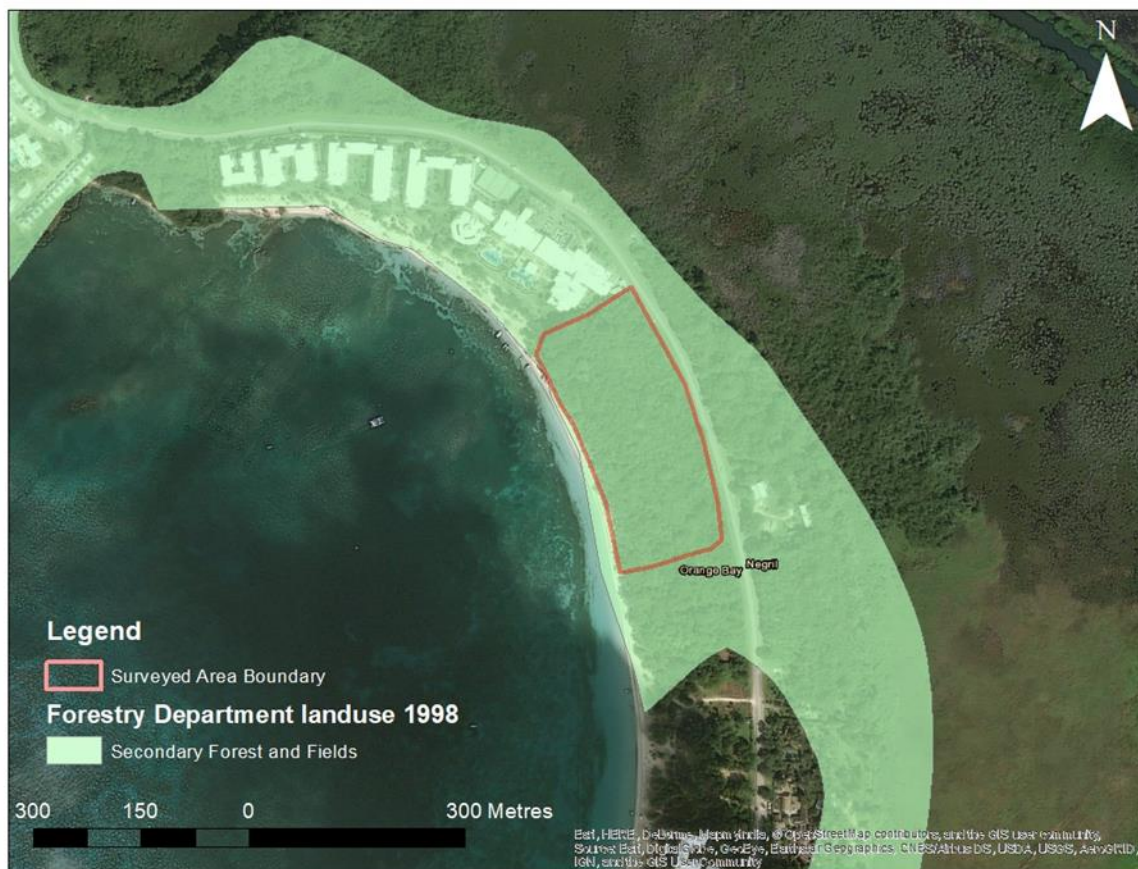
The general project area was designated at the macro level in the Forestry Department's land use map as secondary forest and field. While ground-truthing of the project area, the main vegetation habitat type observed was woodland/overgrown fields.

Figure 6-11: The main vegetation habitat type within the project area according to the Forestry department land use classification

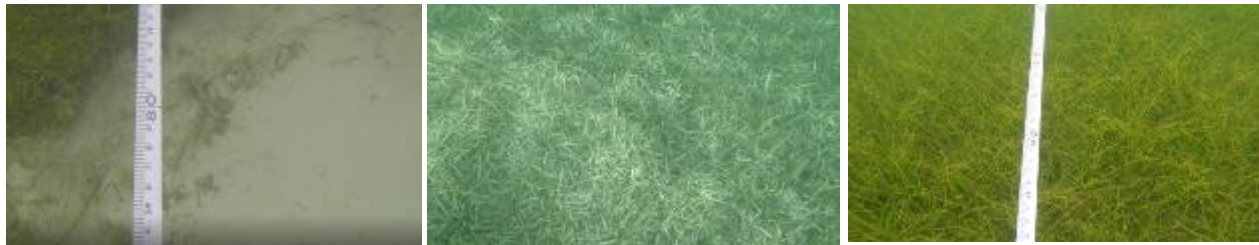
Figure 6-18: Example of substrate observed in the footprint of the northern groyne and proposed groynes 1, 2 and 3

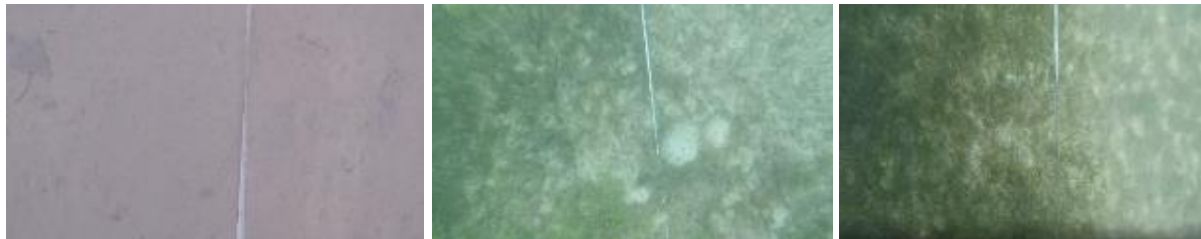
Figure 6-19: Example of sandy/bare substrate in the footprint of proposed groynes 3, 4 and 5

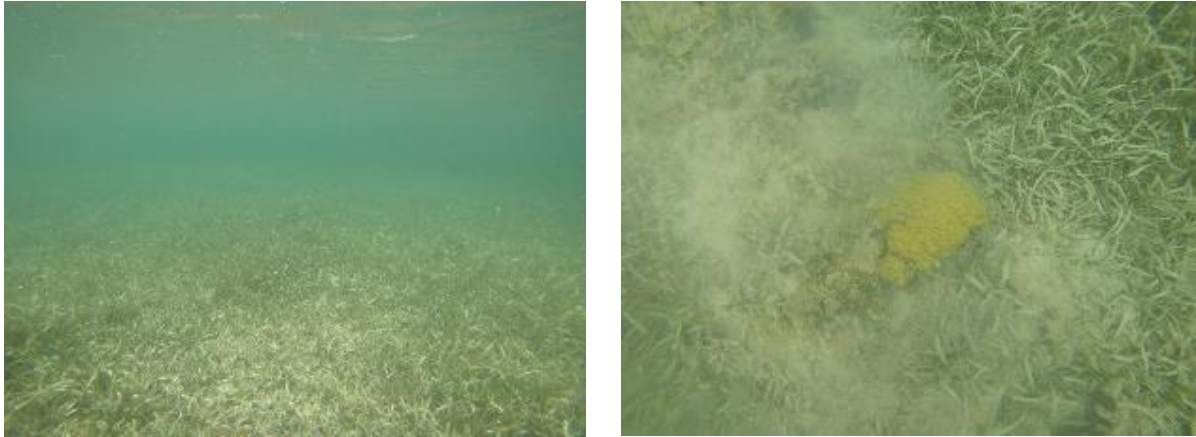
Figure 6-20: Example of seagrass typical of the wider backreef area (left) interspersed with fauna, e.g., small coral colonies (right)

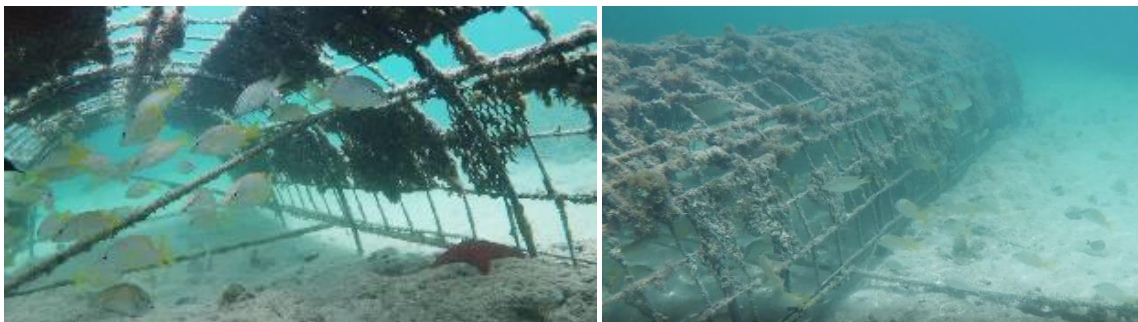
Figure 6-21: Artificial reef structures act as habitats for fish and other invertebrates (left) and are covered in macroalgae (right) (Image source: SWIL, 2018)

To the south-west of the existing groyne are artificial reef structures, or domes, created from steel bars and mesh. The substrate within this area is primarily sand and rubble, while the artificial reef structures are covered in macroalgae.

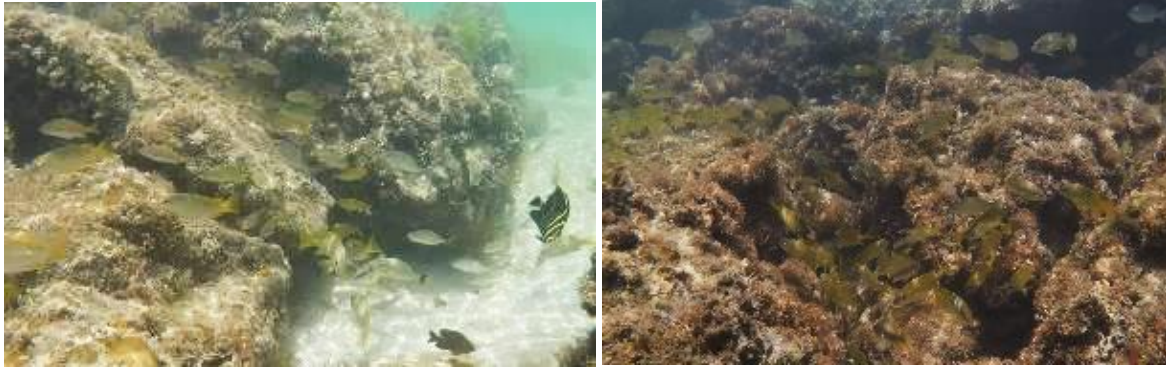
Figure 6-22: Fish foraging within the area of the existing northern groyne (Image source: SWIL, 2018)

The area within the footprint of the northern groyne and within the crevices created by the placement of the existing rock groyne appears to be a nursery for juvenile fish (squirrelfish, grunts, damselfish and wrasses), and coral recruits (mainly *Porites astreoides*, *Porites furcata*). While the abundance of fish was moderate, the diversity (number of species) was low. The black long-spined urchin (*Diadema antillarum*) was frequently observed in this area. This species is of special interest as they are recognised as an important consumer of algae, and populations islandwide are still recovering from a massive die-off in the late 80s. Their presence is considered positive for both the seagrass and reef communities in Long Bay (see Appendix 12.6 for lists of all species observed).

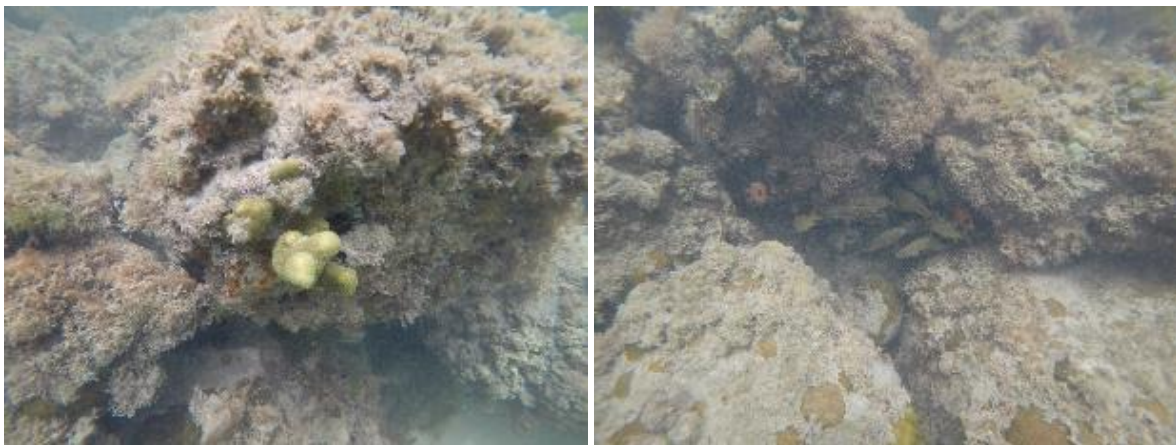
Figure 6-23: Example of coral colonies and juvenile fish observed in the area of the existing groyne (Image source: SWIL, 2018)

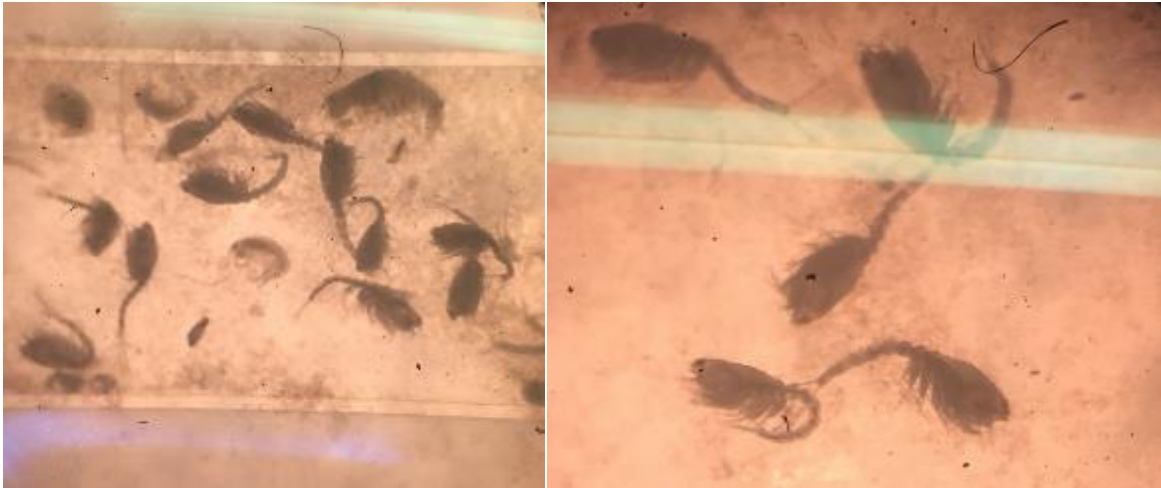
Figure 6-25: Left: Typical field of view displaying a selection of zooplankton spp. found at Sandals Negril; Right: Cumacea (dominant species found in samples)

The zooplankton community from the backreef area sampled was largely dominated by Cumacea, an Order of small marine crustaceans that are typically found in sandy and muddy benthos. Many fish feed on these organisms, hence Cumacea are considered to be an important link in the marine food chain. Additionally, small numbers of other food sources, namely fish, shrimp and crab larvae, were also found in the water column. Overall, this is an indication that the backreef area could generally serve as a foraging/feeding ground for marine fish, as is typical for seagrass communities.

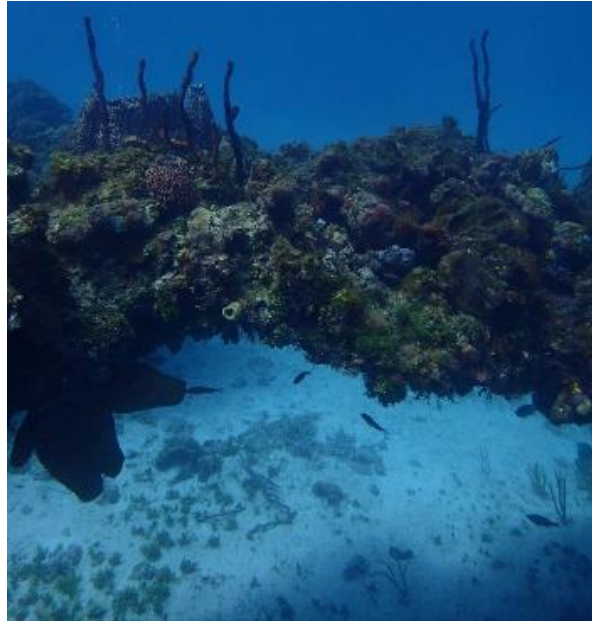
Figure 12-2: The northern section of the forereef showing arch formation typical of the area and high cover of bare substrate (sand, rubble, pavement)

On the northern section of the surveyed reef, live coral cover was higher than other sections, covering 5.67% of the benthic substrate. This section is dominated by sand, rubble and pavement (48.15%) with high macroalgal cover (40.49%). The structure of this section of the fringing reef is characterized by overhangs, ledges forming a number of caverns and arches (see image below). This is an indication of a structurally complex habitat unlike the uniform flat benthos observed in the backreef (the proposed area for the location of the six groynes).

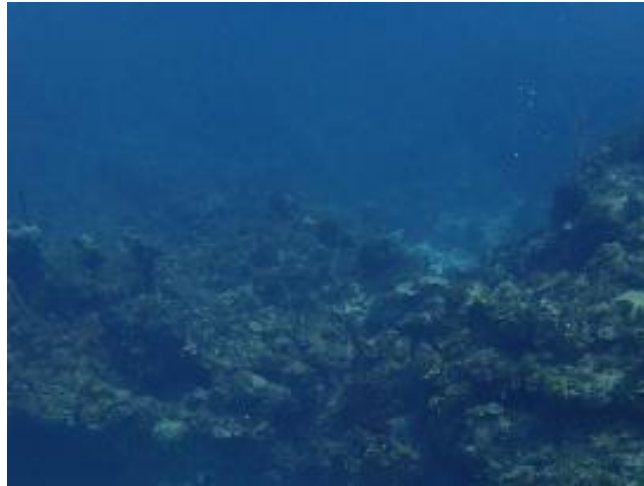
Figure 12-3: The central section of the reef showing cover of macroalgae

The benthos in the central section of the surveyed reef had the highest percentage of macroalgal cover, with 43.33%. Live coral cover in this section was the lowest of the sites sampled at 4.41%, highlighting the poor condition of this reef. Bare substrate (sand, rubble, pavement) accounted for 47.21% coverage along the reef system. The figure below shows a sample image from the central section of the reef. There were signs of sedimentation noted in this area, which is also used heavily as a dive and snorkel site. These cumulative pressures can act to erode reef resilience.

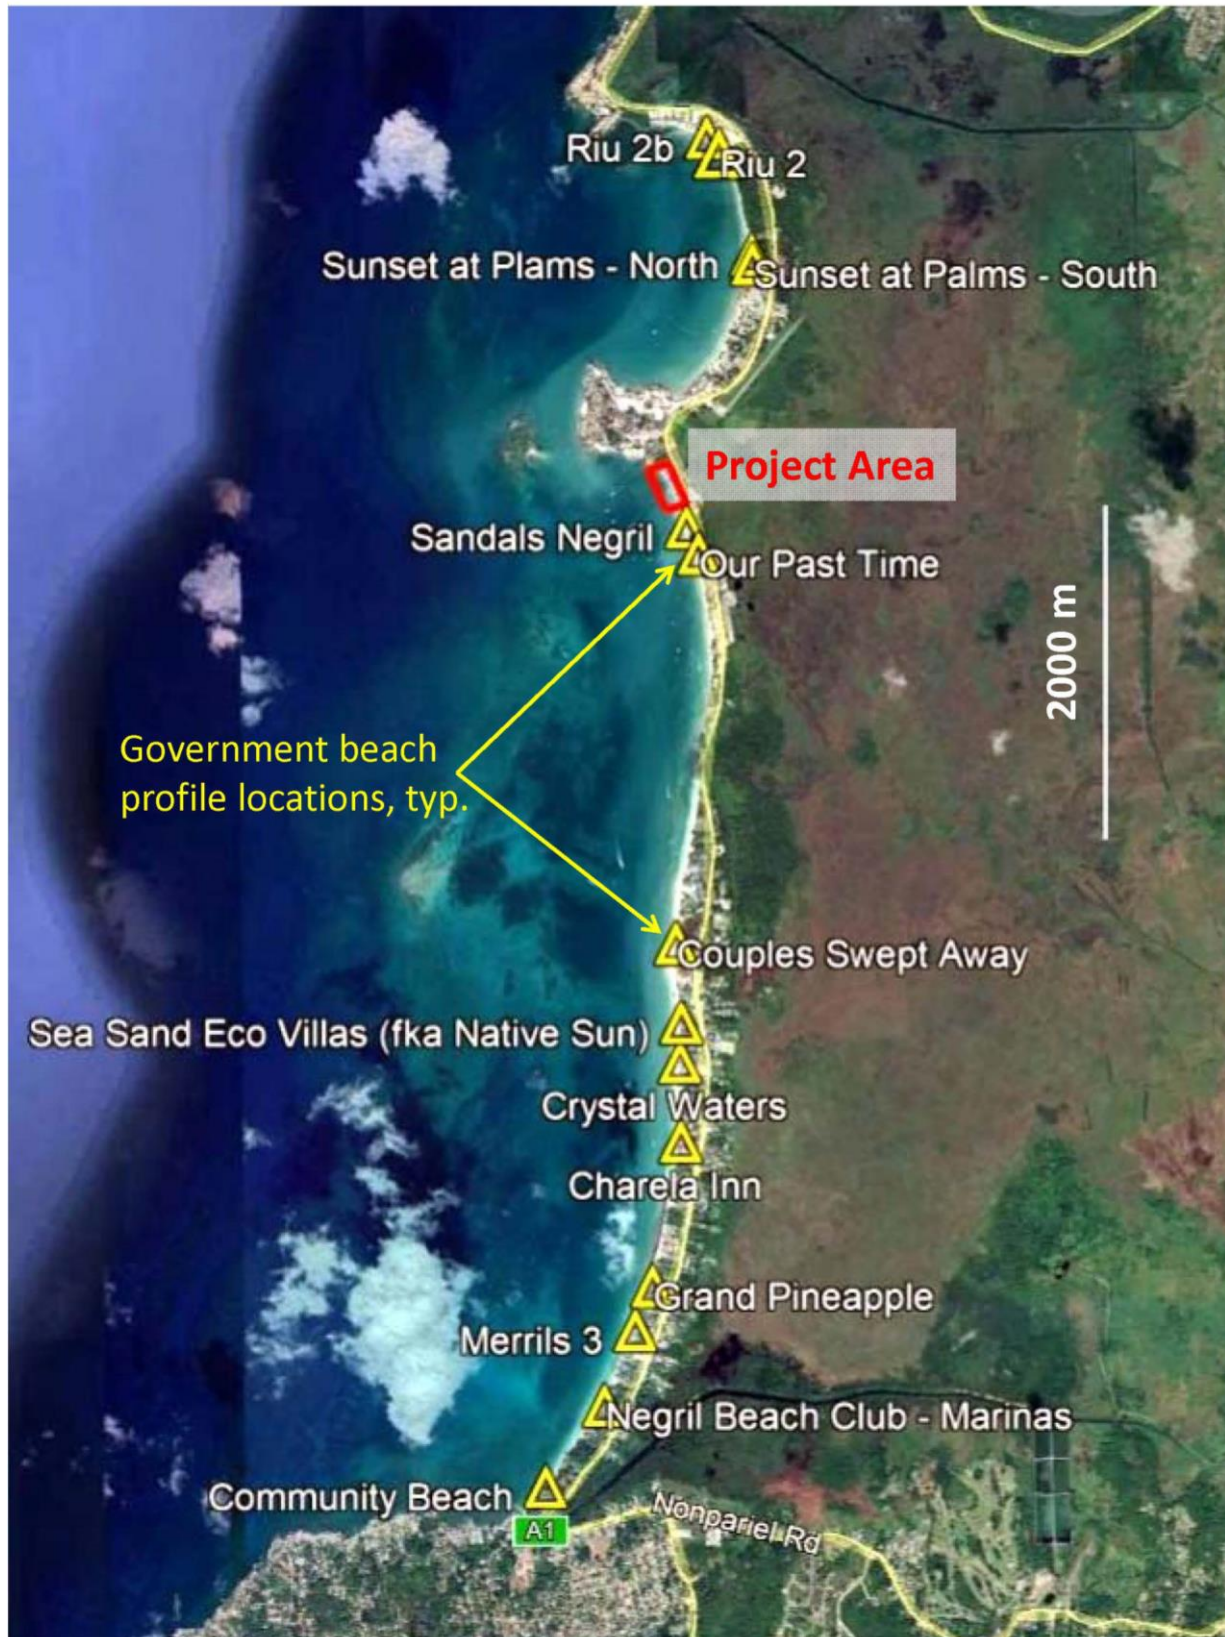
Figure B: Government's existing beach monitoring locations along Negril Beach.

The Government has previously established 14 beach profile monitoring locations along the Negril Beach shoreline. These are illustrated in **Figure A** and **Figure B**. Two of these profiles are located within 140 m and 315 m south of the project area (“Sandals Negril” and “Our Past Time”, respectively). These two profile locations are included within the proposed monitoring plan: viz., Profiles #8 and #10 (see **Figure A**). The other twelve Government profiles at Negril Beach are located too far afield to reasonably capture effects of the proposed Sandals Negril project. Specifically, four of the profiles are located between 1.6 and 2.2 km north of the project area and separated by a headland, and eight are located beyond 2.8 km south of the project area (see **Figure B**). These profiles are too far distant to reasonably reflect any impacts of the small size of the proposed project (~250 m length and ~7000 cubic meters fill), relative to ambient background changes along the broader shoreline.

Beach profile change data at profiles #8 and #10 will be compared to the Government’s longer-term beach profile data at these locations (“Sandals Negril” and “Our Past Time”) to assess contemporary post-project beach behavior relative to the prior record. **Figure C** illustrates changes in the beach profile width from the Government database at these two locations. Here, the *average* (4-year) trend indicates erosion of -1.2 m/yr at “Sandals Negril” and -0.4 m/yr at “Our Past Time”, located about 140 m and 315 m south of the project area, respectively. The annual variations (erosion versus accretion) are noteworthy. Accordingly, the monitoring program shall necessarily assess short-term (survey-to-survey) changes relative to longer-term (multi-year) trends.

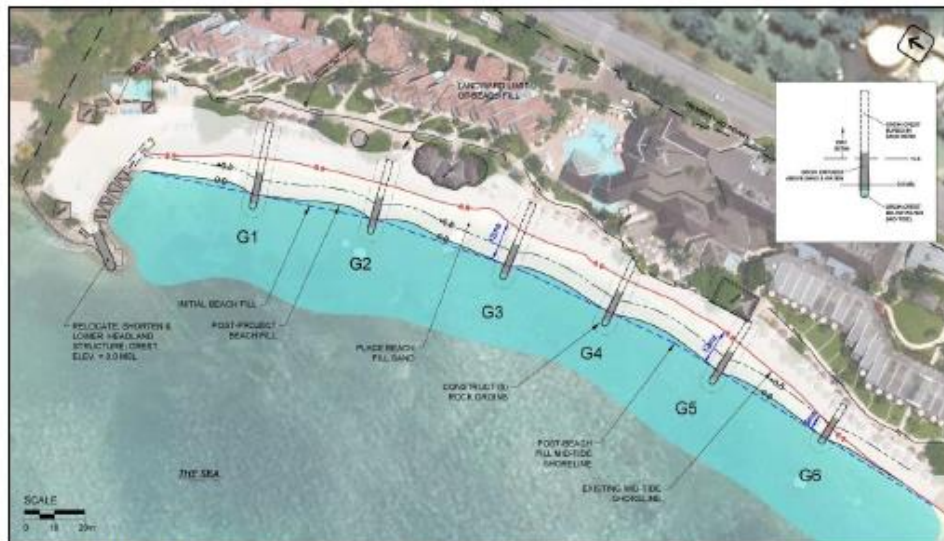
Figure A: Proposed plan with beach nourishment and six groynes.

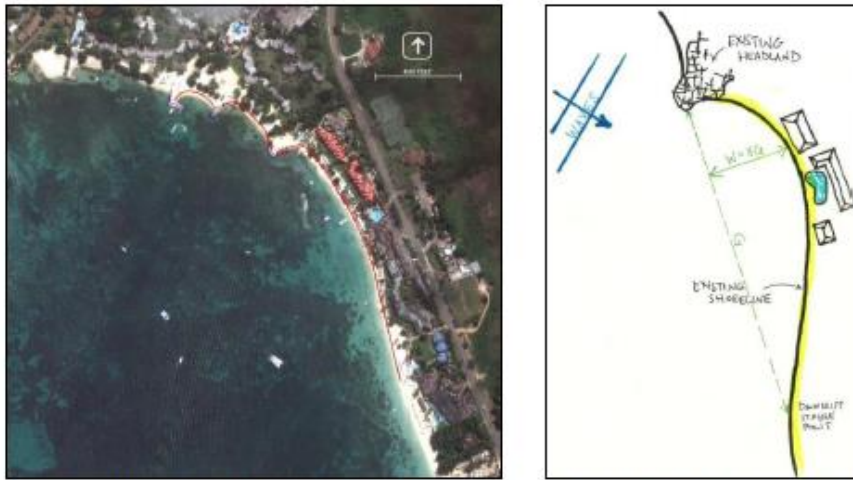
Figure B: The existing shoreline exhibits a weak crenulate shape south of the local headlands. In such shape, the shoreline is “indented” landward by some minor width (W) that is a function of the open shoreline length (G) down-wave of the headland. Filling the indentation with sand to straighten the shoreline (without stabilizing structures) results in rapid loss of the sand fill as the beach seeks to recover its embayment shape. For this reason, some modest level of structures is warranted at the site.

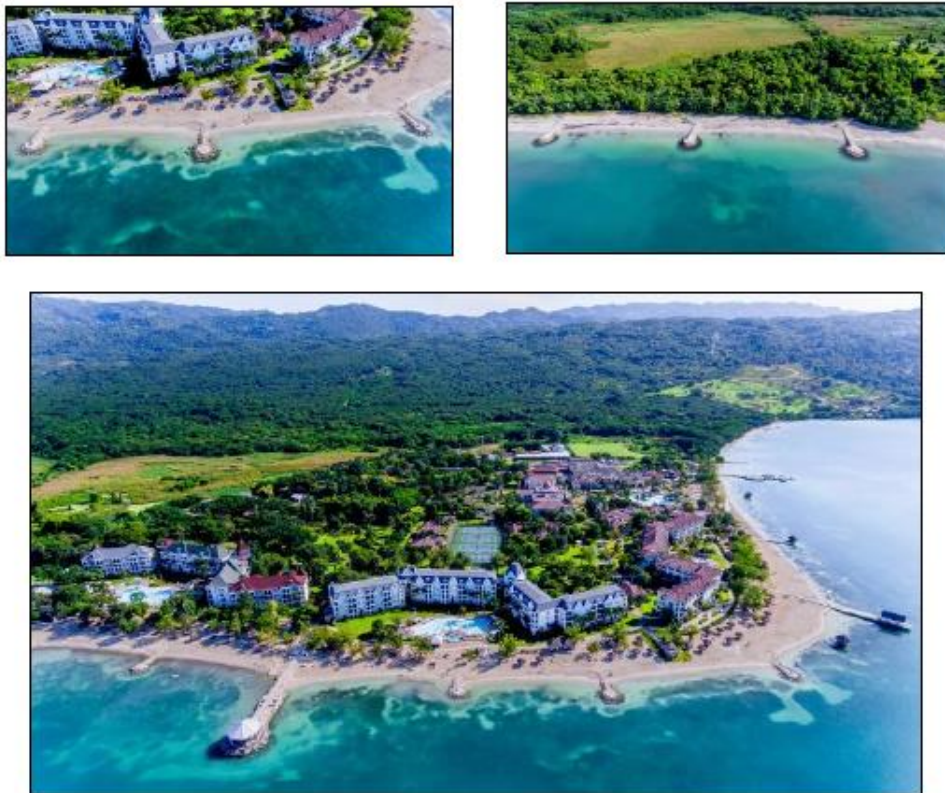
Figure F: Rock groynes at Sandals Whitehouse constructed in 2016-17 to stabilize beach fill amidst a highly eroded shoreline in similar low-energy conditions as Sandals Negril Beach. These groynes are much longer and higher than those proposed at Negril Beach. (The long groyne at lower left was pre-existing prior to the works). Despite highly oblique waves & westerly-directed transport (toward the left in the photographs), little alongshore differential in shoreline location has been observed, and little maintenance has been required.
