ENVIRONMENTAL IMPACT ASSESSMENT

CLUBHOTEL RIU MONTEGO BAY

MONTEGO BAY, JAMAICA

DRAFT REPORT

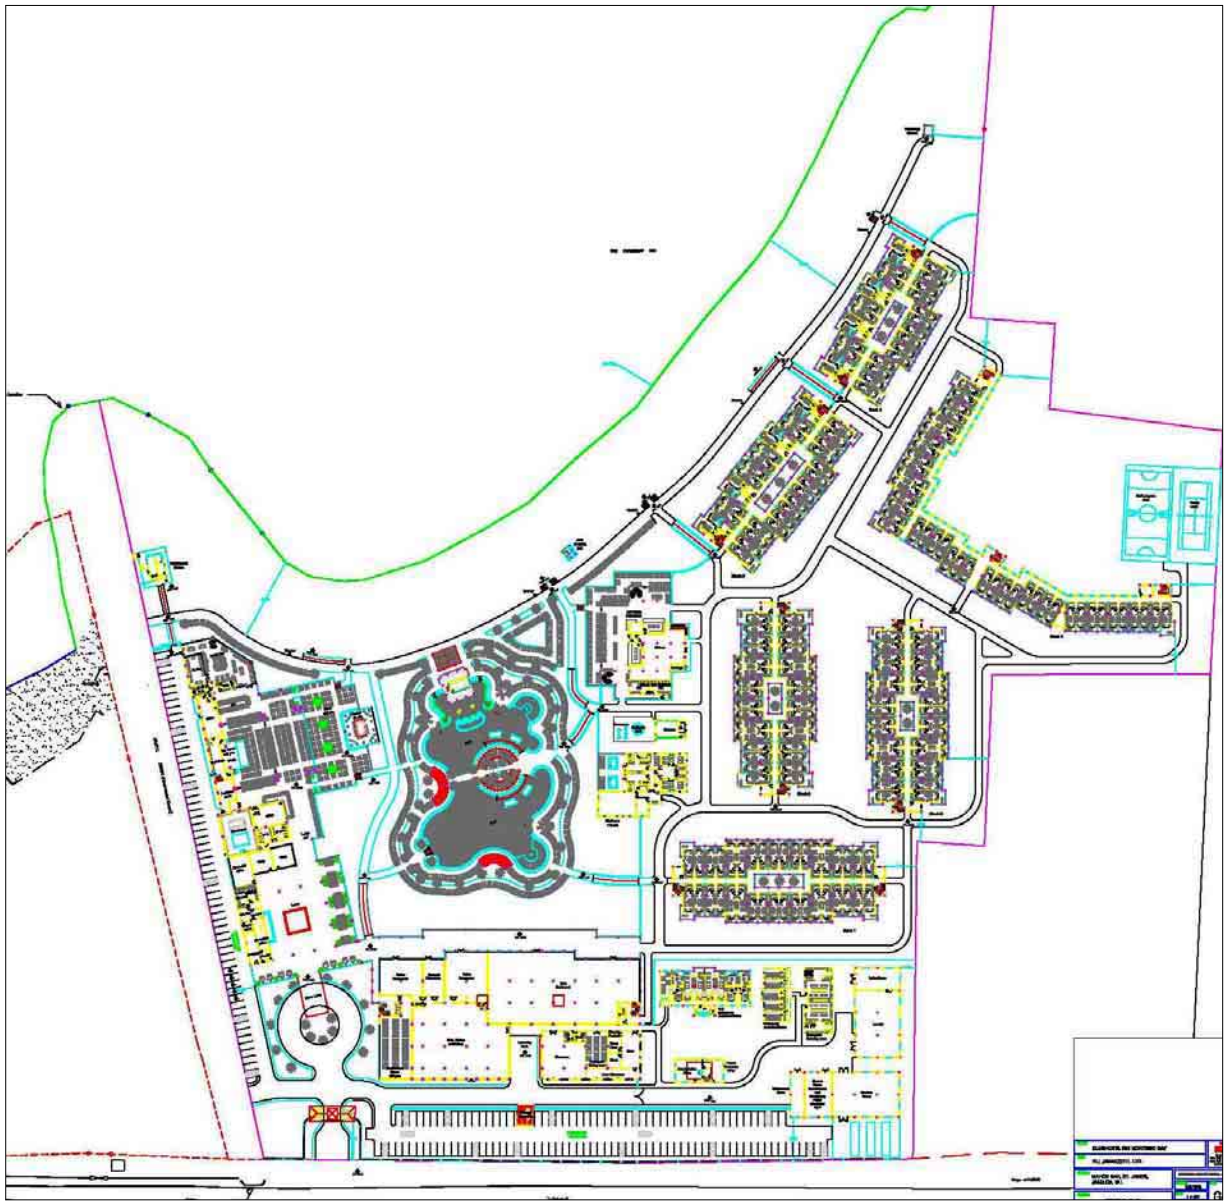
Figure 3.2 Proposed layout of ClubHotel RIU Montego Bay development

rooms, sanitary services and locker rooms. To the east of these buildings, the Administration Office and the Human Resources Office, Maintenance Room, Electrical and Emergency Power Generator, Machine Room, the Air-Conditioning Chillers area, Laundry, and the Boiler Room will be situated, each in separate buildings.

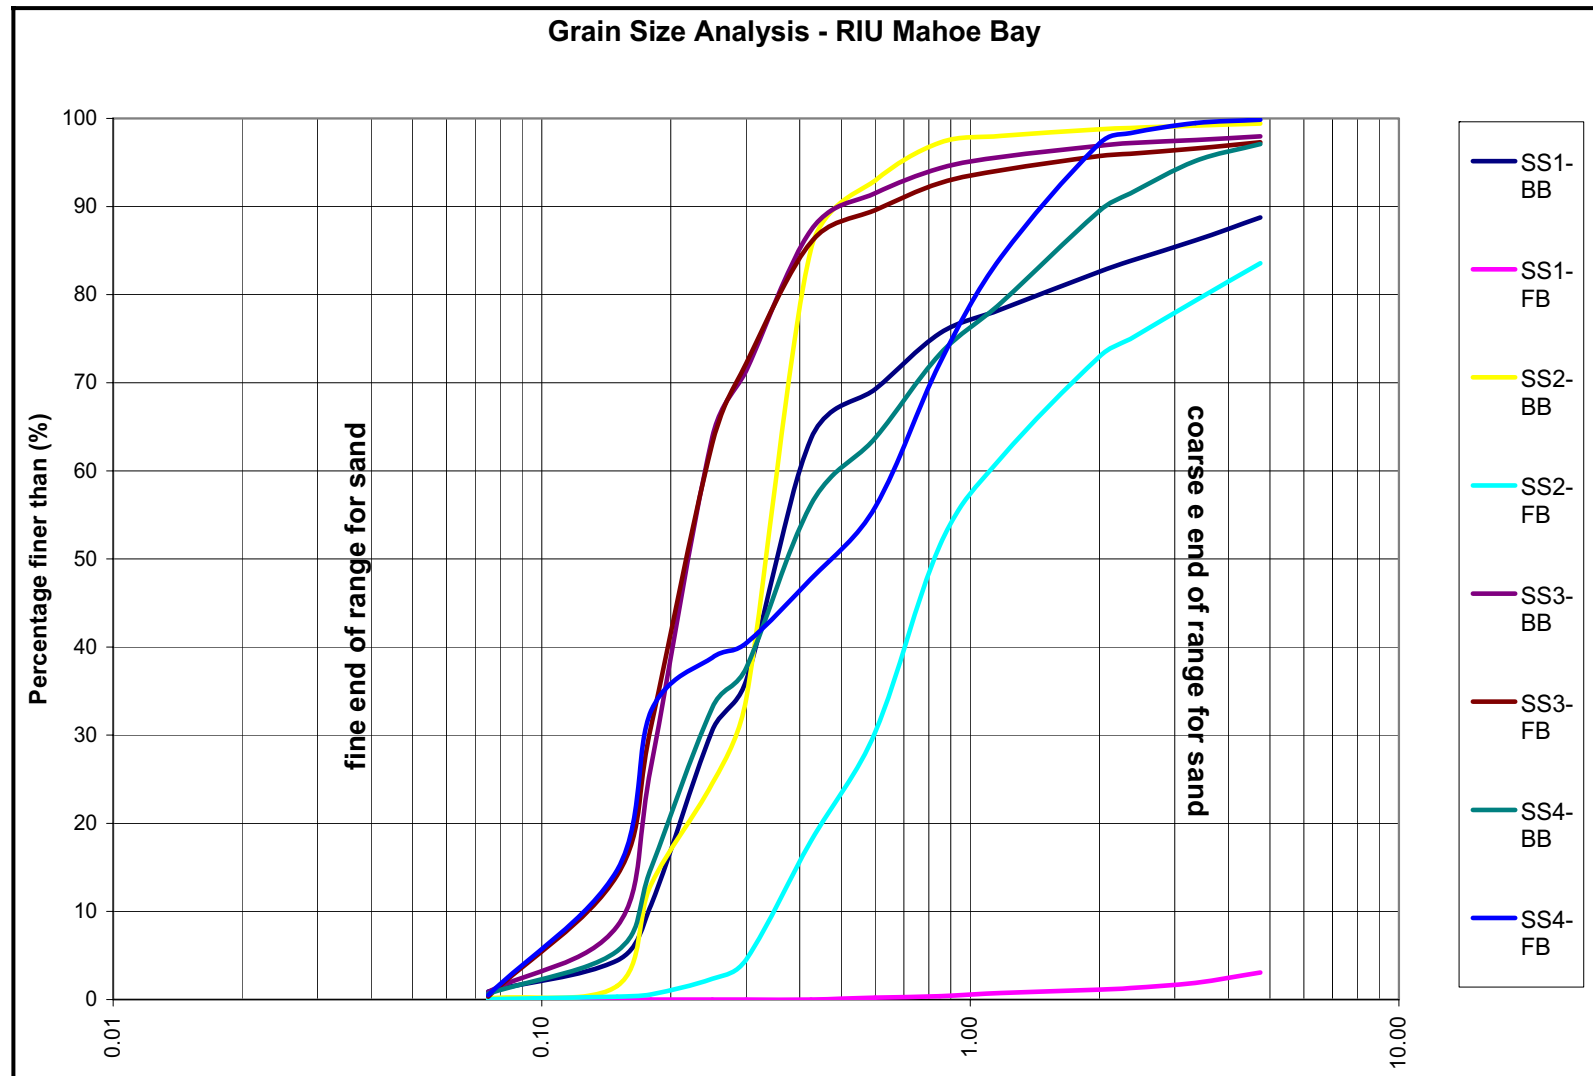
Figure 4.9 Logarithmic graph of sand grain sizes at four sampling locations, Mahoe Bay

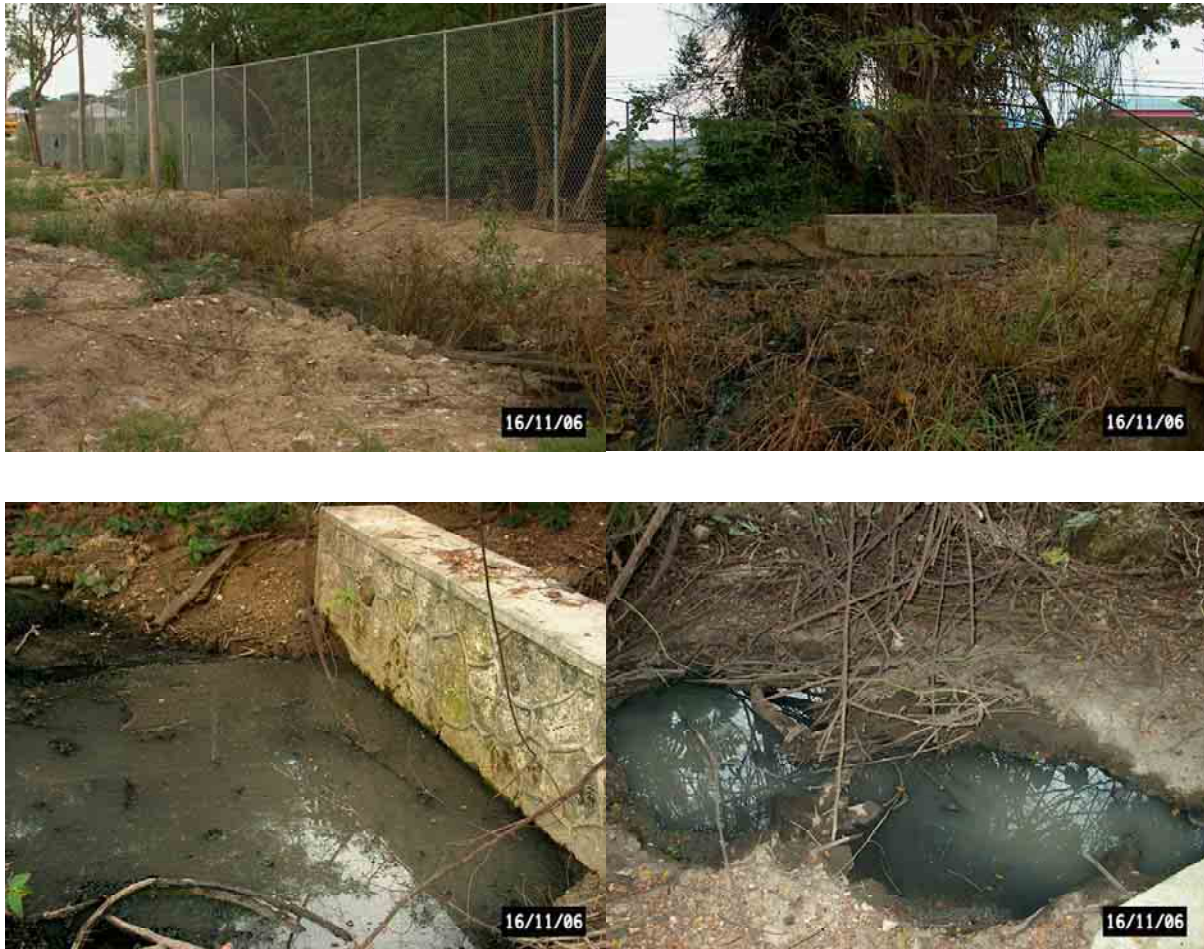
Plate 4.38 Collage showing views of the drain (WQ 8) on Clubhotel RIU Montego Bay, St. James

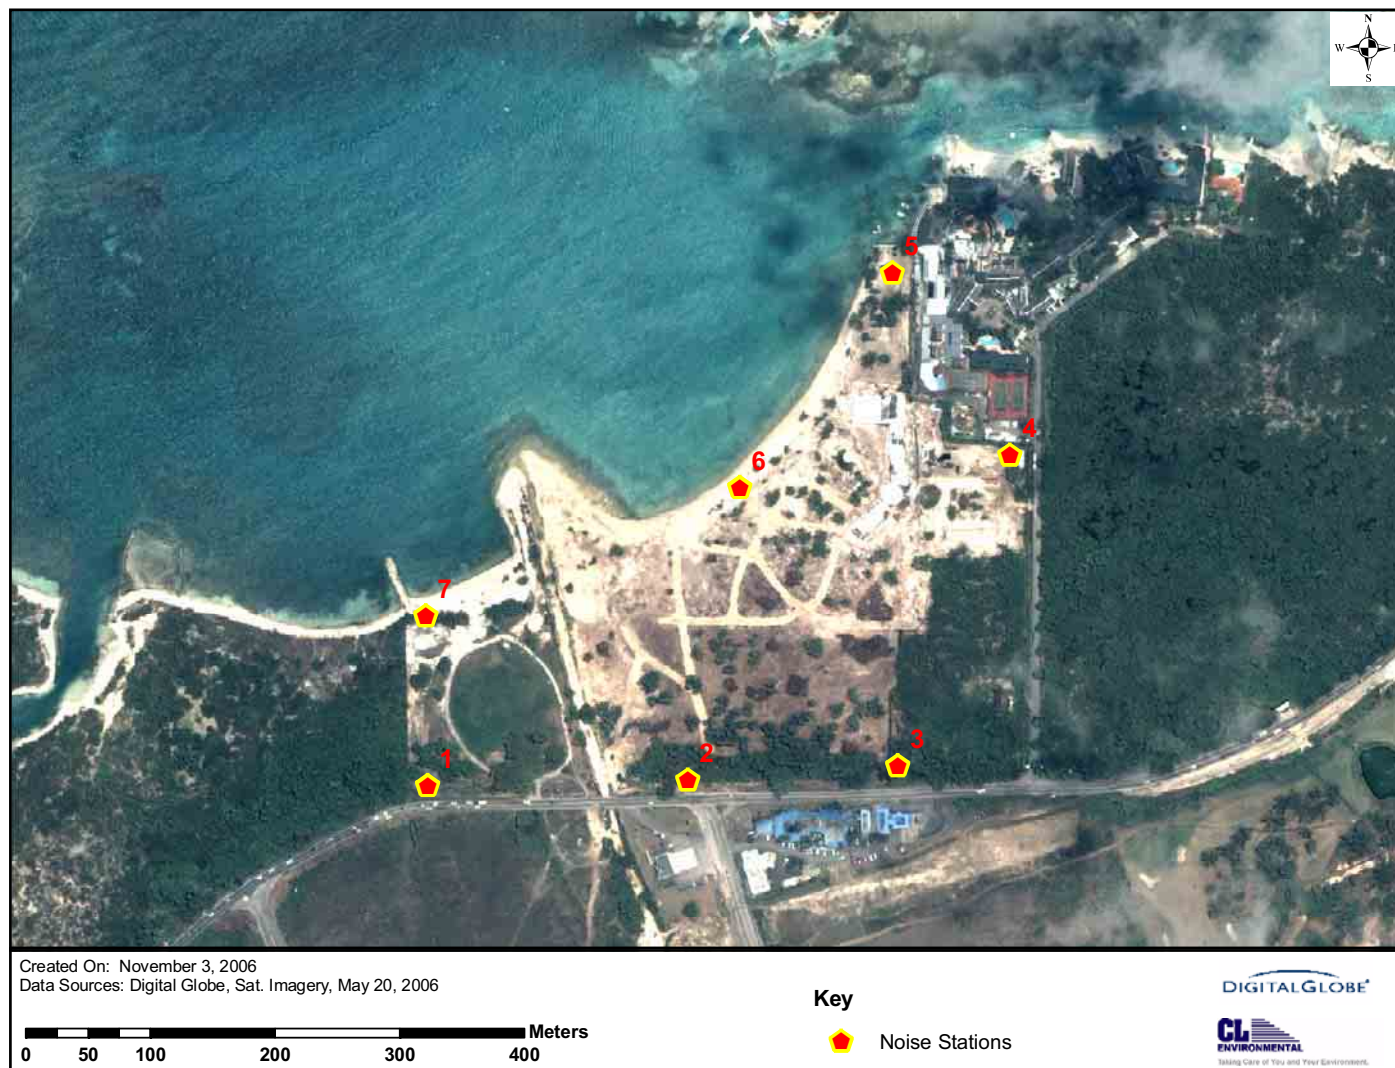
Figure 4.34 Map depicting noise stations at ClubHotel RIU Montego Bay, Mahoe Bay, St. James

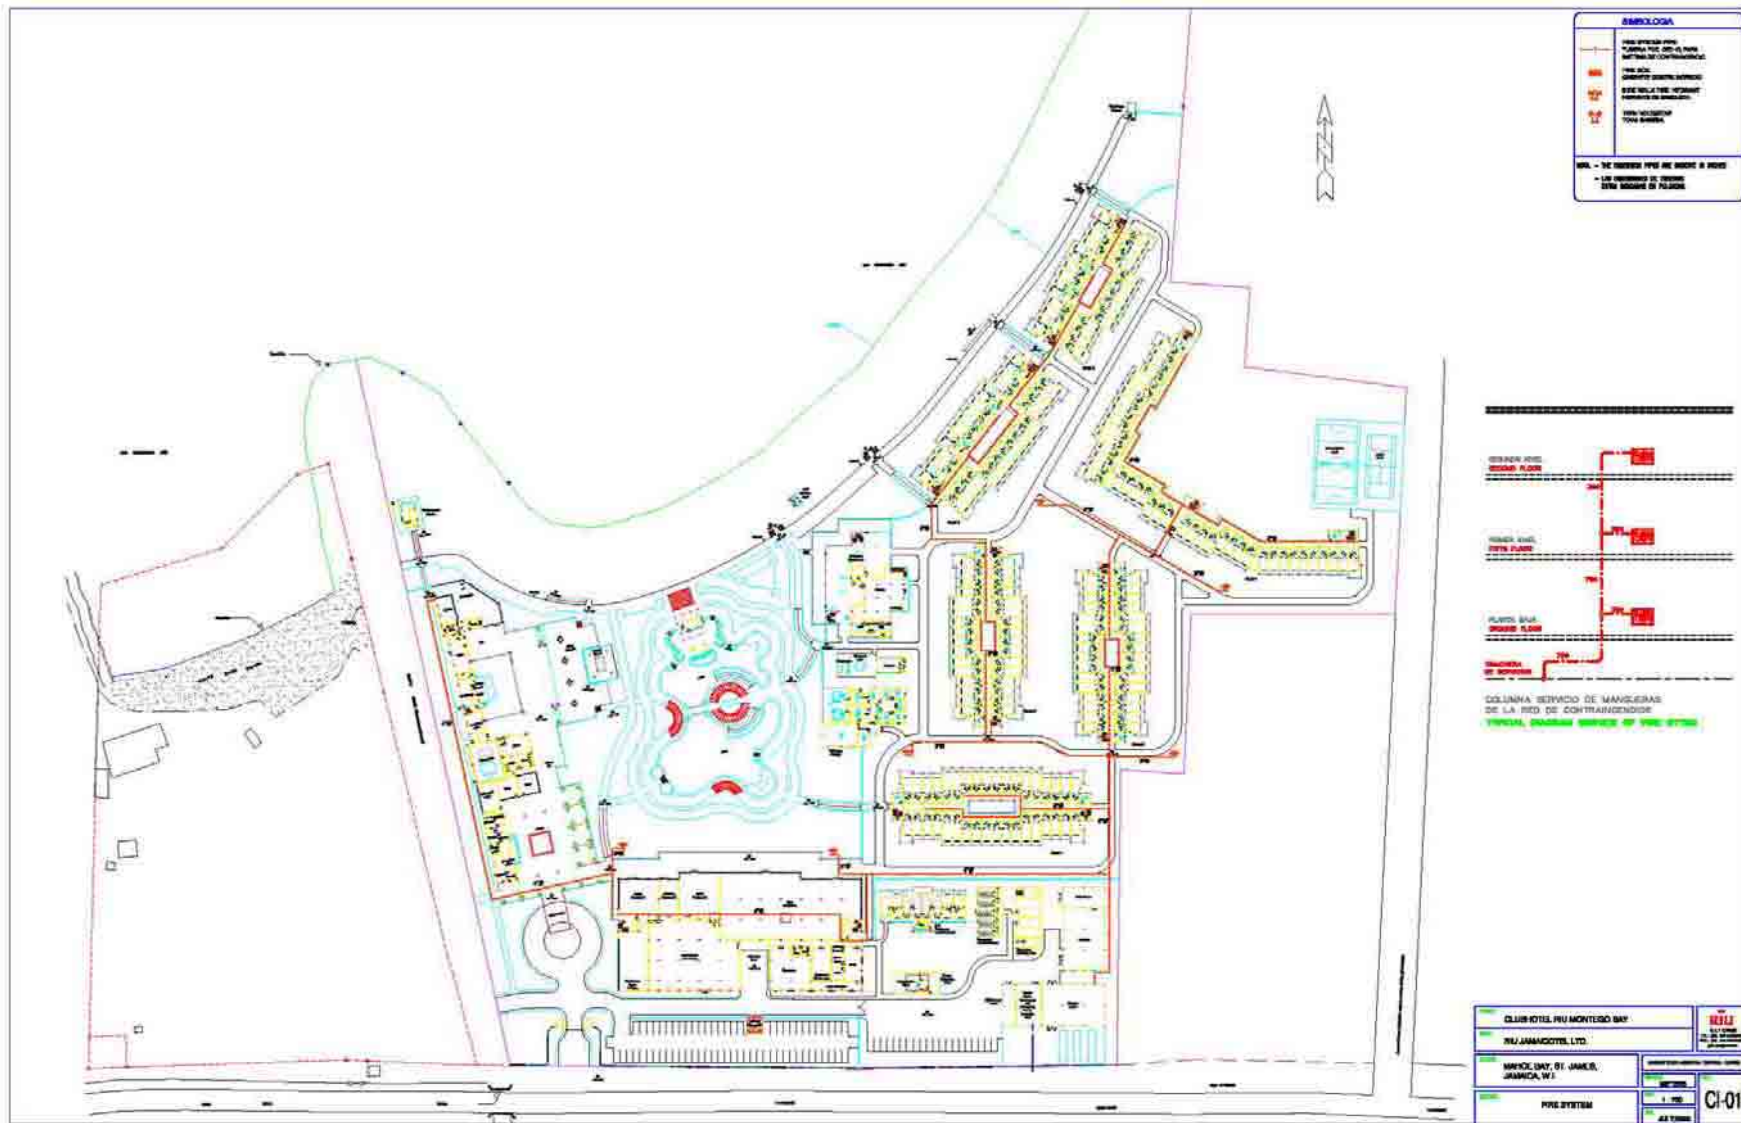
Figure 4.56 Schematics showing fire control systems for the proposed hotel

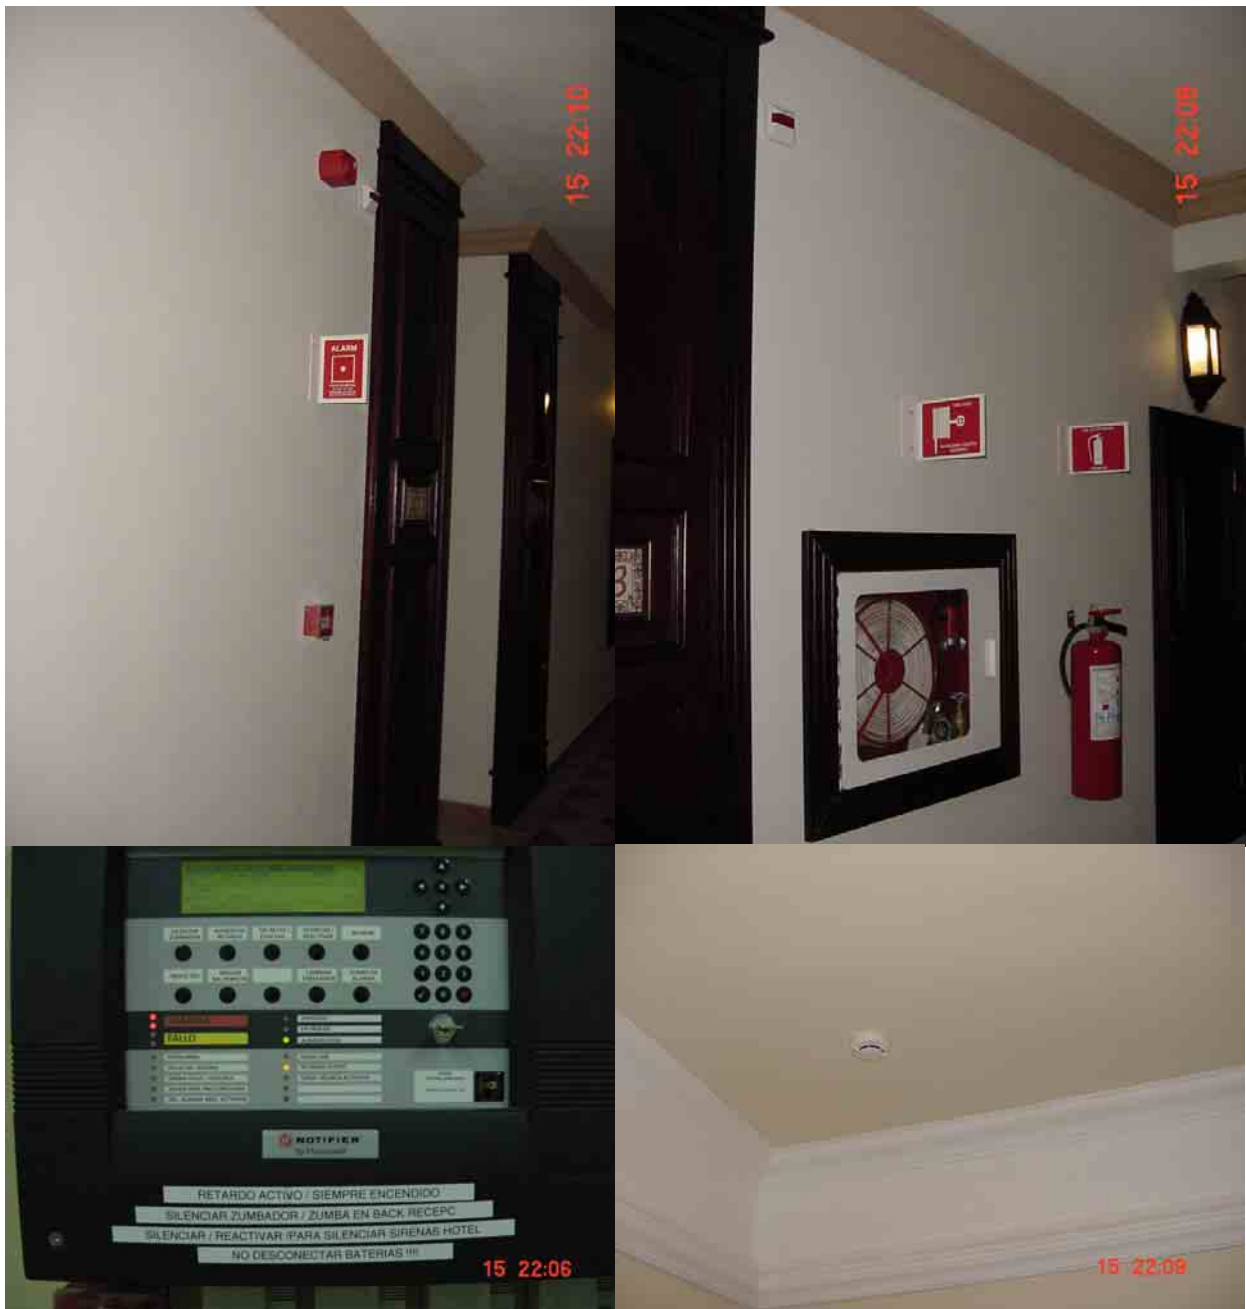
Plate 4.40 Examples of the proposed fire prevention and response systems
