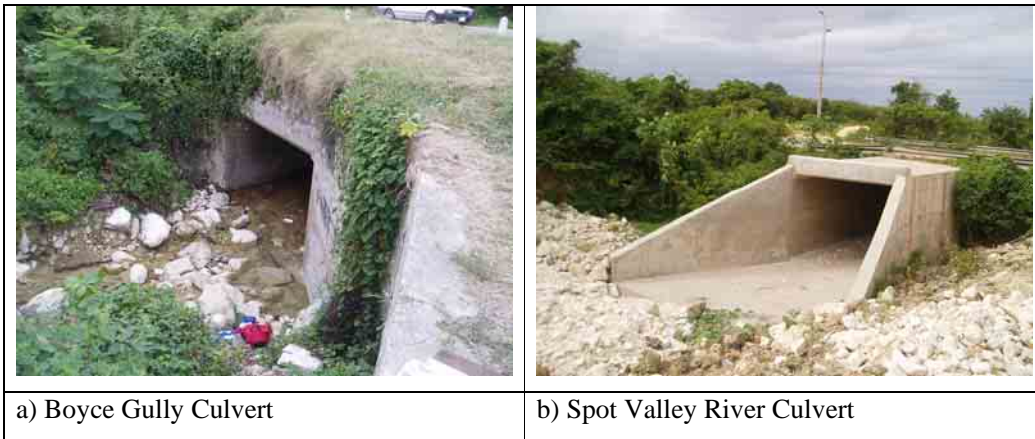
Plate 5.2.5.2 a and b: Box Culverts (viewing on the south side of the road)

North Coast Highway through a 2 m high x 4 m wide x 24 m long box culvert. It flows for an additional 300 m before entering the sea beside the Rose Hall Wyndham Resort.

The river underpasses the North Coast Highway west of Lilliput community through a 3 m high x 4 m wide x 24 m deep box culvert (Plate 5.2.5.2c) after flowing for approximately 2.4 km. The river joins the marine environment after flowing for an additional 400 m. This river is mapped on the 1:12,500 topographic sheet as a seasonal

river. At the time of the field visit the river bed at the location where it underpasses the Highway was dry.

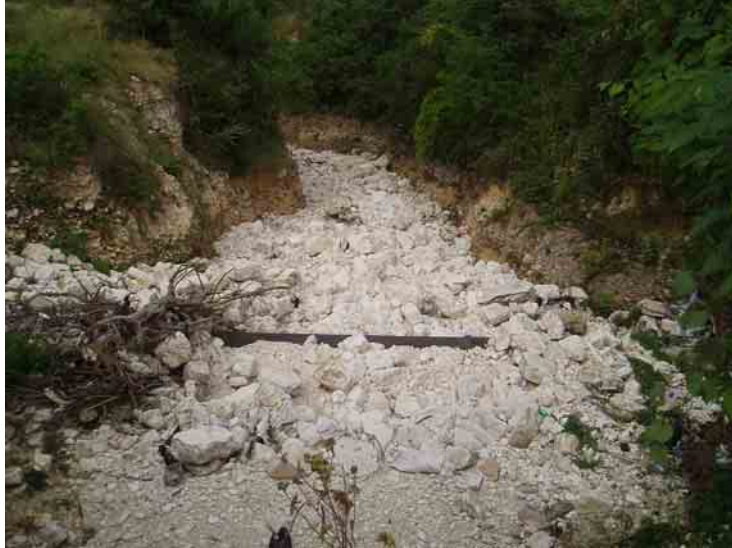
Plate 5.2.8.1: Sediment Build-up (south of culvert, Spot Valley River)

The main north coast road, now being upgraded under the Northern Coastal Highway Improvement Project (NCHiP), has been flooded on several occasions over the last few years, severely hampering vehicular traffic and causing widespread economic damage to tourism facilities and the road network. The section of highway between the Ritz Carlton and Wyndham-Rose Hall resorts has received significant damage. The last major event occurred in April 27, 2005 forcing the Ritz-Carlton to cease operations for an extended period. There is no single reason for flood events to occur. However it appears that inadequate maintenance of drainage channels and the blocking of culverts with debris (rock material, vegetative matter) reduces the capacity of the drainage infrastructure to adequately convey storm water under the coastal road. Plate 5.2.8.1 shows the typical

aggradation of coarse sediment (White Limestone boulders) in gullies near culverts. When comparing the peak flows modeled with the cross sectional area of the two box culverts flooding is likely to occur even with return periods of less than 50 years.

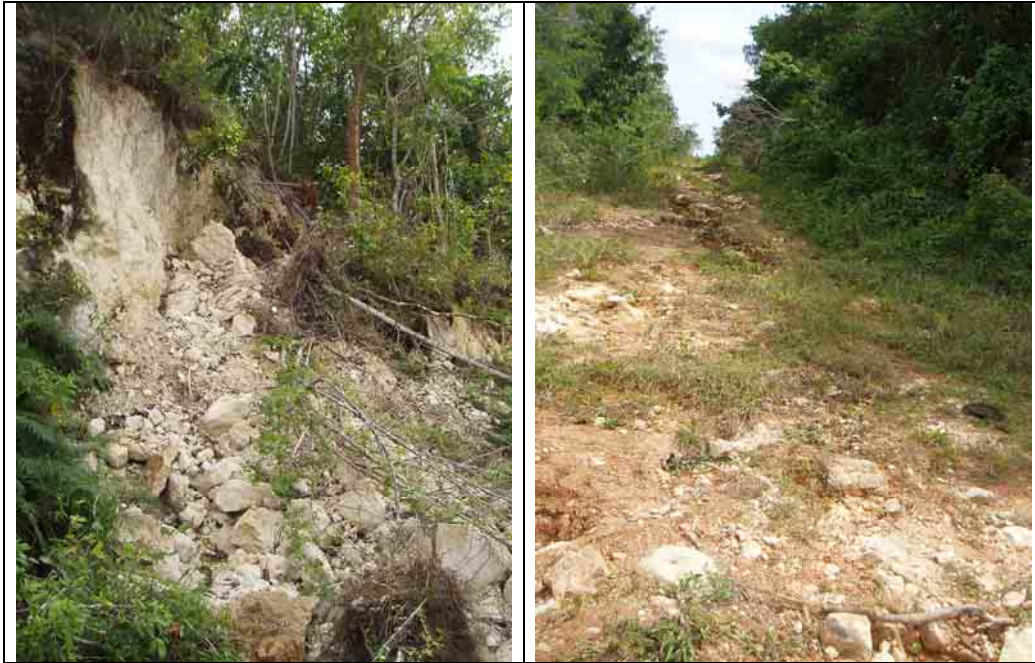
Plate 5.2.8.4 a, and b: Erosion at Rhyne Park

1. Rock falls associated with overhanging slopes of the bedded Montpelier lithology. In general the Montpelier is very stable except where the bedding dips out of the slope. The lithology tends to cleave in blocks along joint/bedding planes, producing boulder-sized rocks.
2. Minor slumping in the massive white lithology. In this situation, loading of the slope can lead to failure. Trees on the slopes can also act as levers to pull sections of the slope away from the main slope.
3. Rill development and gully development along flat or depressed surfaces in the limestone. This can be seen along secondary roads on the property, which serve as preferred pathways in the absence of a storm water drainage system. These rills are essentially first order streams that connect to the major gully systems that drain the property.

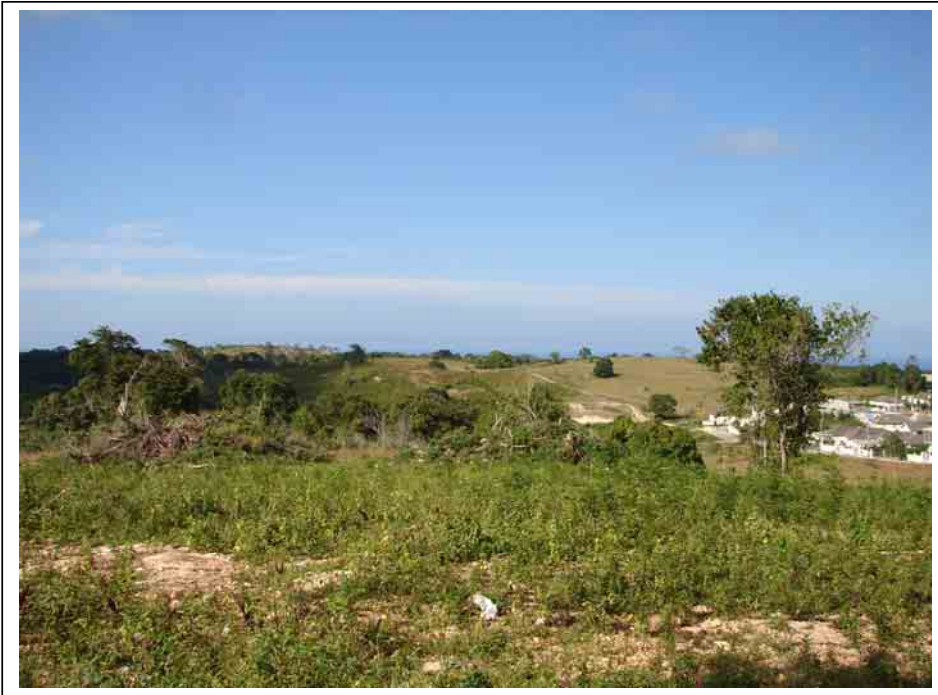
Plate 5.3.1 a: North easterly view across the property and existing VMBS houses

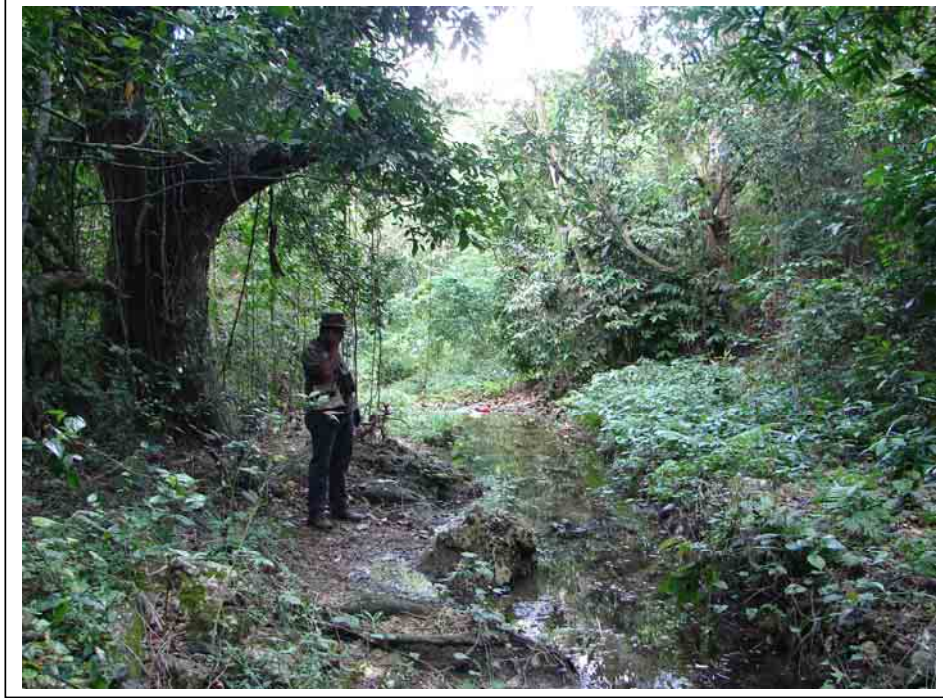
Plate 5.3.1 b: Stream vegetation

The largest trees on the site are found on the steep banks of the stream that cuts across the southwestern margin of the site. There are very large Guango trees (*Samanea saman*), Roseapples (*Syzygium jambos*), and Mangoes (*Mangifera indica*). The relatively stable history of this area is reflected by the size of the trees as well as the presence of epiphytes on the trees including the orchid *Broughtonia sanguinea* (an endemic species) and several species of Tillandsia epiphytes. Royal Palms (*Roystonea altissima*) were common. The banks are thickly covered with ferns including Maidenhair and Polypodium, and the trees with vines and these contribute to a potentially attractive site for a nature walk as proposed on the plan, once garbage has been removed. The height of the deposits of detritus on the vegetation on the banks indicated that floodwaters can reach 3-4 feet above current levels, reinforcing the importance of leaving a buffer of natural vegetation in the gully at least 10 m on either side of the stream.

No rooted aquatic plants were found in the stream bed, it is unclear whether this is normally the case, or whether they were scoured by a recent flood event.
