A MARINE ASSESSMENT REPORT APPENDIX

IN SUPPORT OF A RESORT DEVELOPMENT DUNCANS TRELAWNEY

July 2007

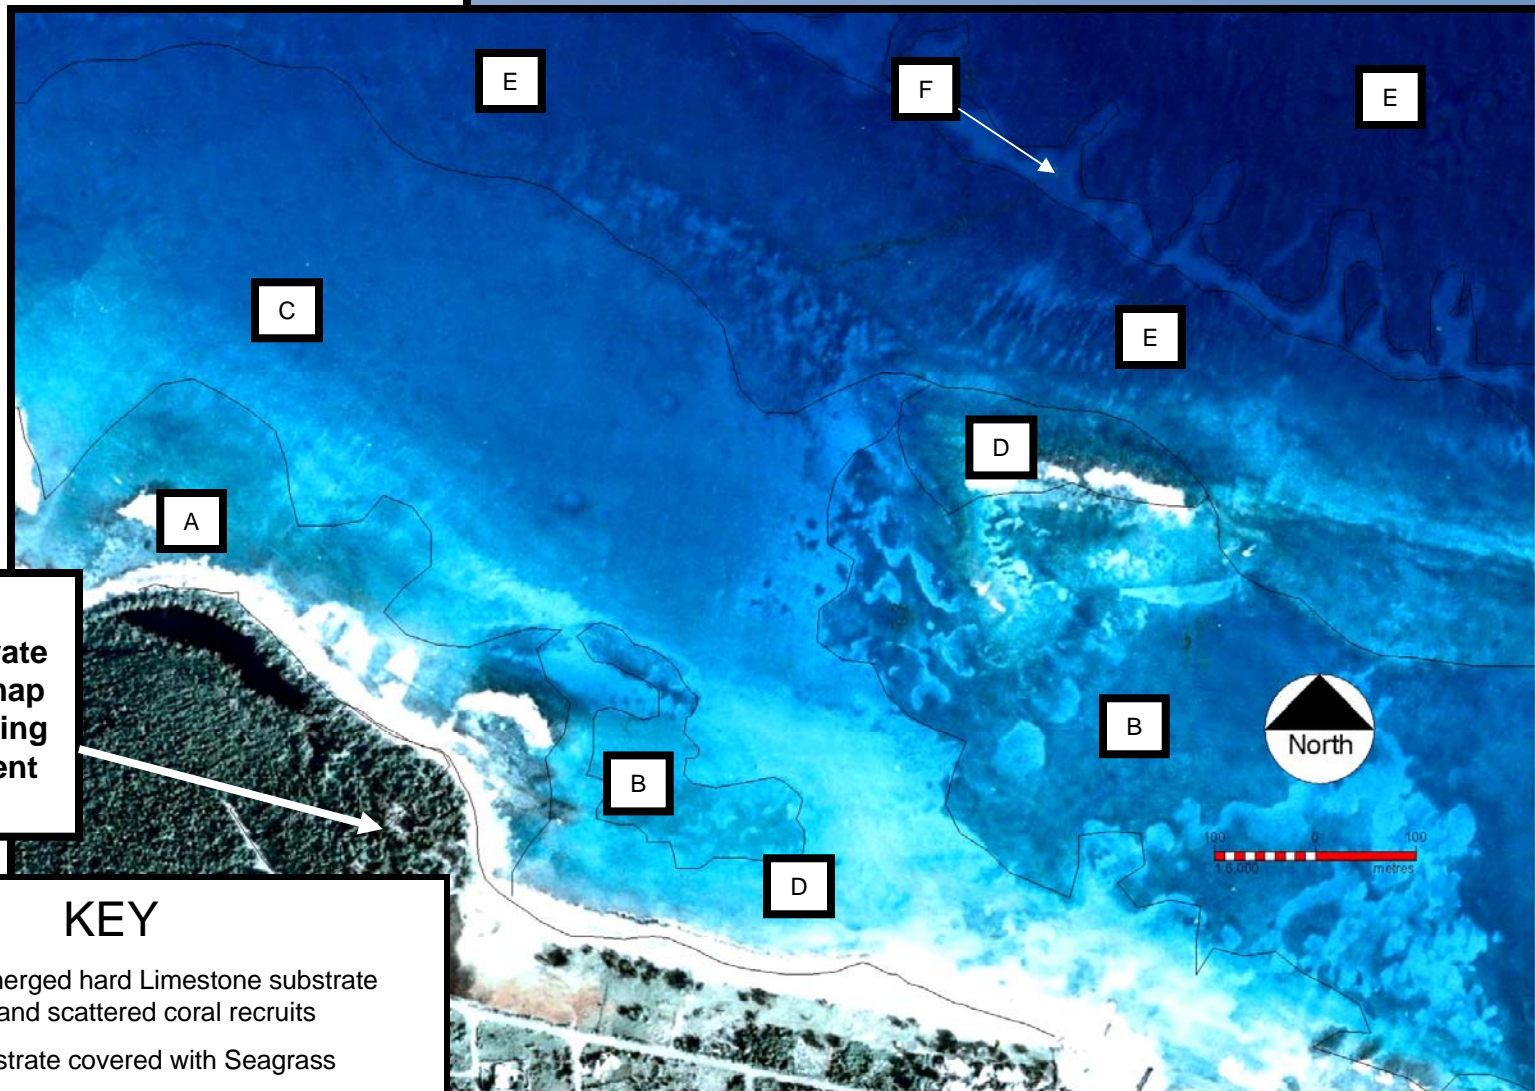
FIGURE 3
Benthic Substrate and Lifeform map
of areas adjoining
the development
site.

- A. Semi-submerged hard Limestone substrate with algae and scattered coral recruits
- B. Sandy substrate covered with Seagrass
- C. Shallow (1-2-6m) submerged hard limestone substrate (contiguous with A.) with algae and scattered coral
- D. Hard limestone substrate supporting shallow coral reef.
- E. Hard limestone substrate supporting deep water coral reef (10 -20m depth)
- F. Deep water sandy substrates.

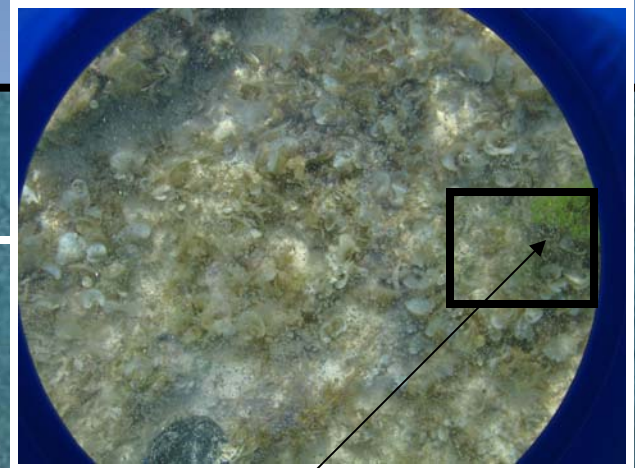
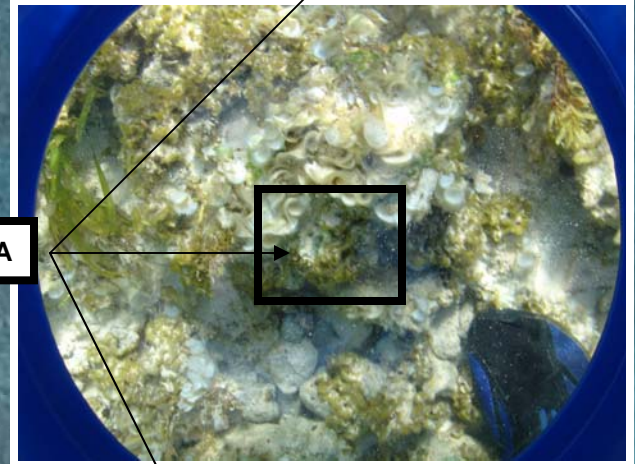
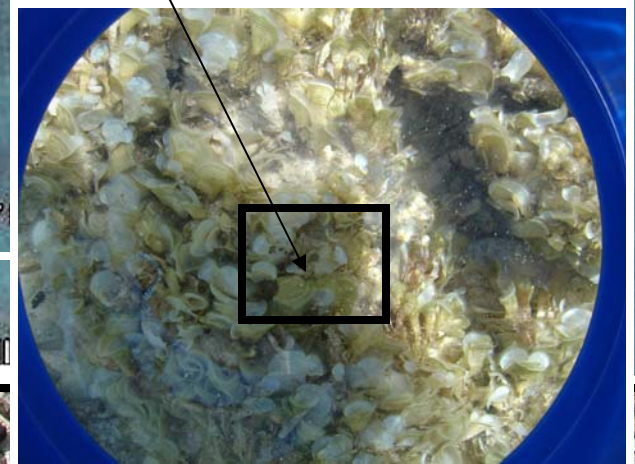
FIGURE 5A

Substrate – Hard Carbonate
Lifeform – Algae (A)
DAFOR - Abundant

Substrate form and
character for shallow
locations (<0.8m)
within
study area

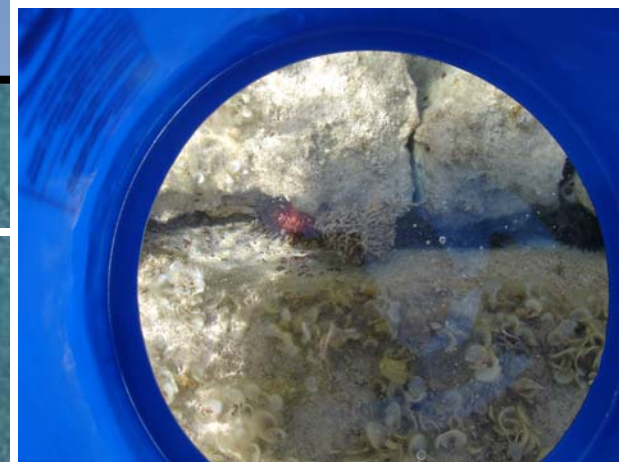
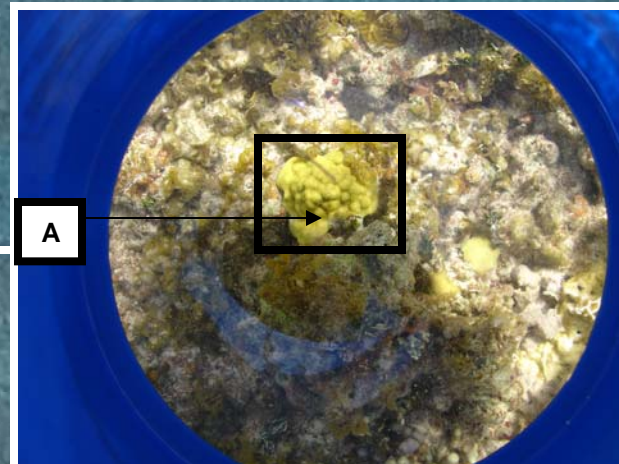
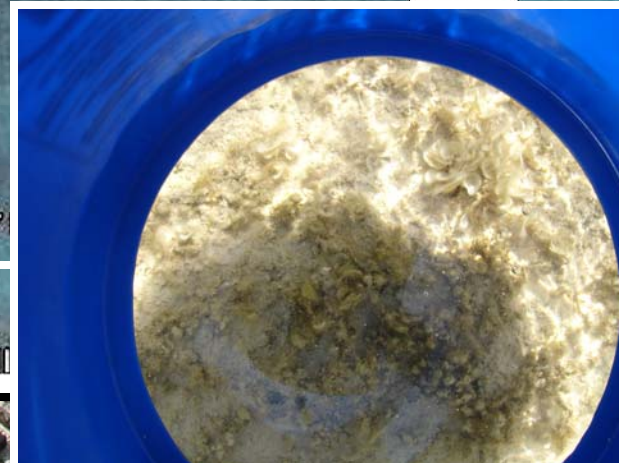
FIGURE 5B

Substrate – Hard Carbonate
Lifeform – Algae
DAFOR – Abundant
Lifeform - Coral (Mustard hill)
Note A.
DAFOR - Occasional

Substrate form and
character for shallow
locations (<1m)
within study
area

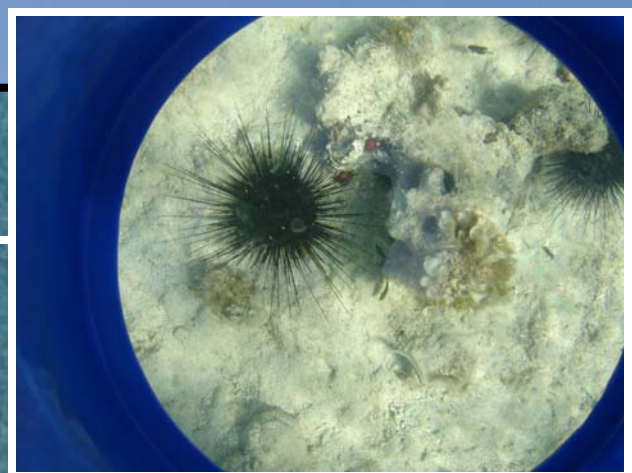
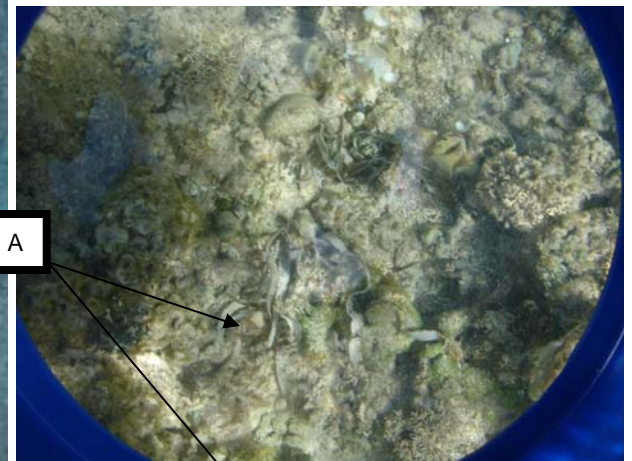
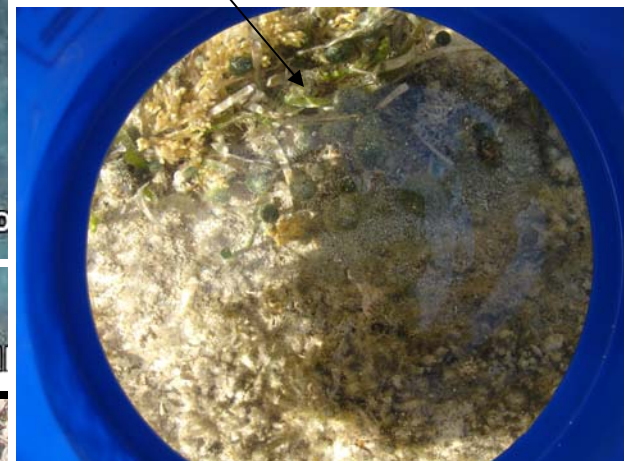
Substrate – Hard Carbonate
Lifeform – Algae
DAFOR – Abundant
Lifeform – Turtle Grass (A)
DAFOR - Occasional

FIGURE 5C
Substrate form and
character for shallow
locations (<1m) within study
area

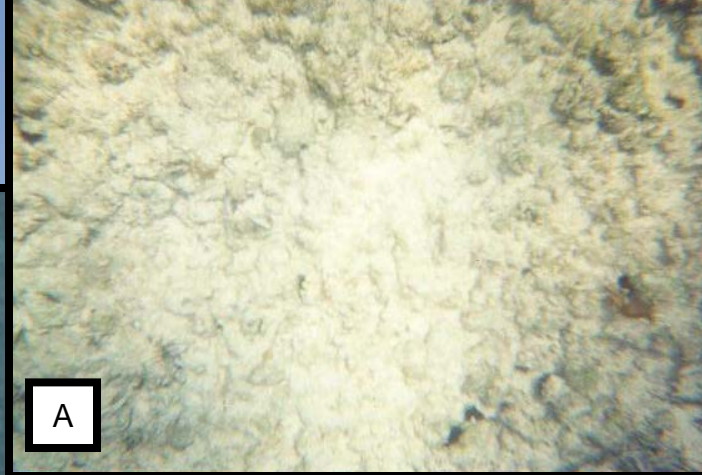
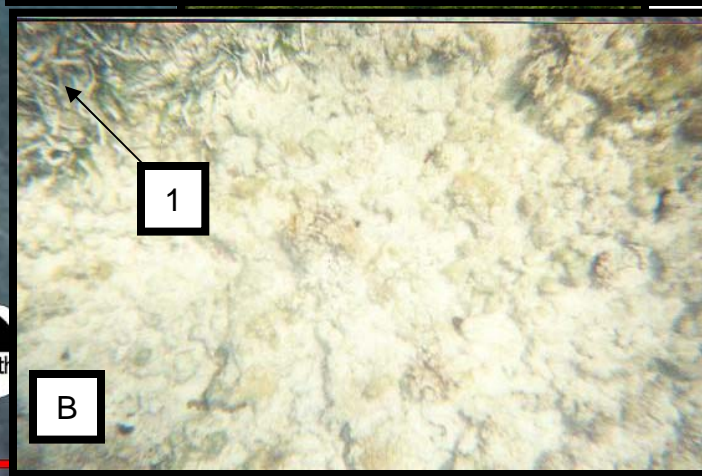
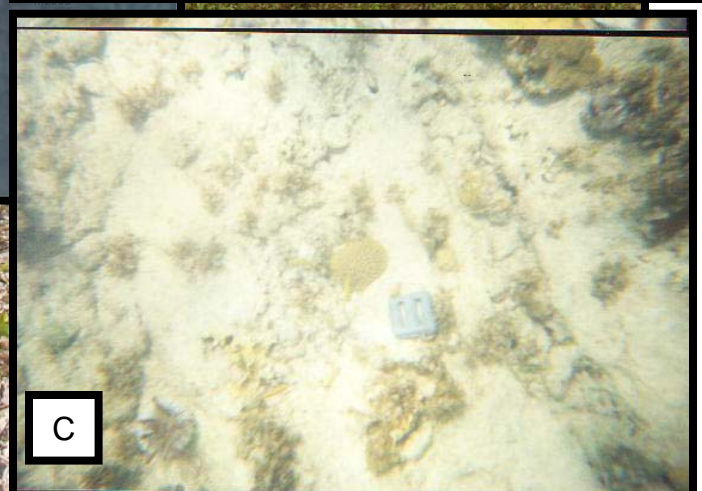
FIGURE 6A
Substrate form and
character for shallow
locations (1.2m -1.5m) within
study area

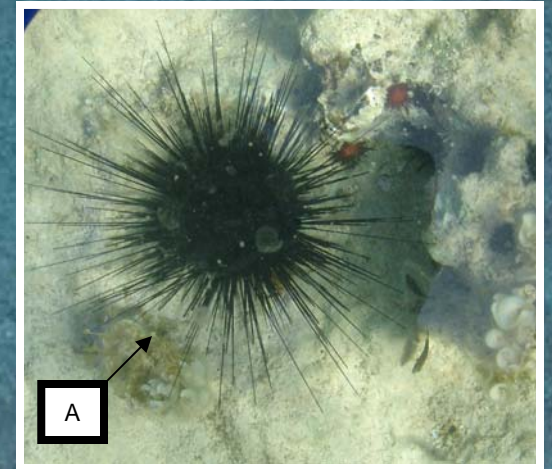
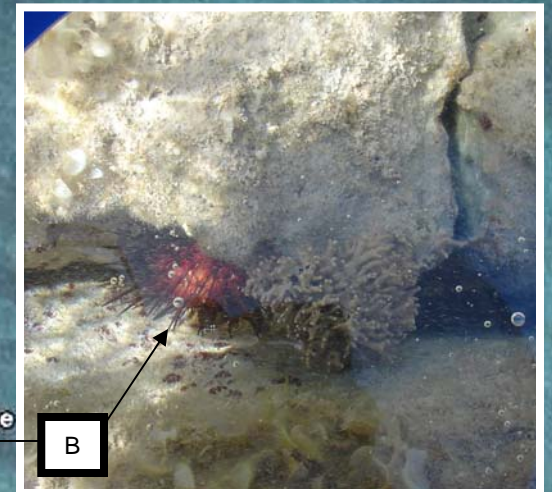
Substrate – Hard Carbonate
Lifeform – Urchins
DAFOR – Frequent

Black Spiny Urchin

Rock Boring Urchin

FIGURE 7A.
Mobile Benthic Organisms
Found Within the Project Study
Area

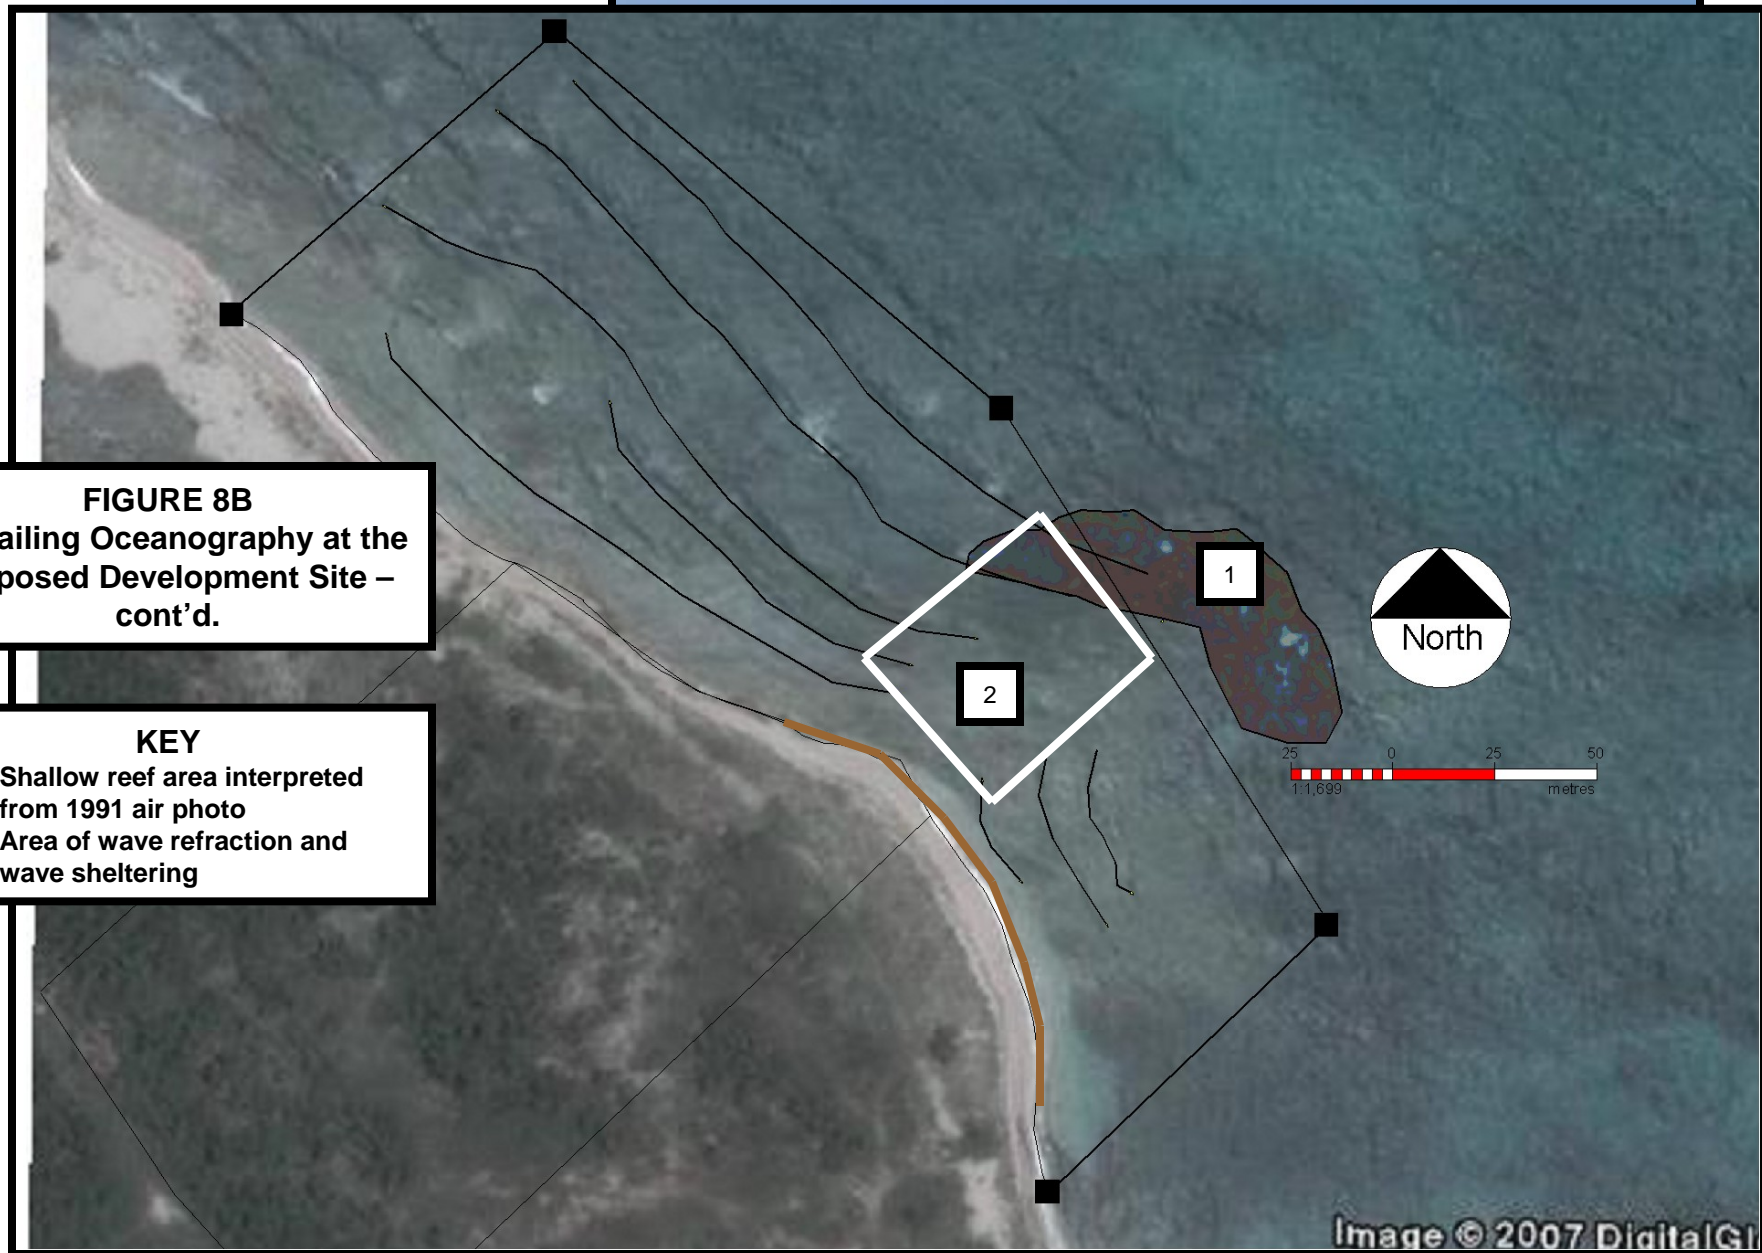
FIGURE 8B
Prevailing Oceanography at the
Proposed Development Site –
cont'd.

1. Shallow reef area interpreted
from 1991 air photo
2. Area of wave refraction and
wave sheltering

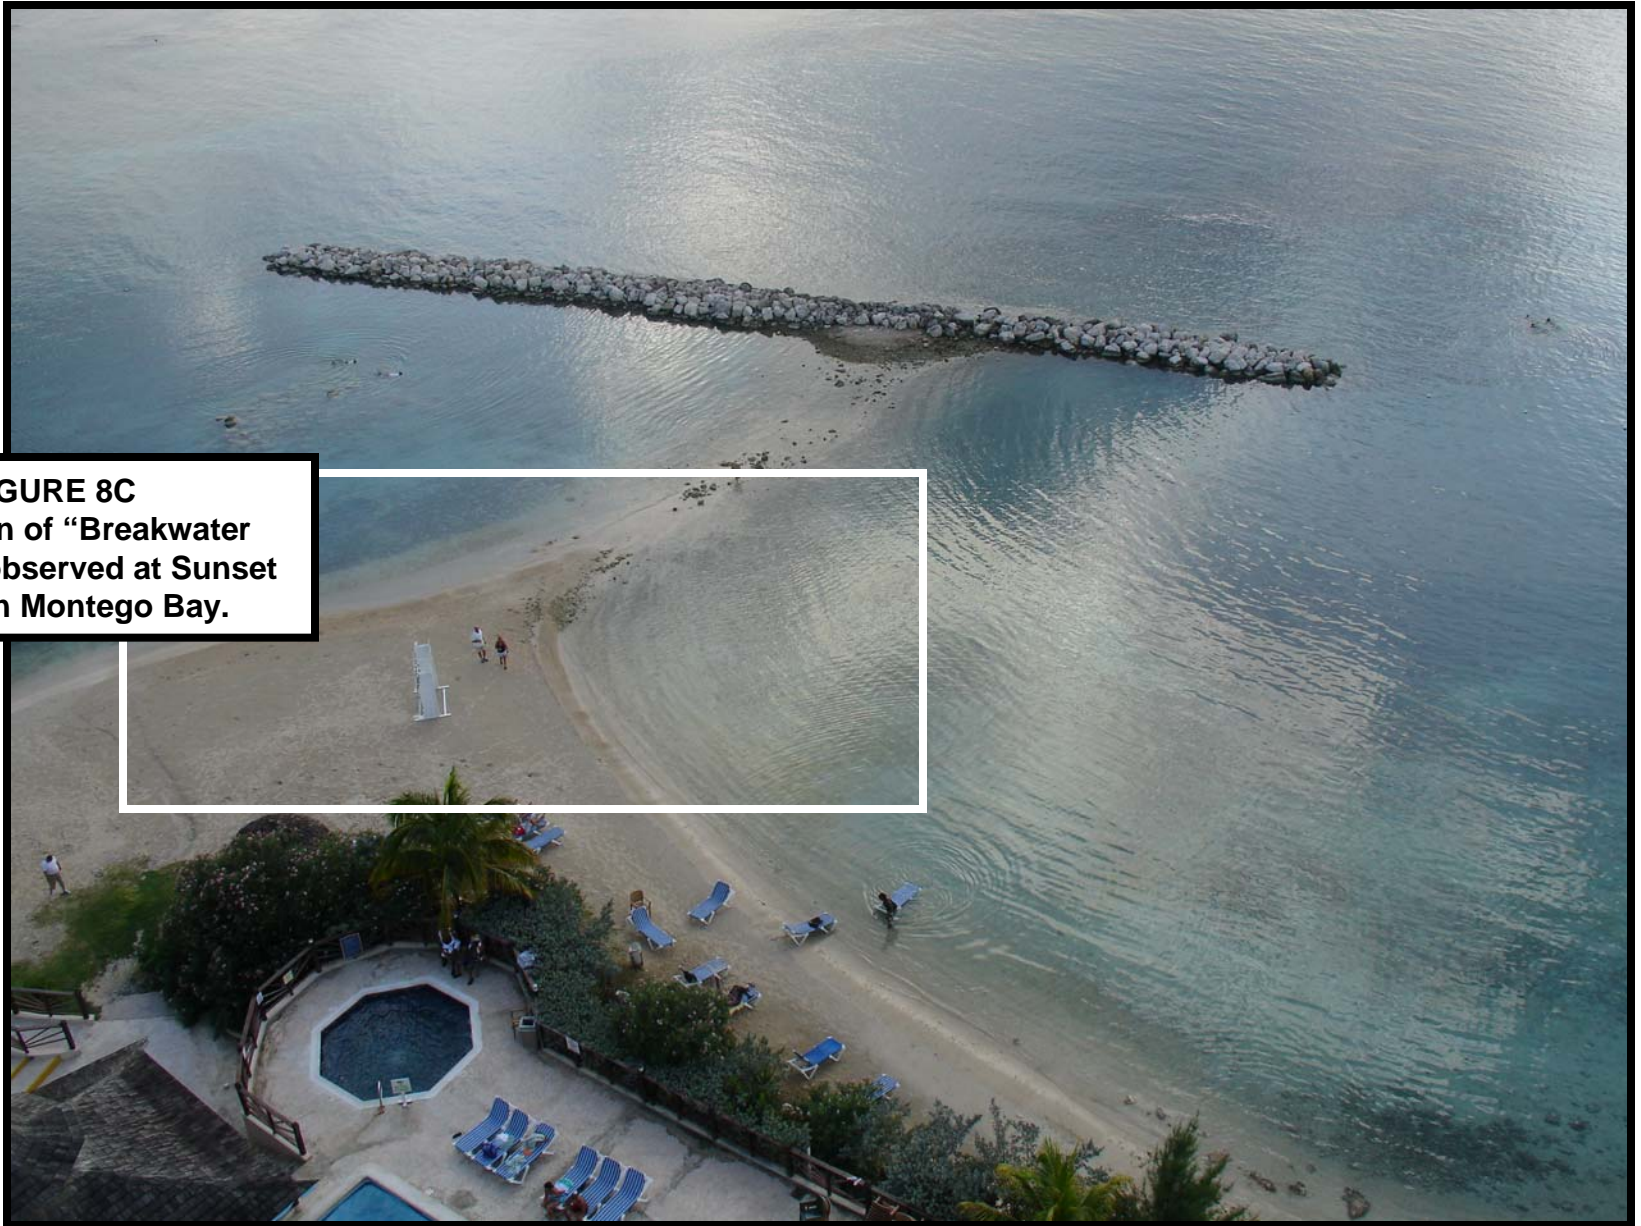
FIGURE 8C
Illustration of “Breakwater
Effect” as observed at Sunset
Resort in Montego Bay.

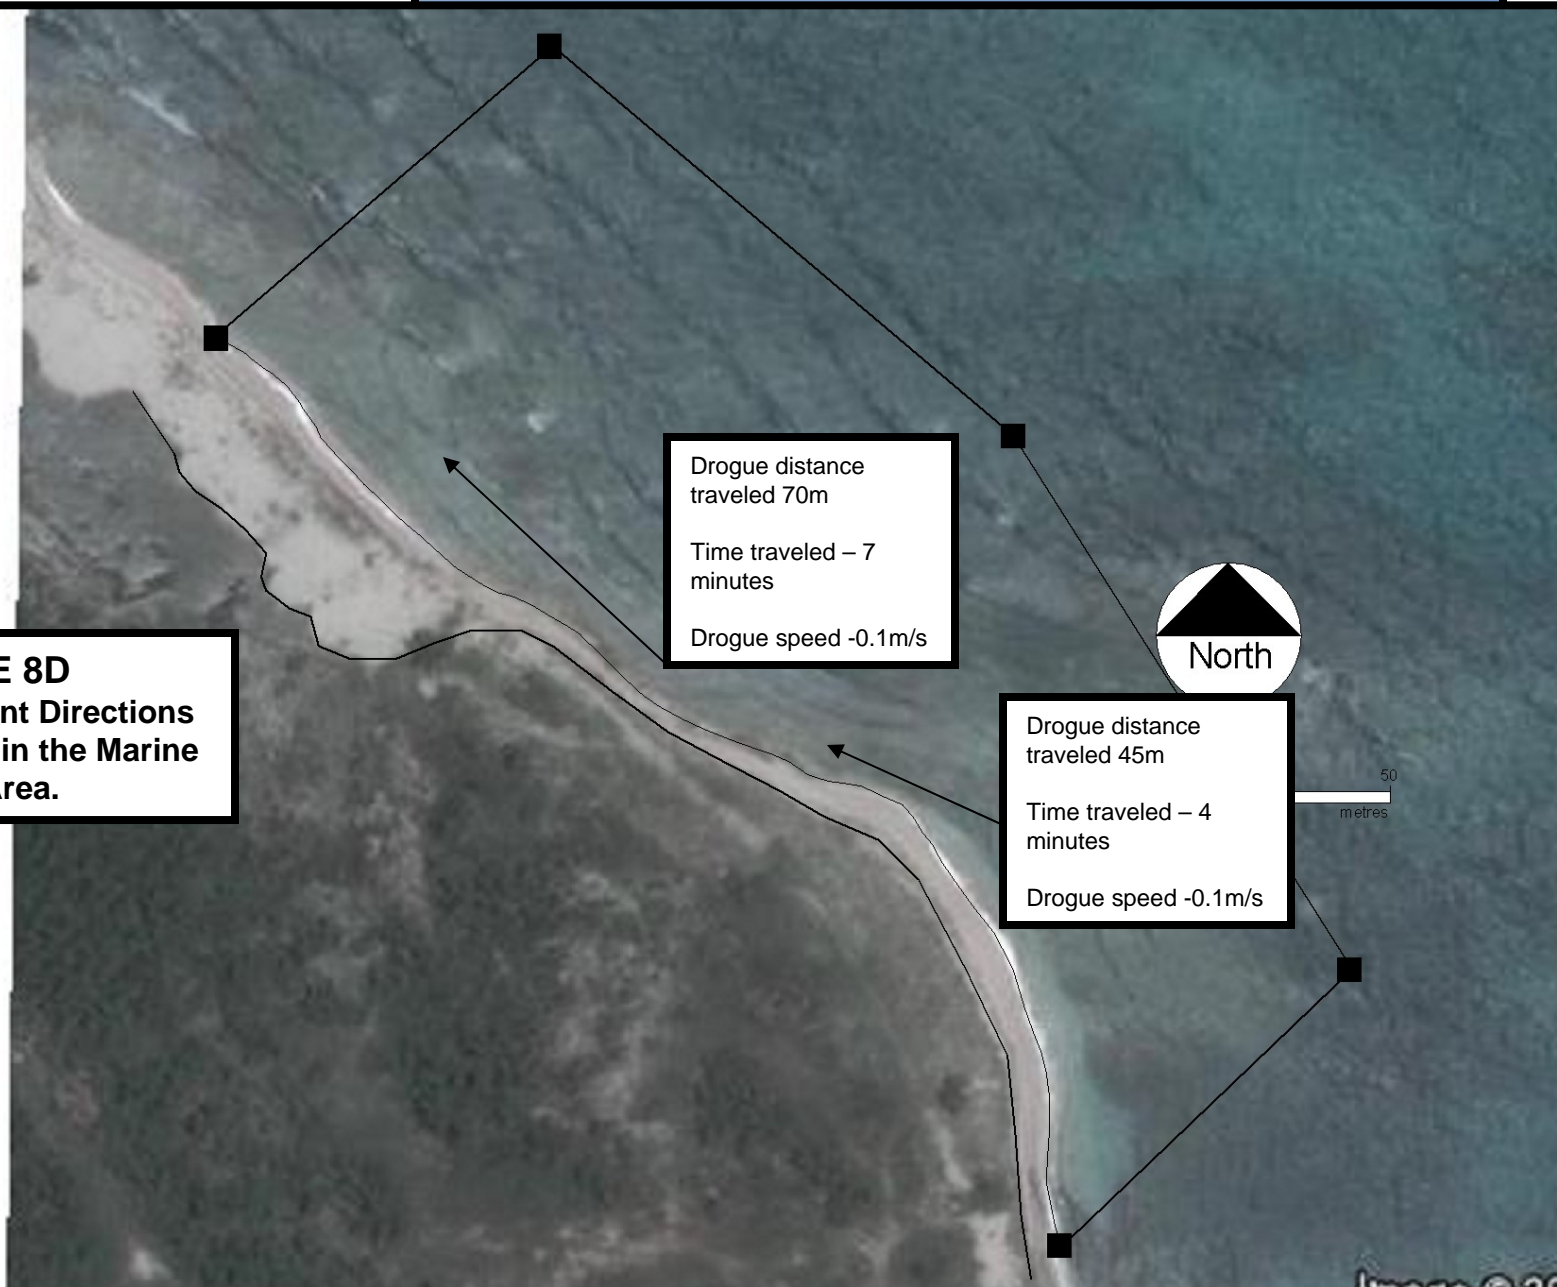
FIGURE 8D
Nearshore Current Directions
and Speeds Within the Marine
Study Area.

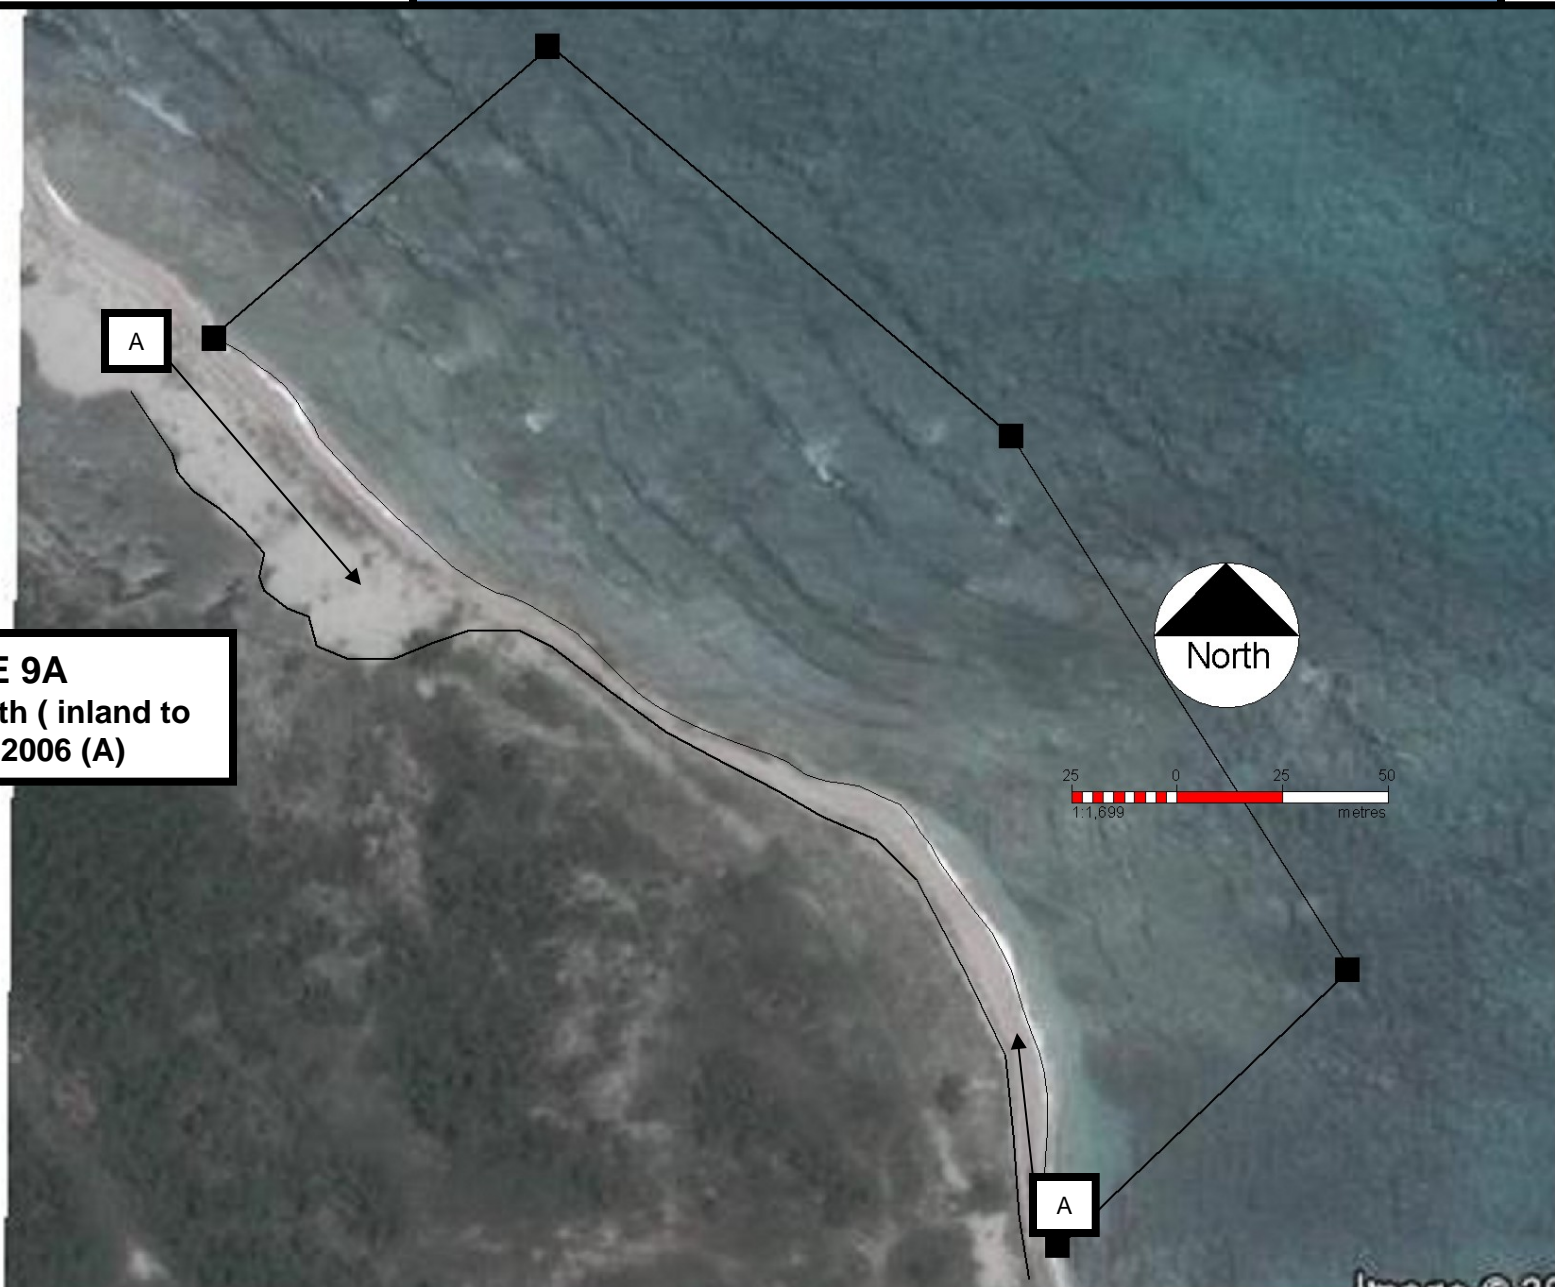
FIGURE 9A
Beach Sand Width (inland to
shoreline) – 2006 (A)

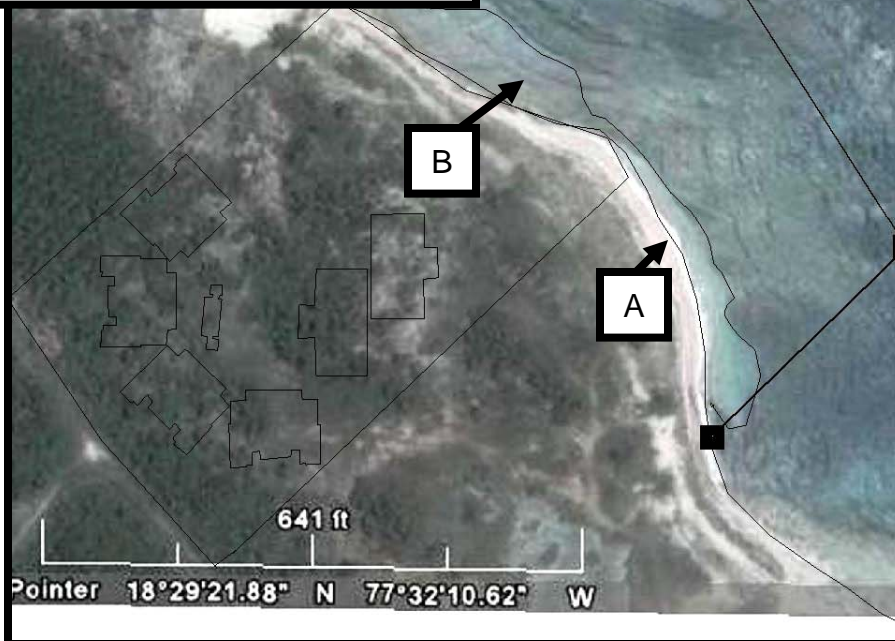
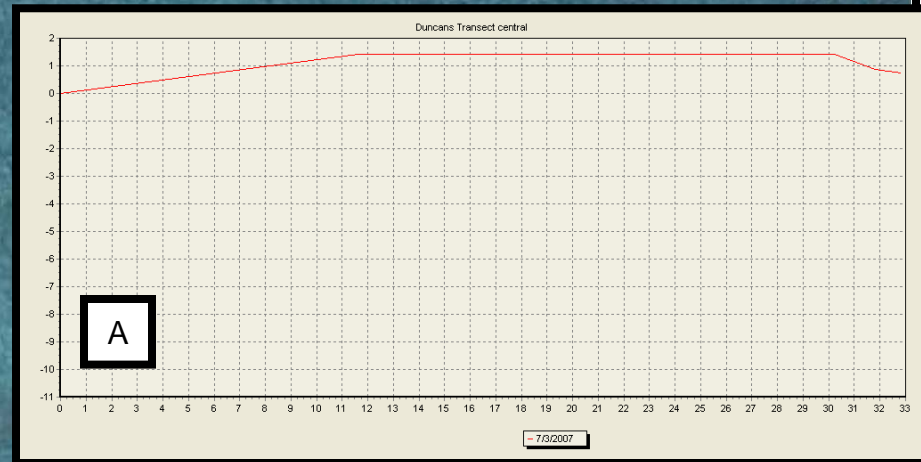
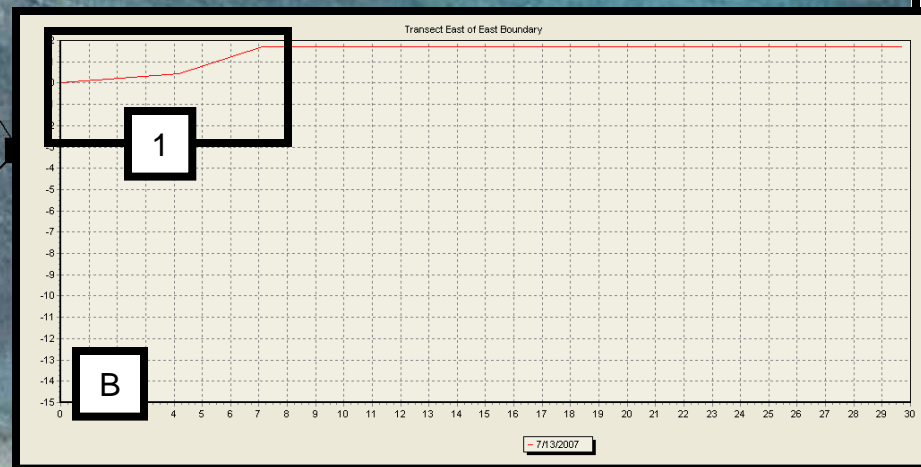
FIGURE 9C
Shoreline Crosssections – 2006
Erosion scarp – (1)
