*Environmental Impact Assessment*  
**PROPOSED PRINCESS HOTELS AND  
RESORTS DEVELOPMENT, COVE,  
HANOVER, JAMAICA**

# ENVIRONMENTAL IMPACT ASSESSMENT FOR THE PROPOSED PRINCESS HOTELS AND RESORTS DEVELOPMENT, COVE, HANOVER, JAMAICA

*Submitted by:*  
**CL ENVIRONMENTAL CO. LTD.**  
20 Windsor Avenue  
Kingston 5

**January 2020**

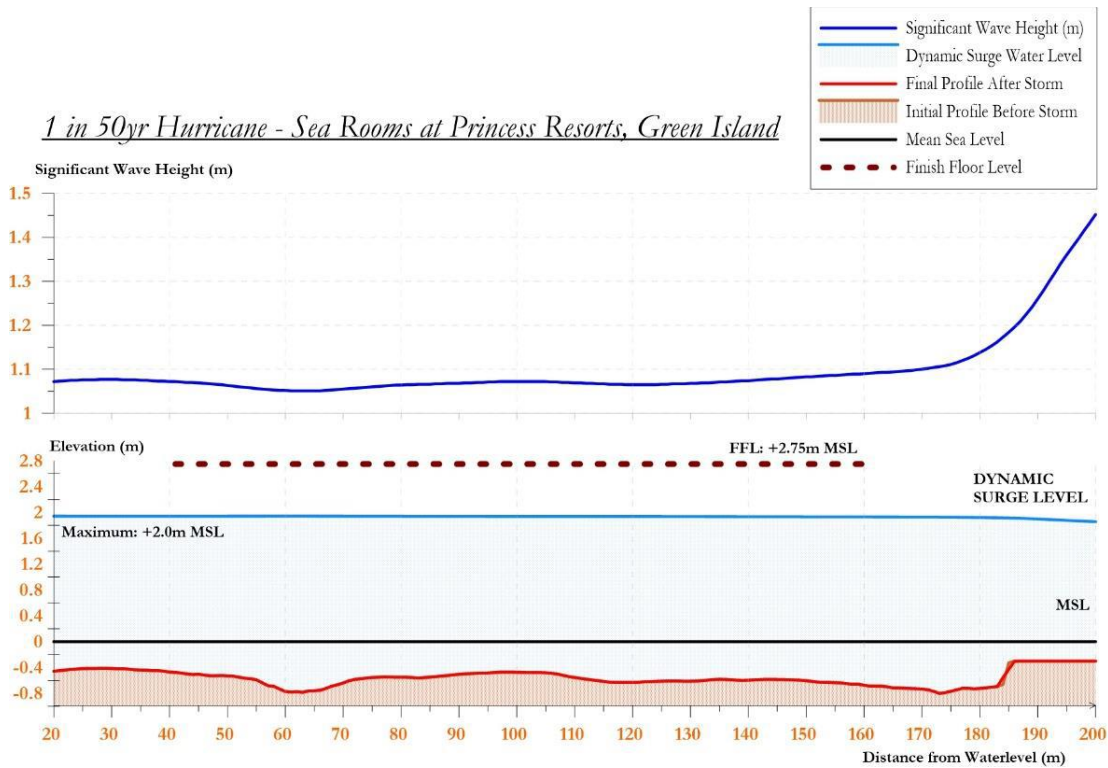
Figure 5-25 Water elevation along the footprint of the searooms under hurricane conditions

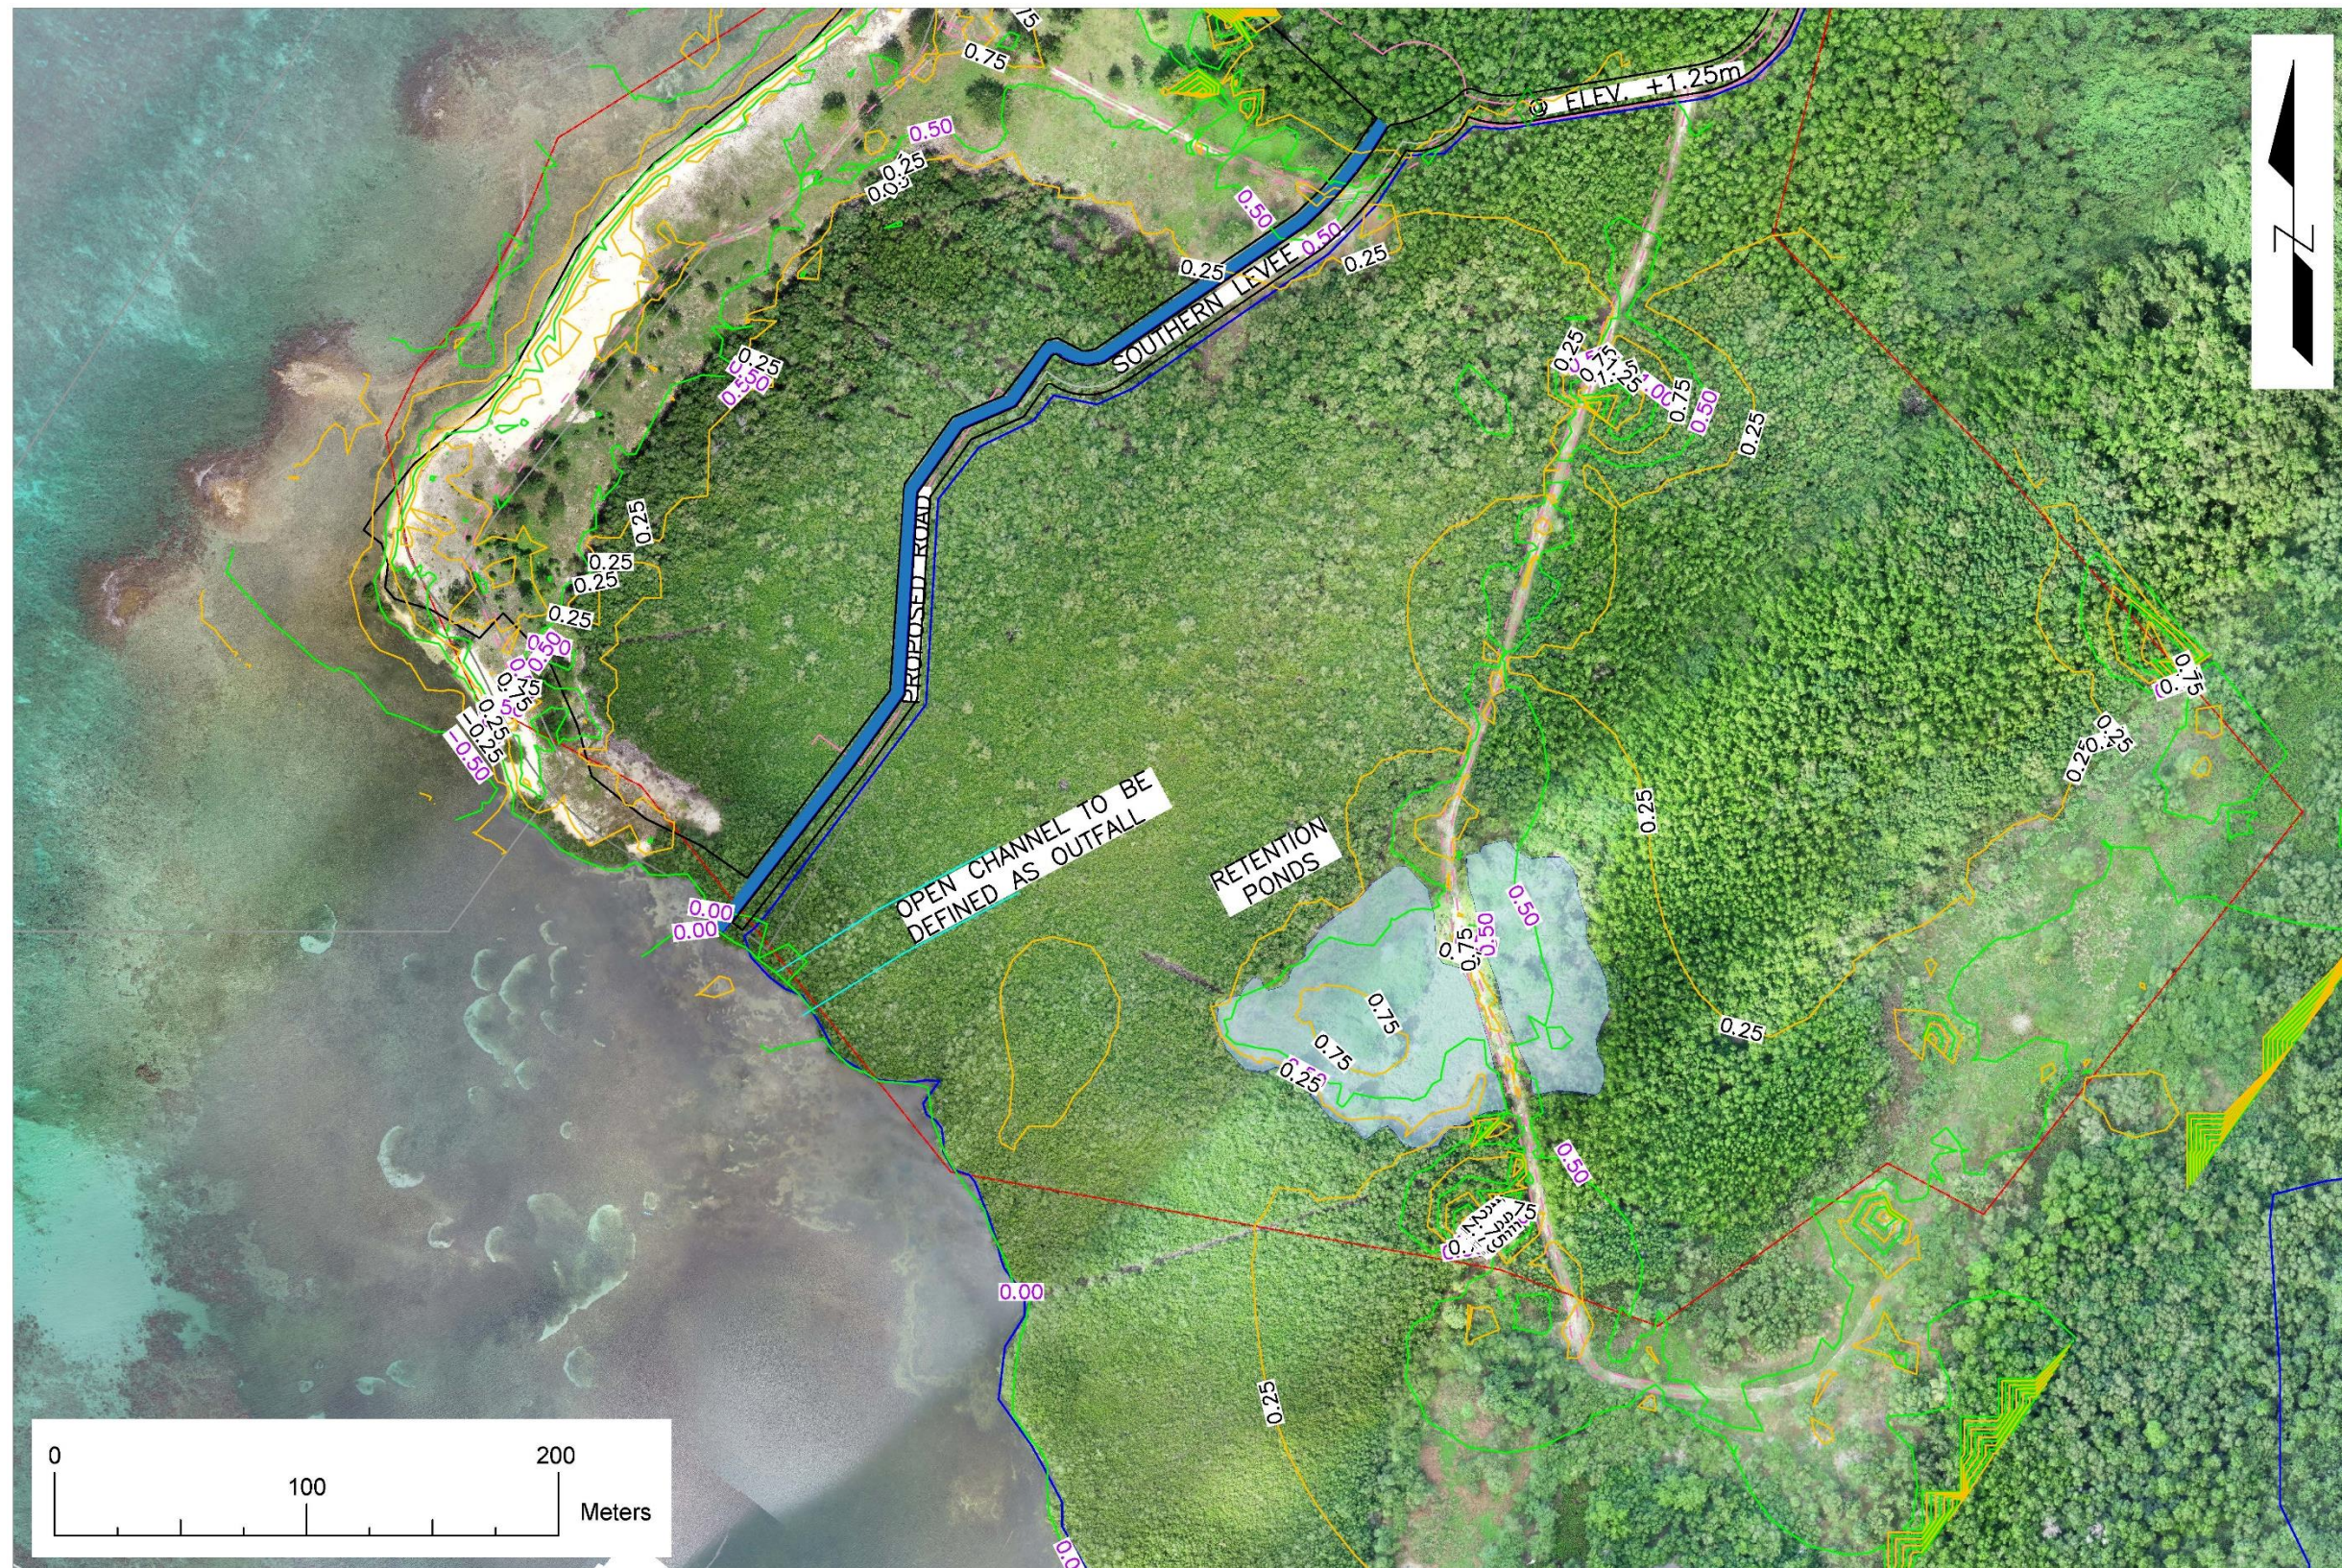
Figure 6-2 Western mangrove topography with proposed drainage ponds

The topographic surveys provide supporting evidence for the theory that roadways act as physical impediments for tidal influence of the whole forest. Figure 6-2 shows that the NW sections of the forest have an identical elevation (+0.25m MSL) to the mangrove forest areas surveyed south of the access roadway, as close to the freshwater transition zone. A similar occurrence is found in the NE forest (Figure 6-3). A 0.20m elevation is found at the eastern canal area, throughout most of the forest and all the way south close to the community. However, no saltwater was recorded in the mid-south area of the forest (yellow circles).

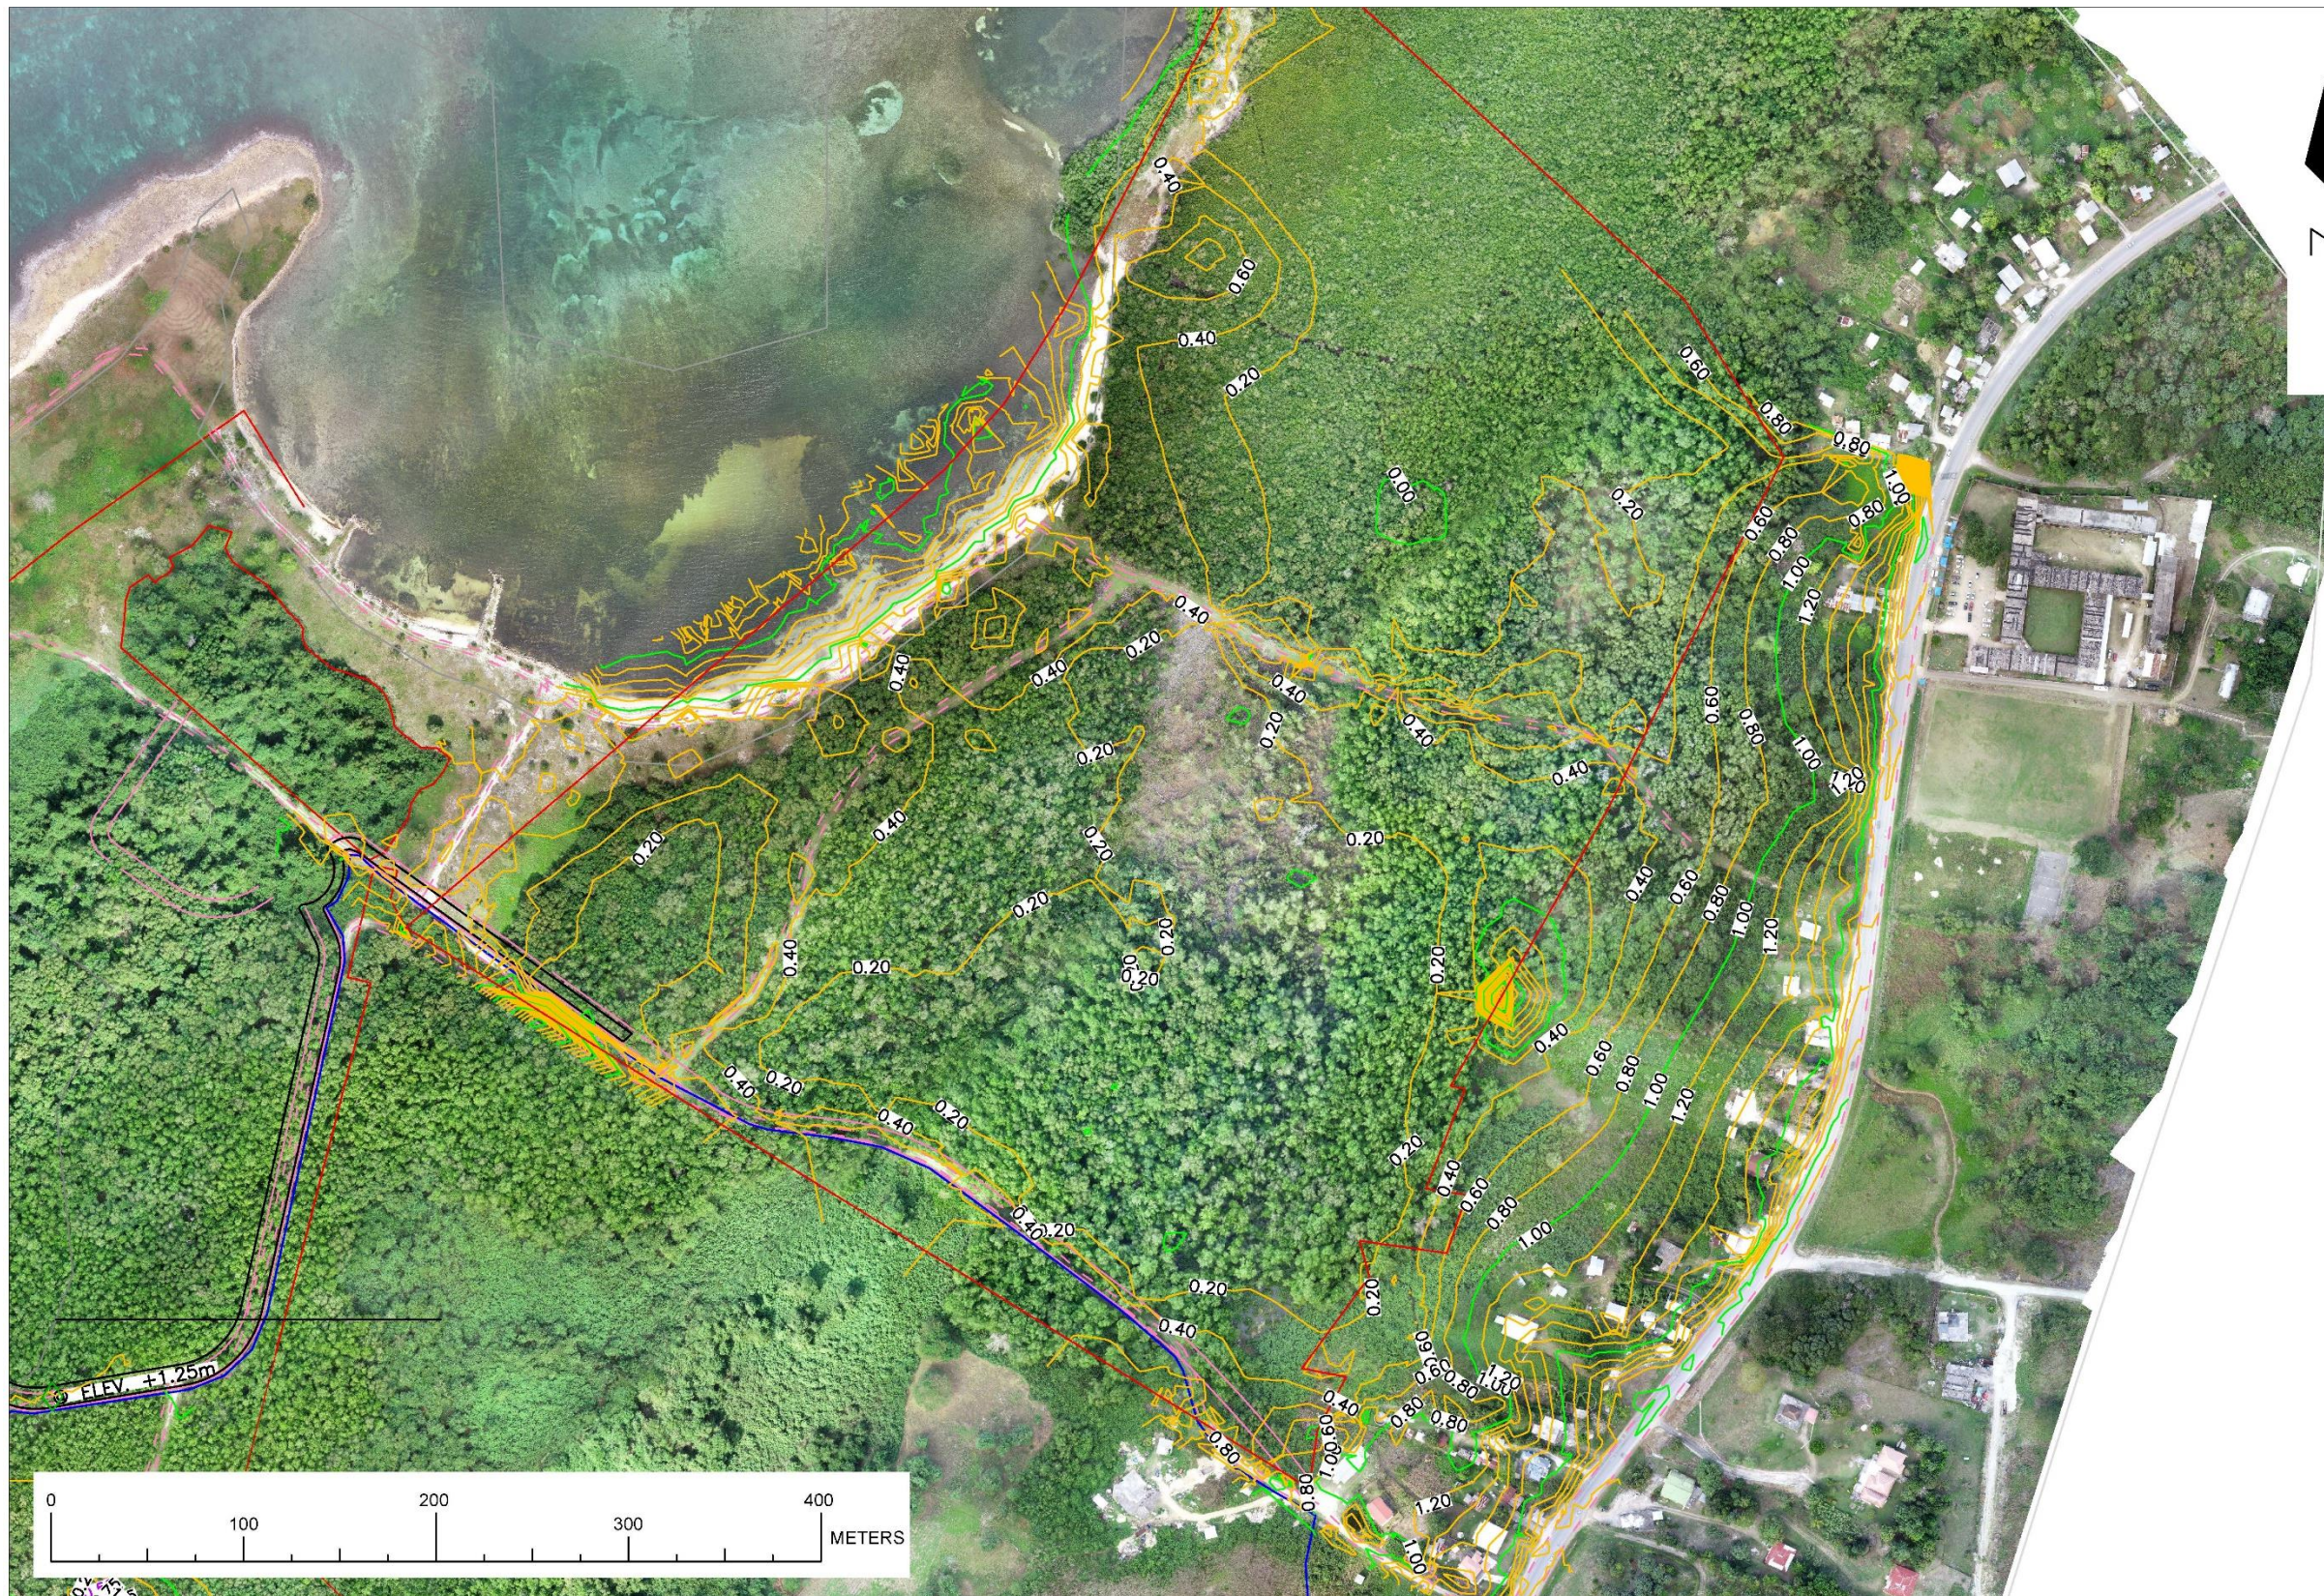
Figure 6-3 Topography at eastern section of property, highlighting identical elevations in mangrove forest (yellow circles)

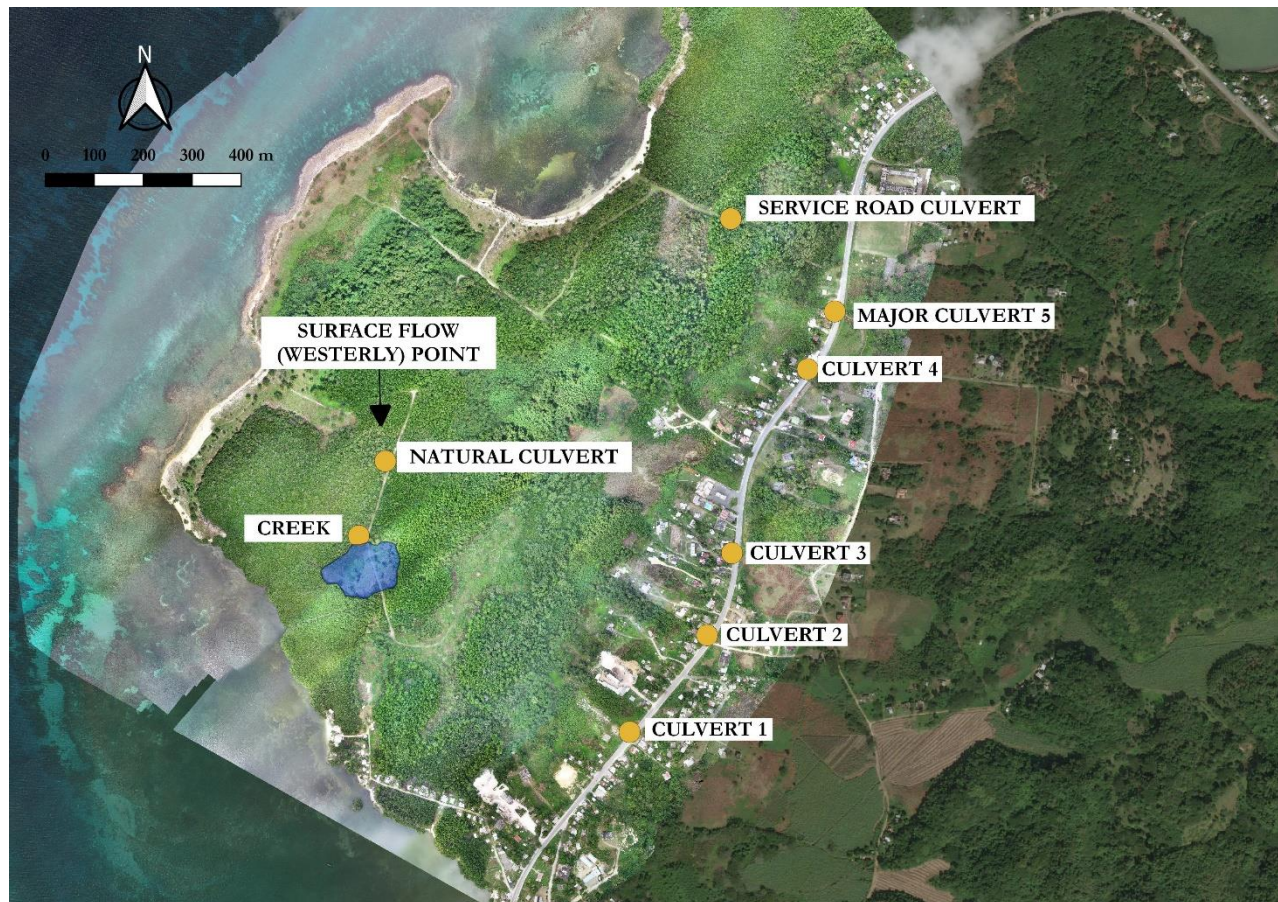
Figure 6-11 Culvert locations on highway and important drainage features on property

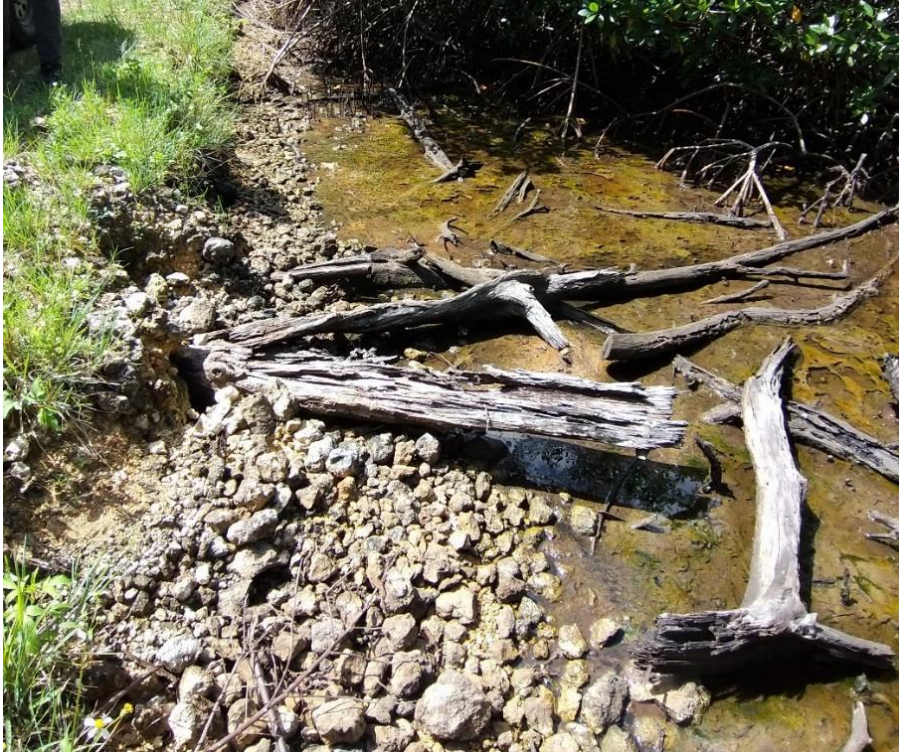
A very clear northern movement of fresh water beneath the roadway was observed on the field visit on 12 October 2019. This section of roadway had a wooden log perpendicular beneath the roadway (Plate 6-2), which is seemingly rotting and provided a passage for the fresh water to enter the tidal mangrove section. A salinity of 0 ppt was measured here on both sides of the roadway.

Plate 6-2 Western access road with log beneath roadway provides visible route for freshwater movement below the road

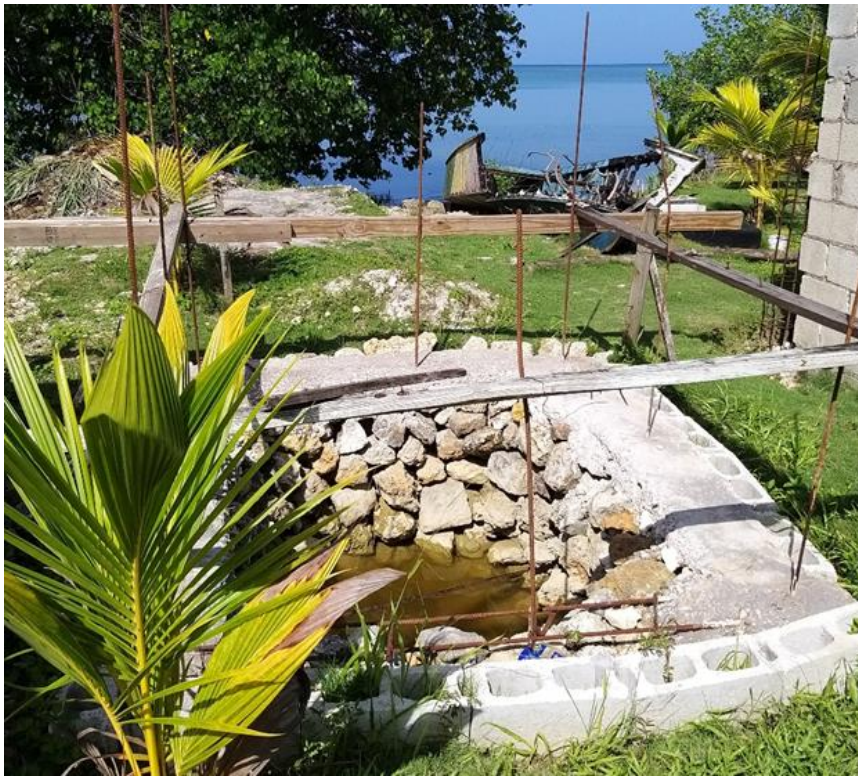
Plate 6-65      Soakaway pit under construction at a property west of proposed hotel project property

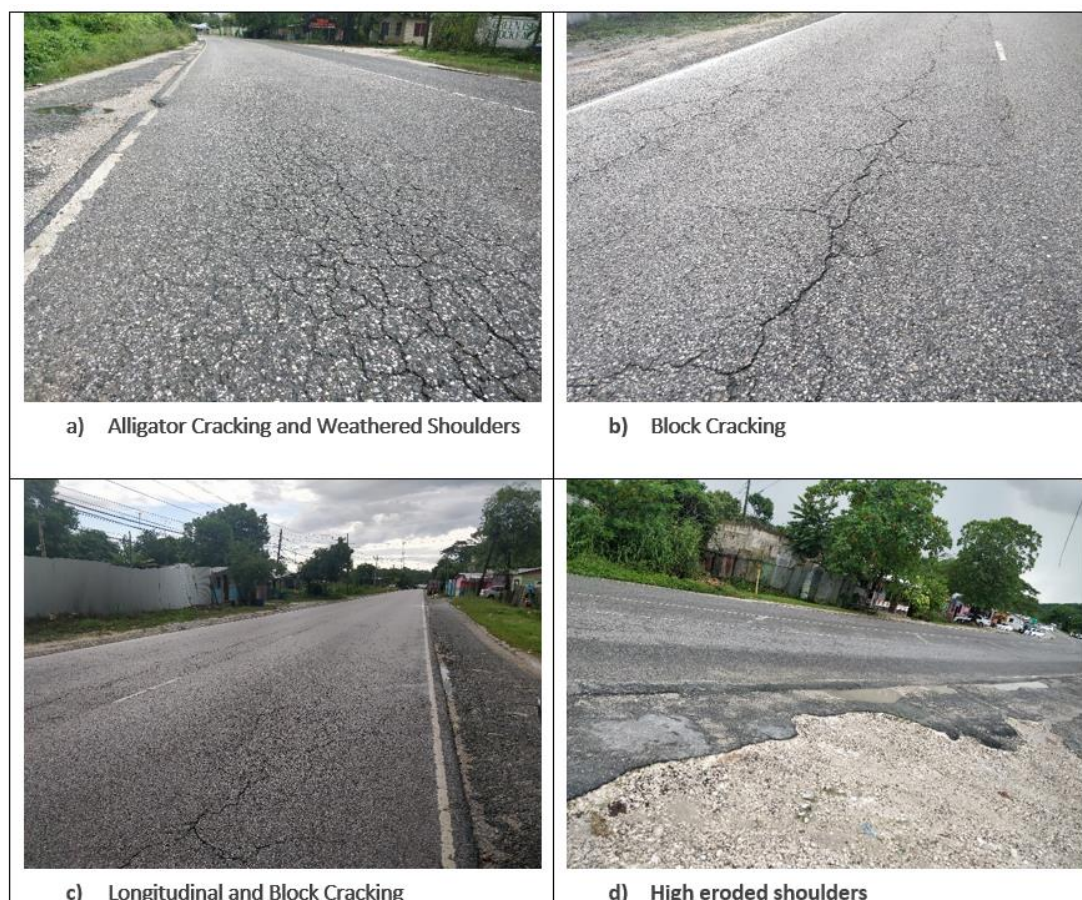
Plate 6-67 Distresses identified along the road surface
