ENVIRONMENTAL IMPACT ASSESSMENT

HOTEL DEVELOPMENT AT PART OF RICHMOND ESTATES, ST. ANN BY SECRETS RESORTS AND SPA

Report Version: **FINAL v2.0**

Date: **March 2023**

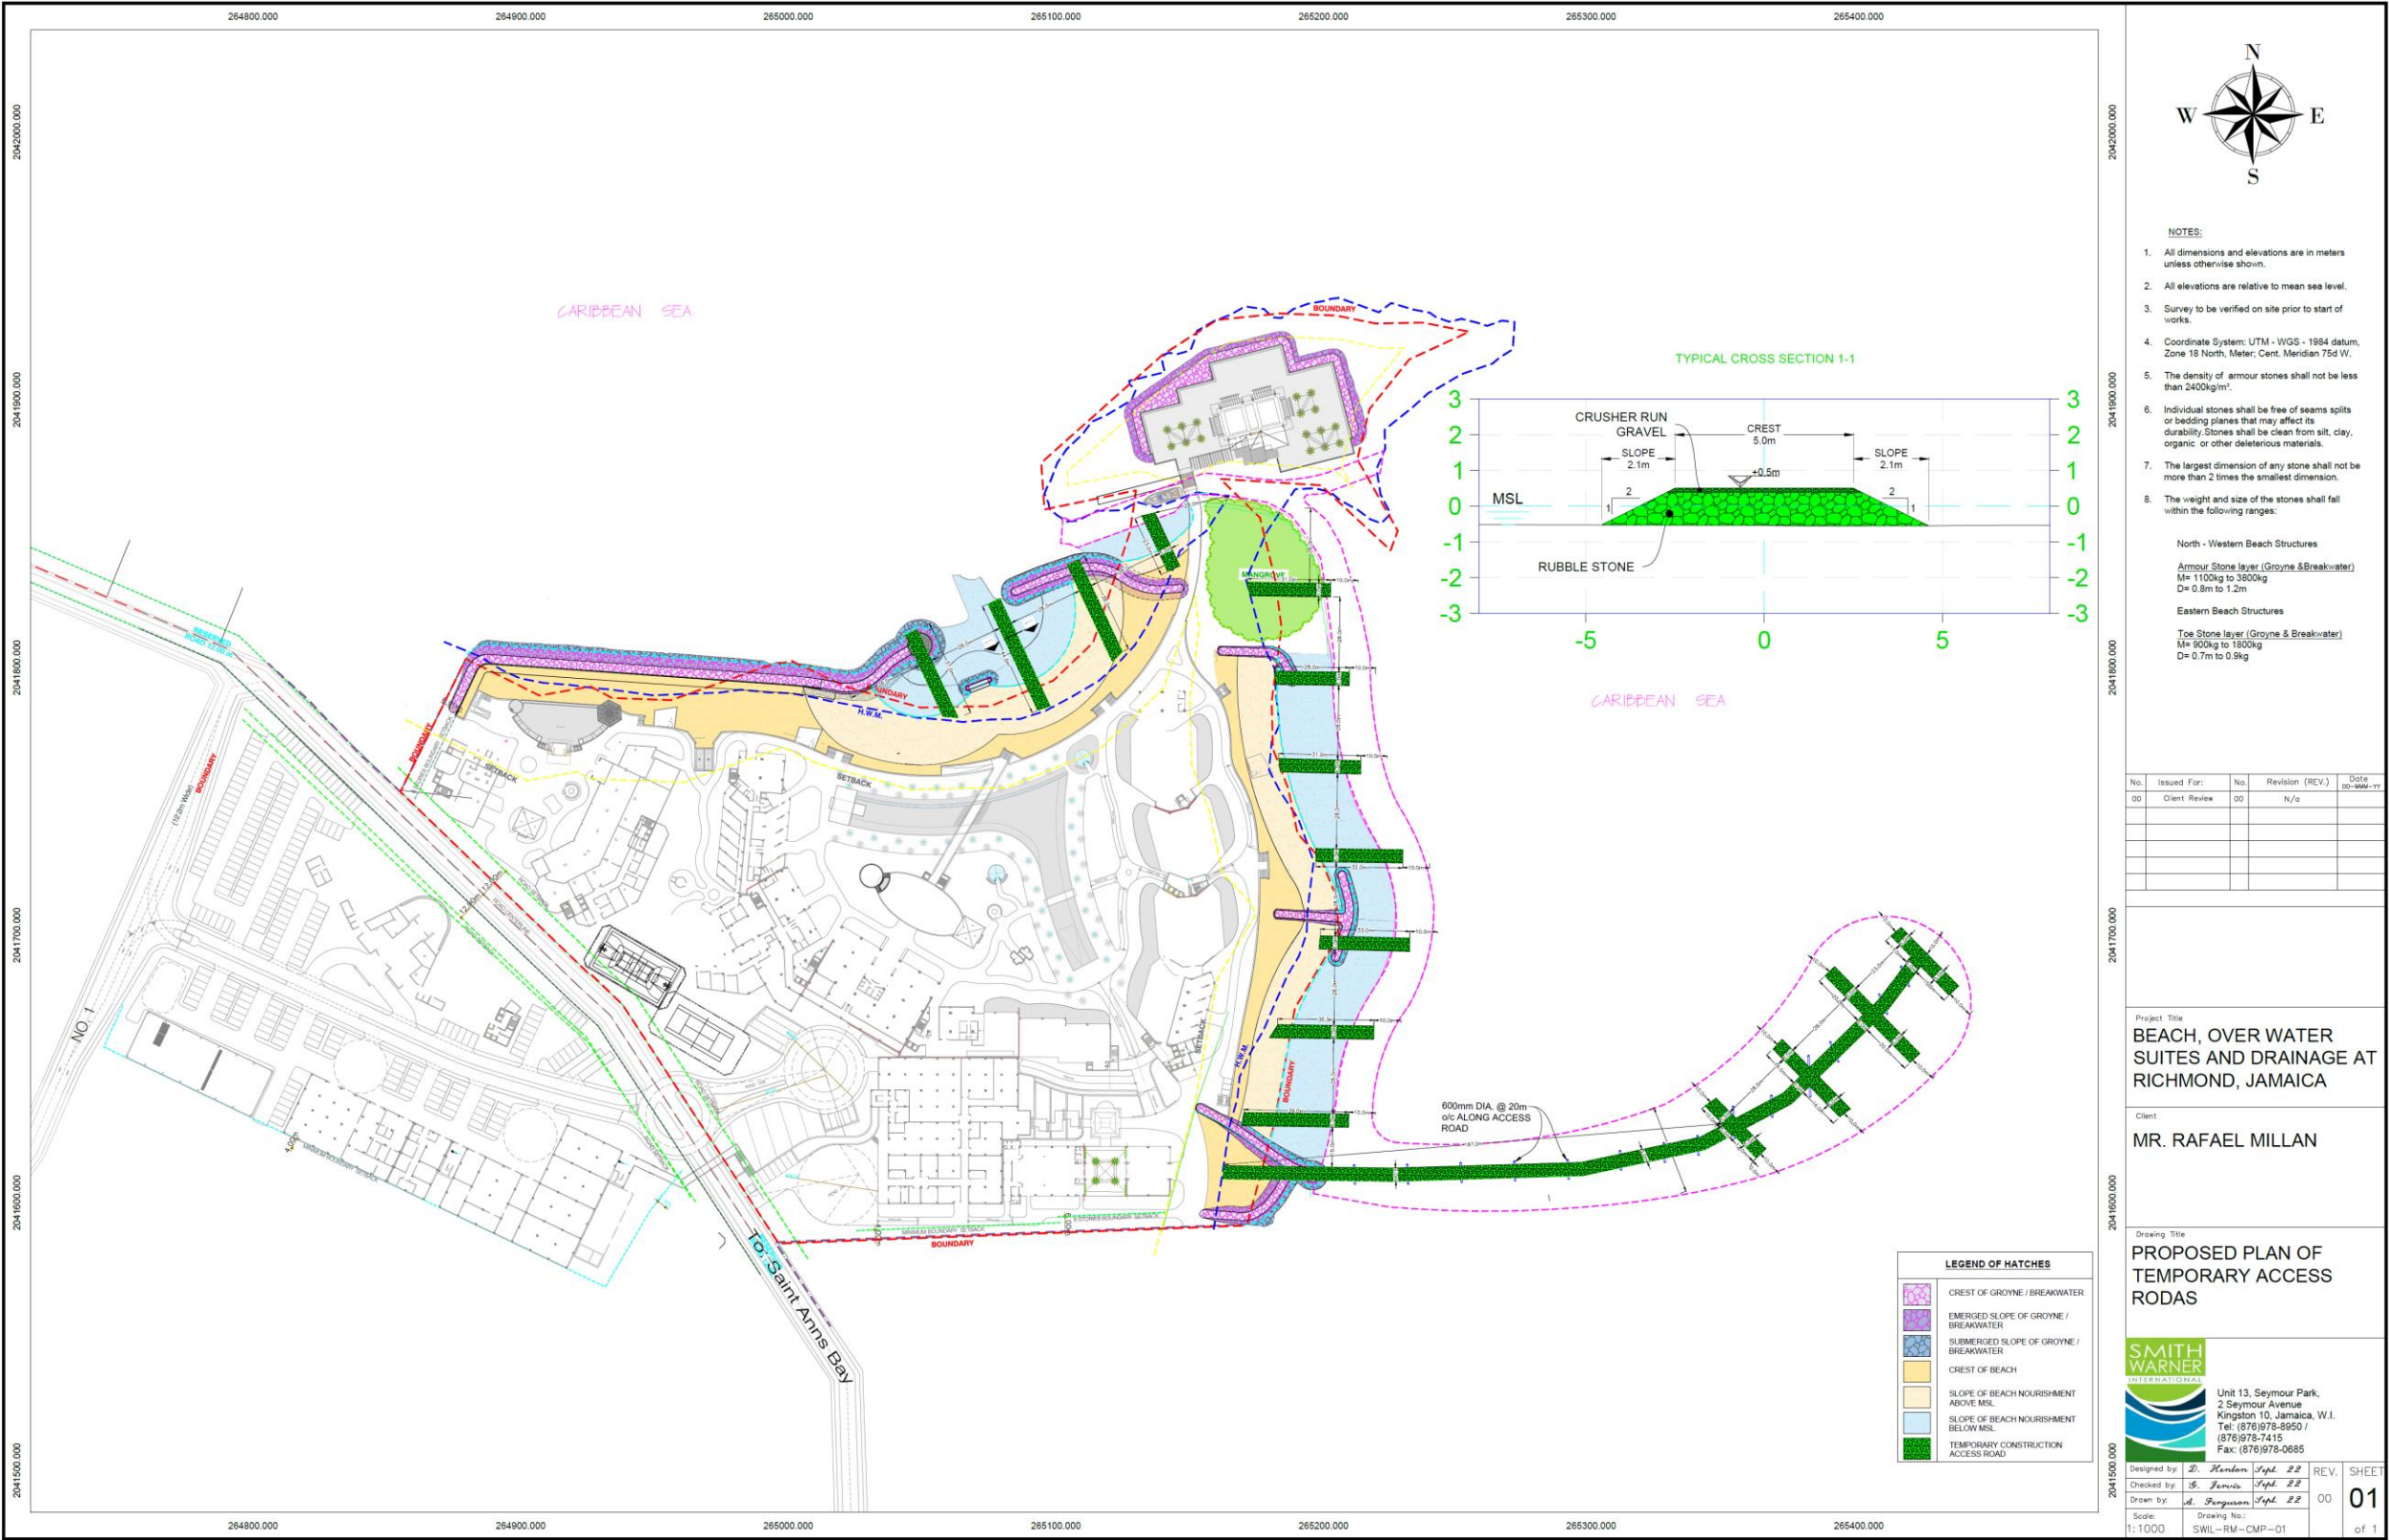
Figure 4-26 Proposed construction layout showing temporary access roads (in green) for the Richmond Development

The structures on the western and eastern beach can be built directly from land with no need for temporary pads except for the emergent breakwater.

A temporary pad will also be needed to construct the overwater suites.

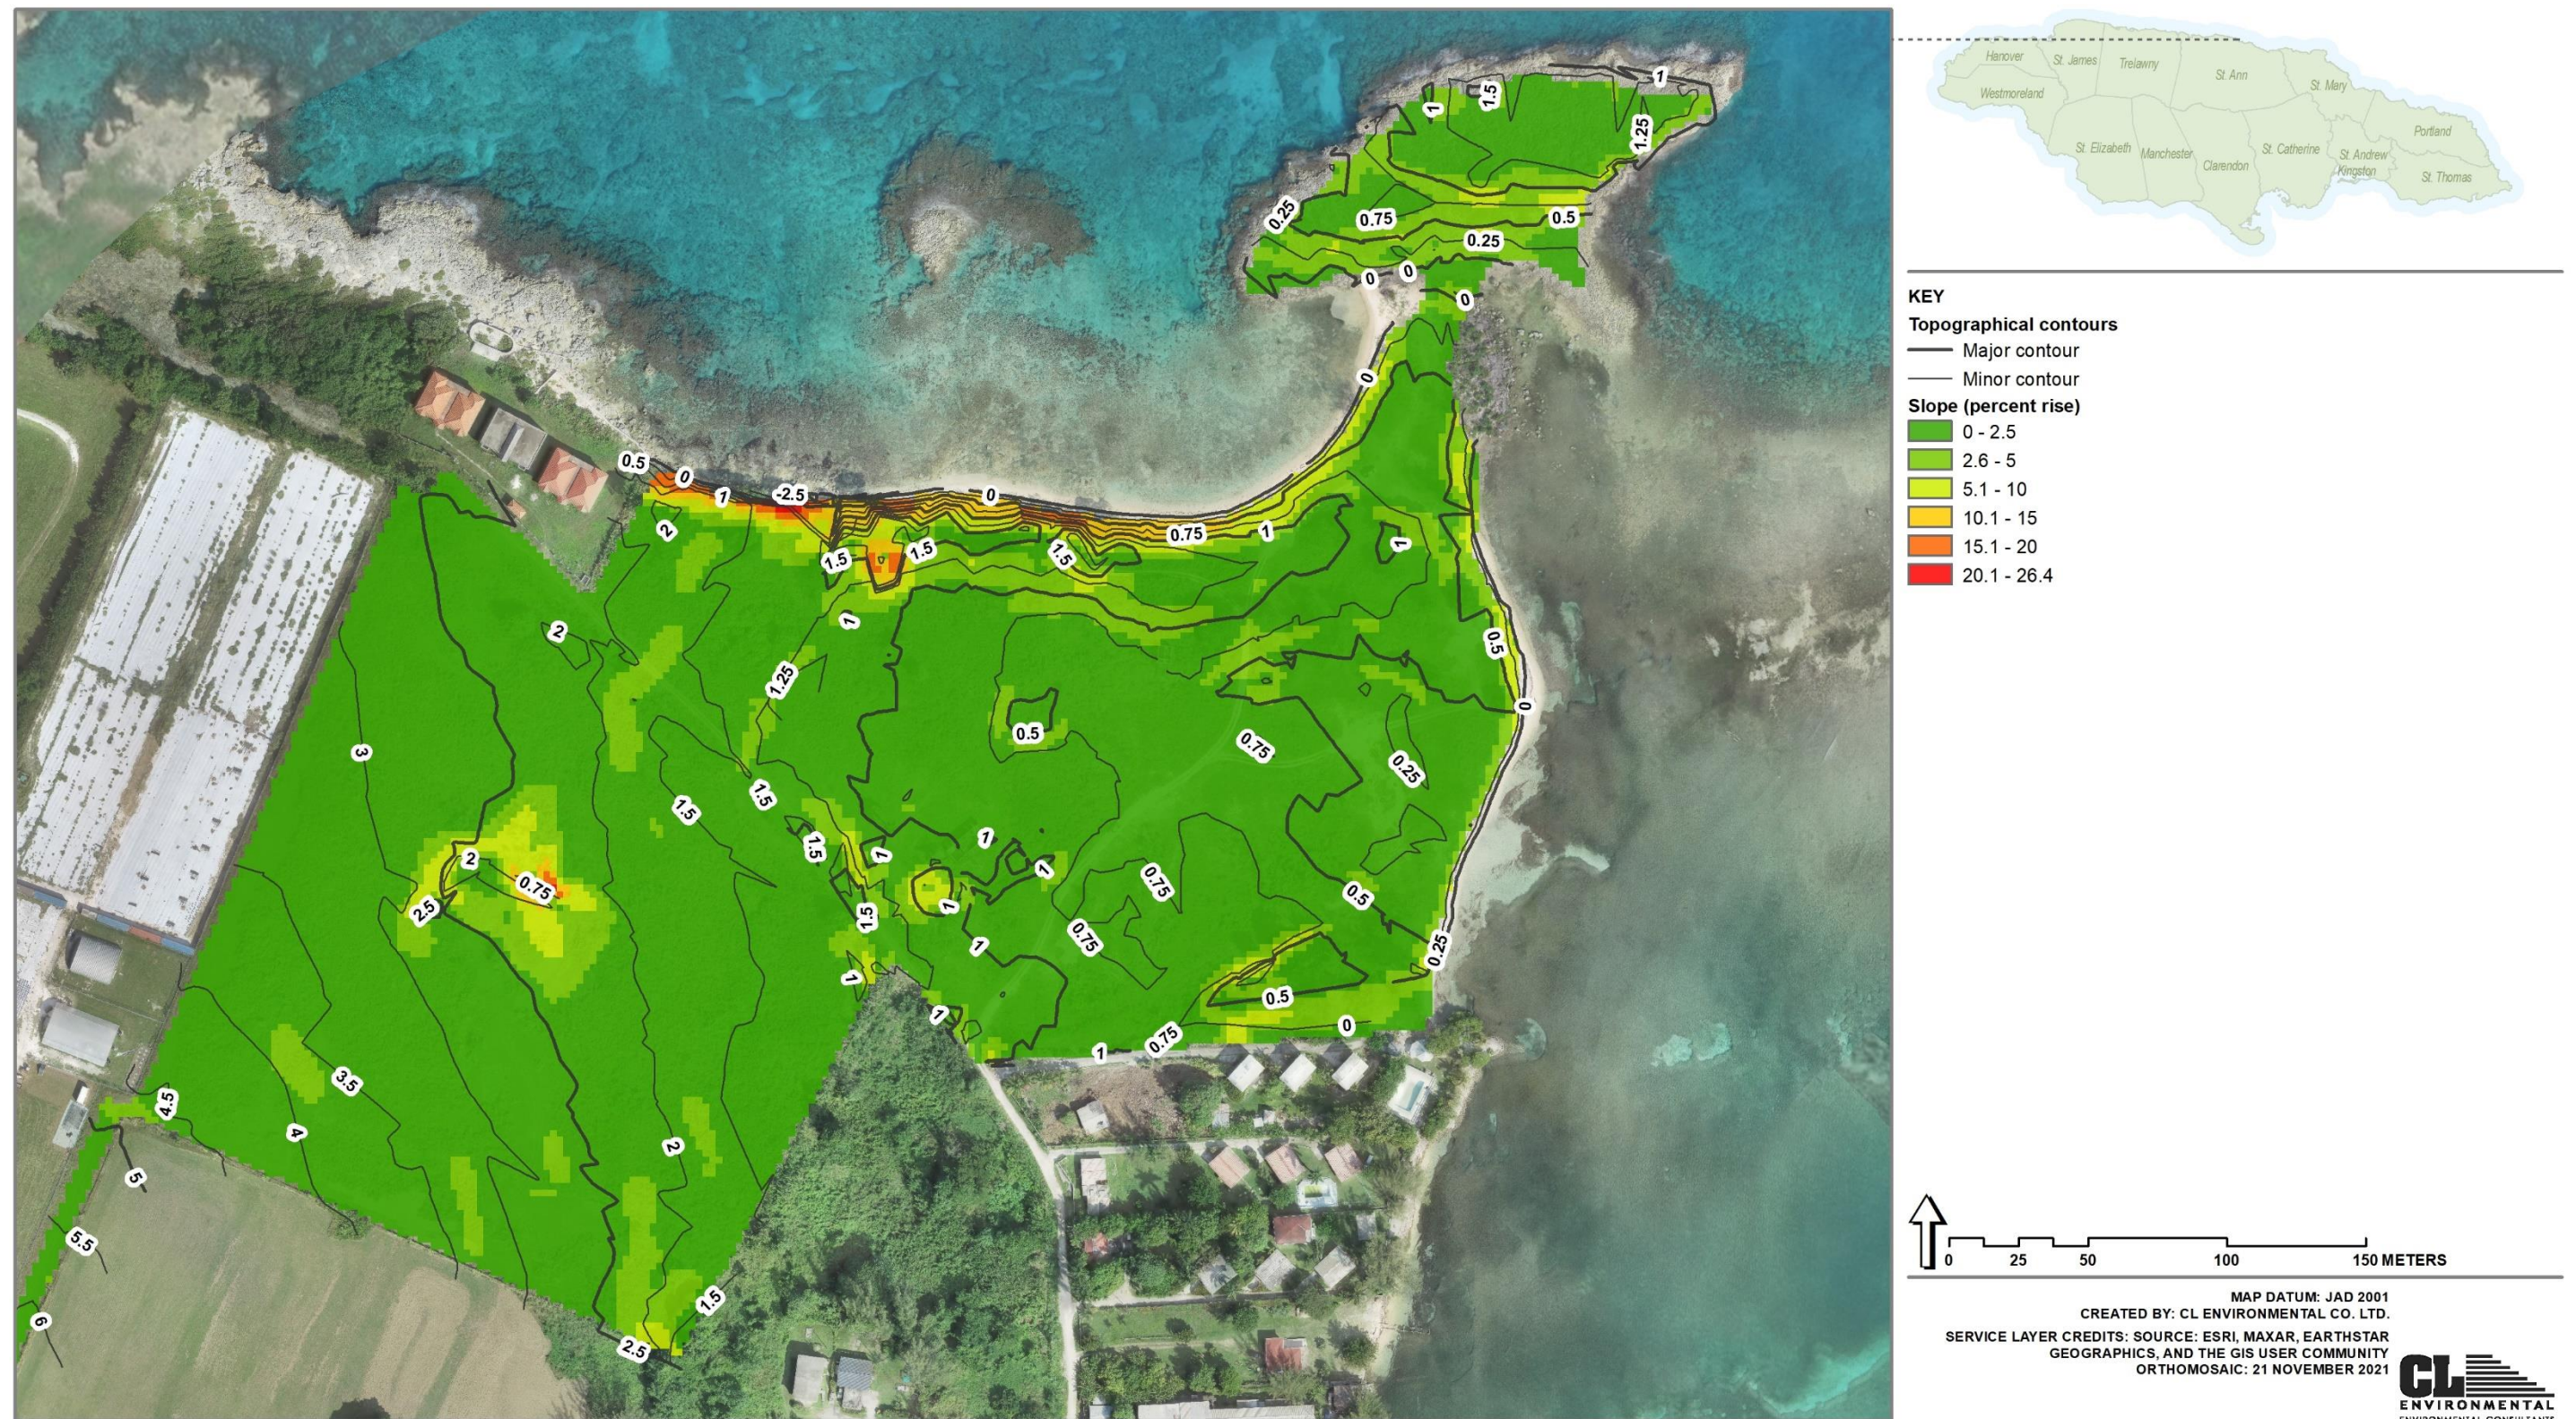
Figure 5-2 Slope derived from Digital Elevation Model (DEM) of the project site

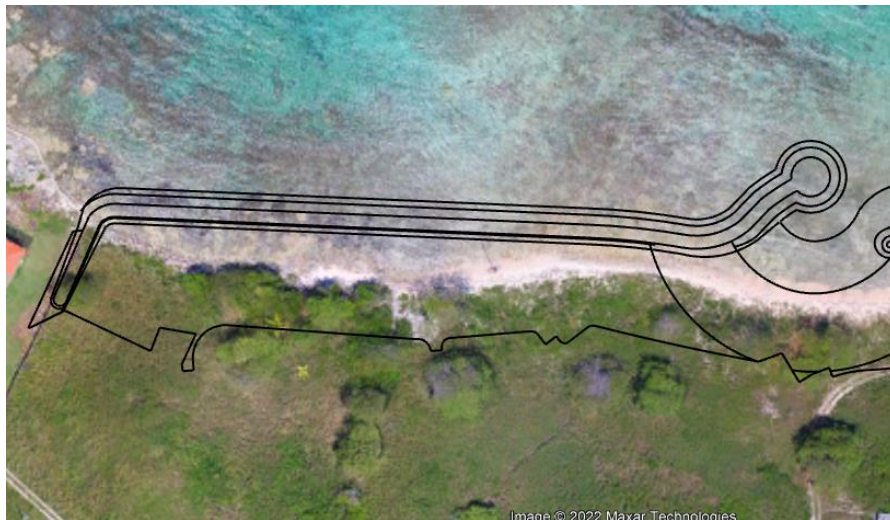
Figure 5-7 Location of the proposed perched beach with outline of proposed plan of enhancement

Main observations regarding the shoreline in this area (Figure 5-7) are as follows:

- The shoreline has sand; however, it's mixed with rubble.
- The beach area is very narrow Plate 5-1A.
- Moving further west, the sand that was present is replaced with rubble and a steep cliff as shown in Plate 5-1B.
- Offshore the perched beach location, the water is noticeably shallower, and several black sea urchins were present on the seafloor.
- Based on the lack of sandy beach in this area, it is likely this location is exposed to a high energy wave environment.

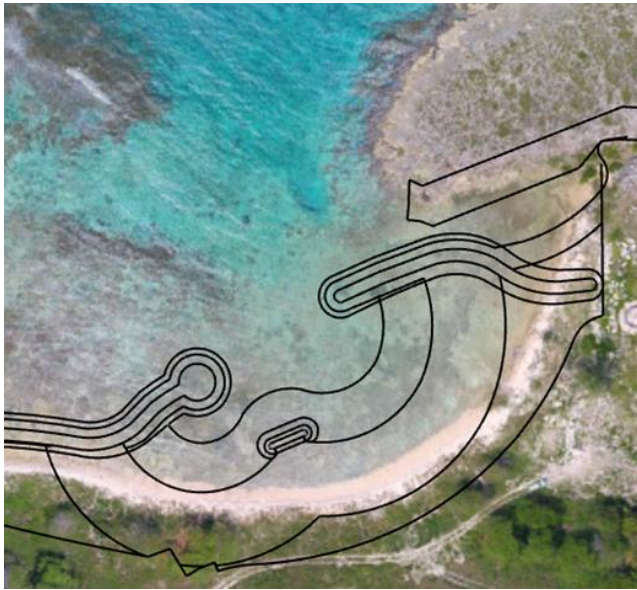
Figure 5-8 Location of the north-eastern beach with outline of proposed plan of enhancement

Main observations regarding the shoreline in this area (Figure 5-8) are as follows:

- This section of the shoreline has more sand than the north-western beach. This could be due to the peninsula providing some sheltering from wave energy.
- Similar to the north-western beach, the water depths offshore were very shallow with an abundance of black sea urchins.
- In this section, the back of beach was not as steep as the north-western section and would be susceptible to inundation by extreme storm events (Plate 5-2A).
- Plate 5-2C shows the ironshore on top of the peninsula looking back at the north-eastern beach.

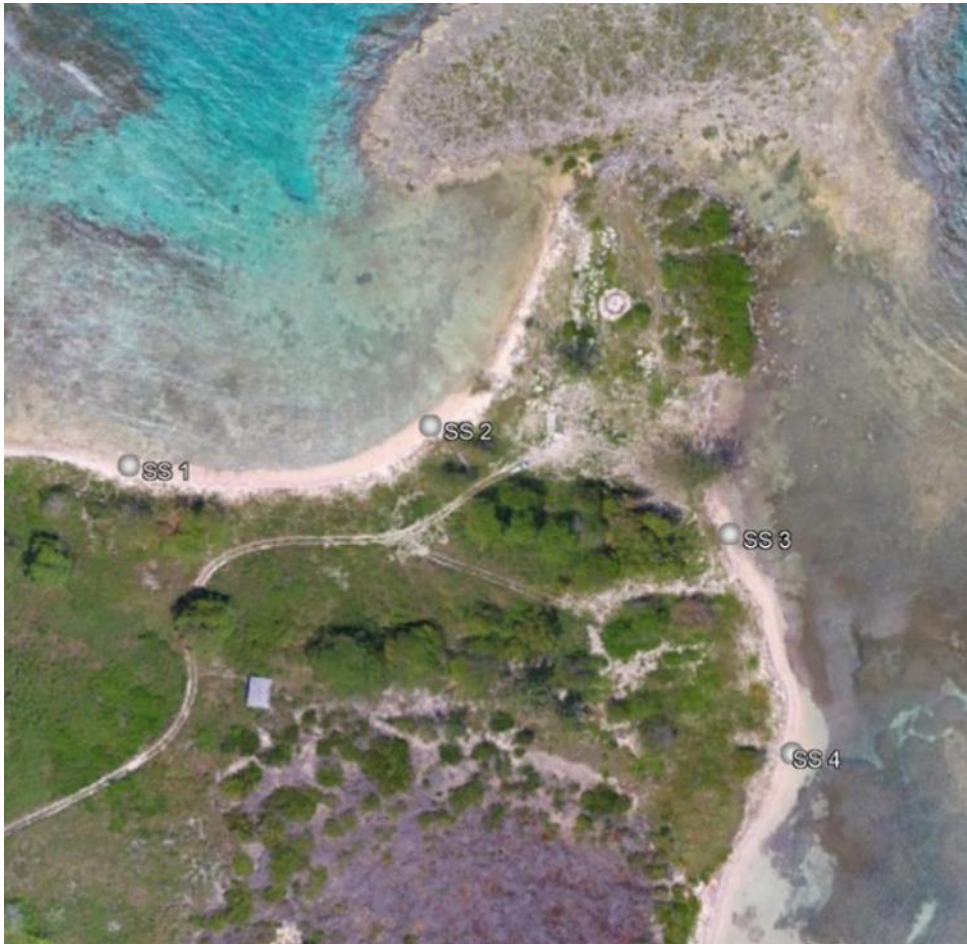
Figure 5-10 Sediment Grain Size Analysis Sampling locations

An analysis of sediment grain size on a beach can aid in the understanding of the coastal processes. Four sand samples were collected at the Priory property, two along the western beach and two along the

eastern beach as shown in Figure 5-10. The collected samples were sent to a geotechnical lab to be visually inspected, air dried and subjected to a standard dry sieve analysis to determine characteristic parameters. The results are shown in Figure 5-49. The analyses indicate that all the samples are poorly graded sand, composed on average of 99% sand, with small percentages of gravel and/or silt. The results also showed that the sediment on the western beach was coarser than that on the eastern beach, which coincides with observations made during site visits. The western beach average D50 was 1.06mm while the eastern beach average D50 was 0.70mm. The sediment grain sizes are relatively coarse. This implies high energy wave environment, especially on the western side of the shoreline.

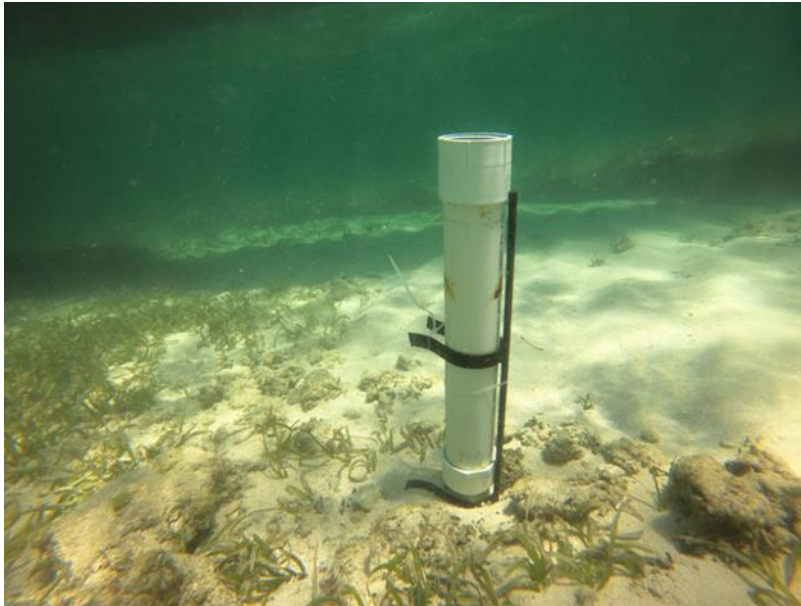
Plate 5-4 Example of Sediment Trap deployed

Baseline sedimentation data were collected using sediment traps. A total of six (6) sediment traps were deployed in and around the project area. The traps were retrieved after 33 days, and its contents analysed to determine the rate of sedimentation ($\text{mg}/\text{cm}^2/\text{day}$) in the area. The sediment trap dimensions were approximately 21.4" (54.3 cm) long with an internal diameter of 3" (7.6 cm) (Plate 5-4). Sediment traps were taken to the Caribbean Environmental Testing and Monitoring Services Limited for analysis.

The contents of the sediment traps were filtered through a filter paper, dried and then weighed. The results are represented in the form of "Mass of Sediment Recovered". Using the results retrieved from the laboratory, the sedimentation rate per day ($\text{mg}/\text{cm}^2/\text{day}$) was calculated by dividing the mass of sediment recovered by the number of days deployed and the area of the sediment trap opening.

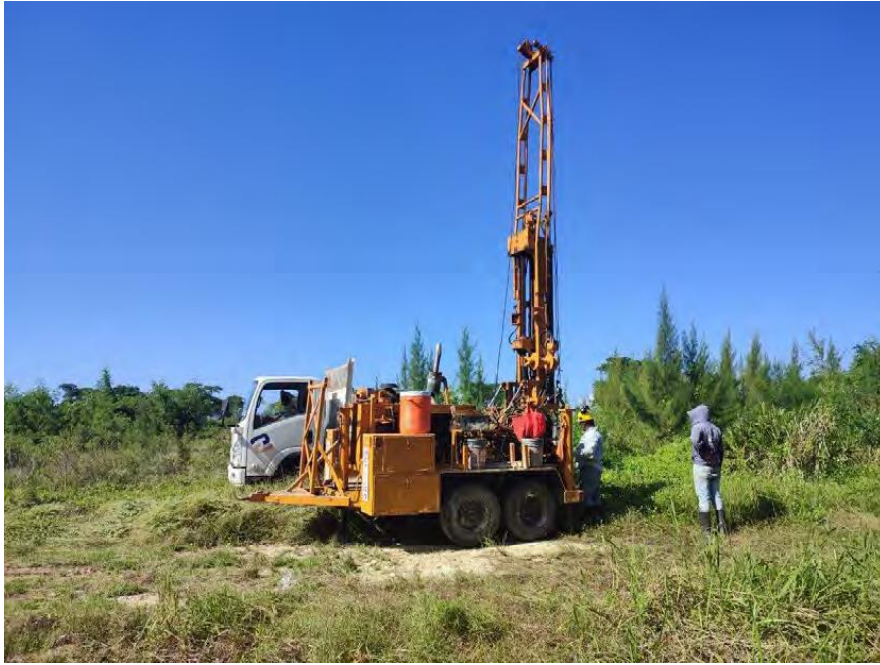
Plate 5-5 CME-55 drill rig

Forty-seven (47) soil borings were drilled for this project up to a depth of 37 meters below the ground surface. A CME-55 drill rig and 8-inch diameter hollow-stem augers (HSA) were used to advance the boreholes (Plate 5-5). The soils were sampled by following the Standard Penetration Test (SPT) ASTM D-1586 with an automatic 140-pound hammer falling from a height of 30 inches per blow was made. A 24-inch long, 2-inch diameter split spoon sampler was utilized.

SPT tests were performed at intervals of 5 feet. The number of blows required to advance the sampler every 15 cm are recorded in field logs. The sum of the second and third blow counts for each 24-inch sampling interval constitutes the SPT-N value in blows/foot. The CME-55 drill rigs use an automatic hammer release mechanism with Efficiency (Em) of 0.8 (80%).

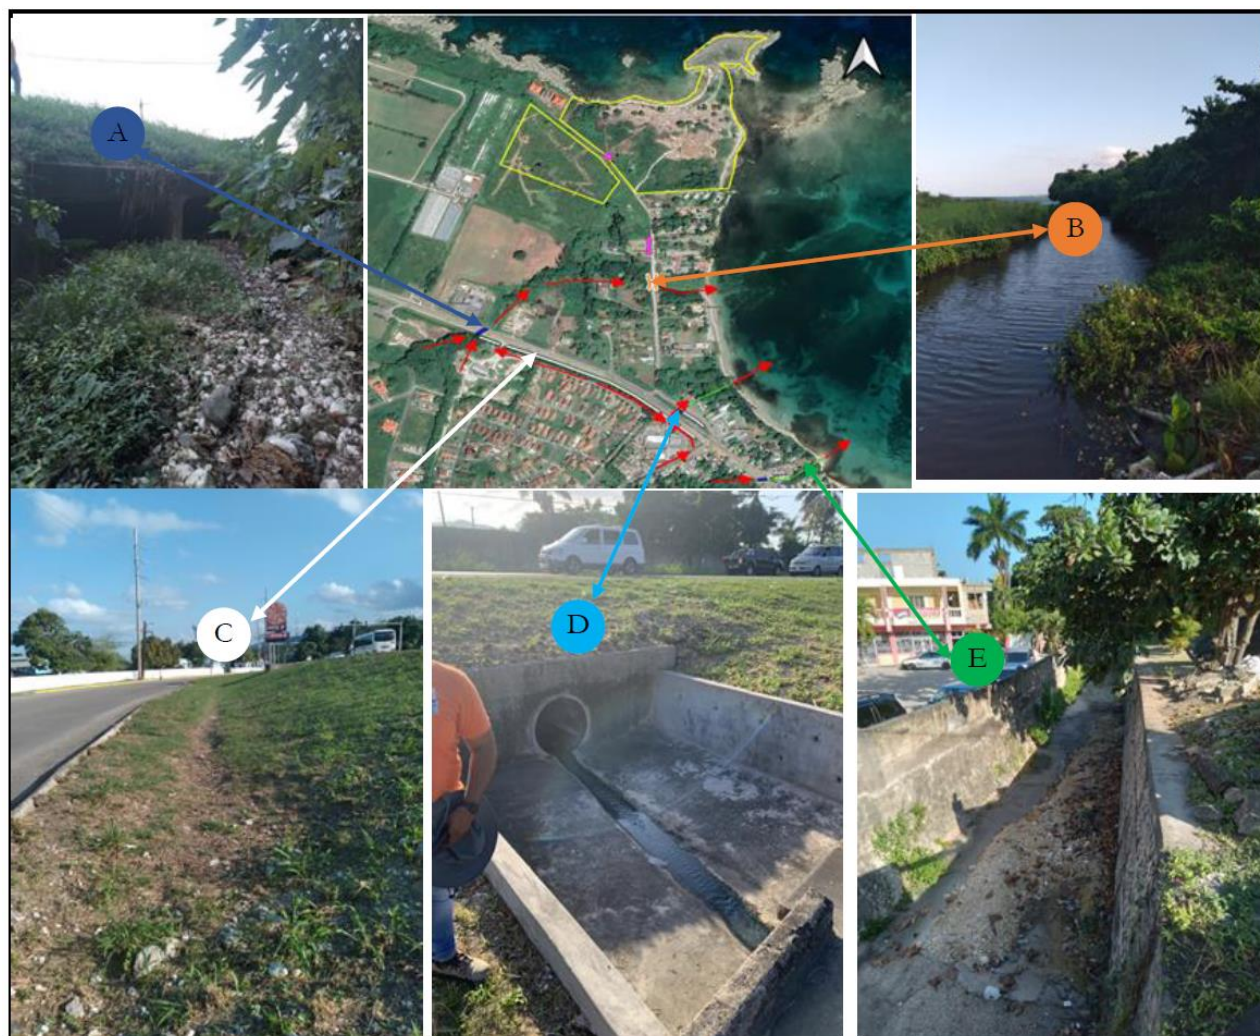
Figure 5-22 Existing drainage features within the catchment area showing (A) Double Box Culvert, (B) Earth Drain that discharge into the sea, (C) earth swale, (D) Pipe Culvert and (E) Open U Channel

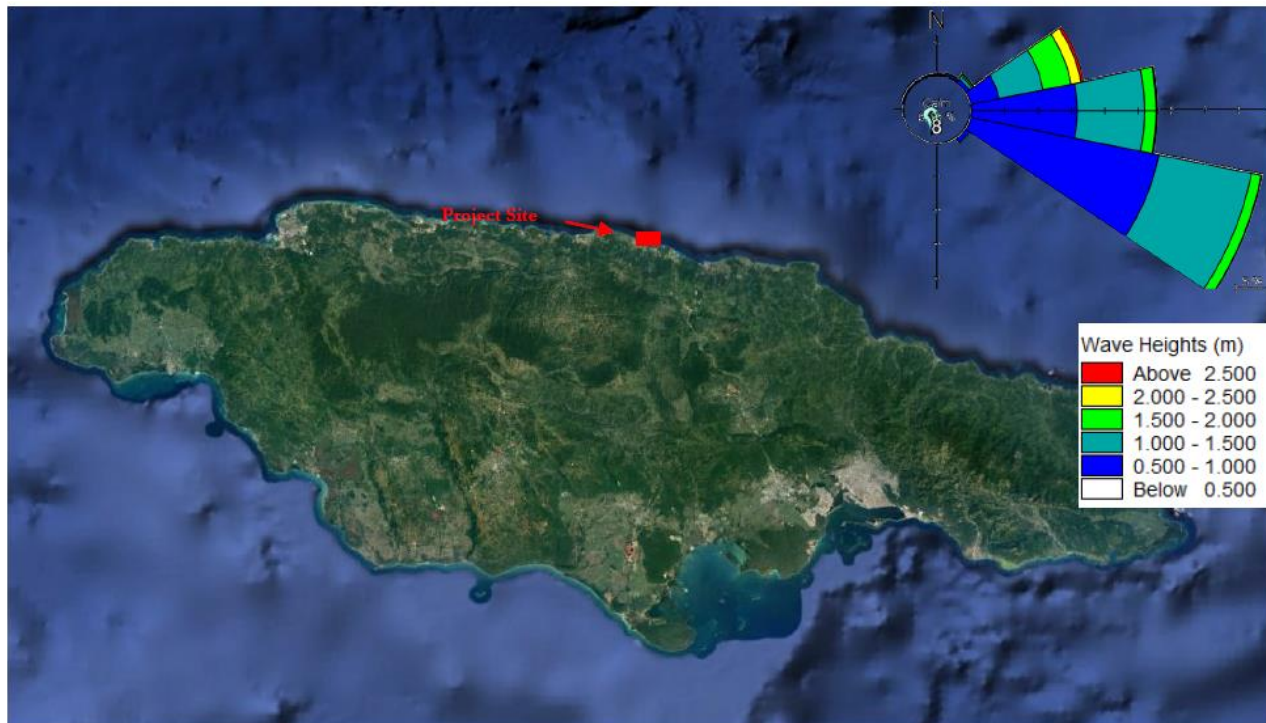
Figure 5-29 Wave Rose at the offshore ERA 5 Node 8 summarizing 42 years of data

resulted in 2,452 different conditions or “events” representing a combination of wave height, peak period and direction, each with a specific duration related to the number of occurrences over the 42-year period. Analysis of the binned data showed that waves approached from the northeast to southeast sectors most of the time. Figure 5-29 shows the wave height distribution and the location of the node (Node 8) that was selected for the project. In terms of magnitude, typical significant wave heights (H_s) offshore the coast are 0.5 - 2m, with associated with average peak periods (T_p) of 6-8 seconds.

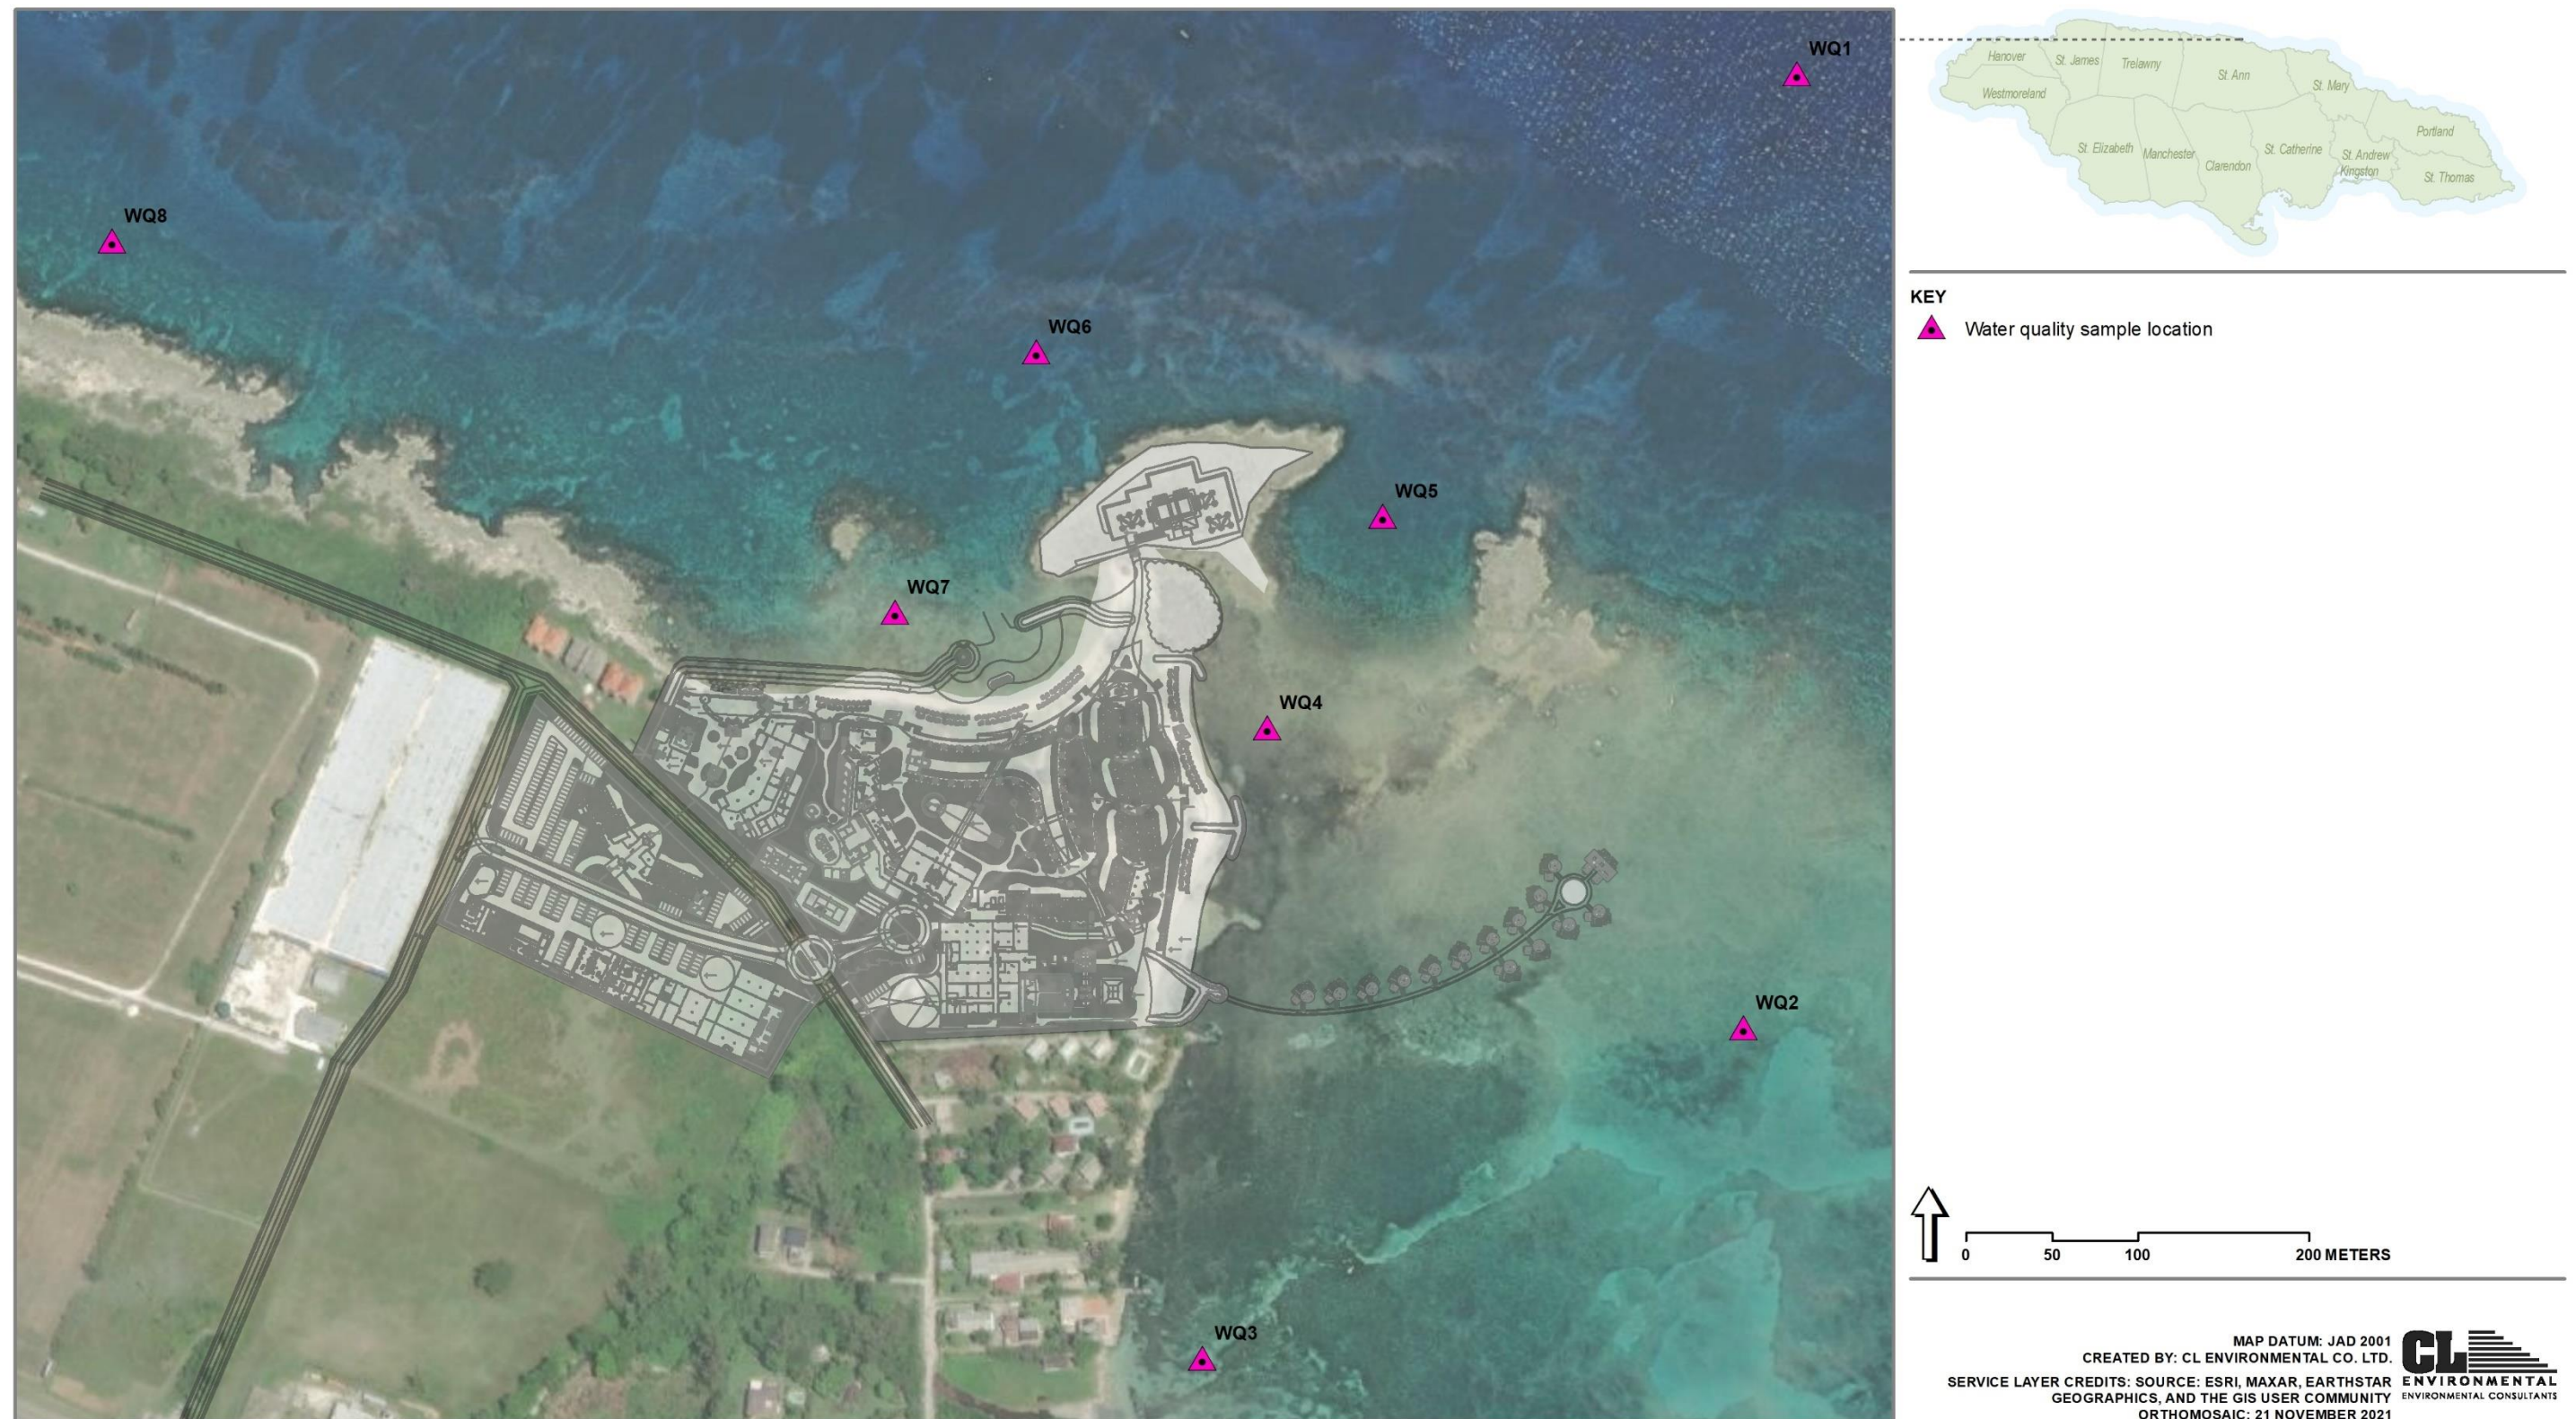
Figure 5-34 Water quality sampling stations

Station	X	Y
WQ1	726750.425995	700554.072031
WQ2	726719.304891	699997.169290
WQ3	726403.366916	699804.264826
WQ4	726441.070389	700172.231628
WQ5	726508.738200	700295.704440
WQ6	726306.307239	700391.592790
WQ7	726223.802976	700239.690060
WQ8	725766.749713	700456.327471

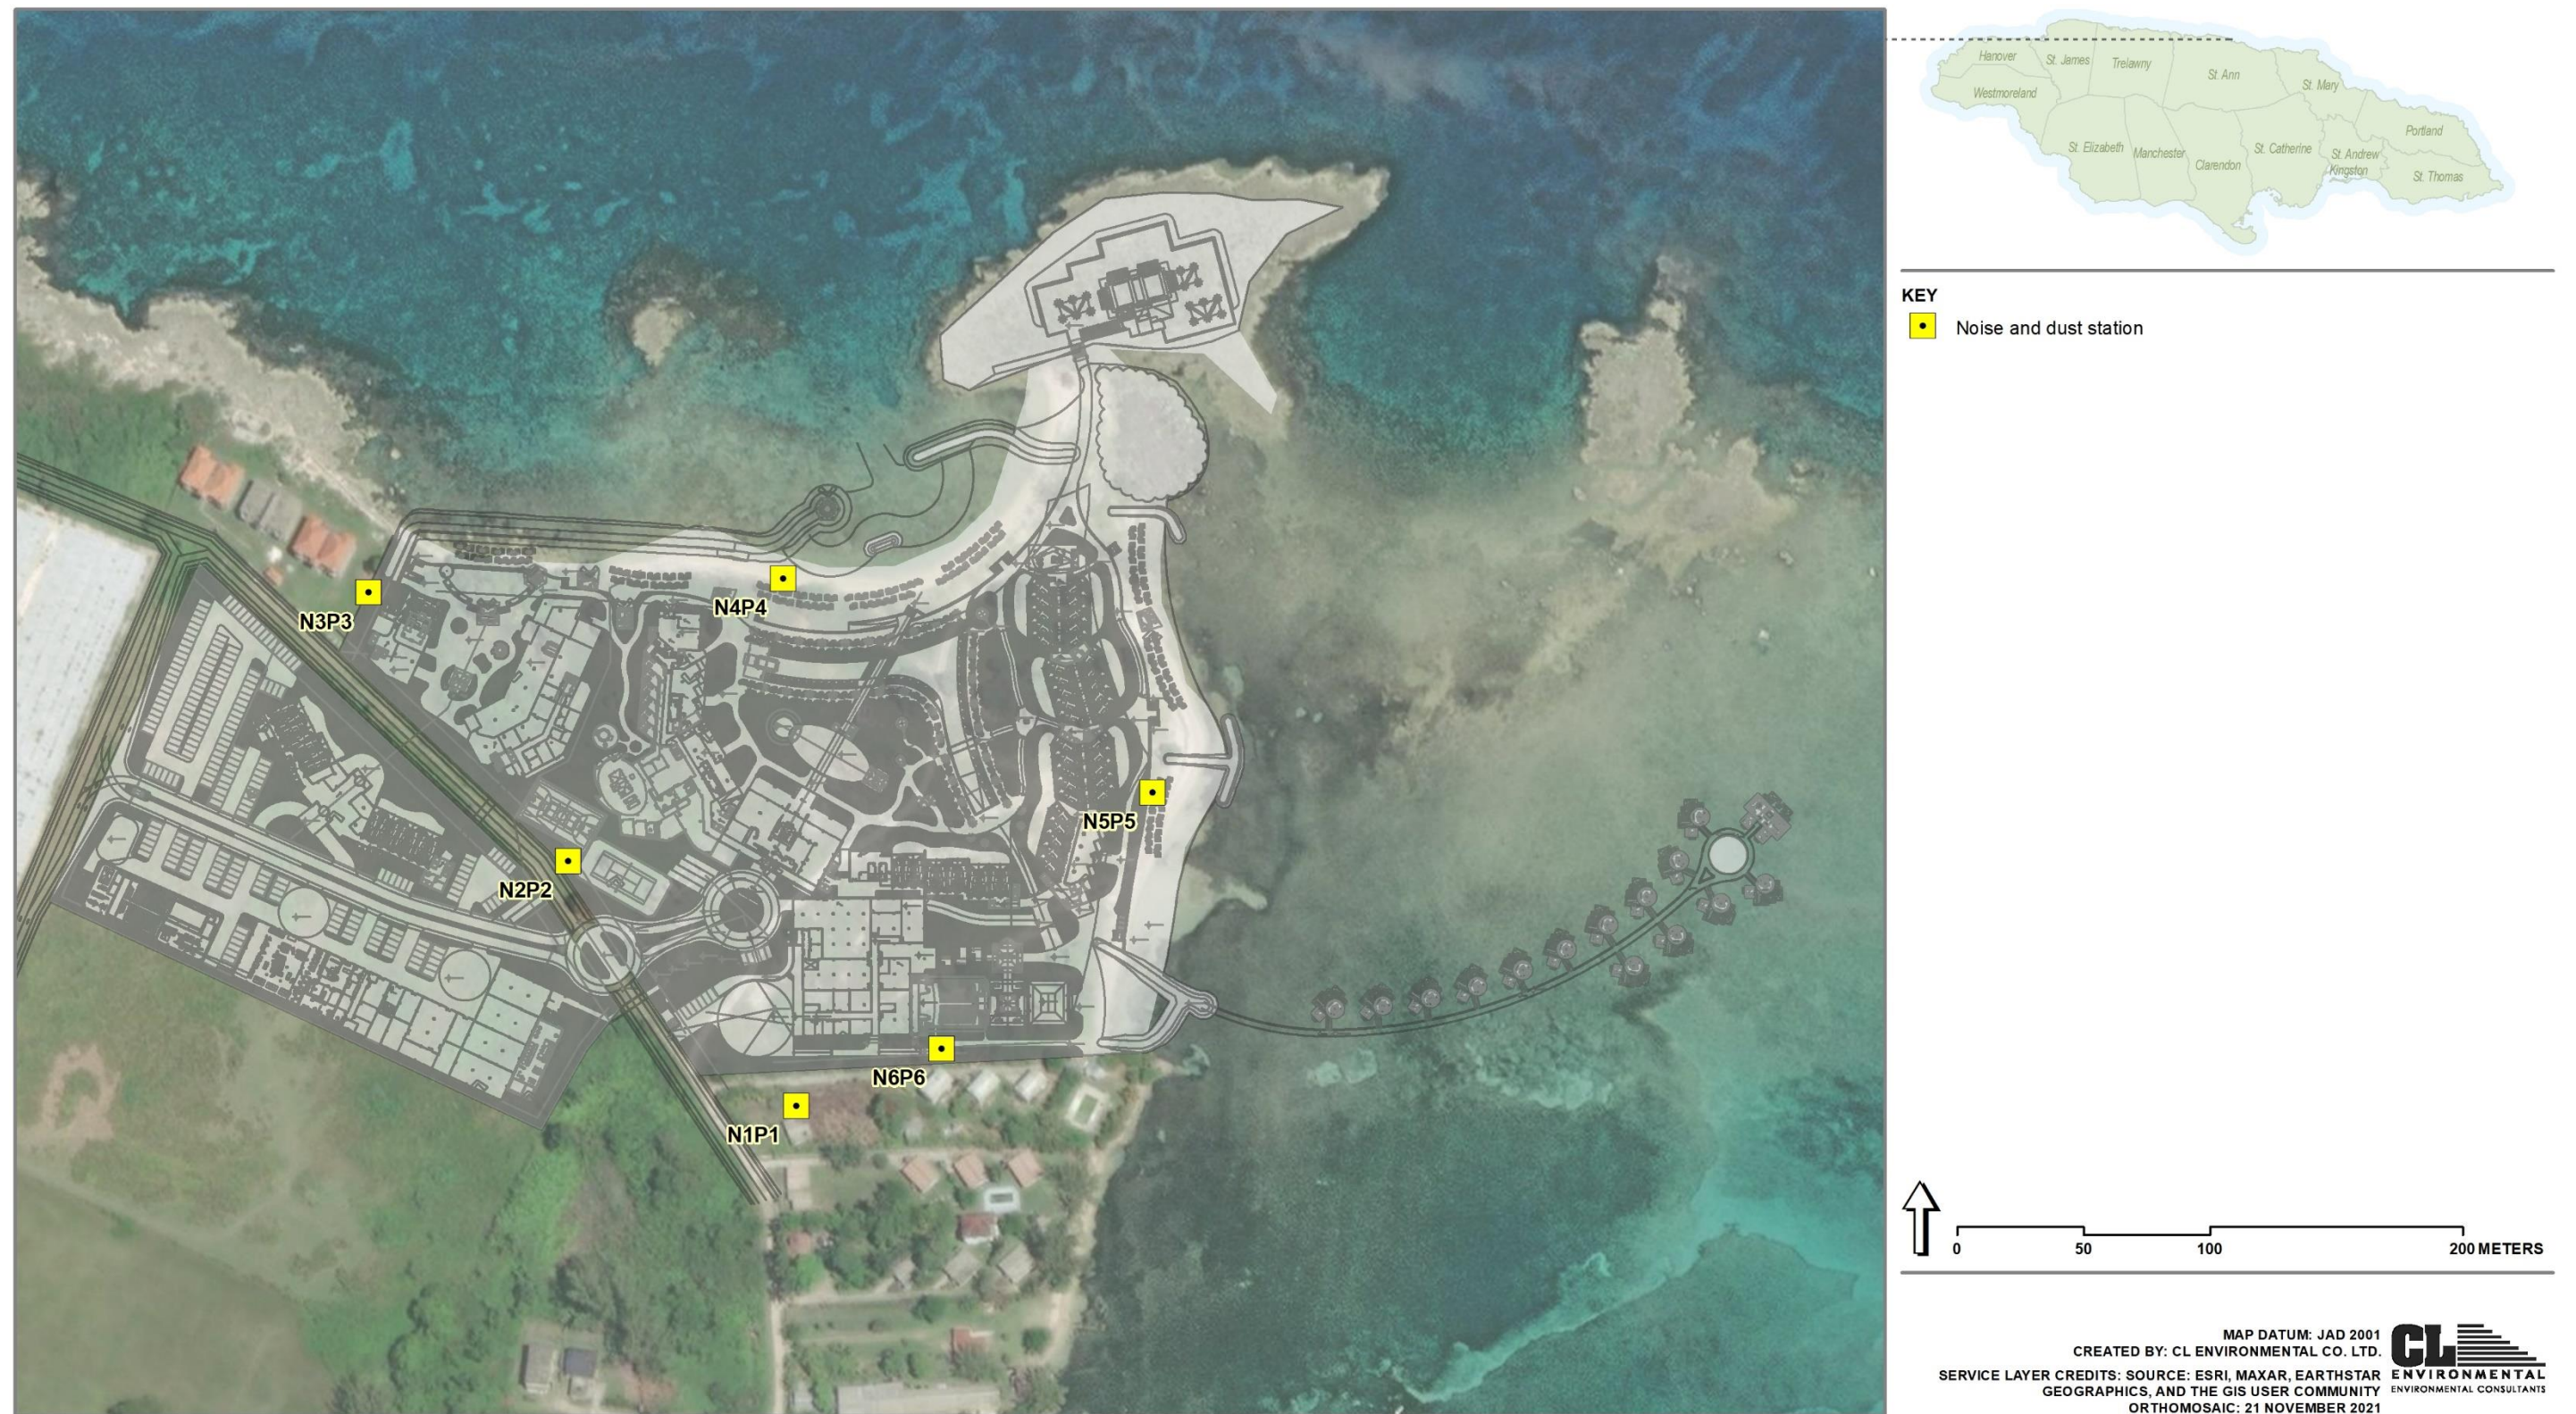
Figure 5-48 Location of noise and particulate monitoring stations

Station	X	Y
N1P1	726251.5635	699977.2074
N2P2	726161.3112	700074.2485
N3P3	726082.2406	700180.4746
N4P4	726246.3720	700186.0655
N5P5	726392.5327	700101.4041
N6P6	726309.0693	699999.9701
