ENVIRONMENTAL IMPACT ASSESSMENT

HOTEL DEVELOPMENT AT PART OF RICHMOND ESTATES, ST. ANN BY SECRETS RESORTS AND SPA

Report Version: **FINAL v2.0**

Date: **March 2023**

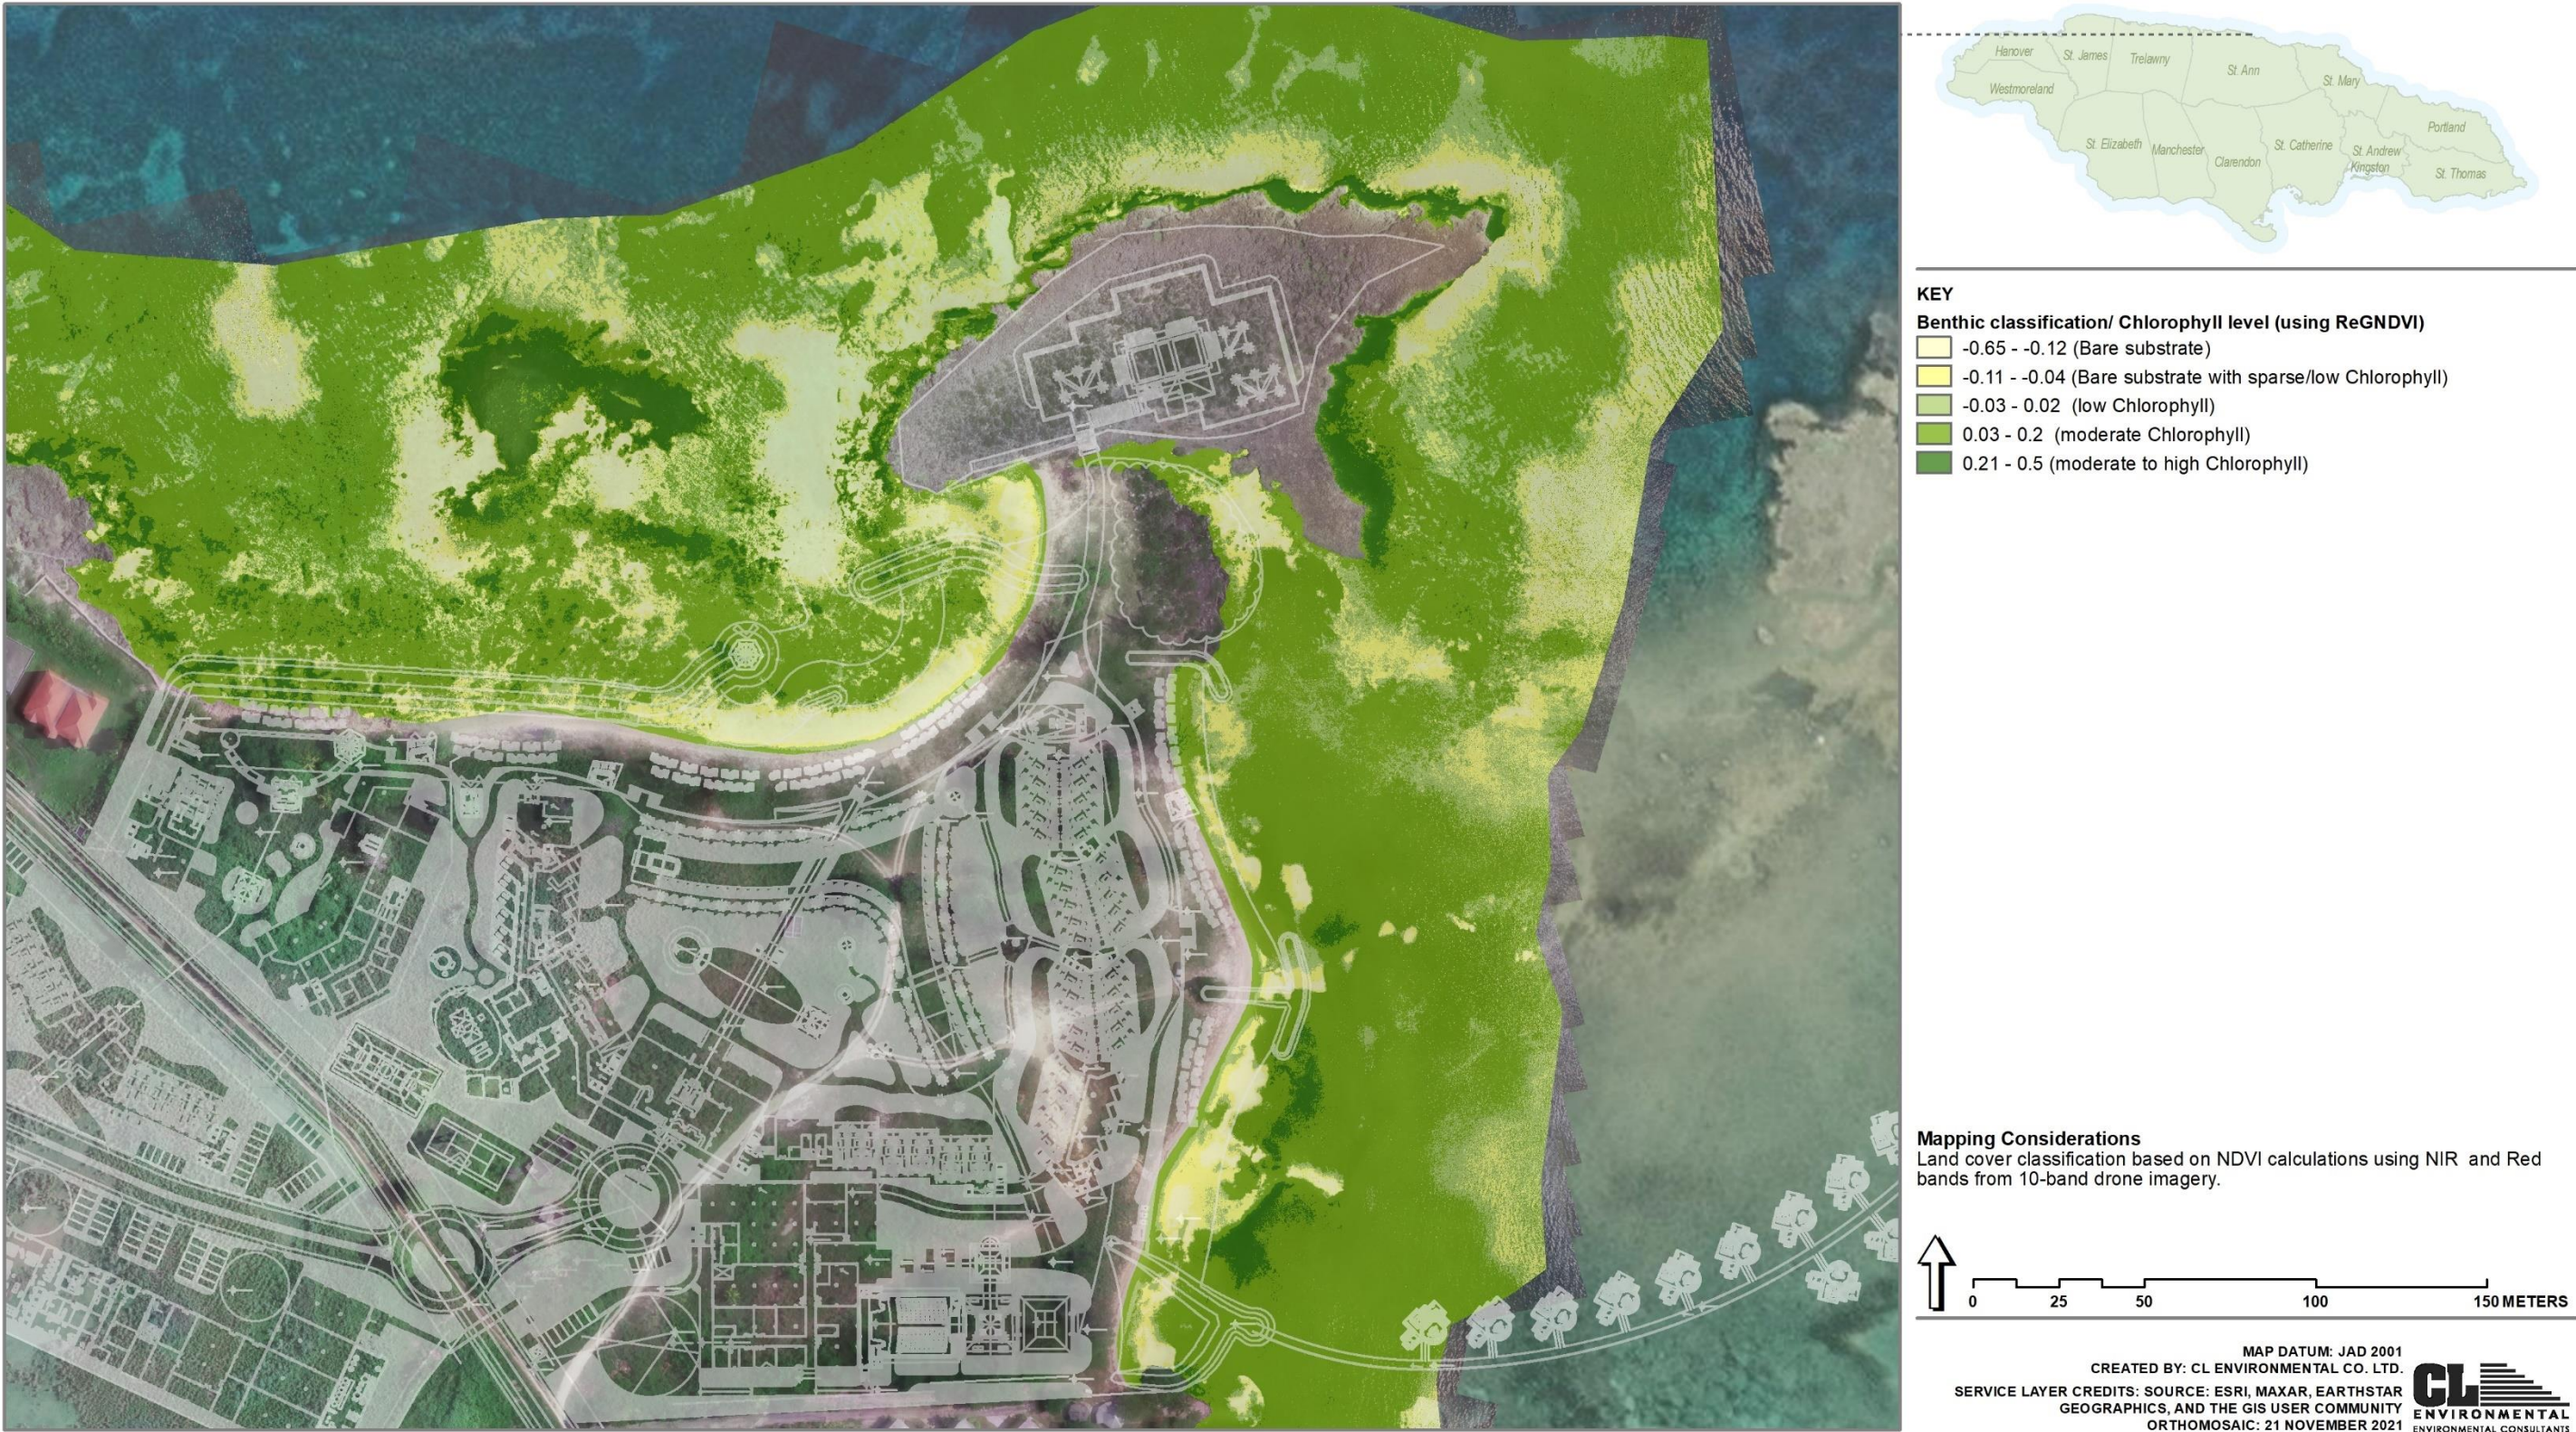
Figure 5-65 Normalized Difference Vegetation Index (NDVI)-based benthic classification at the project site

The resulting ReGNDVI-based classification corresponds well with field-collected data (see section 5.2.2). In the eastern bay, bare substrate is found predominantly along the shoreline and in patches amongst moderately dense seagrass beds further offshore. The nearshore patches of sparse *Halodule* seagrass mapped in the field correspond with areas having ReGNDVI values between -0.11 and 0.21 in the nearshore areas. The areas with higher Chlorophyll content throughout the eastern bay were observed to be *Thalassia*-dominated seagrass beds. In the western bay, negative ReGNDVI values represent bare substrate (rock, rubble and sand) and higher NDVI values with field-mapped nearshore mixed macroalgae and *Thalassia*.

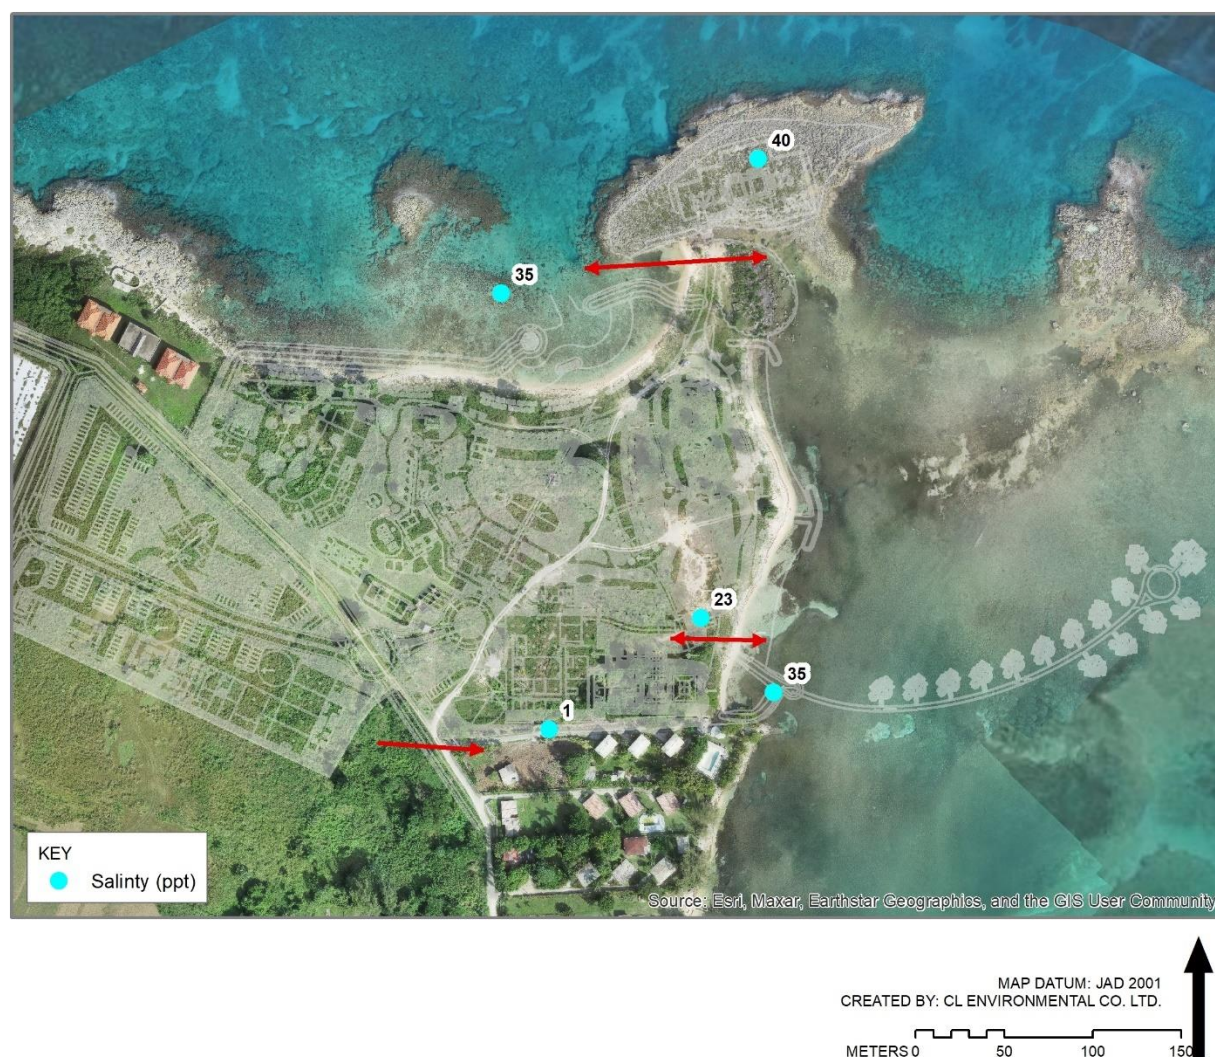
Figure 5-68 Salinity and observed flow of water (red arrows) at the project site.

To understand the hydrology of the site, salinities of standing water bodies were collected where possible. Figure 5-68 shows that the property is mostly devoid of standing water bodies, with just 3 locations on the development footprint having standing water.

Fresh water (1ppt) was recorded in crab holes at the Southern end of the property, coinciding with wetland type vegetation in this area. Despite the area not being waterlogged during the visit, the guttering, culvert presence across the roadway, and being adjacent to a wetland to the West, is a clear sign that this area is occasionally subject to freshwater flow. An area of tidal influence (double sided arrow) was observed, having a salinity of 23ppt (Figure 5-68). This area had a negligible assemblage of mangrove saplings, but the salinity indicates that there is an exchange of seawater at this location, and fresh water that dilutes the water (seawater is 35ppt). Historical aerial images show that there was a thicket of coastal vegetation in that location up to 2009 (Figure 5-61 and Figure 5-69), and anecdotal information from residents suggests that these plants were mangroves.

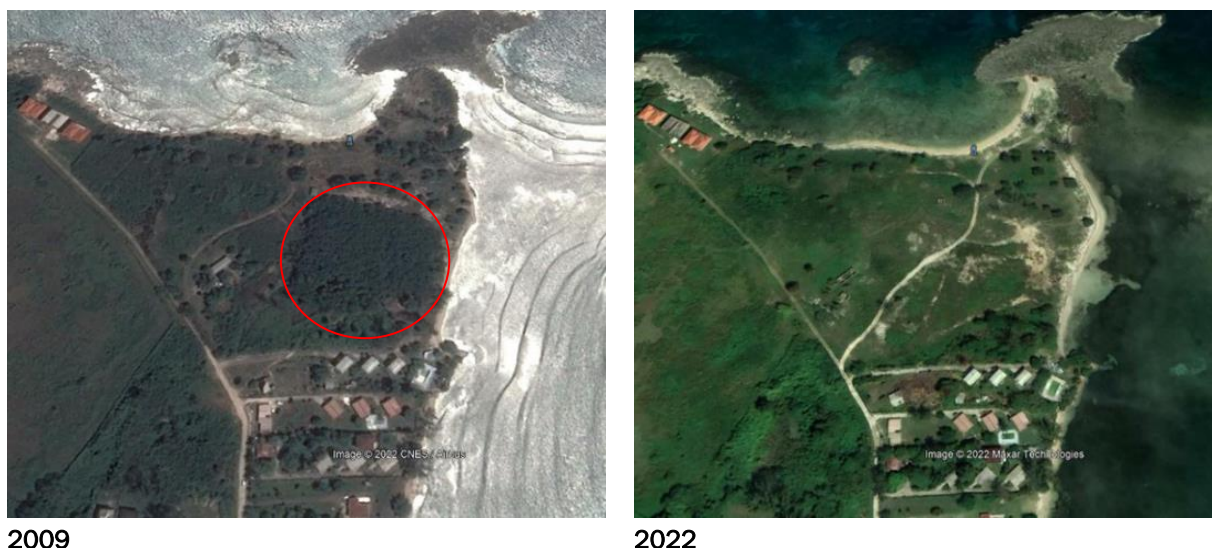
Figure 5-69 Location of historic mangrove (red circle in 2009 image)

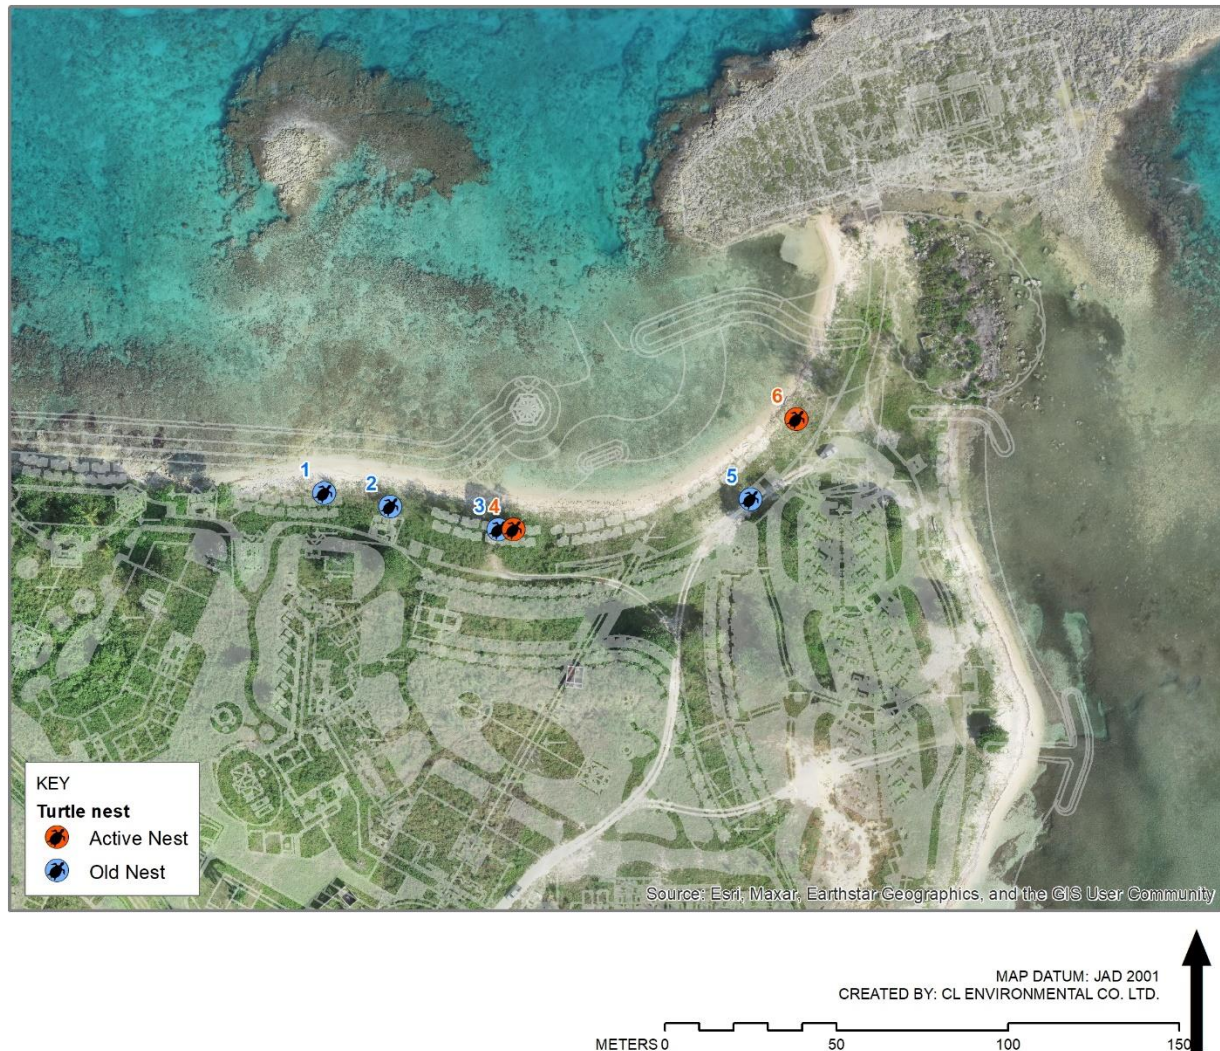
Figure 5-71 Location of the nest observed on the property.

Four old nests with old eggshells (Plate 5-24) were observed on the beach on the site (Figure 5-71). Two mounds on the property could be active nests or test digs observed during the study (Plate 5-26). The Hawksbill is the common turtle species regularly seen in the parish. These nests are highly vulnerable to poaching by fishermen, one of the nests appeared to have been poached. The nest and turtles are also vulnerable to dogs regularly seen on the property. Solid waste (Plate 5-7) also threatens both the potential nesting turtles as well as the hatchlings. One nest in particular was at risk of being driven on by cars and trampled by users.

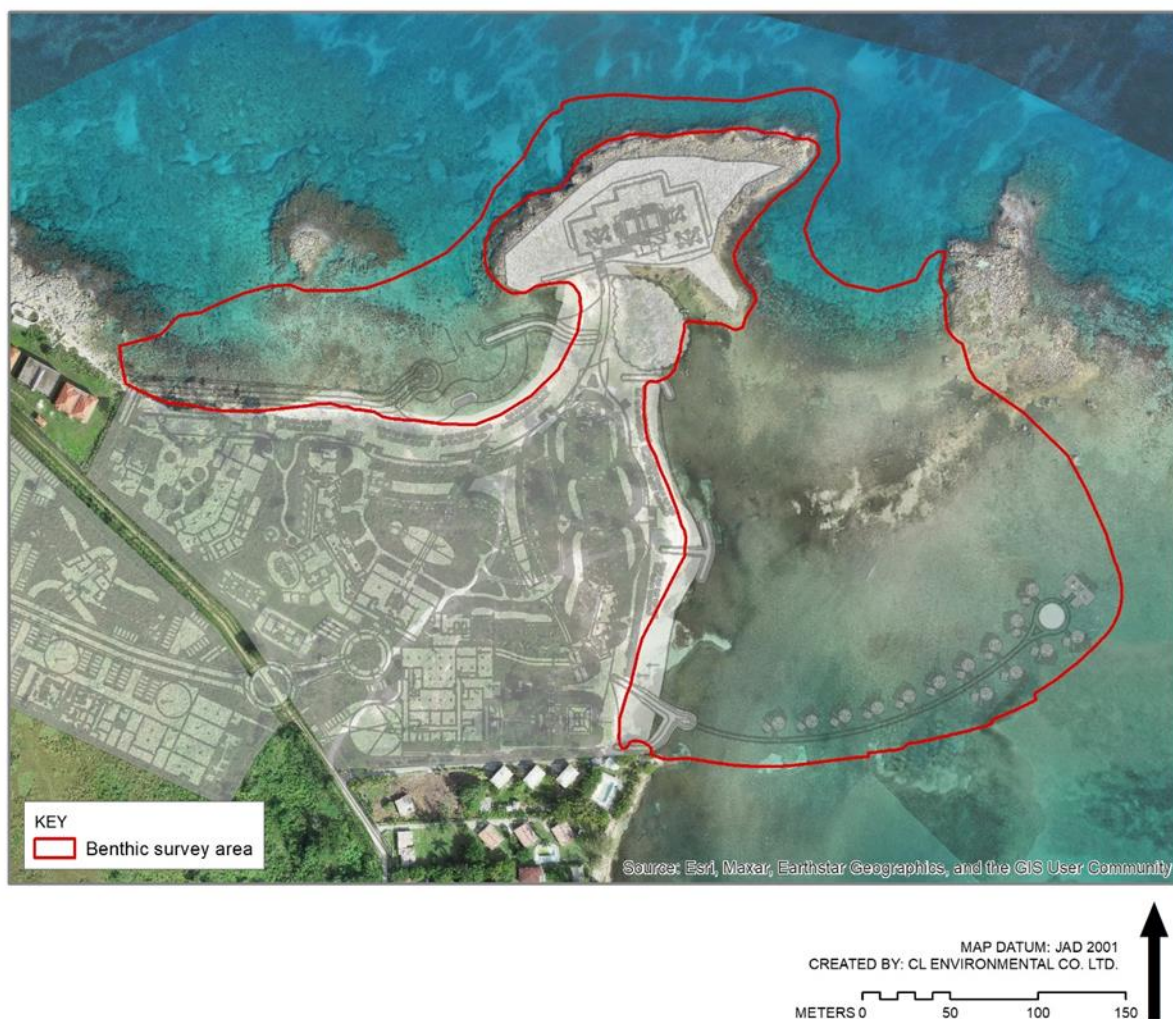
Figure 5-75 Benthic Survey area

The proposed project footprint includes some coastal modification along the entire property shoreline. This length of coastline has several different substrate types, varying seagrass bed density and diversity, coral, pavement, rocky shores and intertidal communities. Various survey methods were used to assess the benthic community, these included transect lines, quadrats and roving surveys. Figure 5-75 gives the benthic survey area. An additional reef survey was conducted outside the immediate project area.

A total of 487 large (10cm or greater) hard coral colonies and 167 soft corals were mapped. Of these hard corals mapped 49 of were *Acropora palmata*. A total of 48,446.5m² of seagrass was mapped for the project area.

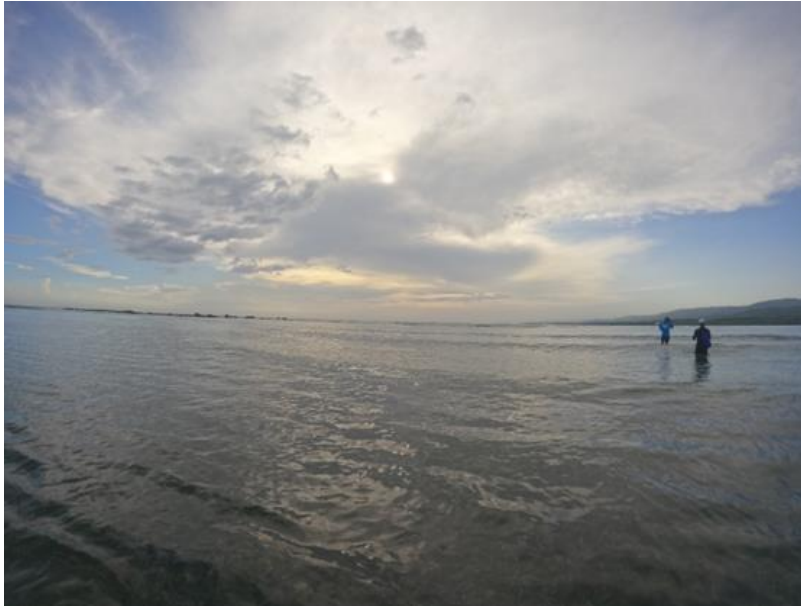
Plate 5-31 Mapping of seagrass beds

The seagrass beds and other distinct communities within and nearby the proposed project footprint were mapped and surveyed using a Trimble Geo 7x Global Positioning System (GPS). The beds were mapped by walking along the boundaries where possible. Aerial imagery was obtained by using a Quantum Trinity F90+ fixed wing drone, and georeferenced orthorectified imagery of the project area was created. Habitat maps were then created for each bay.

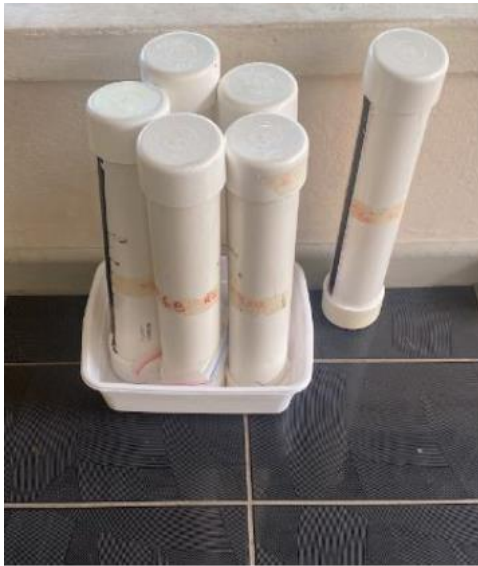
Plate 5-34 Labeled core samples taken from Richmond Cay

Within the project area a total of seven (7) seagrass cores were extracted. At each site, diving was utilized to extract core data using a PVC core and sledgehammer. The core was then capped and removed. GPS locations were then taken at the site of core extraction Table 5-35. The removed core and contents (vegetative and soil plug) were then carried to the surface and stored for later processing as seen in Plate 5-34. This process was repeated for each sample taken.

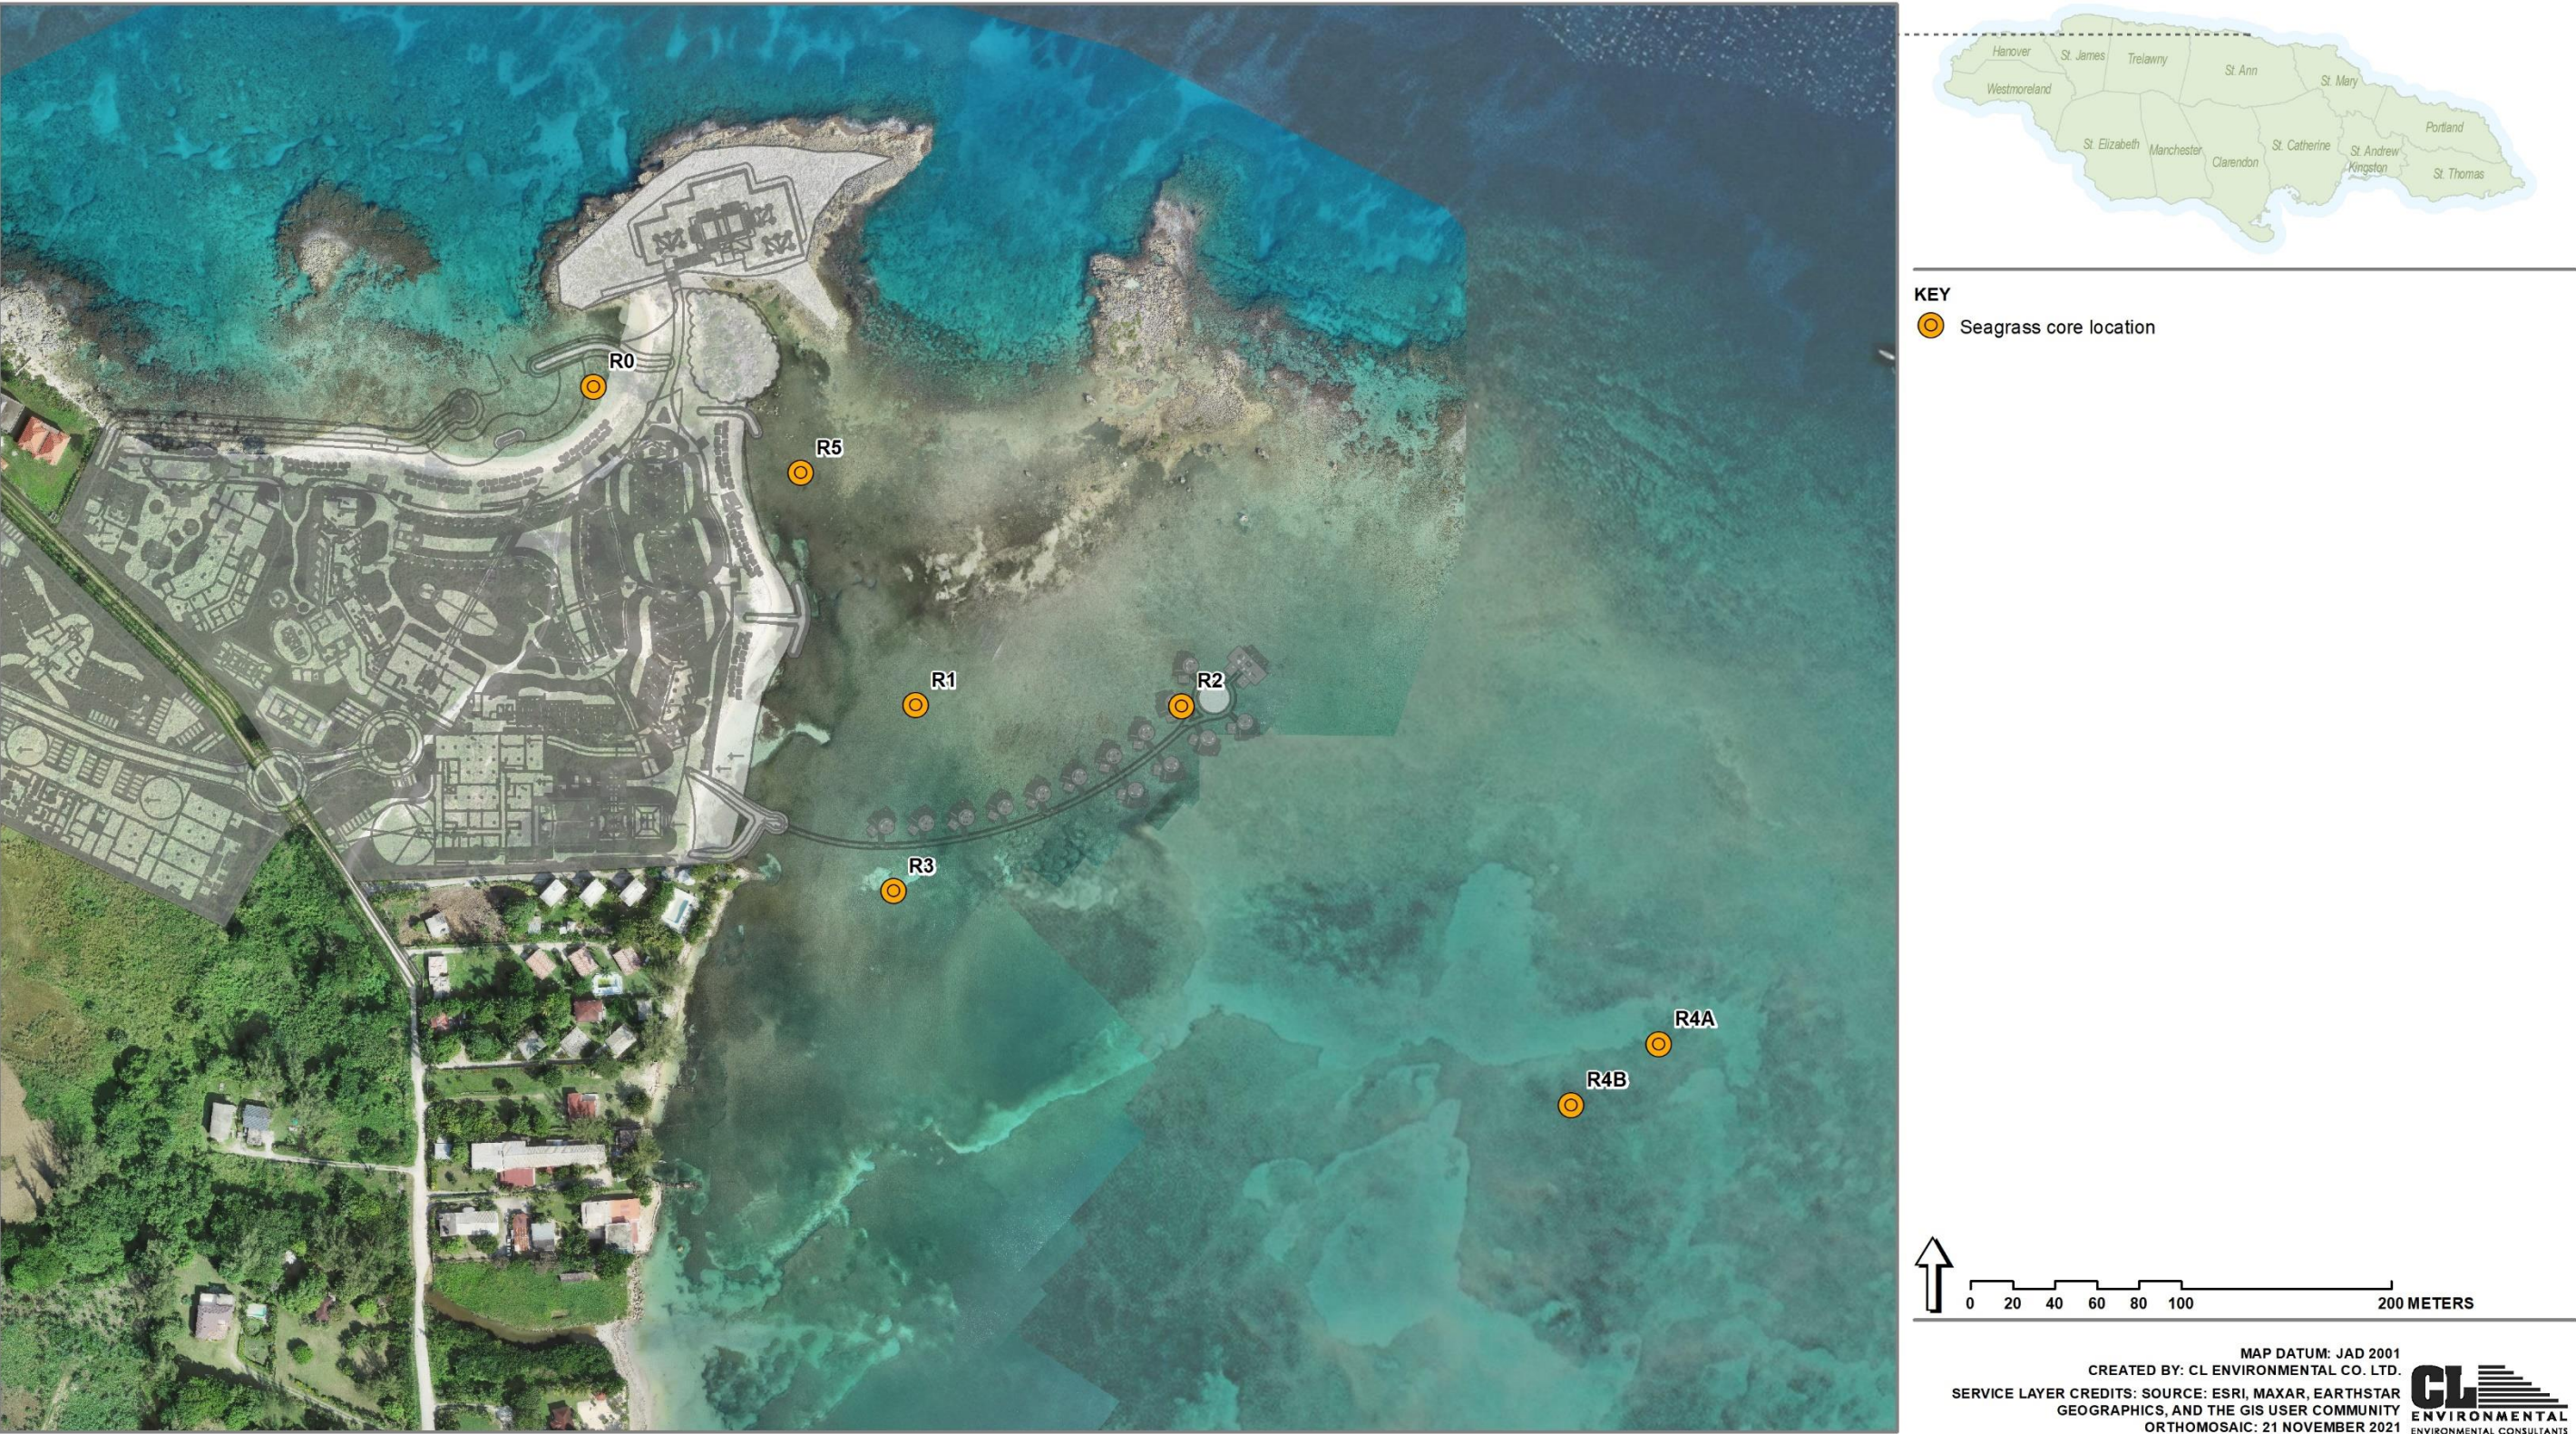
Figure 5-76 Map of core extraction points at Richmond Cay

Core Name	Eastings	Northings
R0	726478.6741	700073.0623
R1	726605.0007	700072.6555
R2	726468.102	699984.7461
R3	726789.890	699883.2530
R4 A	726831.6098	699912.0963
R4 B	726325.6702	700224.2086
R5	726424.1097	700183.3684

Additional sites sampled within the eastern bay but outside of the immediate project area included R4B and R4A (Figure 5-76). Depths within this area ranged between 10 – 13 feet. The seagrass bed present within this area consisted of continuous and extensive stands of *Thalassia testudinum* projecting further offshore.

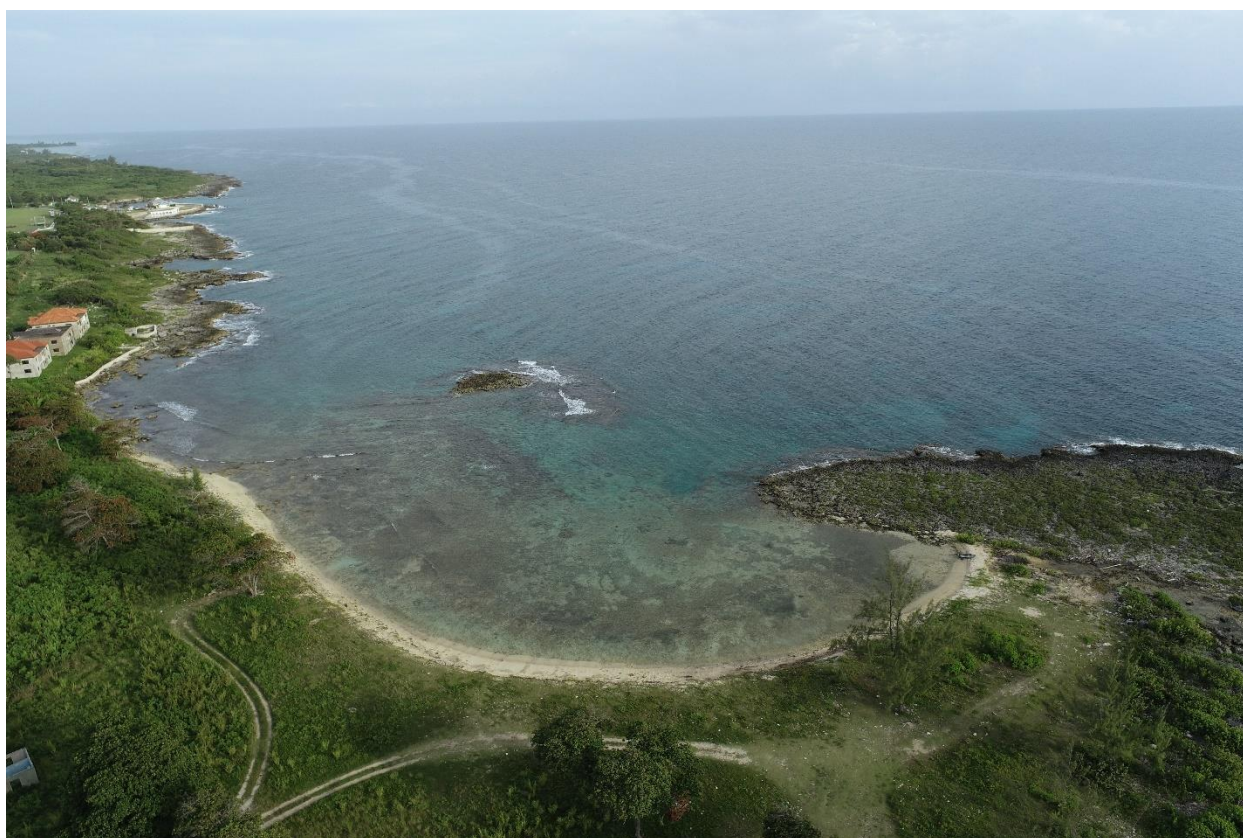
Plate 5-35 Aerial photo of the west bay

The western bay is shallow back reef protected by a fringing reef system and rocky shore headland. Most of the substrate throughout the area is hard with little to no sand. Sparse seagrass in pavement and rock and rubble dominated the eastern section of the bay while the western side is a mixture of iron shore and algal reefs. Dense *Echinometra* zones are also found within the shallow, sheltered bay. The fringing reef is dominated by seafans, in particular on the eastern side and around the middle cay.

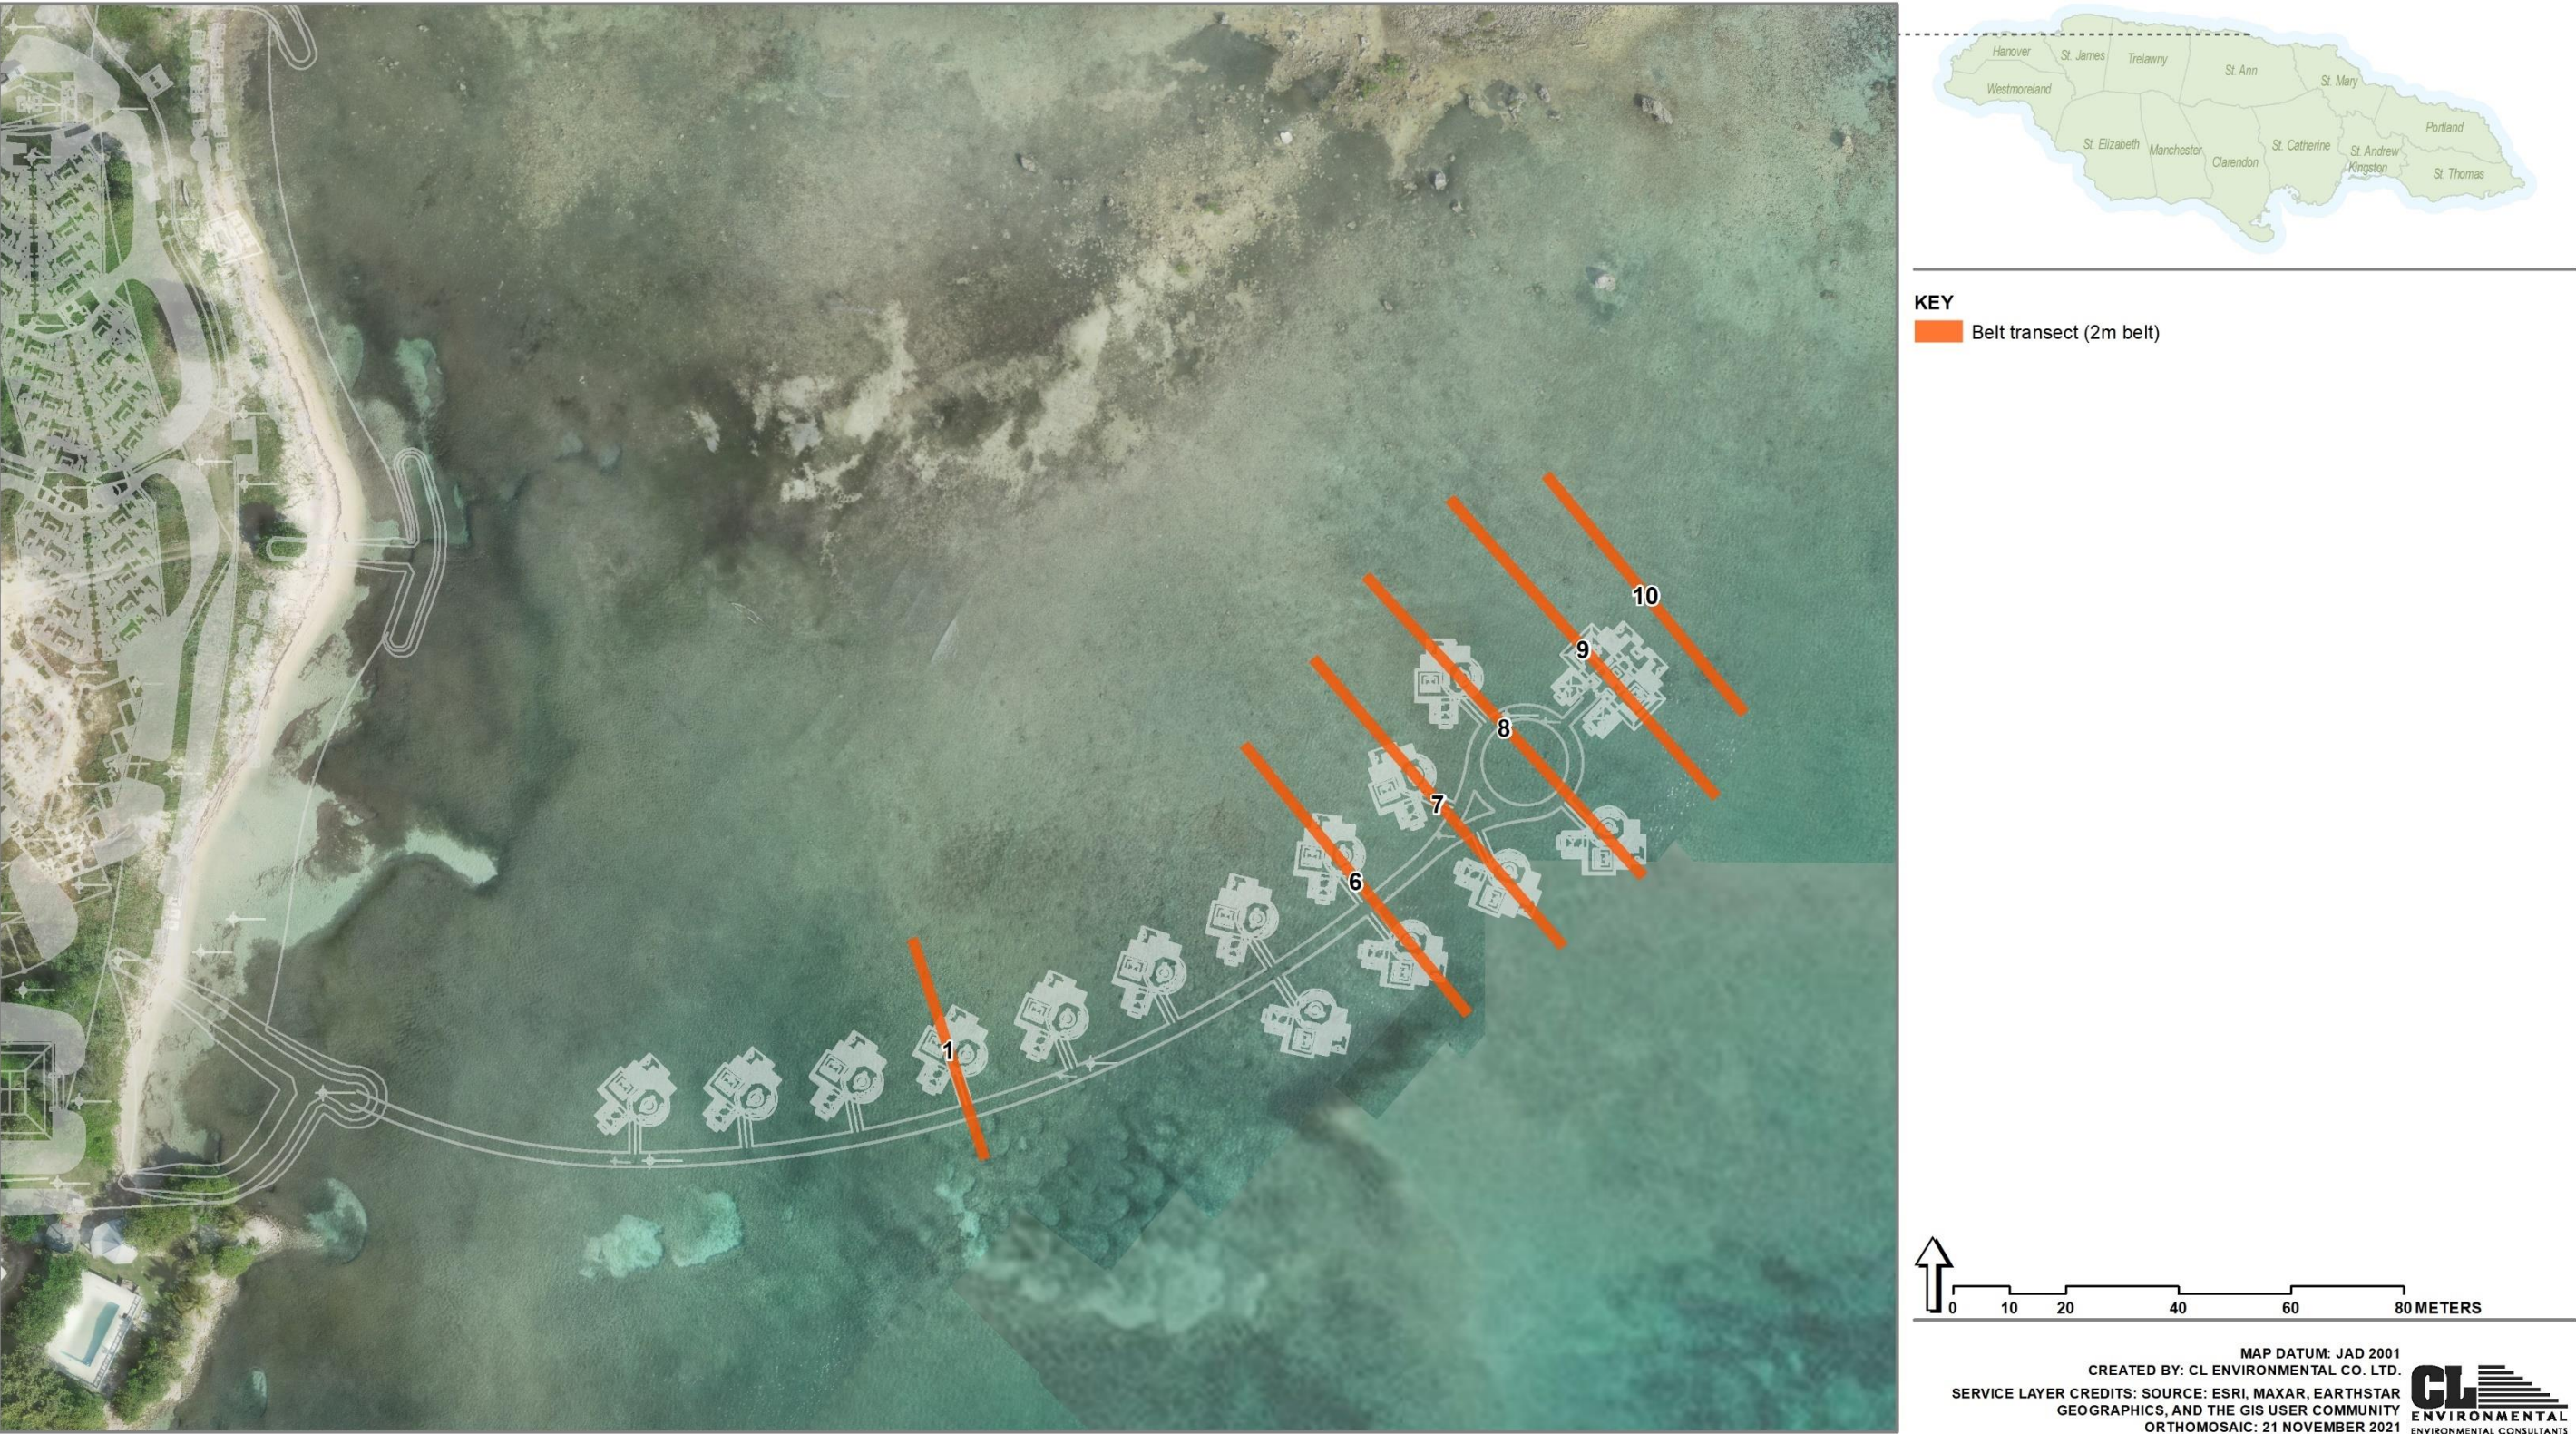
Figure 5-93 Belt transects in the East Bay

18 *A. palmata* colonies and an additional 61 >10cm hard corals were mapped in the west bay. All coral mapped were 10cm or larger. Many corals and fire corals could not be mapped due to wave action and their location in very shallow or hazardous areas of the fringing reef. Dense areas of seafans were seen along the submerged sections of the Ironshore and reef areas. Further away from the shore, 6, belt transects (Figure 5-93) were used to estimate species composition and density of larger coral colonies and patch reefs. Roving surveys were also used to record larger coral colonies All hard and Soft Coral mapped are shown in Figure 5-94.

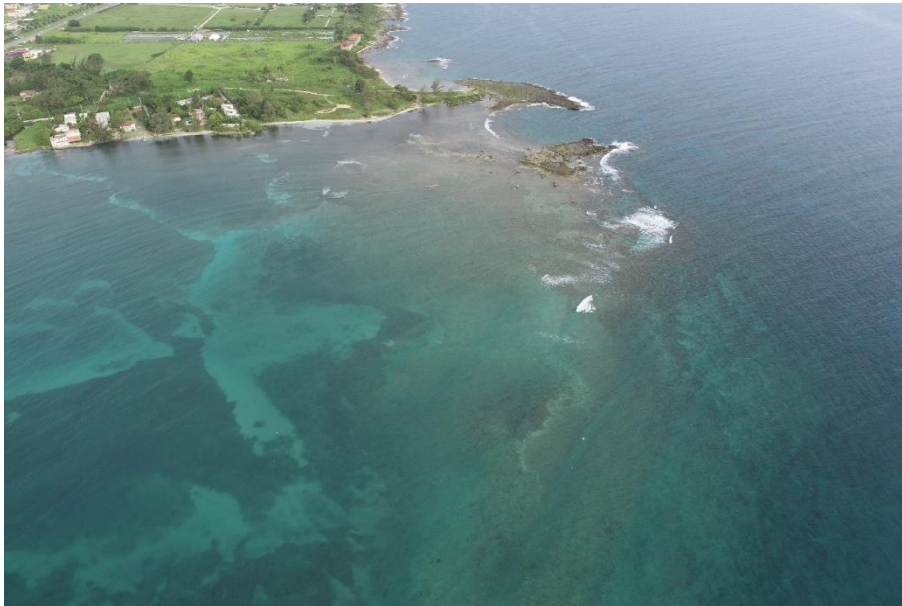
Plate 5-56 Aerial image of the east bay and fringing reef

Additional benthic parameters such as substrate type within the east bay include bare sand along the coastline with noticeable transitions into pavement, rock and rubble, coral (dense *Porites divaricata*) and sand dominated areas projecting further offshore. Benthos within the eastern bay may be categorized into four zones: rock and rubble, seagrass, sand and rubble, seagrass and sand and pavement.
