ENVIRONMENTAL IMPACT ASSESSMENT

HOTEL DEVELOPMENT AT PART OF RICHMOND ESTATES, ST. ANN BY SECRETS RESORTS AND SPA

Report Version: **FINAL v2.0**

Date: **March 2023**

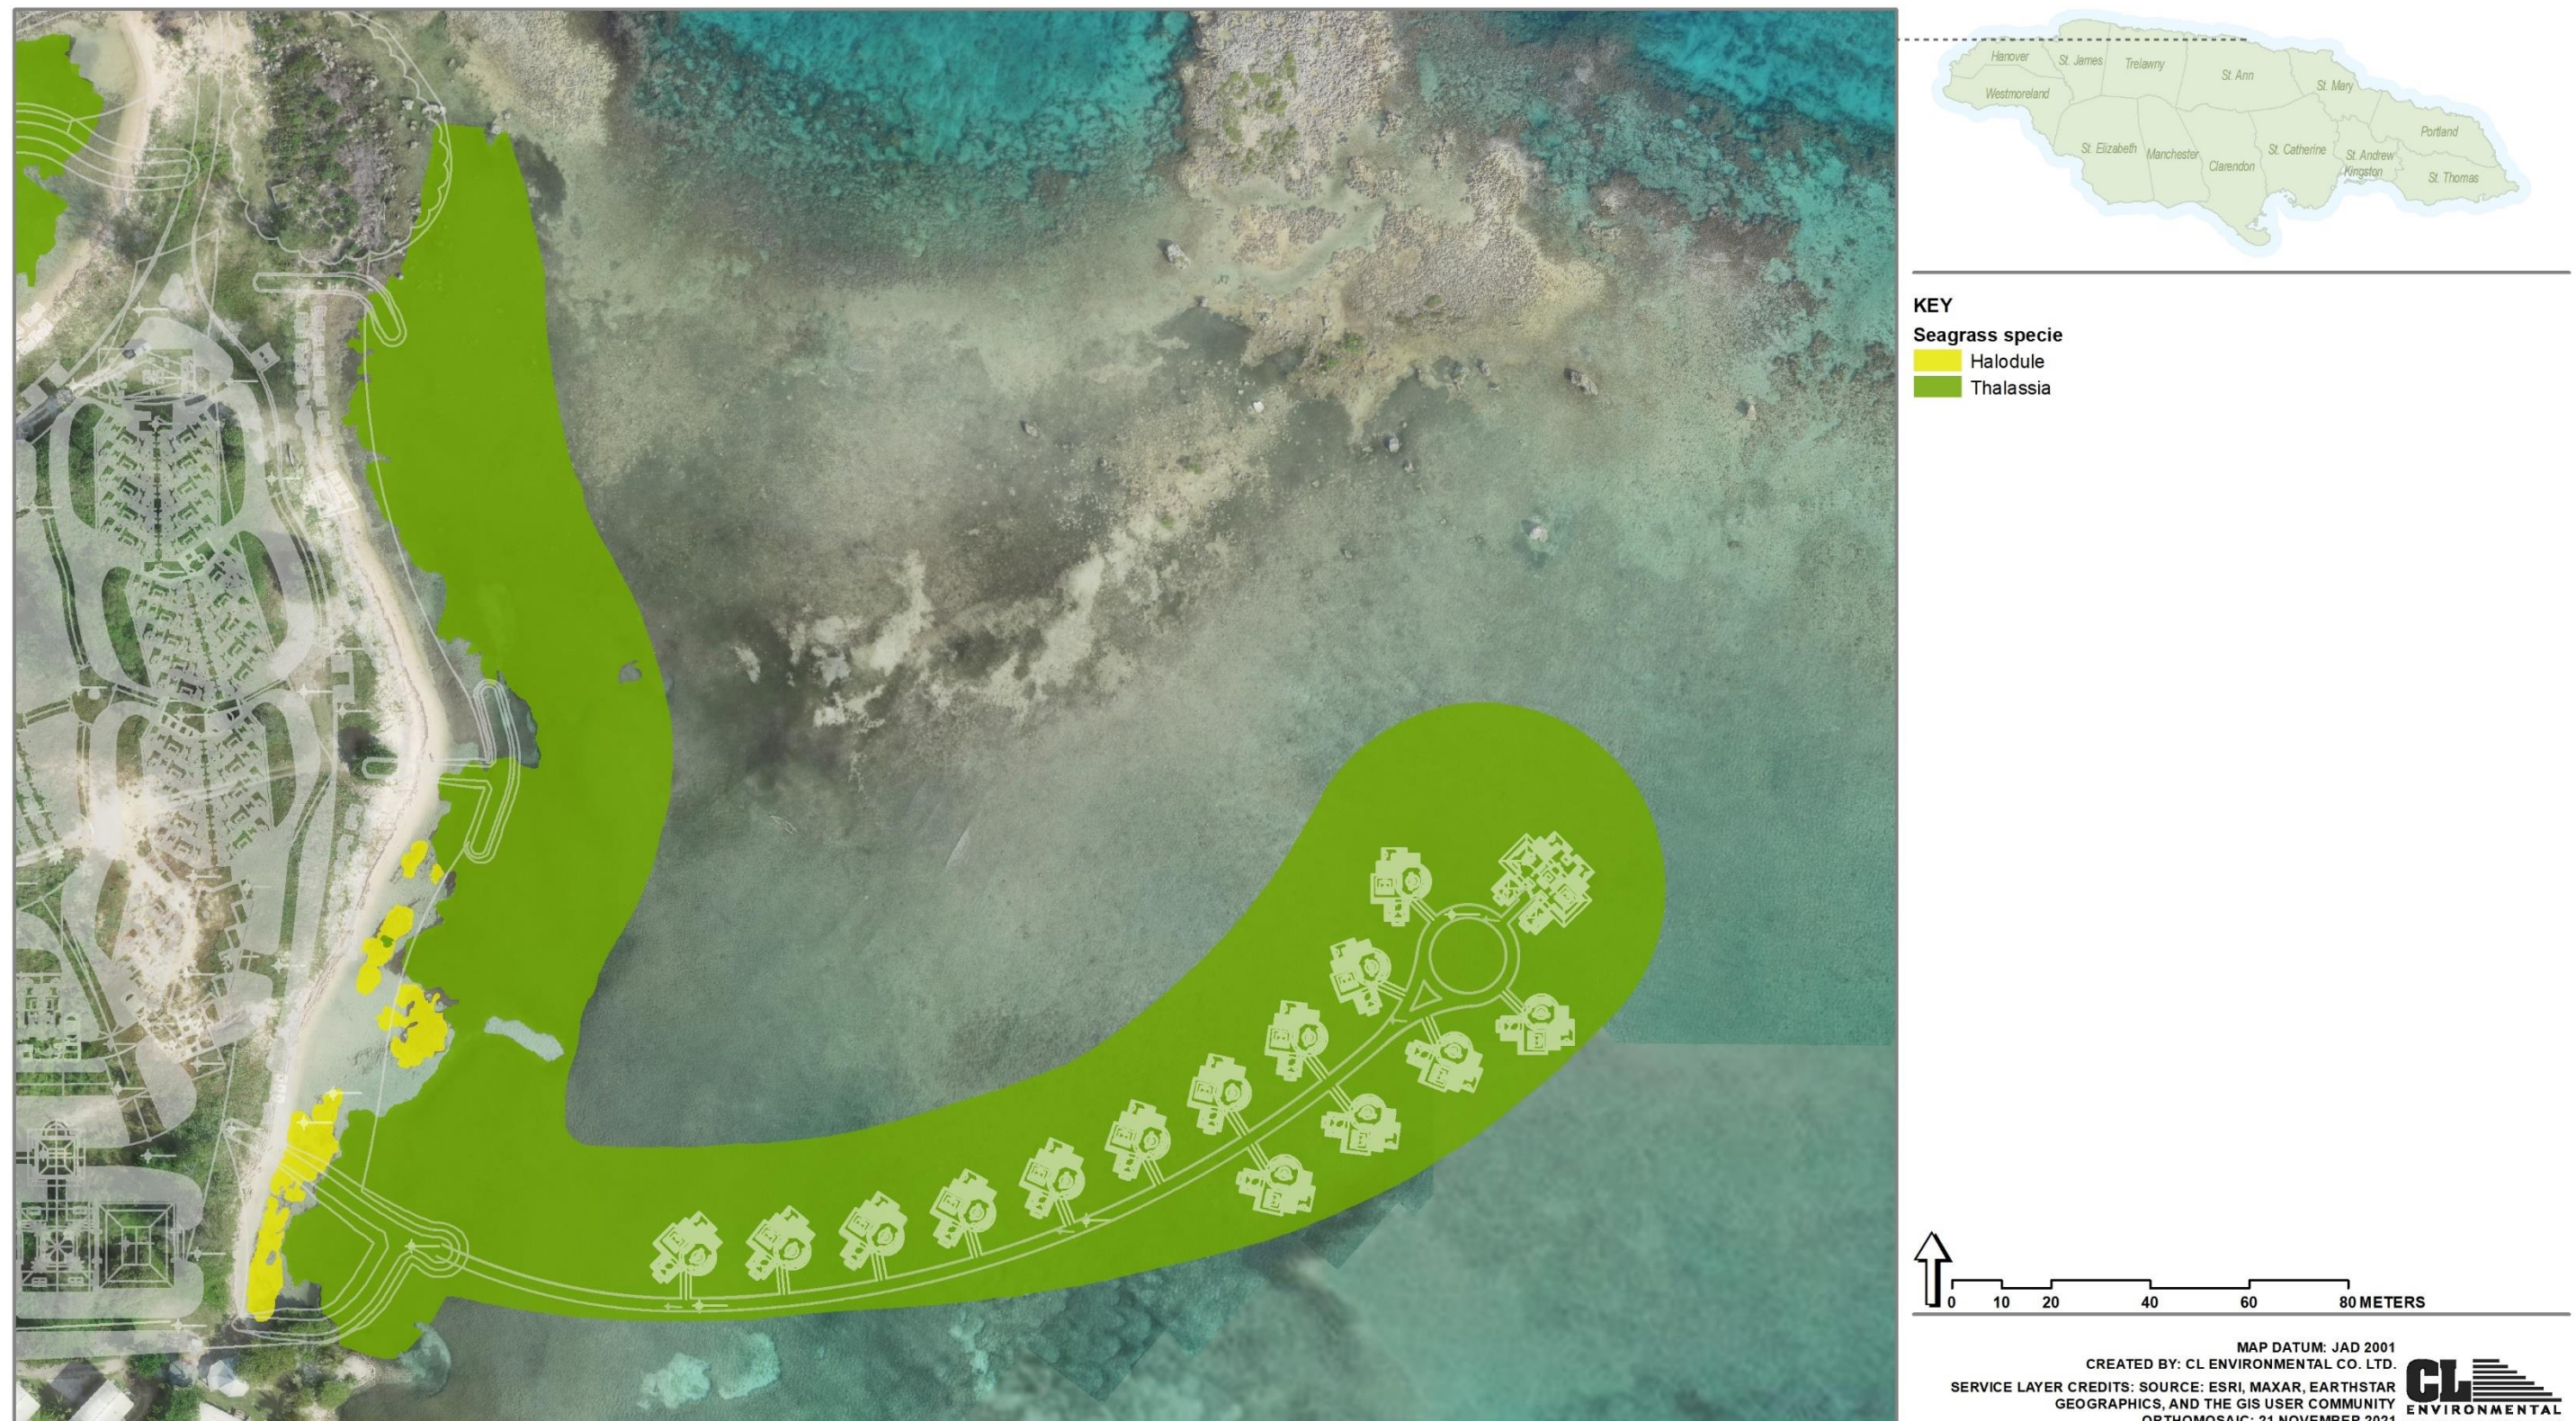
Figure 5-95 Mapped seagrass in the east bay

The dominant vegetative type within the eastern bay is the seagrass *Thalassia testudinum* which occupies 21,218.4 square meters. Additional seagrasses found in the eastern bay include stands of *Halodule wrightii* (542.7 m²). (Table 5-47). These seagrasses are present in various densities throughout the bay and may be associated with dominant substrate types and physical limitations within their environment. Along the westmost coastline of the east bay, seagrasses are present in dense mats within silt and sandy substrate, progressing further east along the coastline these *Thalassia* stands are joined by the sand and nearshore inhabiting seagrass *Halodule wrightii*. This species is present in isolated beds towards the boundary of the project area. Though the eastern bay possesses a greater depth profile in comparison to the west bay, an extensive shallow backreef which receives high hydrodynamic influences is present. Within this backreef area seagrass distribution is sparse and may be a result of prevailing conditions.

Seagrasses within this shallow backreef portion of the eastern bay have a noticeable smaller blade length, width, shoot density and percentage cover in comparison to other areas. Further east, within deeper areas of the bay seagrasses blade lengths and densities are present in increasing numbers.

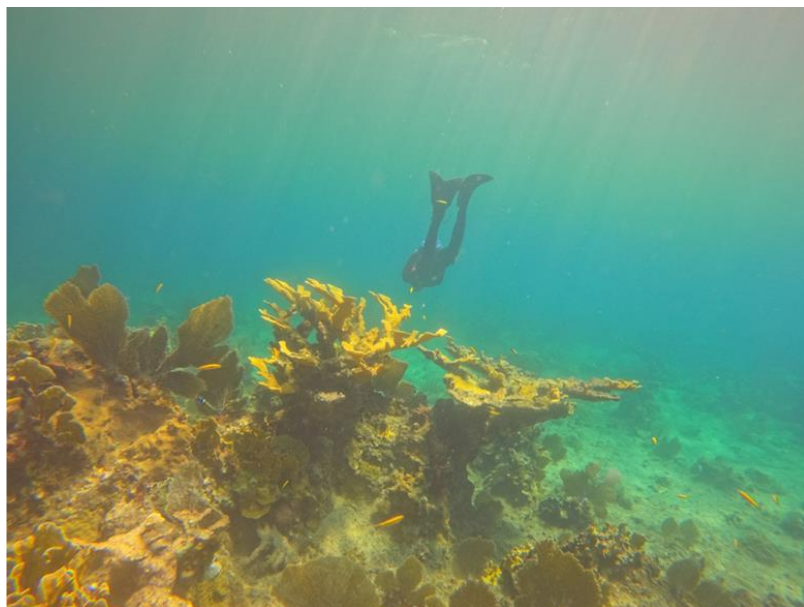
Plate 5-58 *Acropora palmata* colonies

Plate 5-58 - Plate 5-66 are some examples of sections of the fringing reef.

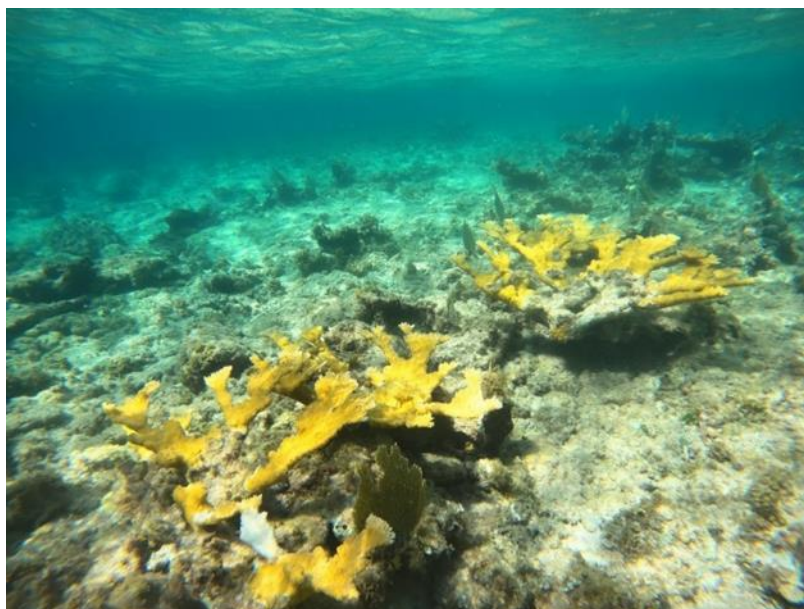
Plate 5-59 *Acropora palmata* colonies

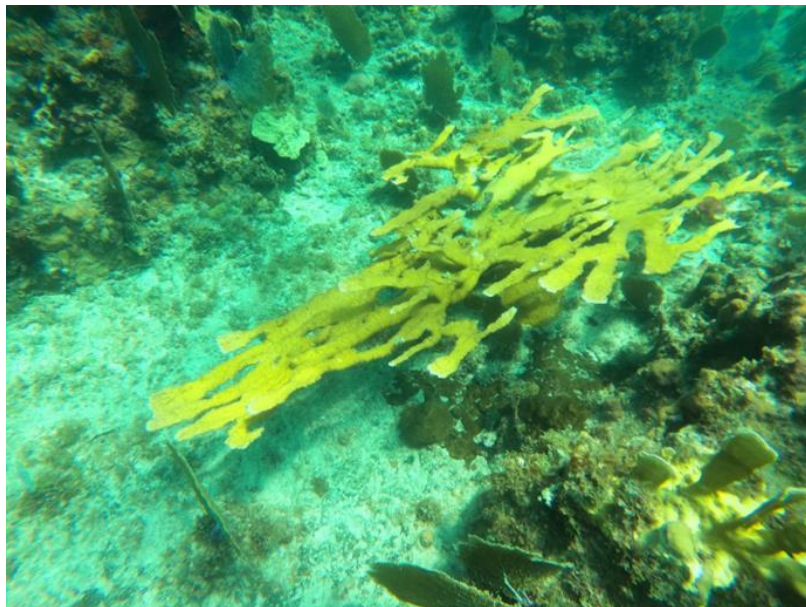
Plate 5-60 *Acropora palmata* colonies

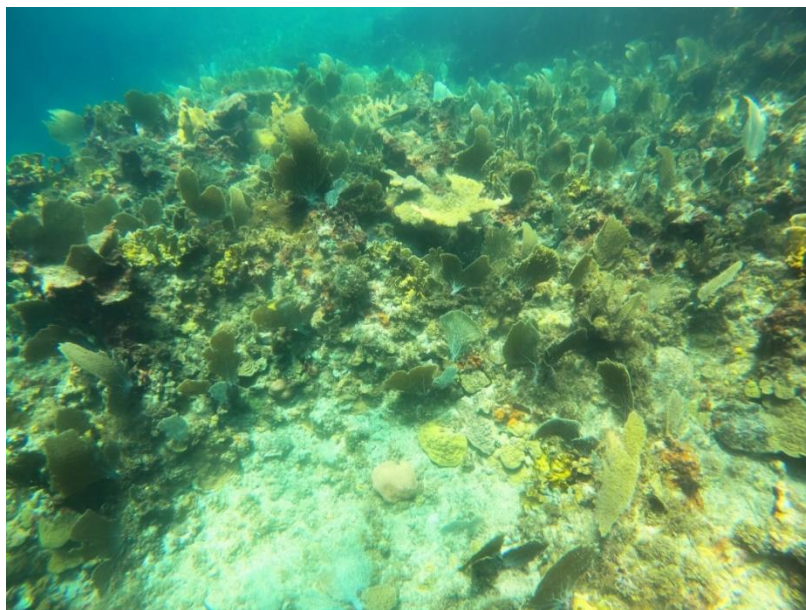
Plate 5-61 *Acropora palmata* colonies and numerous sea fans

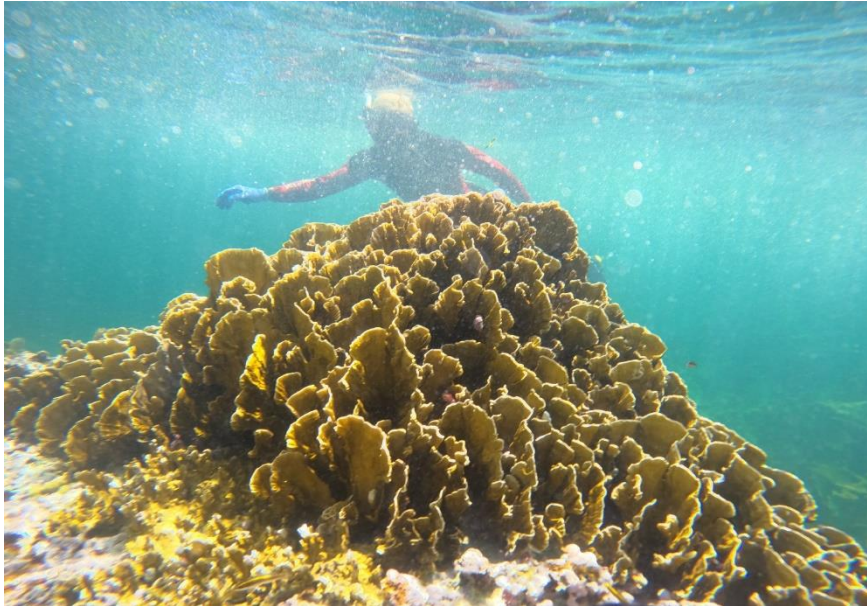
Plate 5-62 Large *Millepora* colony on the reef crest

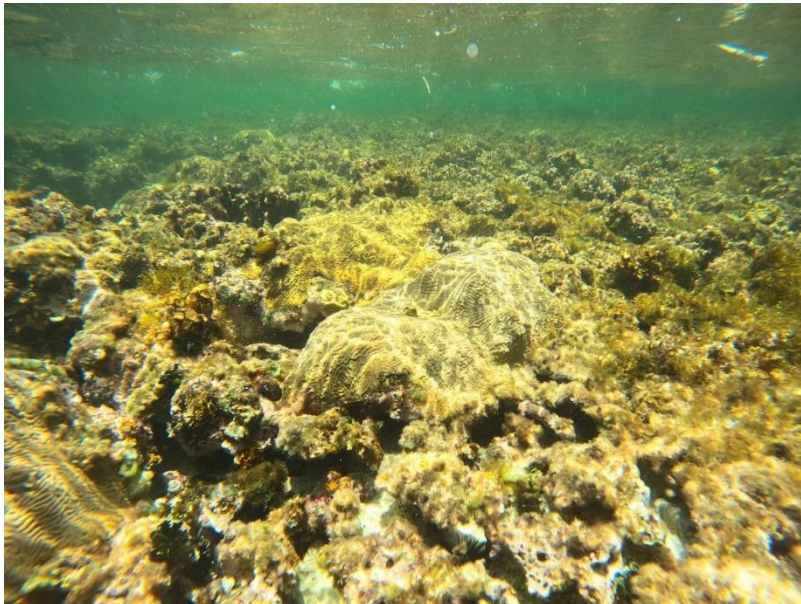
Plate 5-63 Large encrusting *Pseudodiploria* colonies

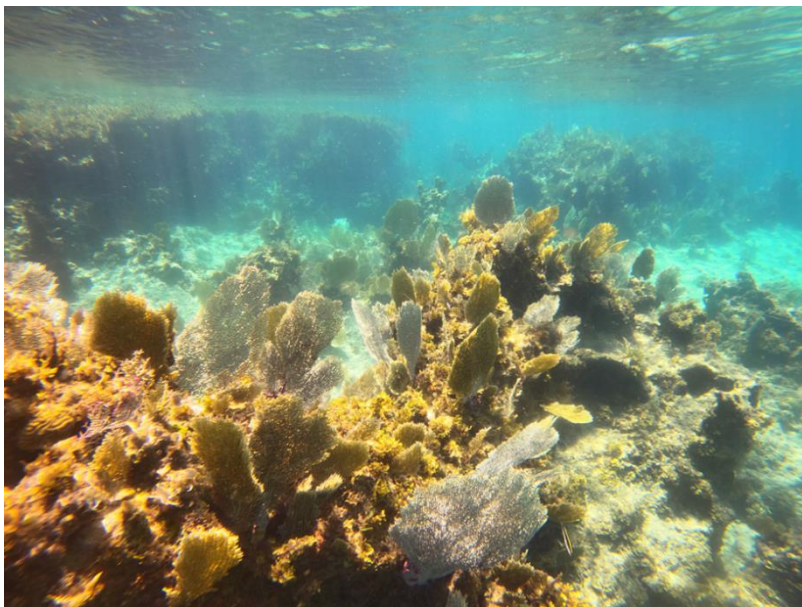
Plate 5-65 Dense Sea fan zone

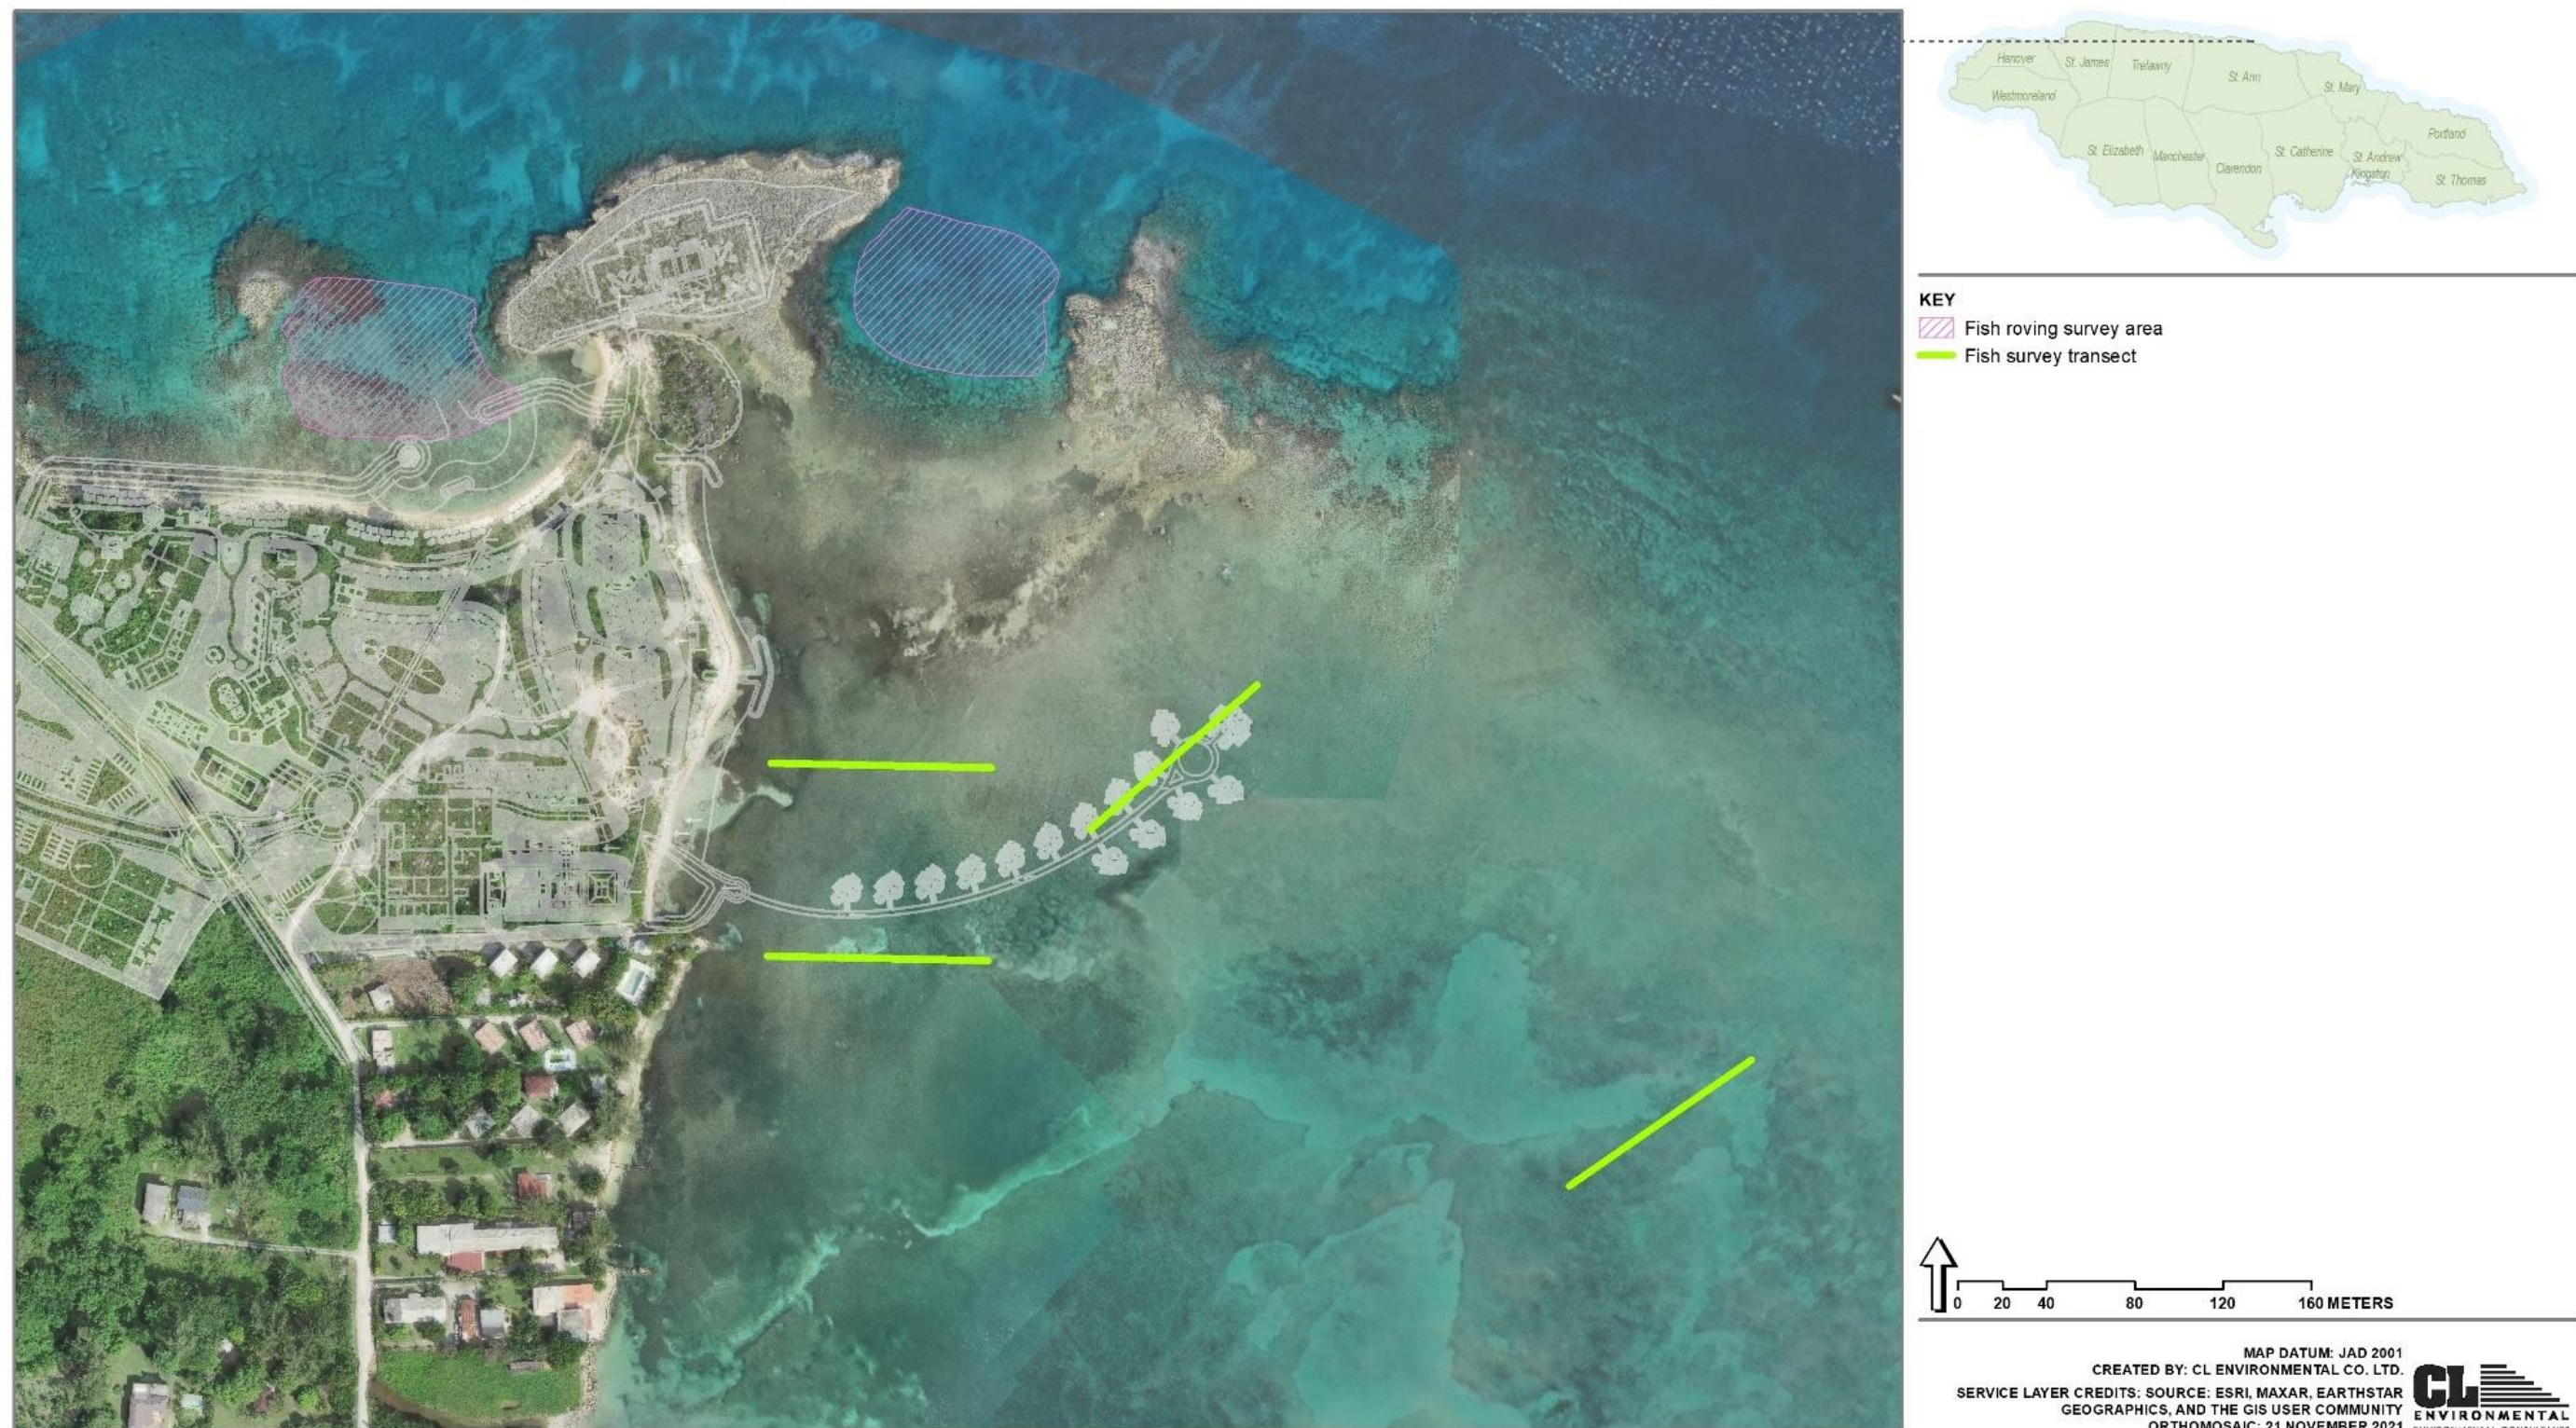
Figure 5-101 Roving and Fish Transect Survey Areas within the Eastern and Western Bays

Surveys were conducted within the Eastern Bay for fish, with surveys along transect lines and a roving survey within the bay, The four transect lines and roving survey areas can be seen below in Figure 5-101. No top predator species such as Barracuda, or invasive lionfish were observed during the Eastern Bay surveys.

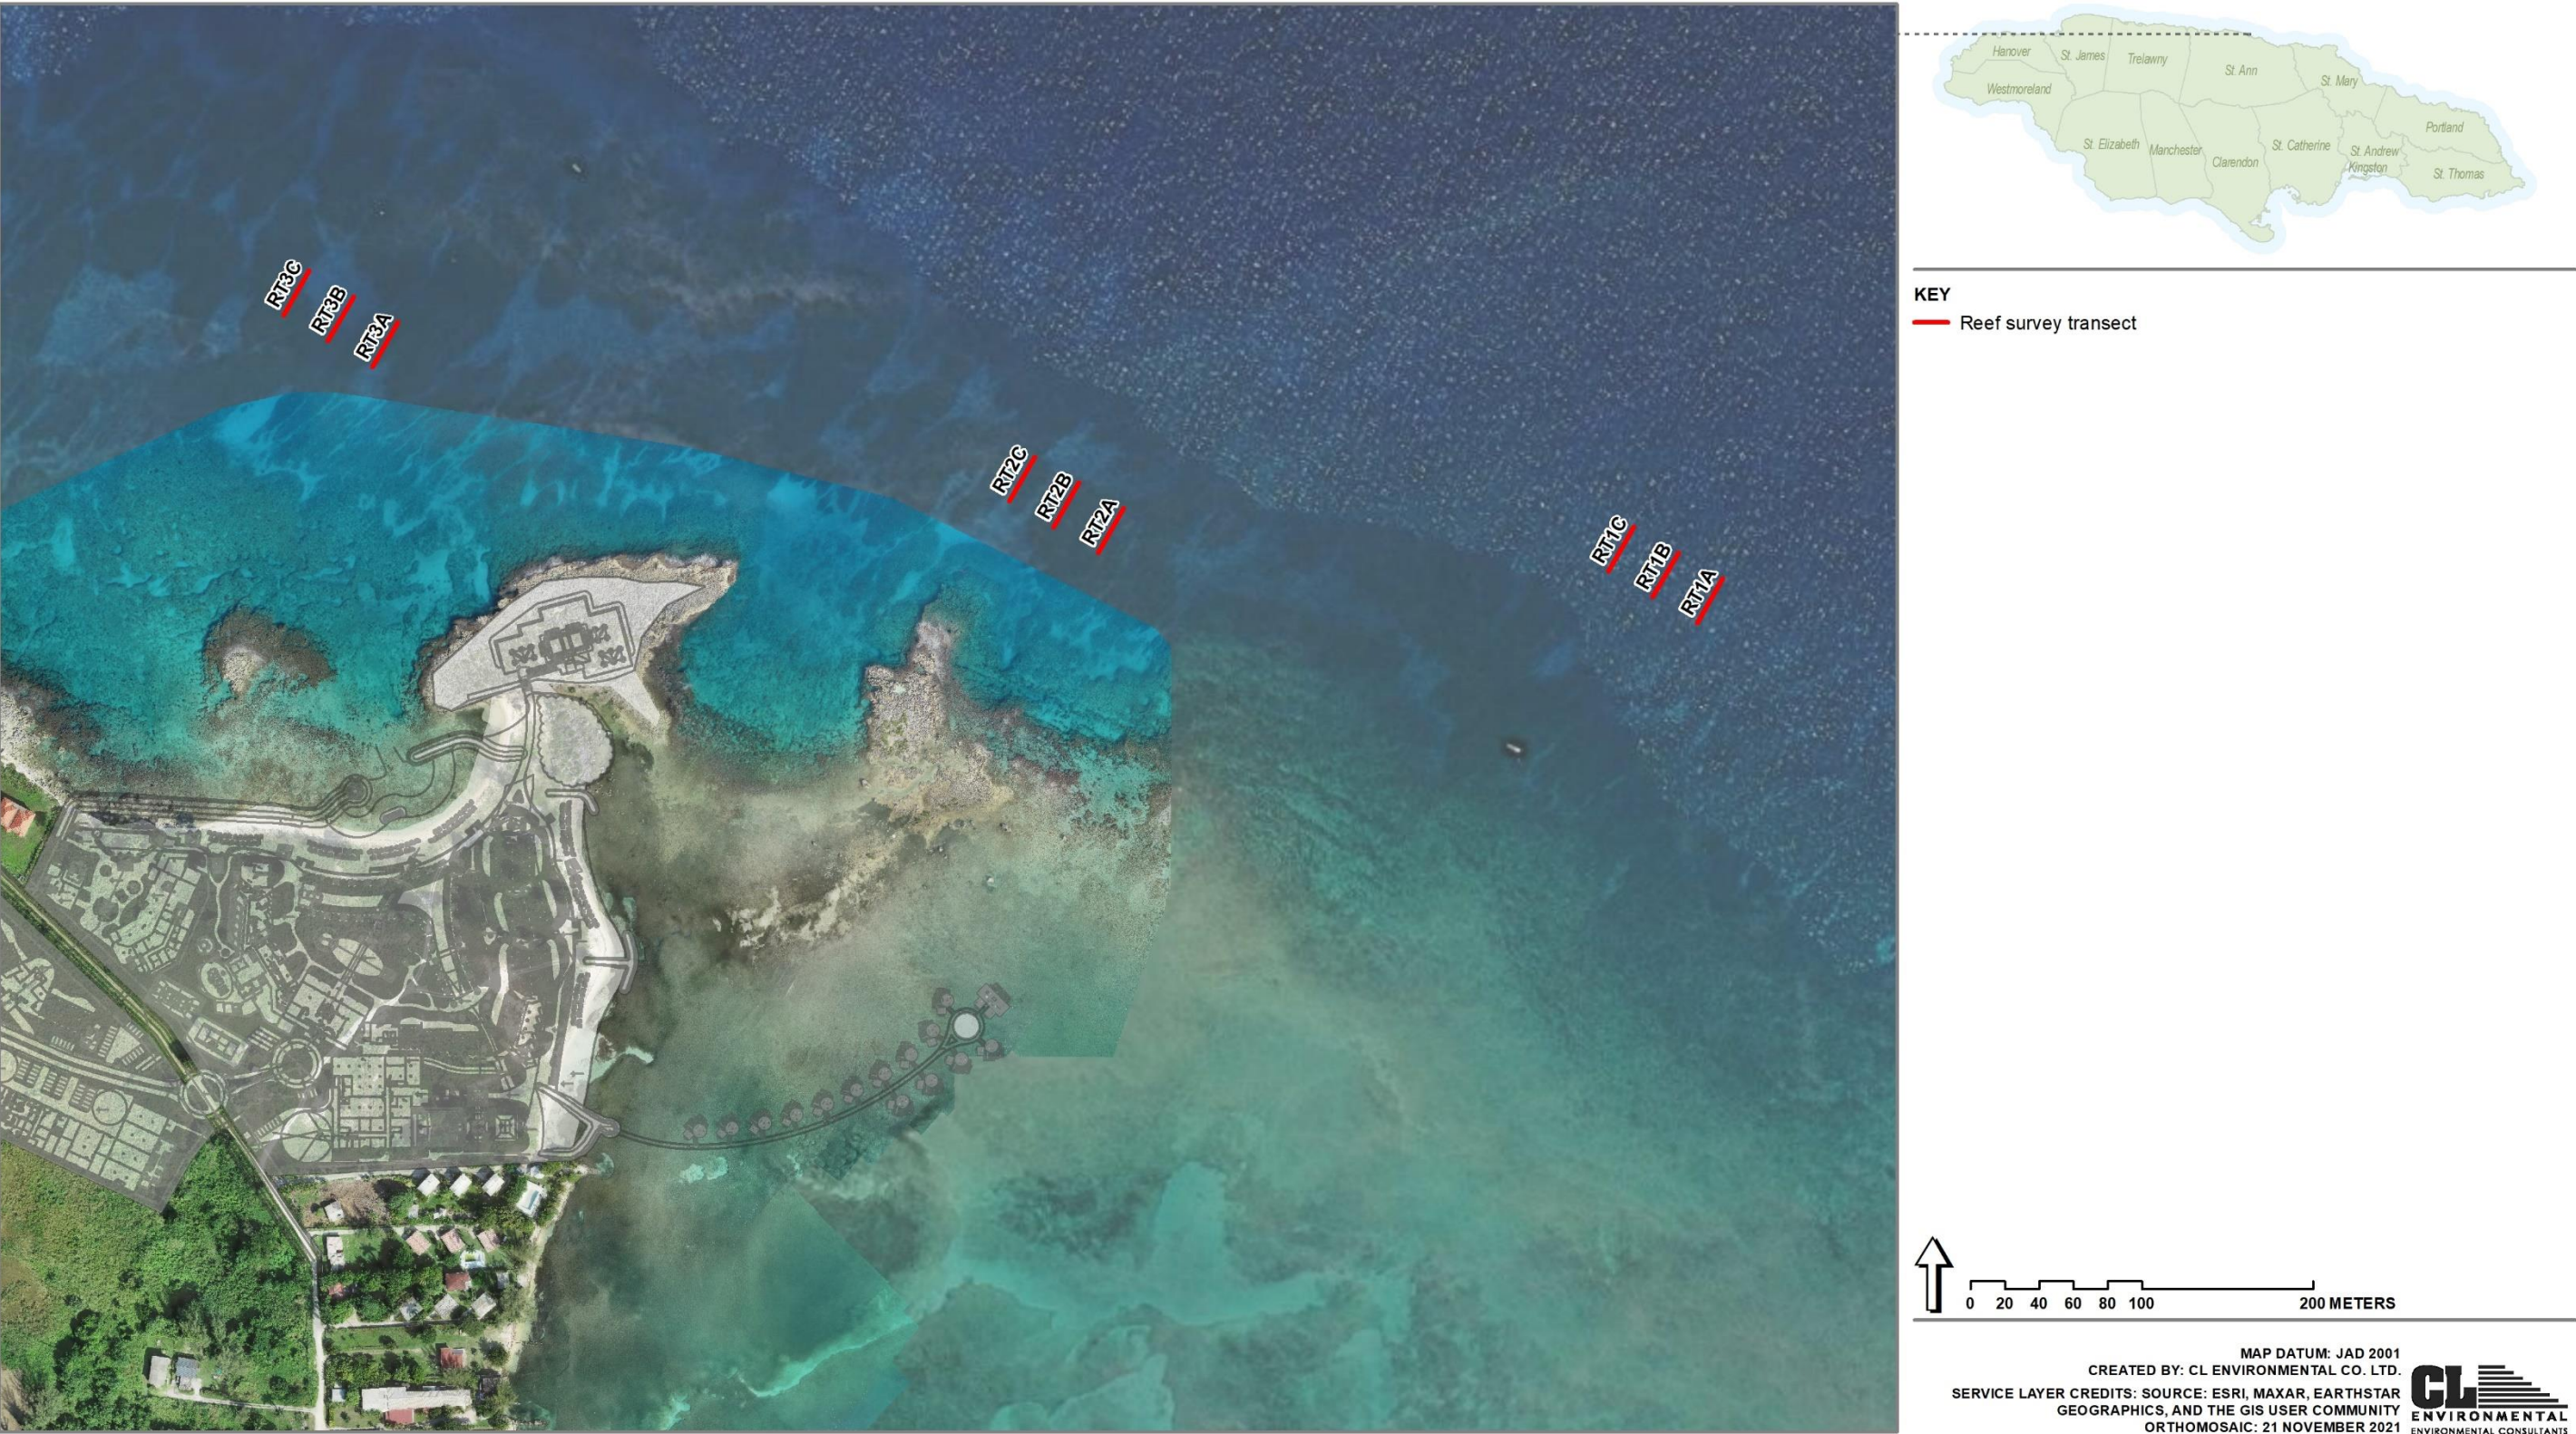
Figure 5-102 Reef Survey Locations

Three (3) reef survey sites were chosen, RT1 (eastern), RT-2 (central), and RT-3 (western) shown in Figure 5-102. Each of the sample sites had three, 30 metre transect lines, each run along sections of the reef to avoid large sand patches and high-low relief variations. Along each 30m transect line, photos were taken every 3 meters using a 1 m² quadrat, totalling 10 photos per transect, giving a total of 30 photos per site.

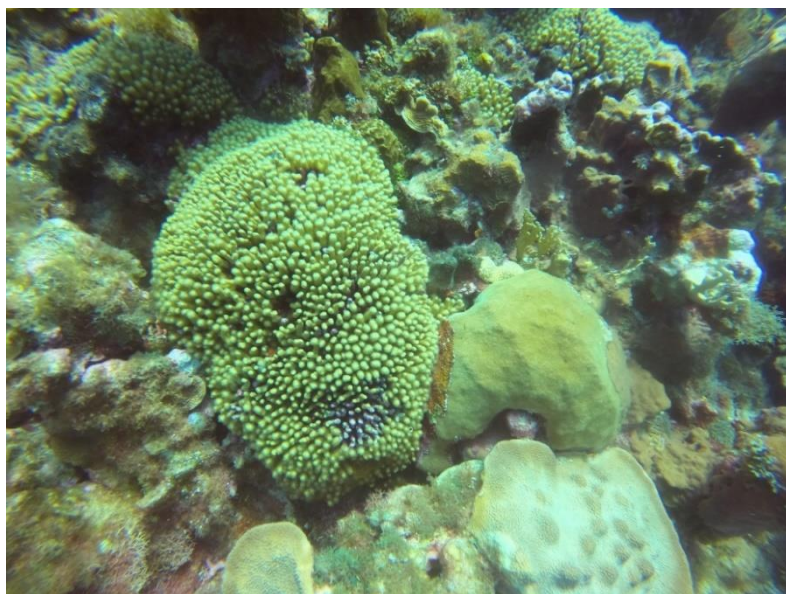
Plate 5-67 Large bouquet of Madracis

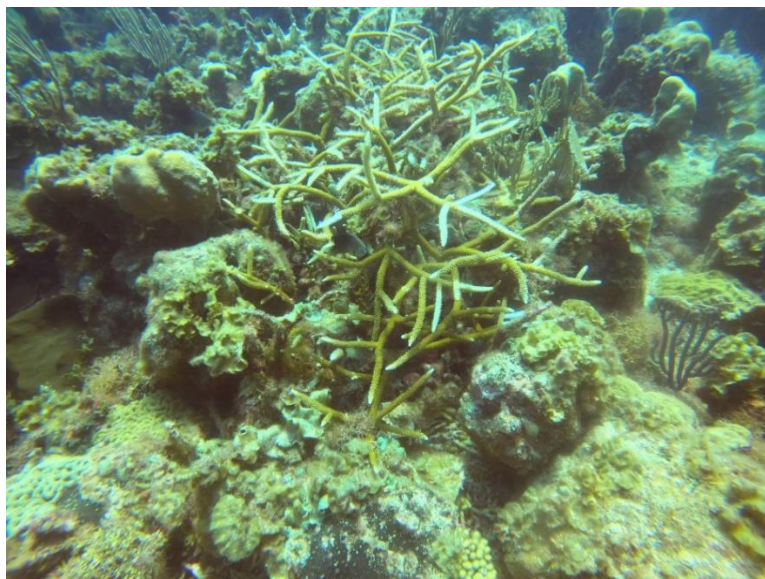
Plate 5-68 Thicket of *A. cervicornis*

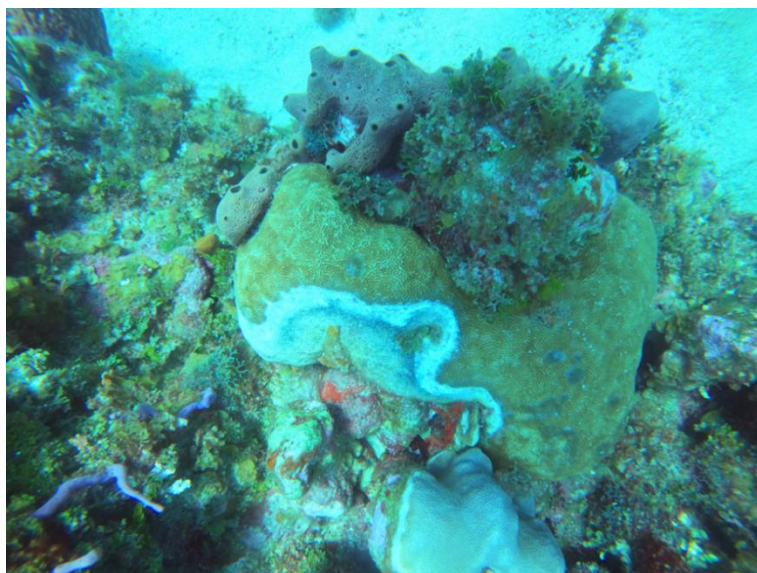
Plate 5-69 Diseased colony outside the transect area

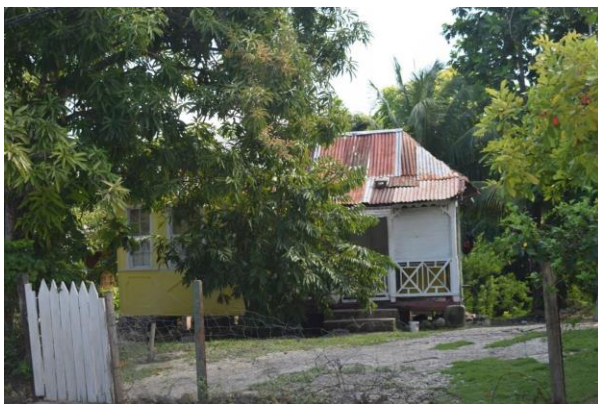
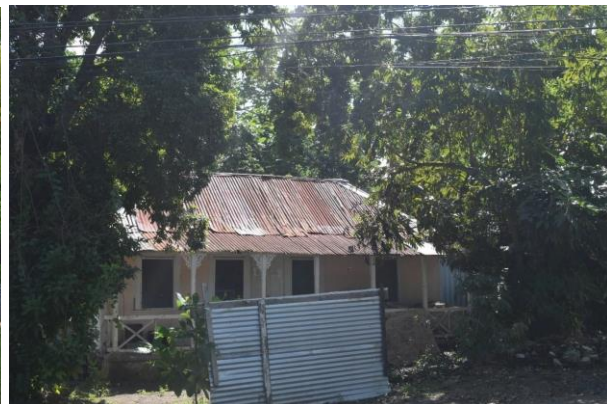
Two vernacular houses were also identified in Priory (Plate 5-81). These houses form an important part of Jamaica's architectural heritage. They are made with hip roofs, wooden flooring fretwork for decoration, sash and French windows. This kind of housing is not being constructed anymore and must be preserved.

Plate 5-81 Showing two vernacular houses with hip roofing, verandah, wooden rails, sash windows and wooden doors

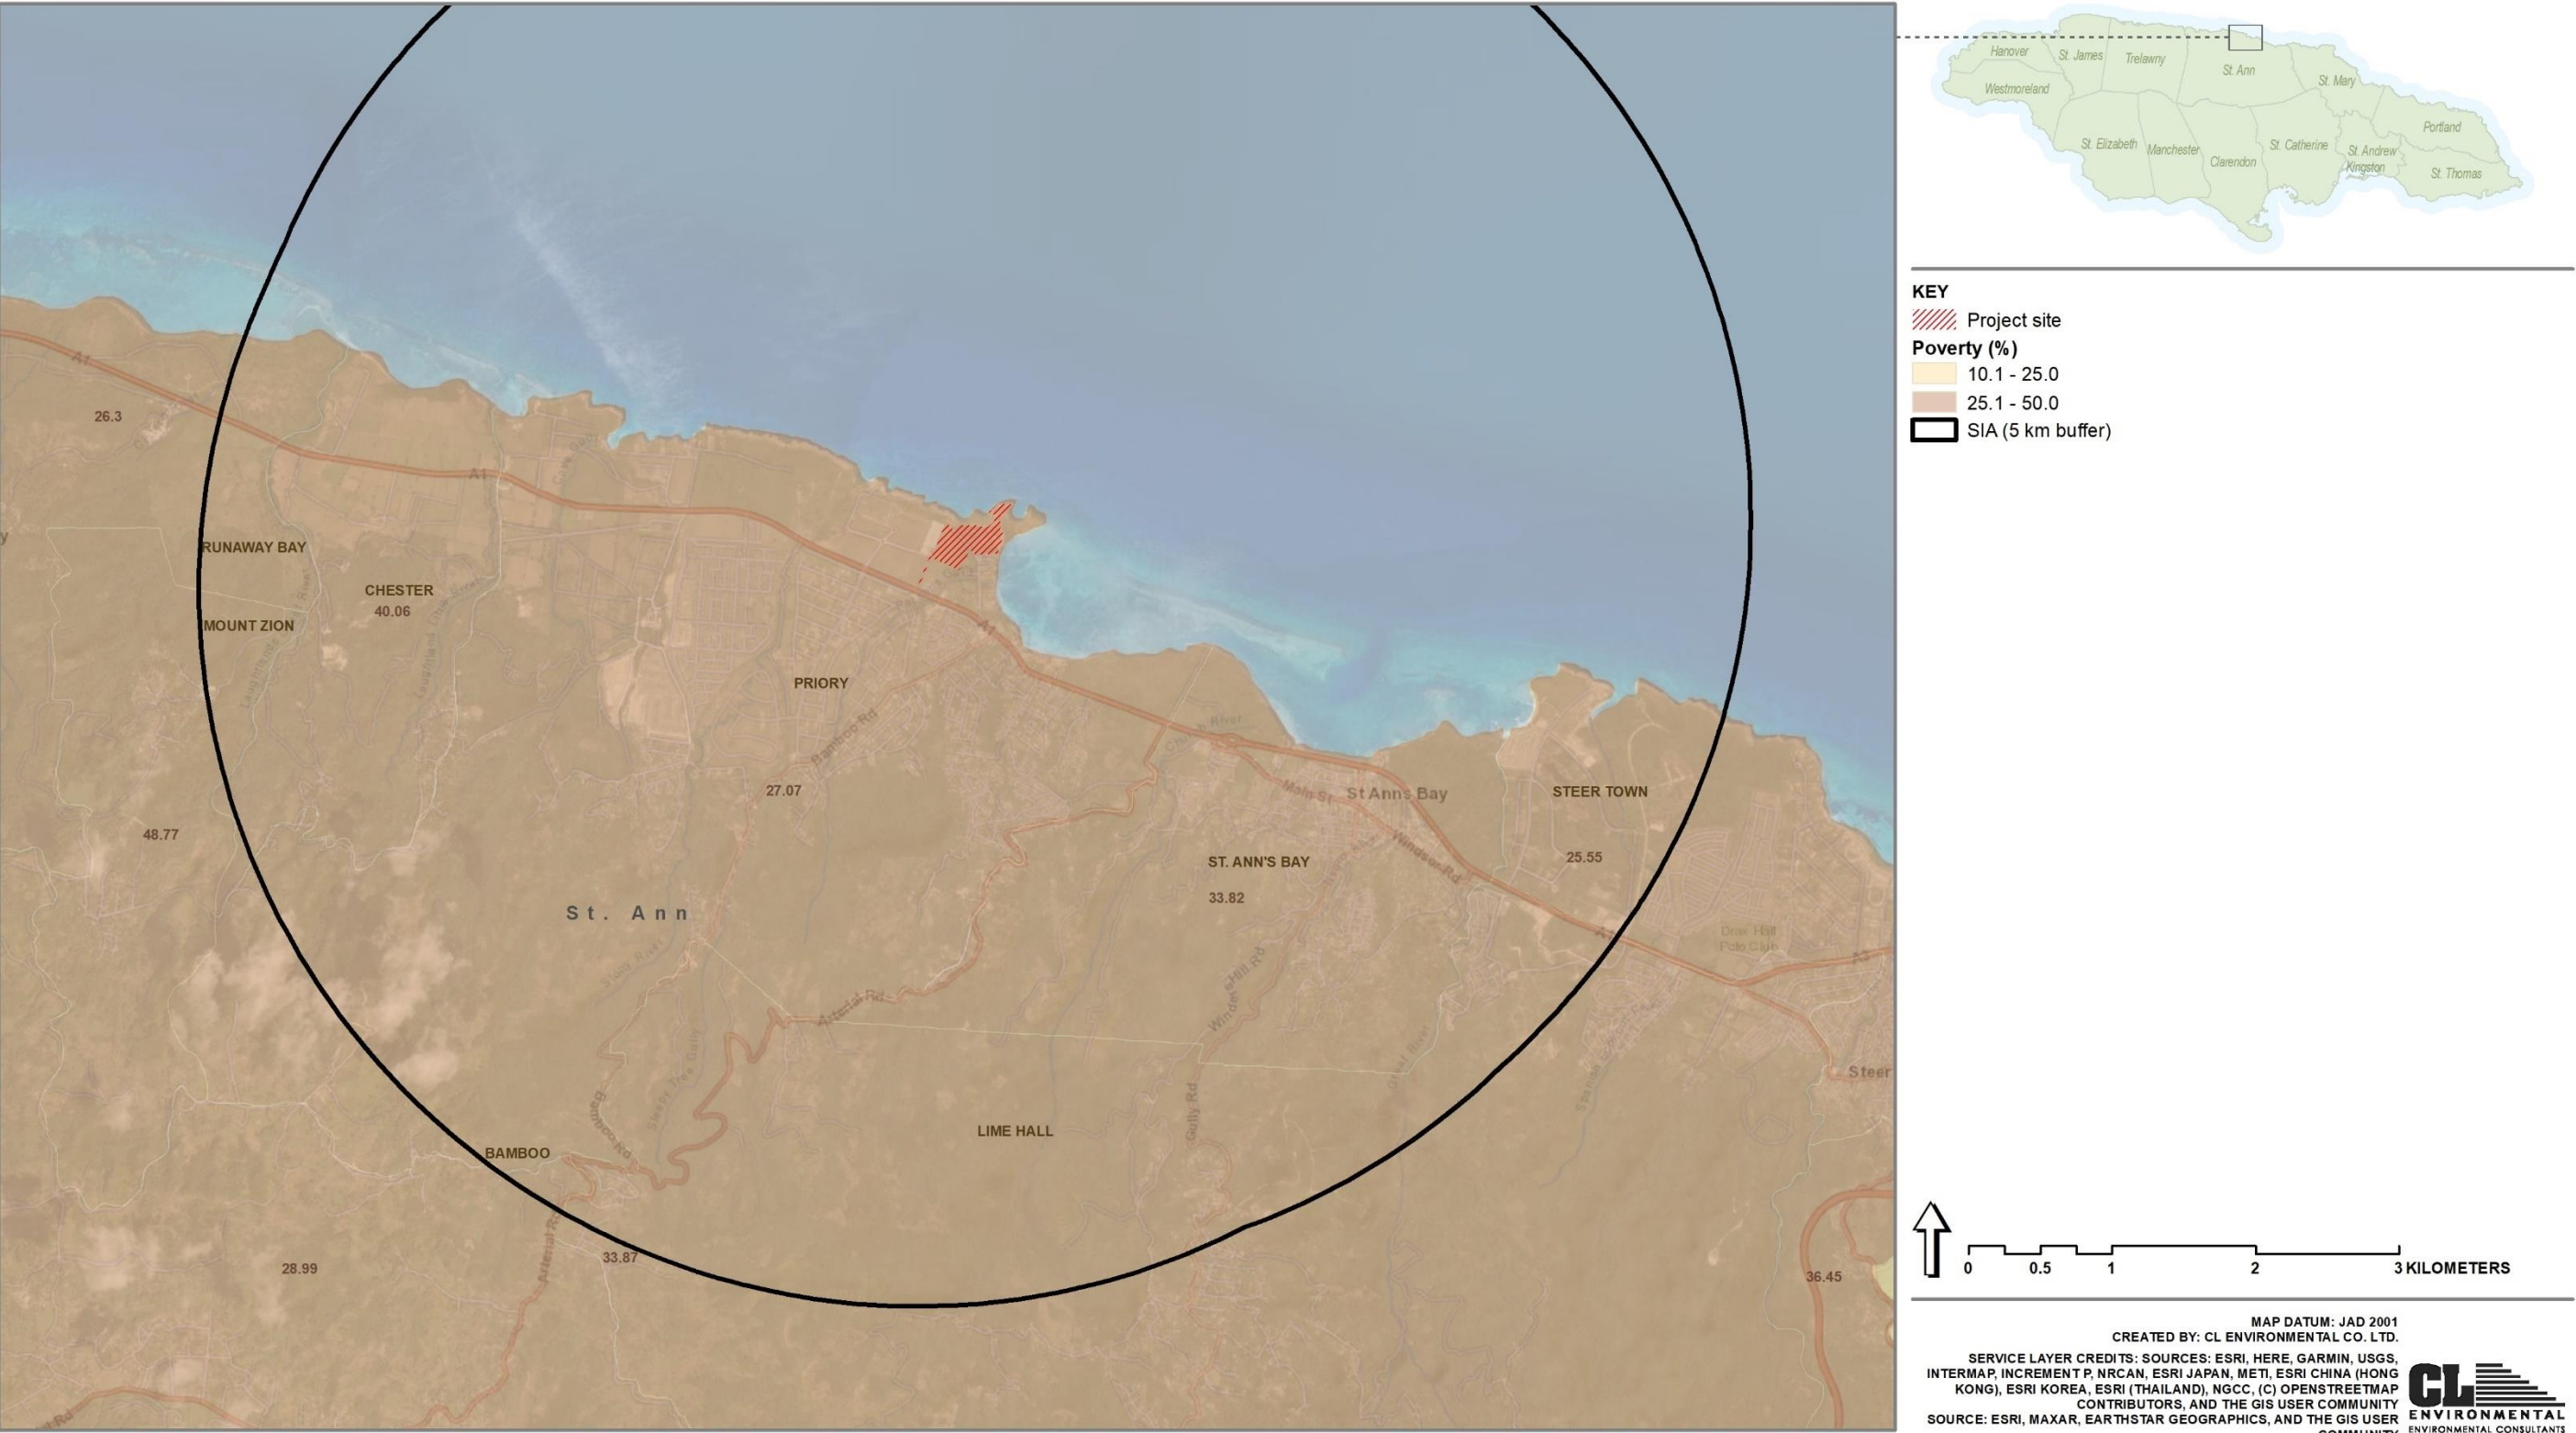
Data source: PIOJ (with contributions from STATIN, SDC and the University of Technology)
Figure 5-135 Proportion of persons in poverty in each community within the SIA

The SIA population has poverty levels between 25.55% and 48.77% of persons living in poverty (Figure 5-135).
