ENVIRONMENTAL IMPACT ASSESSMENT

HOTEL DEVELOPMENT AT PART OF RICHMOND ESTATES, ST. ANN BY SECRETS RESORTS AND SPA

Report Version: **FINAL v2.0**

Date: **March 2023**

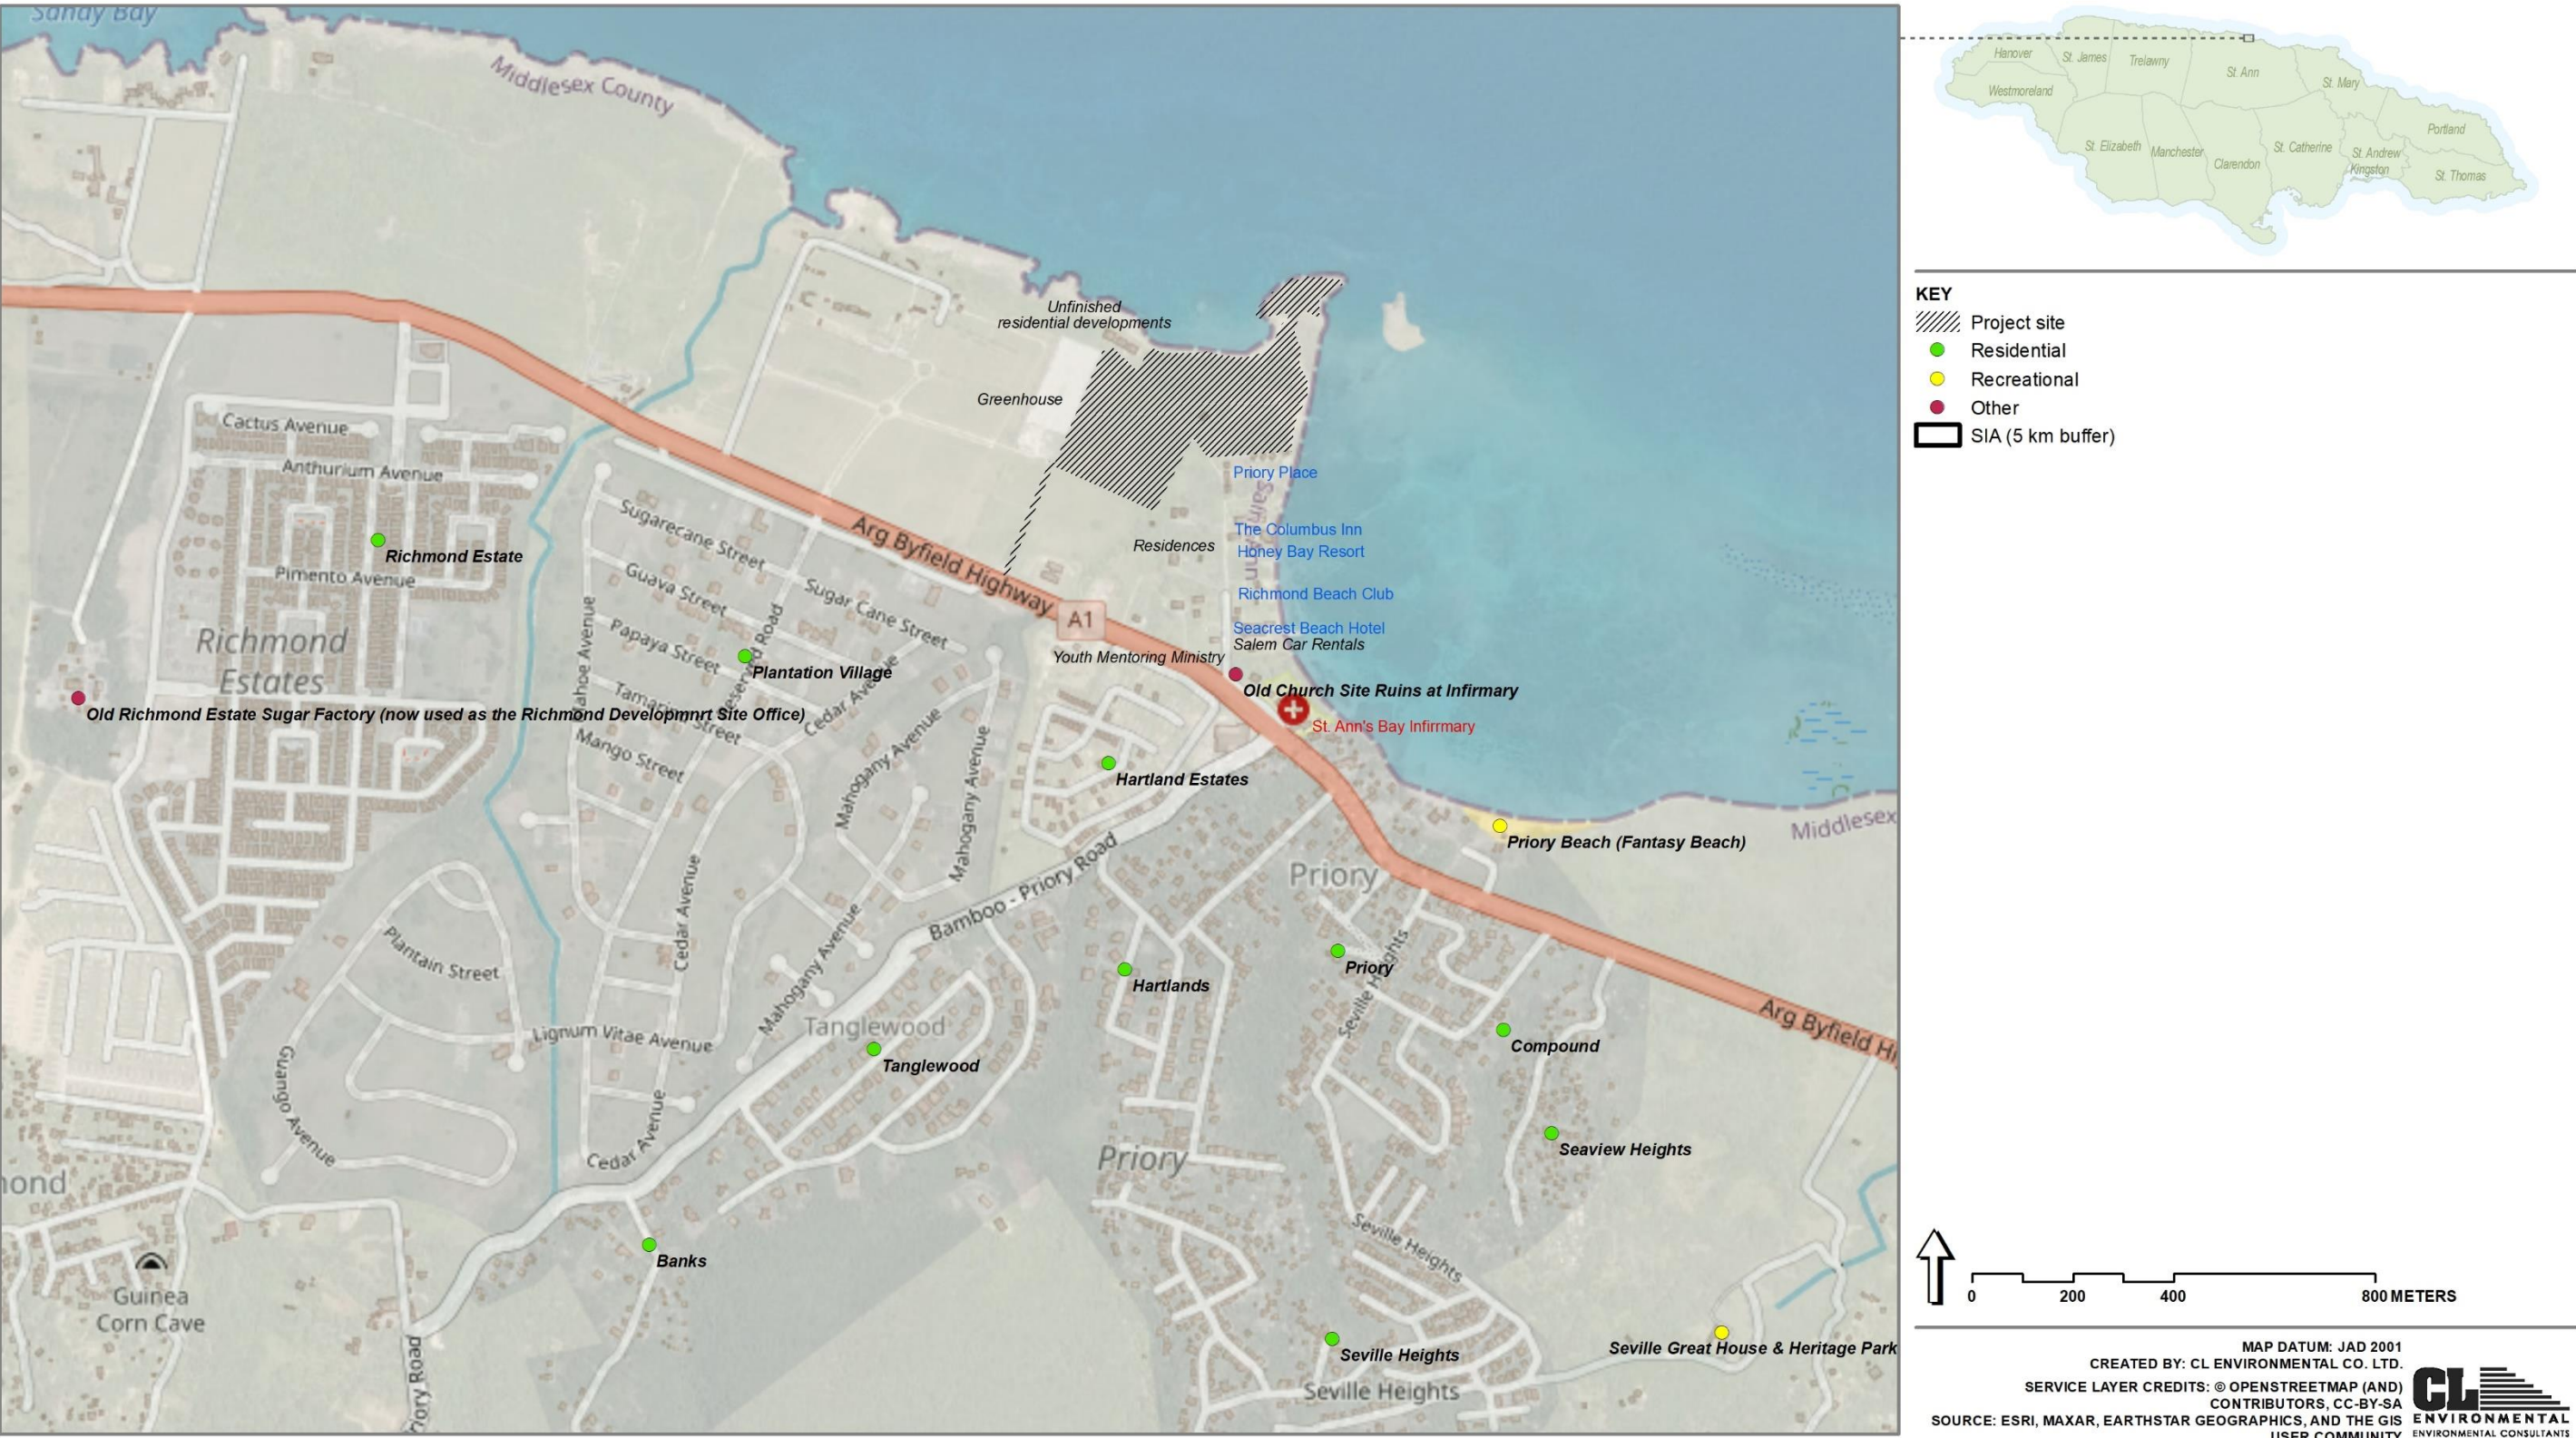
Figure 5-149 Land use in proximity to the project site

Land cover within the SIA consists of buildings and other infrastructure, disturbed broadleaved forest, secondary forest and fields, and plantation (crops) (Figure 5-148). The ARG Byfield leg of the A1 highway is part of the north coast corridor and links various residential communities in the Richmond and Priory area with the commercial town of St. Ann's Bay, about 3 km east of the project. The residential communities are primarily located on the southern side of the main road and include Richmond Estates, Plantation Village and Hartland Estates (Figure 5-149).

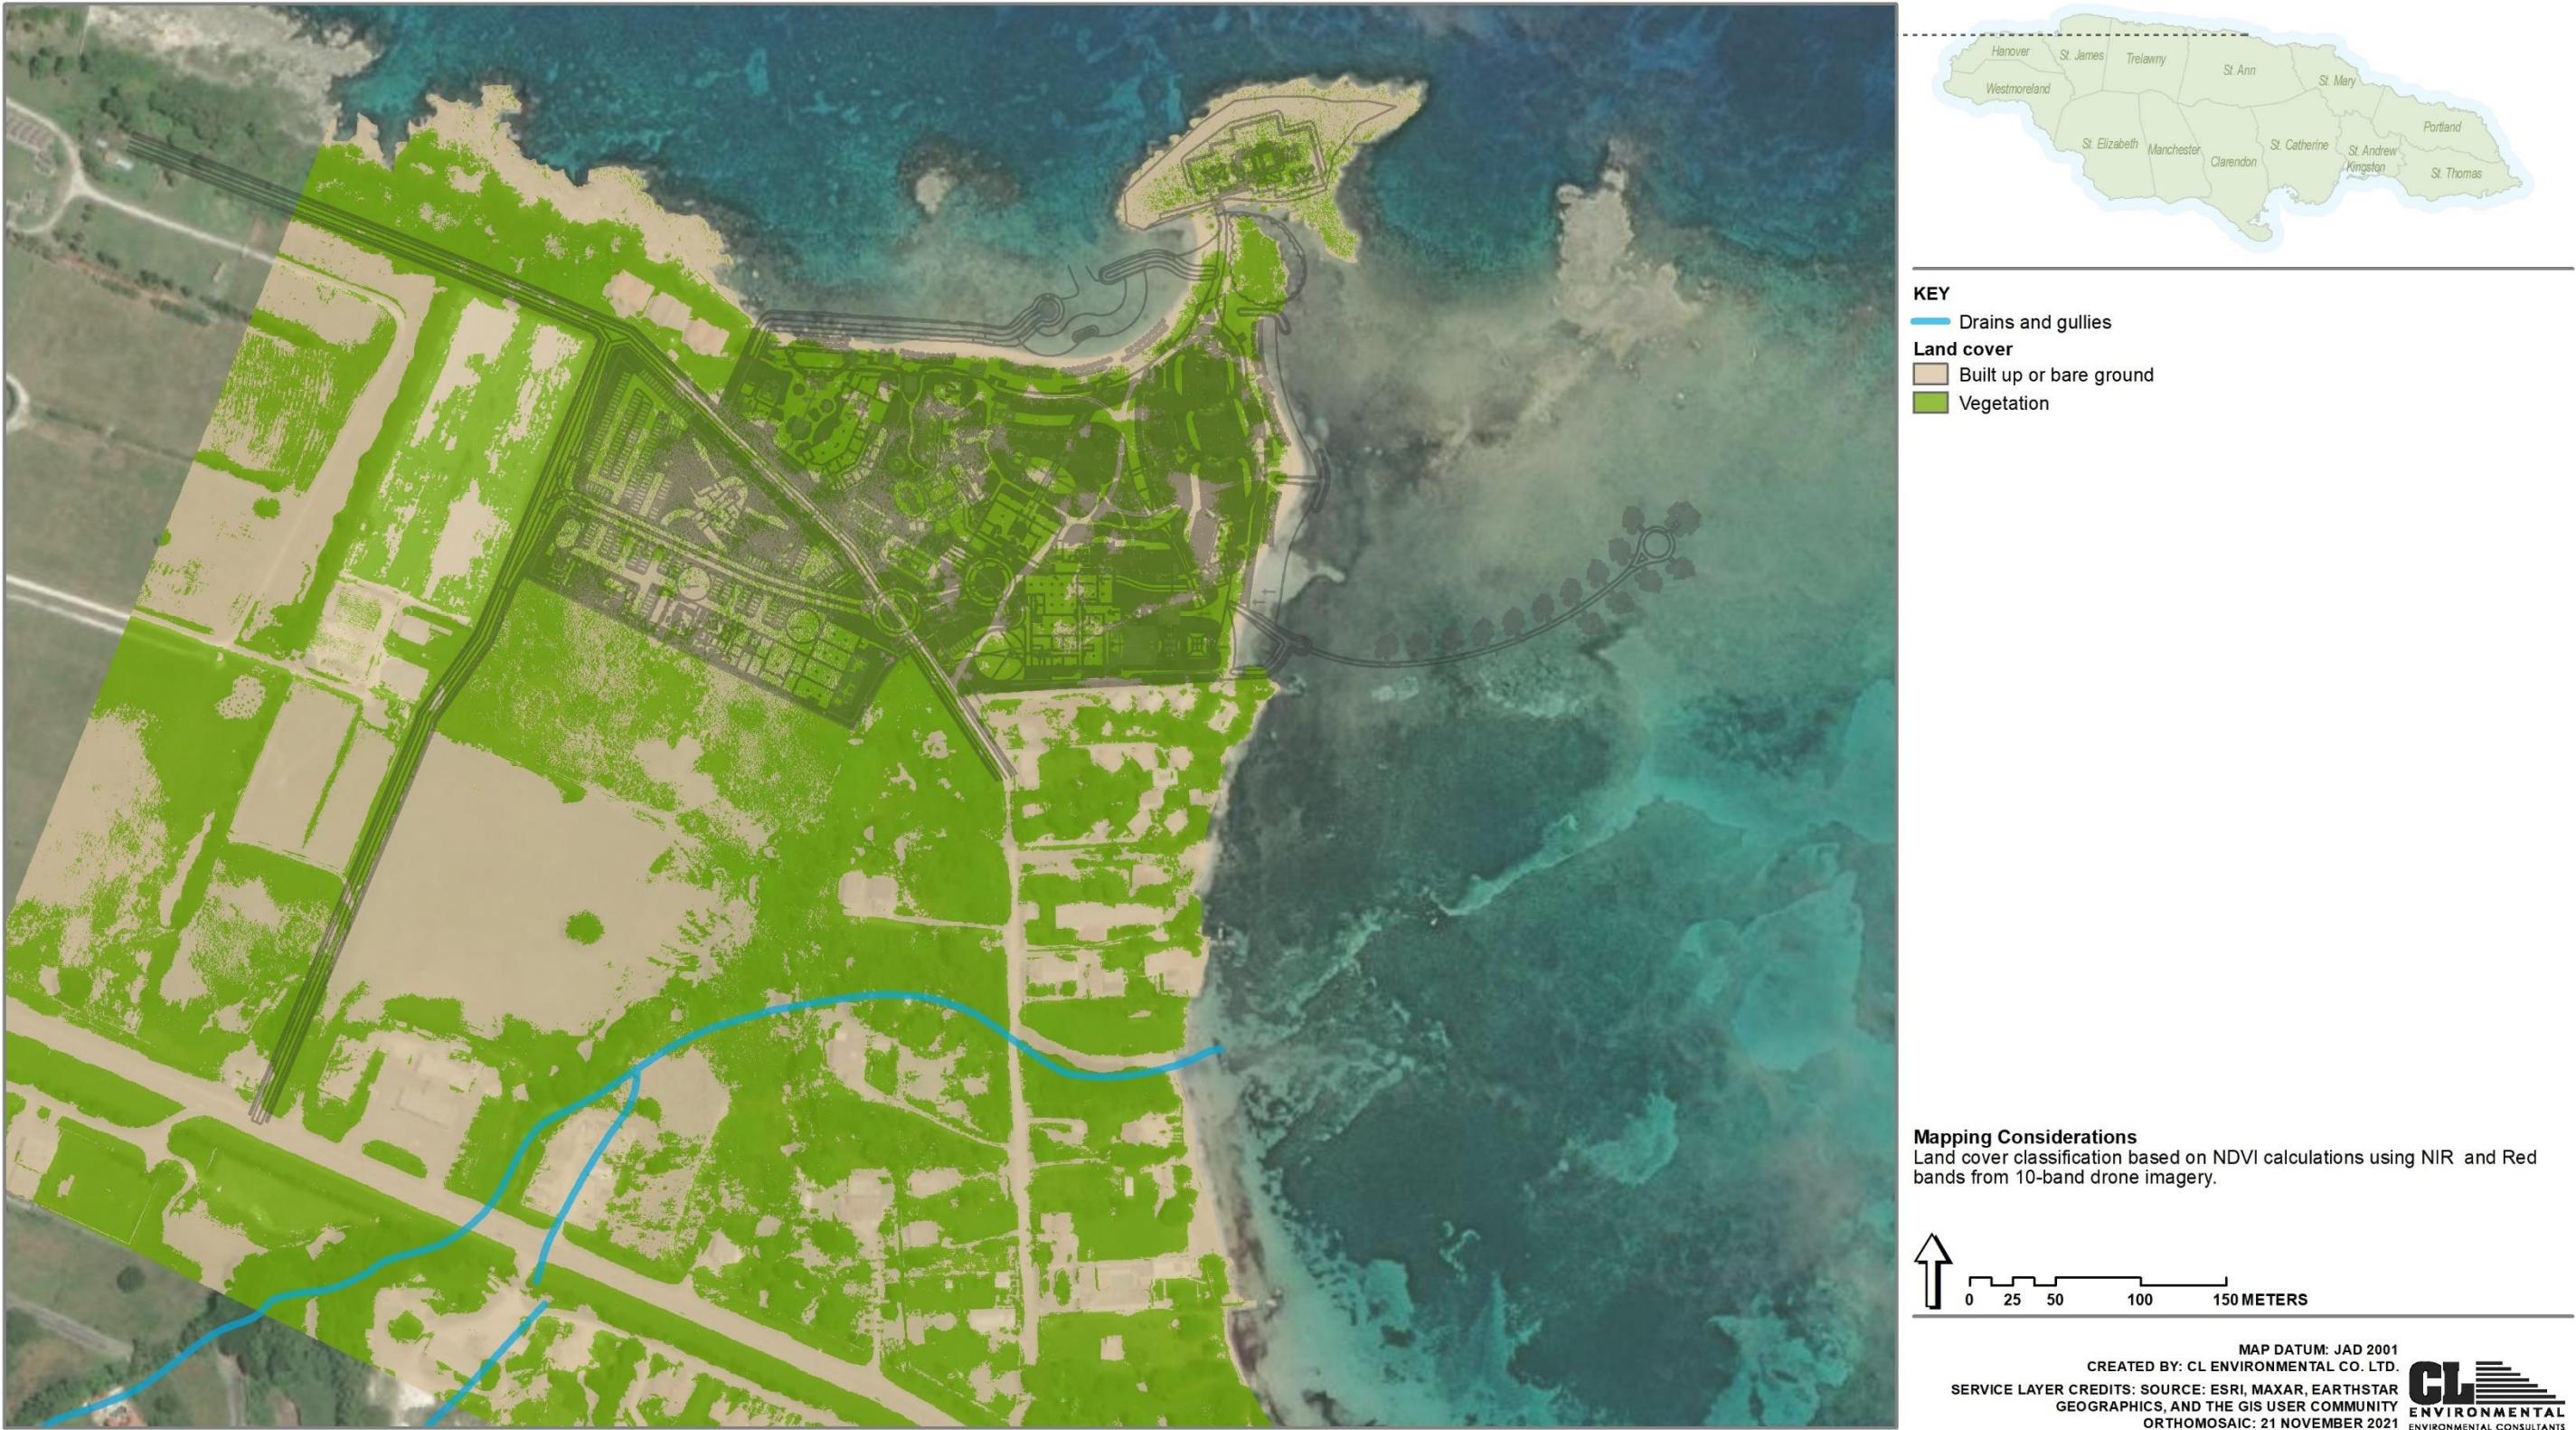
Figure 5-151 Land cover classification at the project site

At the project site, vegetation is the dominant land cover (Figure 5-151). The overall classification is described as open fields, consisting primarily of trees and shrubs with some grasses, as well as coastal vegetation along the coastline with patches of mangroves to the north and southeast of the property. Two bays exist, a smaller west bay and larger eastern bay, both possessing sandy beaches, actively used by turtles for nesting.

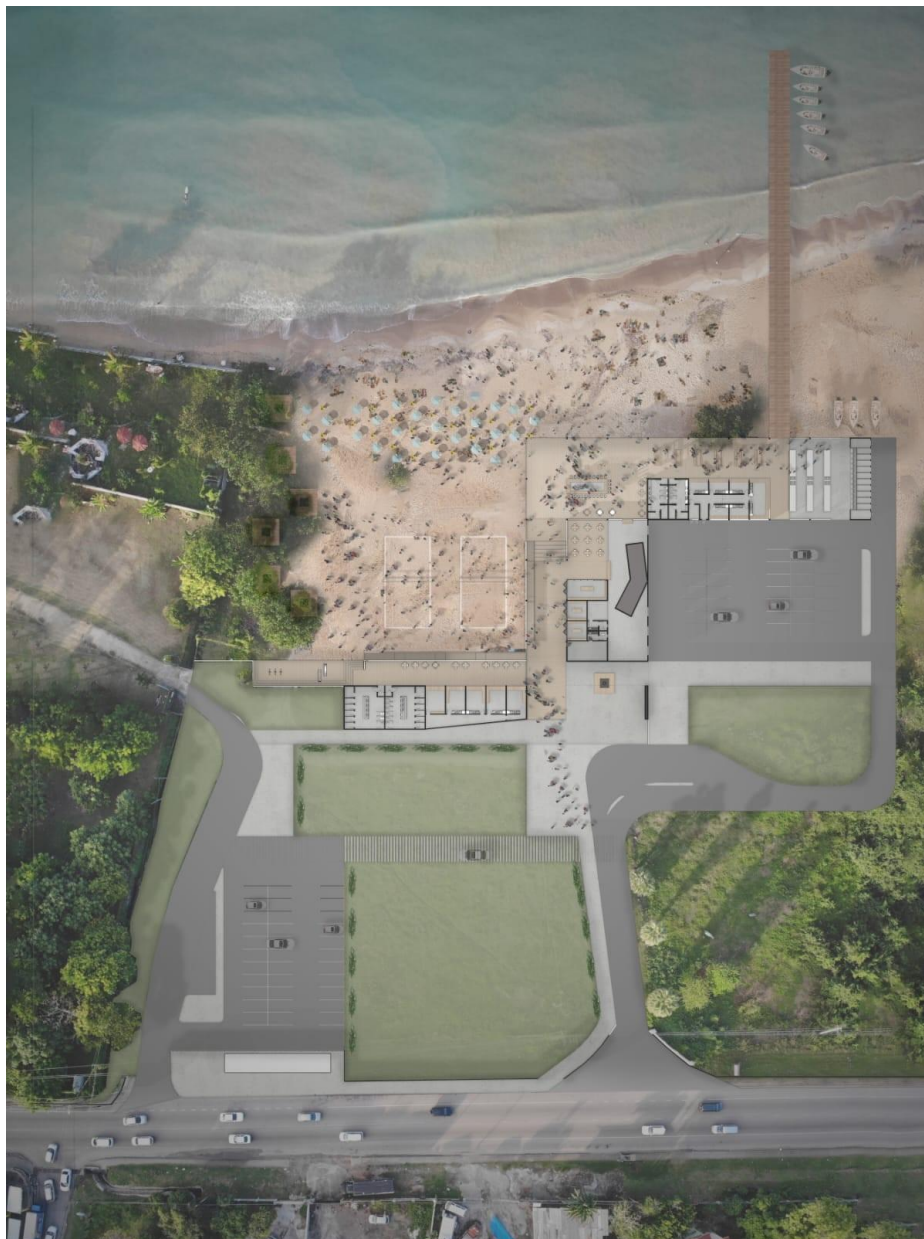
Figure 5-152 Proposed redevelopment of Priory Beach (plan view)

- **Renovation of Priory Beach** – The redevelopment of Priory Beach, located approximately 1 km southeast of the project site (Figure 5-152 and Figure 5-153), is a part of the Tourism Enhancement Fund's Beaches Programme and includes improvements to the beach facilities. It is the intention that the beach will remain accessible to residents and free-to-use (Jamaica Observer, 2022).

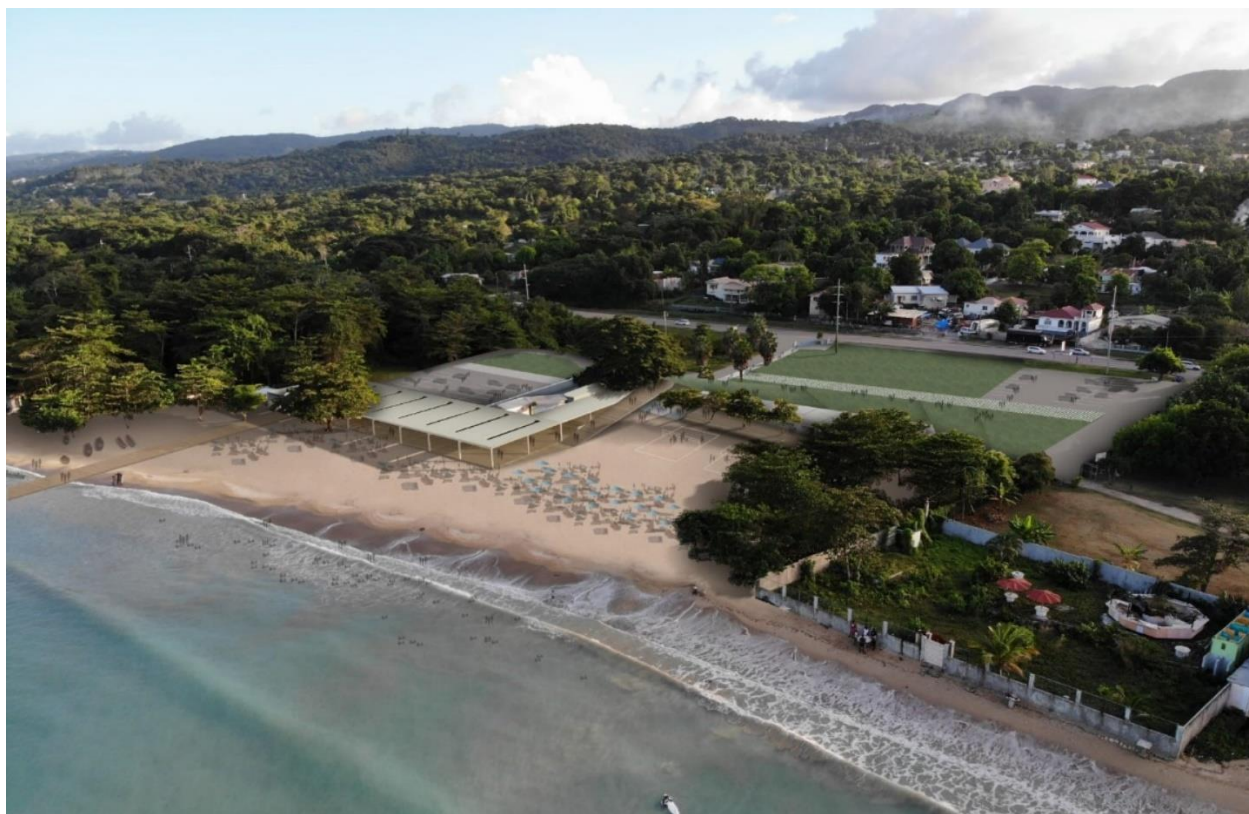
Figure 5-153 Proposed redevelopment of Priory Beach (3D view)

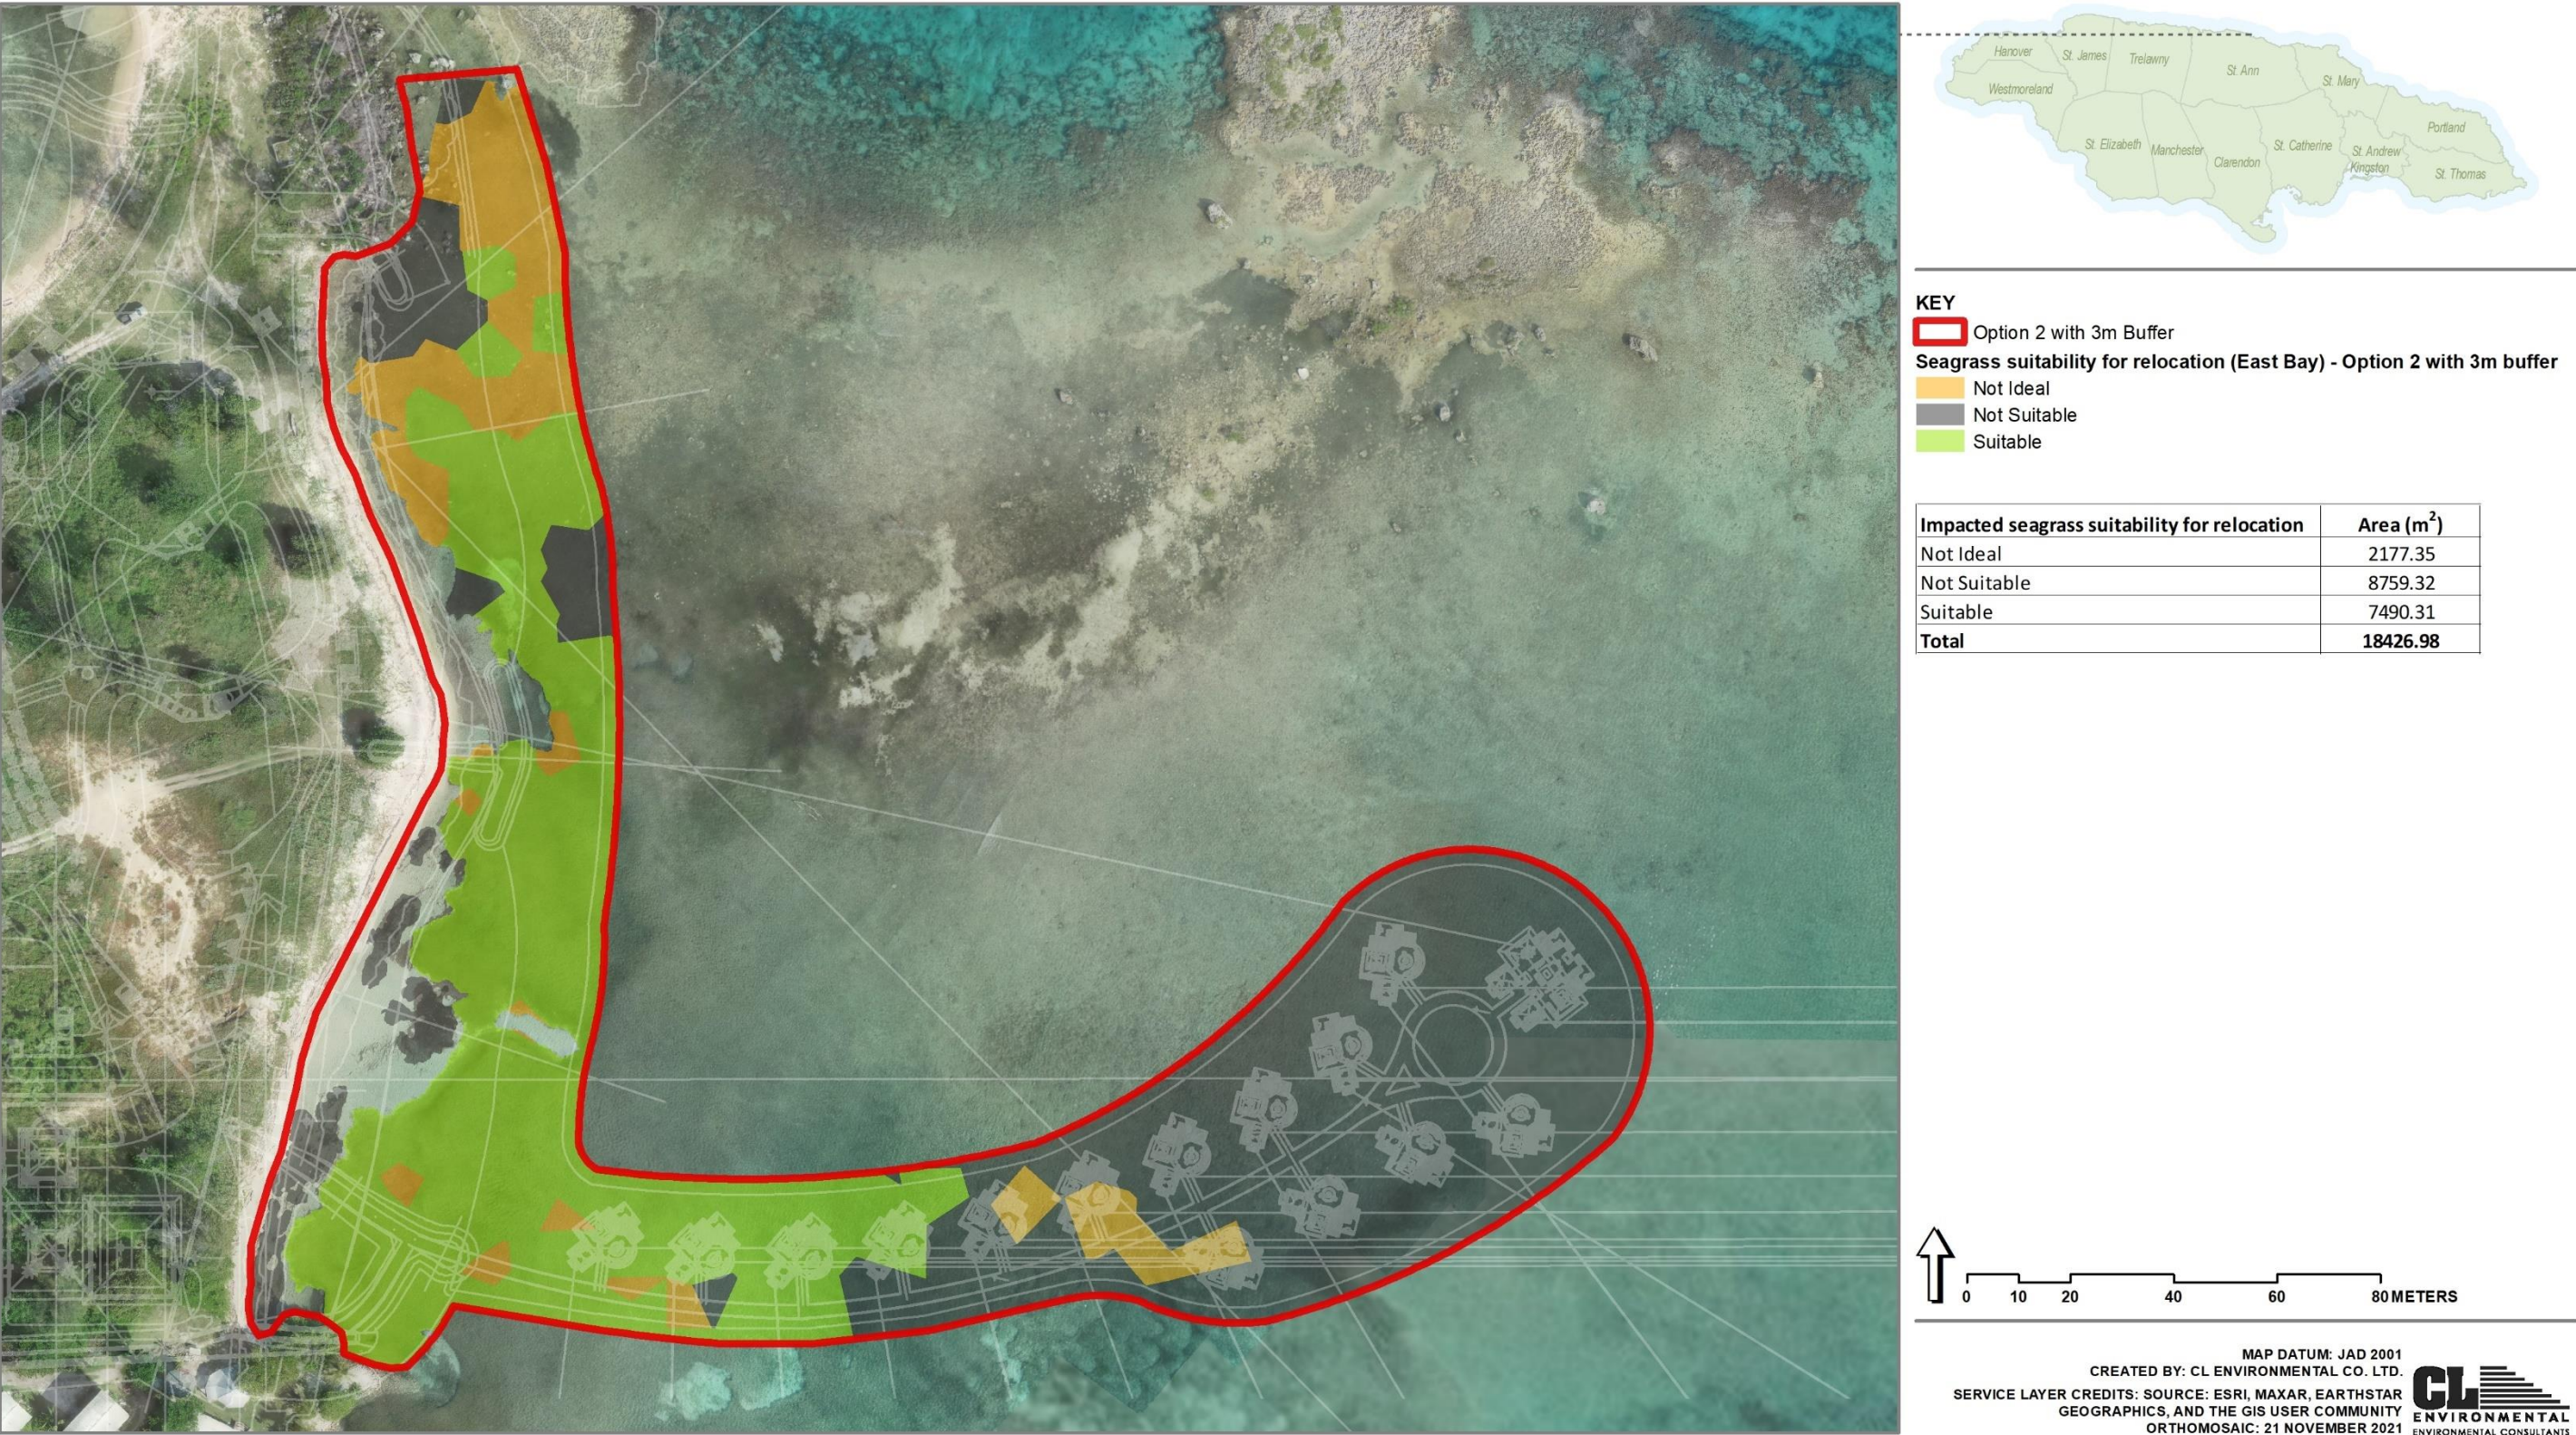
Figure 8-5 Alternative 7 Eastern Beach Impacted Seagrass and Relocation Suitability

The layout is illustrated in Figure 8-4, while Figure 8-5 illustrates Impacted Seagrass and Relocation Suitability.
