# ENVIRONMENTAL AND SOCIAL ASSESSMENT FOR PROPOSED HOUSING DEVELOPMENT- CORAL SPRING VILLAGE 2 TRELAWNY

Draft Final Report

**Prepared for:**

Gore Development Ltd.  
3 Braemar Avenue  
Kingston 5

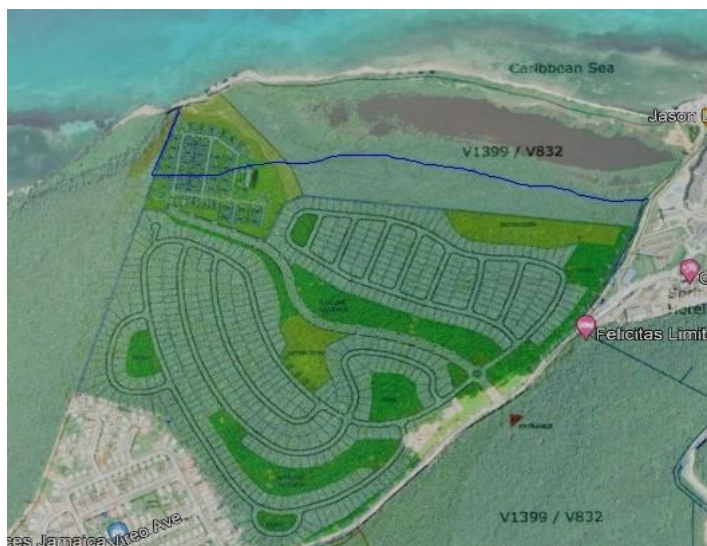
*Figure 1-1:(a) Preliminary subdivision plan with conservation overlay*

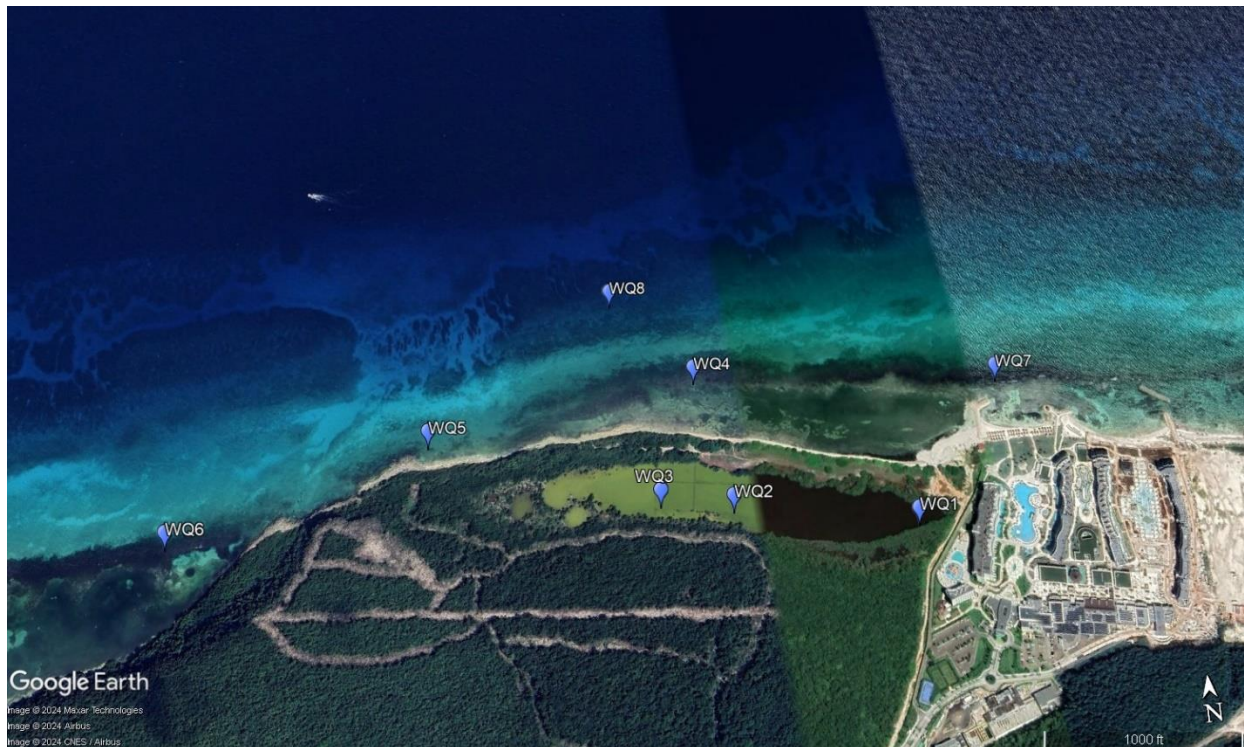
*Figure 1-5: Water Quality Assessment Points*

Sample locations are shown in Figure 1-5 below, while the findings and description of each water quality location sampled are presented in section 4.1.7..

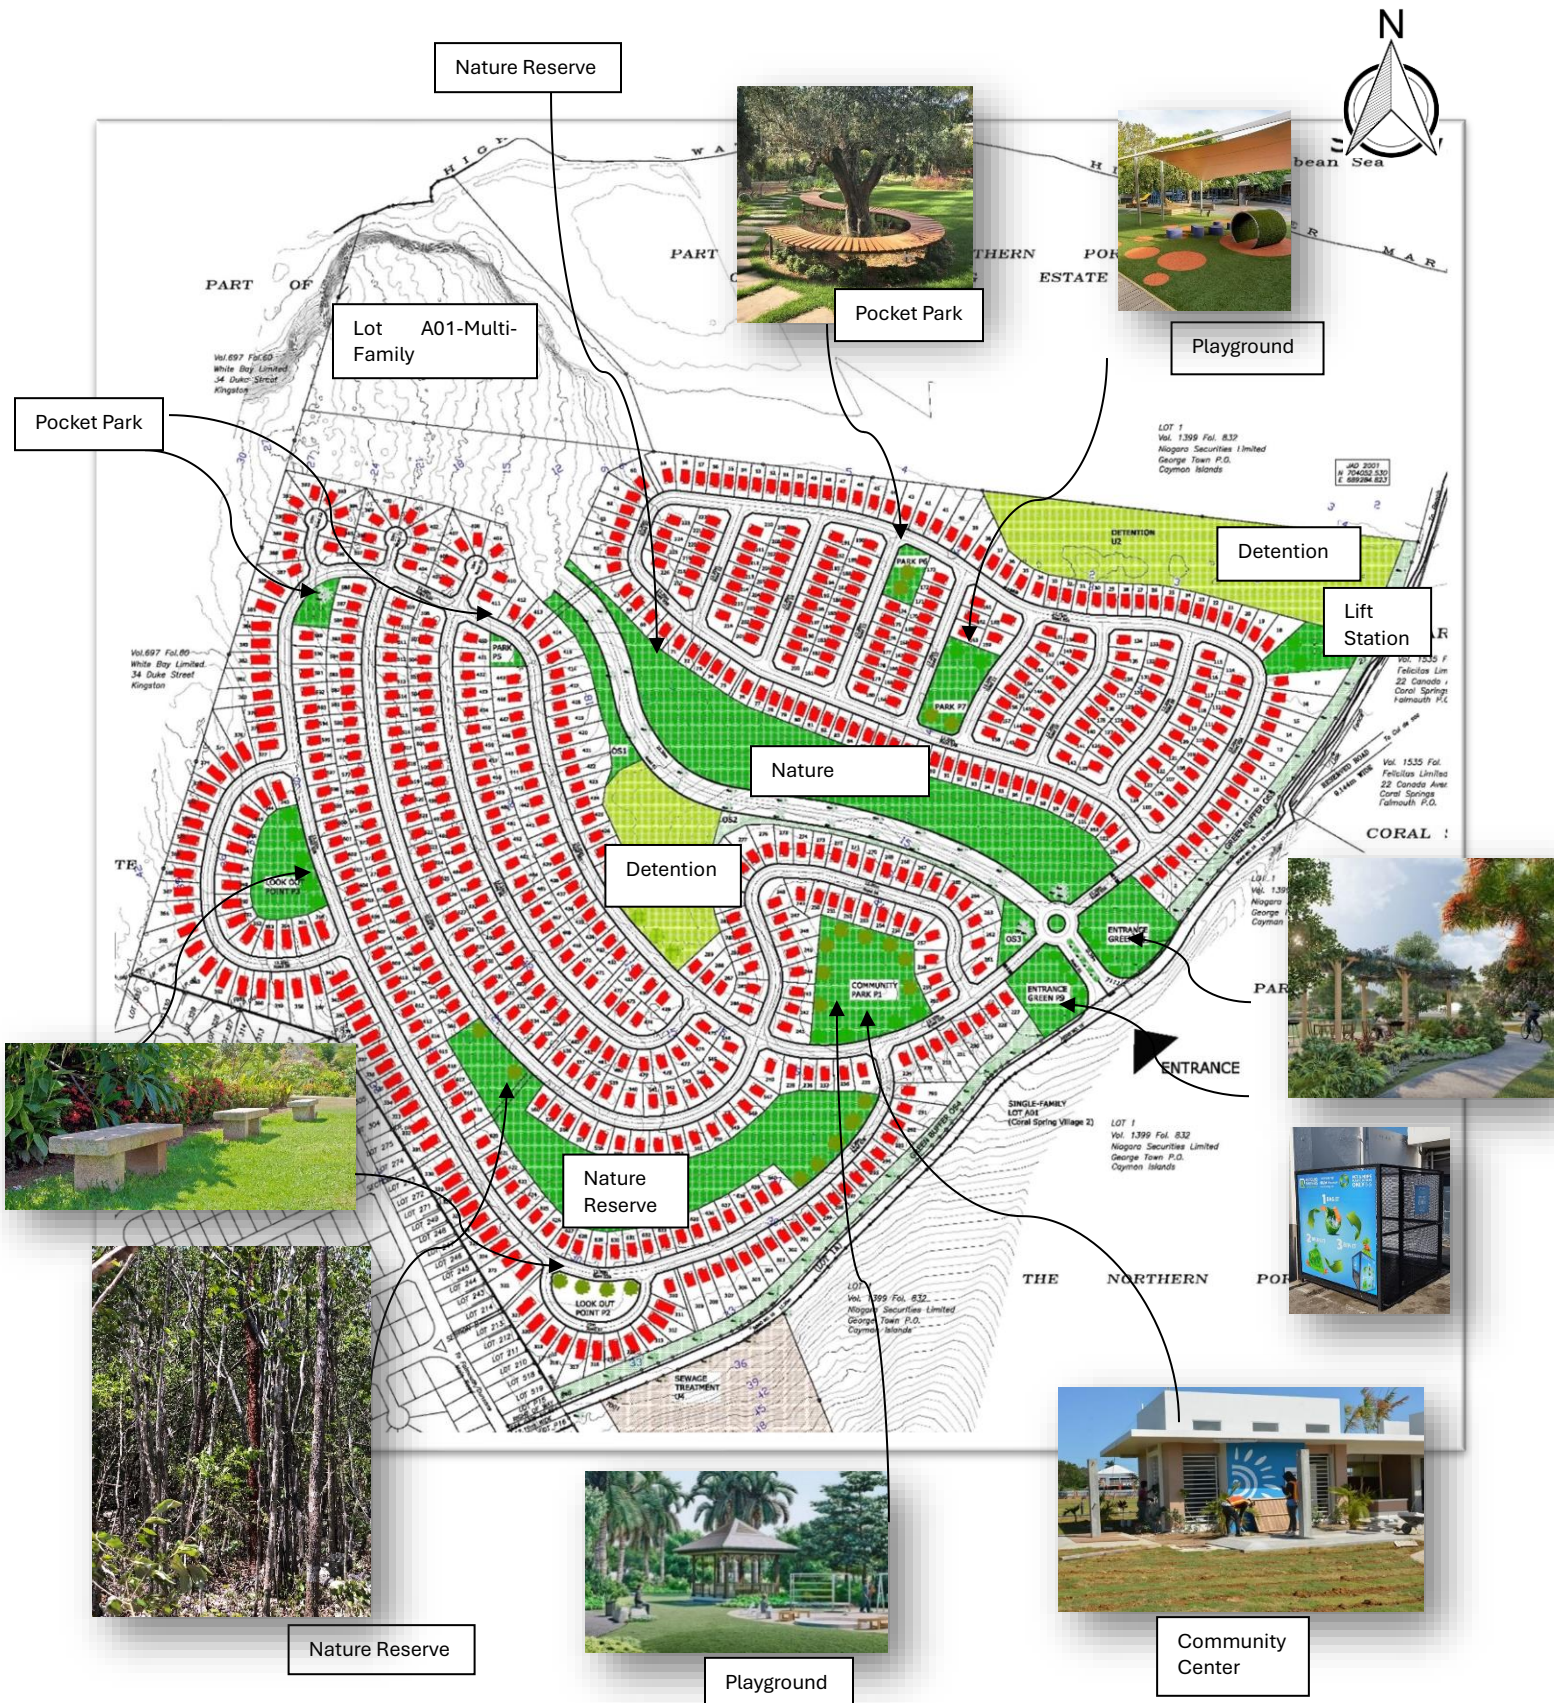
Figure 3-3: CSV II Preliminary Landscaping/ Open Space Design

The proposed open space and landscaping design incorporates a diverse array of native and endemic plant species, as outlined in Table 3-6 below. This approach not only promotes biodiversity but also ensures that the vegetation is well-suited to the local climate and soil conditions. By predominantly utilizing native and endemic species, the landscape design supports local wildlife, reduces maintenance needs, and enhances the overall sustainability of the development.

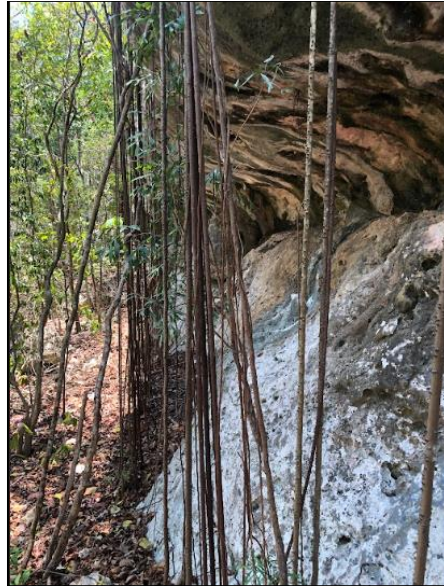
*Figure 4-3: Old Wave-cut platform observed in the Mm after it was uplifted due to tectonic uplift.*

During the Miocene period, Jamaica experienced tectonic uplift, leading to the exposure of the White Limestone Group and Coastal Group on the north coast, forming raised reef terraces, beaches, and headlands. Evidence of this uplift was observed during the site reconnaissance, with a wave-cut notch present in the bluff of the Mm (see Figure 4-3).

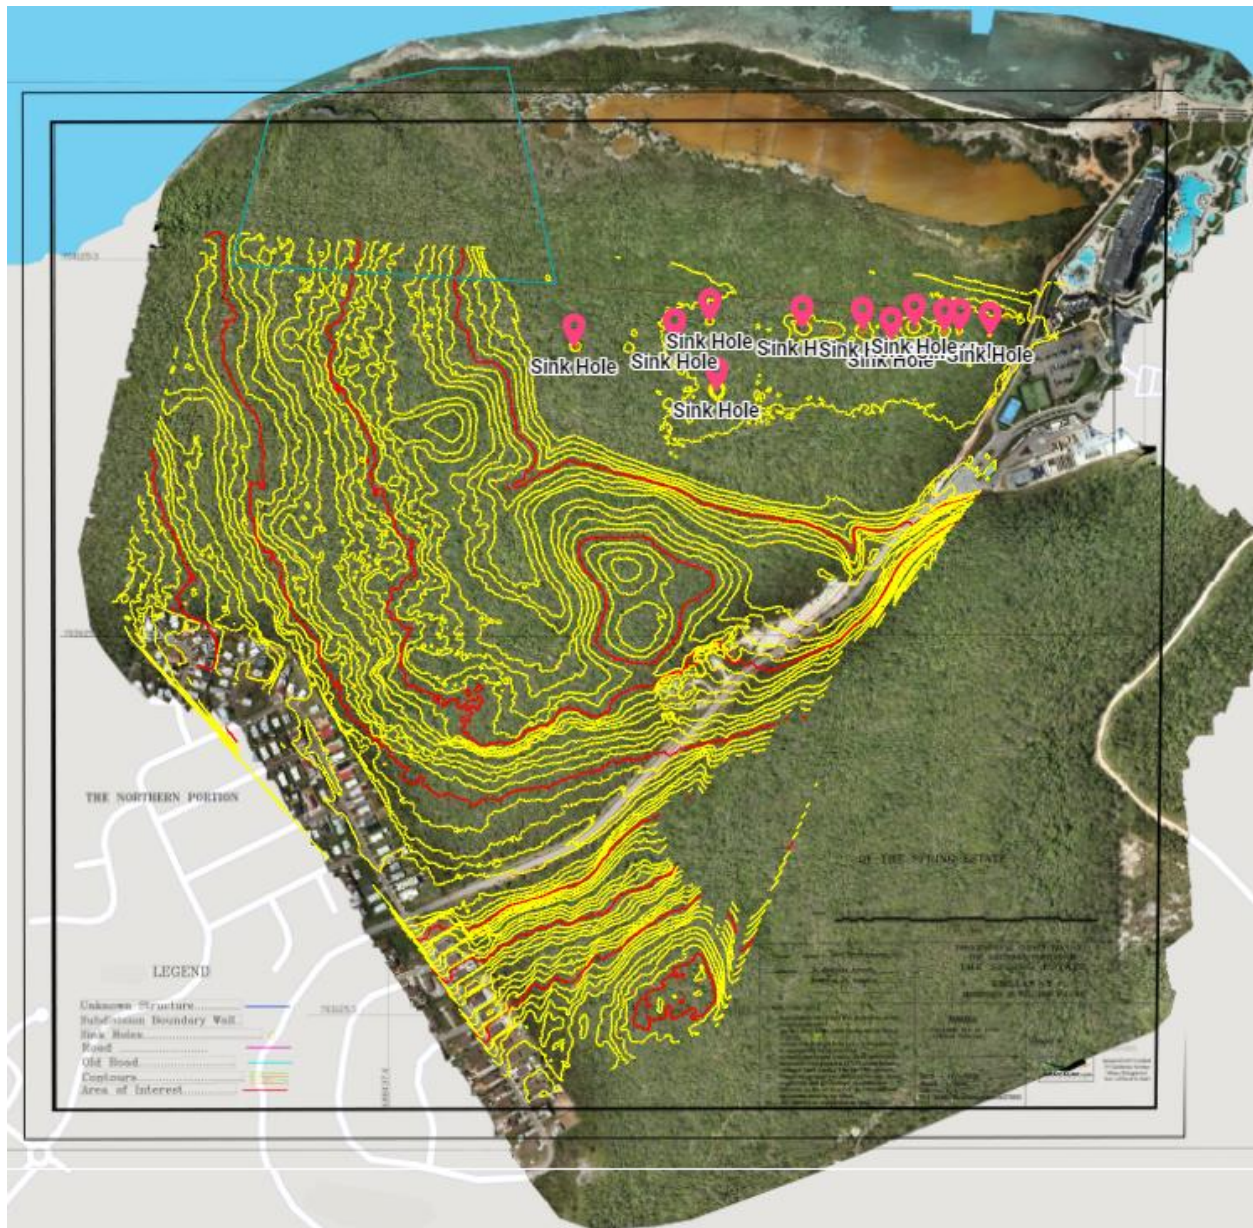
*Figure 4-5: Map showing the contour lines as surveyed in the property and the mapped sinkholes in the northern boundary.*

Figure 4-5). A notably steep hill is situated in the northeastern section of the site, where the elevation is high (approximately 65 degrees), gradually transitioning into gentler terrain characterized by rounded hilltops and an undulating landscape. The slope and elevation map suggest that surface runoff would flow northward, toward the mangroves and sinkholes (as indicated by the arrow in Figure 4-4).

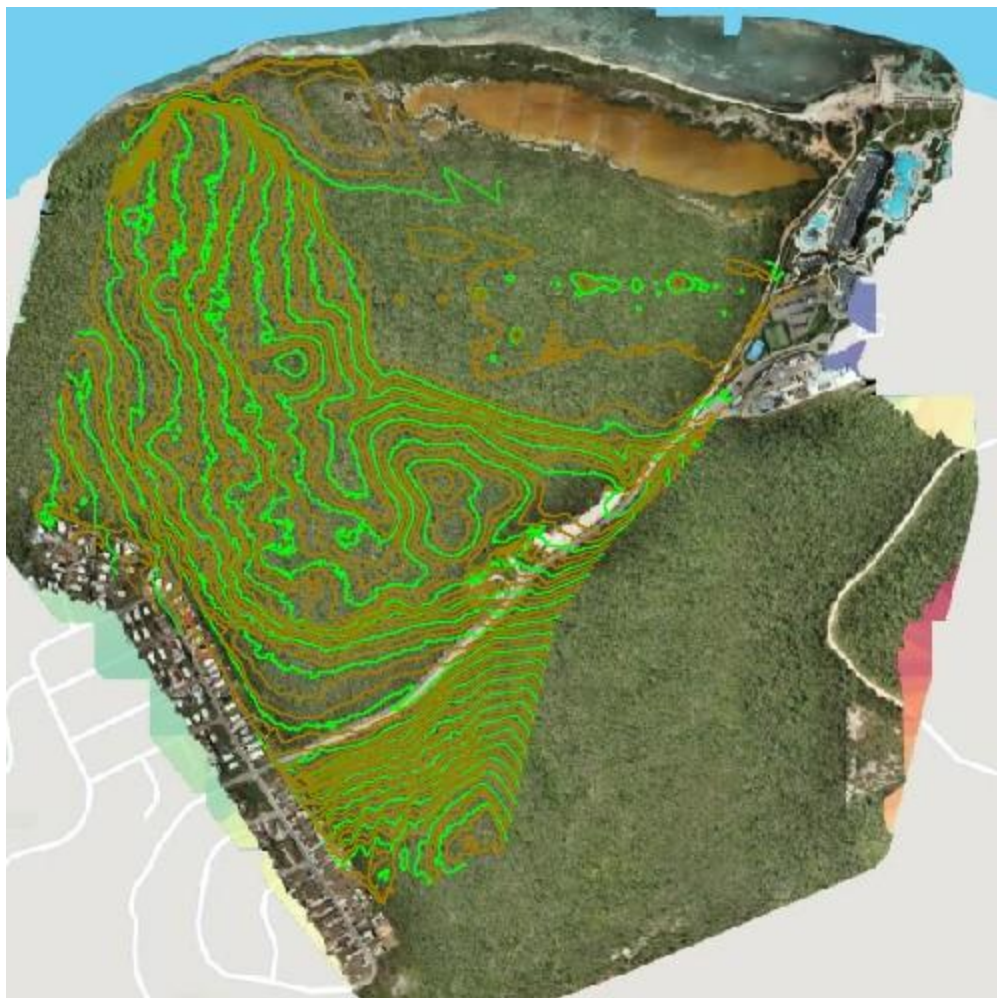
Figure 4-7: Coral Springs Village 2 site plan with 1m contours over aerial image
