**REPORT  
ENVIRONMENTAL IMPACT ASSESSMENT  
FOR  
SANDALS MONTEGO BAY  
(OVERWATER BUNGALOWS & VILLAS)**

March 18, 2025

Document No.: TEMN-ESL/SRI-2024-01

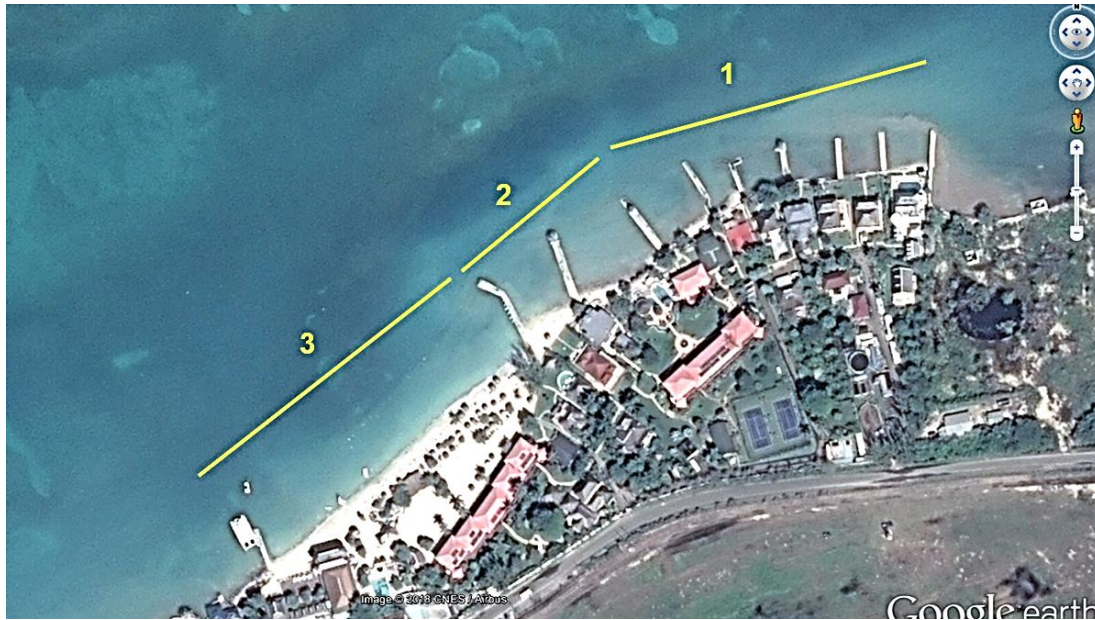
Based on different beach characteristics, the entire shoreline can be divided into three sections (**Figure 1-2**). The eastern section (Section 1), the middle section (Section 2), spanning between the eighth and tenth groynes (from the east), and the western section (Section 3).

The erosive nature of Section 1 shoreline corresponds with the relatively higher wave along this section under the dominant ENE and NE incident wave conditions. Section 3 benefits from the westward longshore sand transport and the protection from the reef crest, resulting in a relatively wide beach. Longshore transport is confined by the groynes. However, based on the westward increasing trend of beach width, the pre-2017 groynes allowed some of the westward longshore sand transport to move through. This was likely the reason that the groyne field was reinforced in 2017-2018.

FIGURE 1-2: BEACH CHARACTERISTICS AND SECTIONS ALONG THE SANDALS MONTEGO BAY SHORELINE

The beach conditions after 2017 were largely controlled by the engineering solutions. The third and fifth groynes from the east were removed and the remaining groynes were reinforced with T-heads and Y-heads. The original fifth groyne was replaced by a short, detached breakwater. The removal of the groynes resulted in longer sections of beach between the groynes. In addition, the beach between the groynes was nourished concurrently with the groyne improvement. The artificial beach appears to be quite stable since 2018 based on the time-series aerial photos from Google Earth. The beach to the west of the groyne field remains stable, as compared to the state before the groyne improvement. The westward longshore sand transport discussed above is largely interrupted by the groyne field. The beach to the west of the groyne field appears to be in a state of equilibrium before and after the groyne improvement, as indicated by the rather stable shoreline.

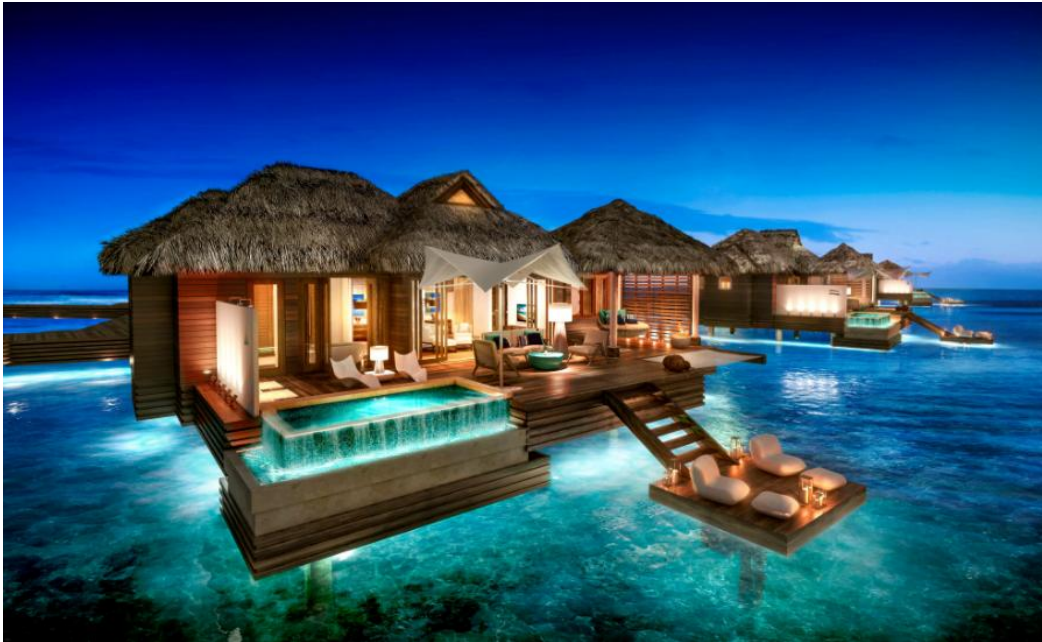
The design of the bungalows has a Polynesian flair and will use synthetic thatch for the roof, Bahama-style hurricane shutters on the windows and exotic hardwood.

To withstand the elements, pressure-treated wood rafters with insulation, marine-grade plywood and hurricane straps at each rafter will be utilised to comply with manufacturers' instructions and the highest quality workmanship. Access to each unit will be via a 9' (2.743m) wide boardwalk and the units will be surrounded by wooden railings, designed to bear up to 200-pound load. Ambience will be further enhanced by sea-floor windows, ceiling fans and accent lighting (**Figure 4-5** and **Figure 4-6**).

**FIGURE 4-5: EXTERIOR DESIGN OF BUNGALOW**

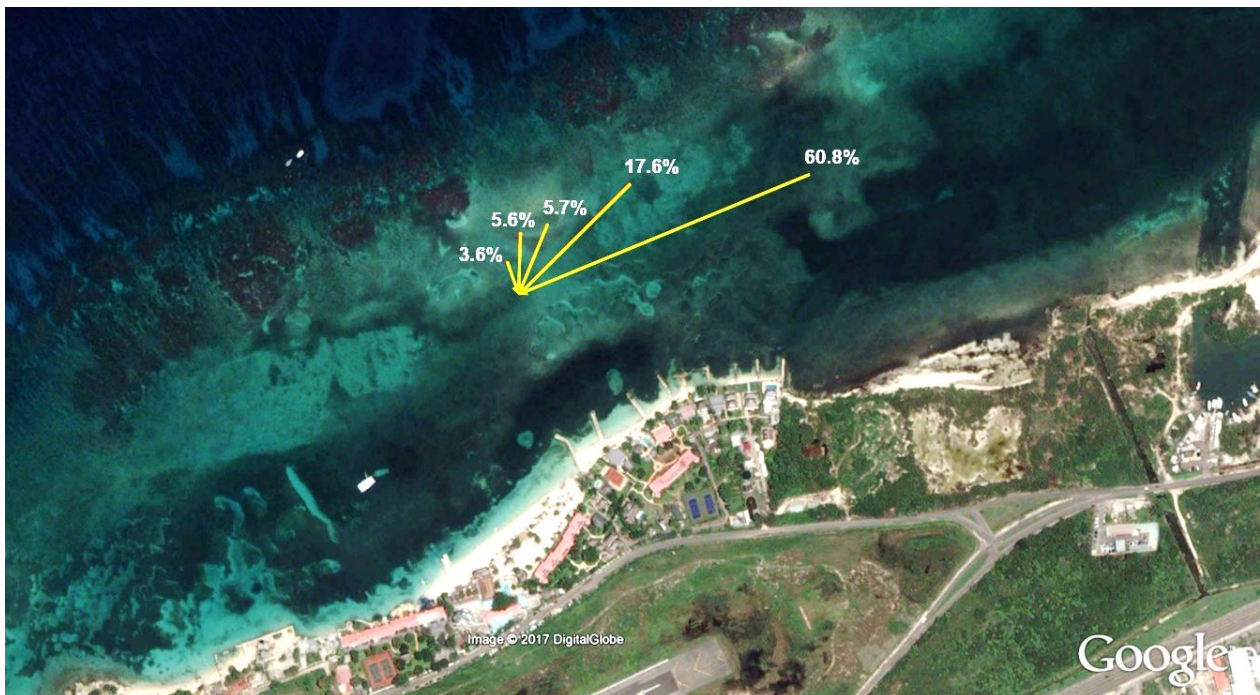
FIGURE 5-8: MOST FREQUENTLY OCCURRING OFFSHORE INCIDENT WAVE DIRECTIONS.

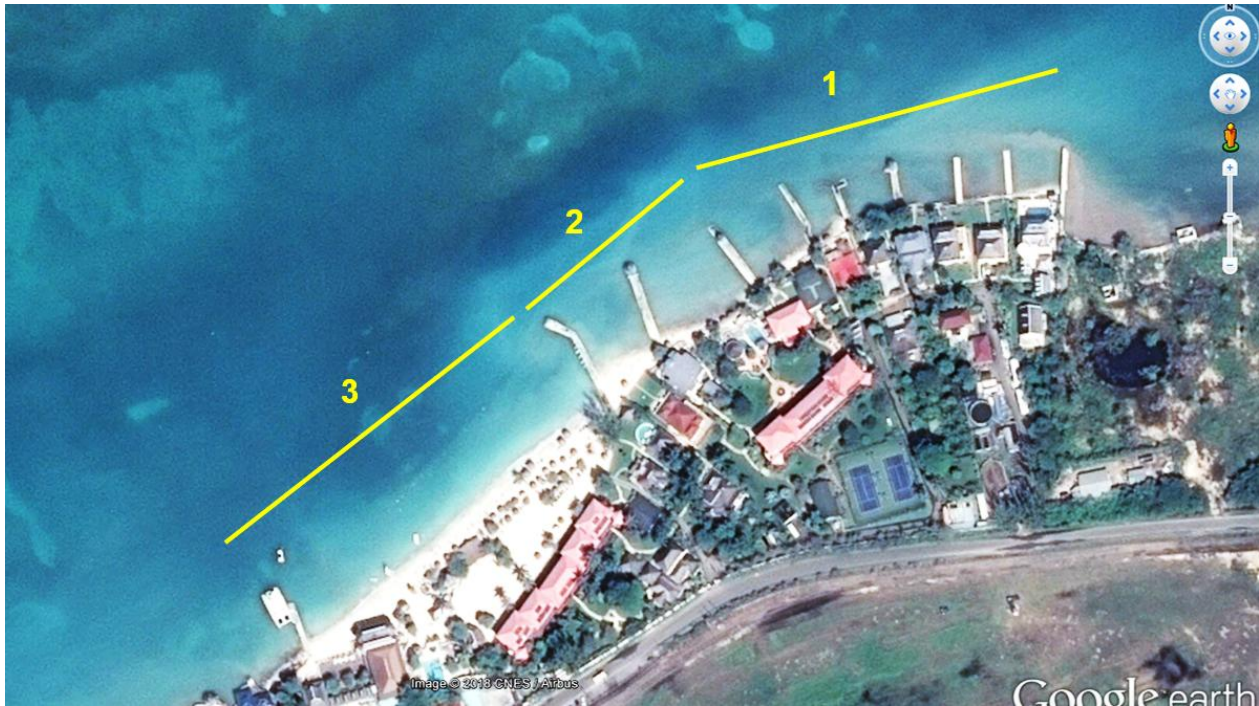
The beach characteristics along the Sandals Montego Bay shoreline are heavily influenced by engineering solutions. The groyne field was installed before 2001 and can be seen from the earliest Google Earth photos in 2001. Based on different beach characteristics, the entire shoreline can be divided into three sections. The eastern section (**Figure 5-9**, Section 1, the middle section (**Figure 5-9**, Section 2), spanning between the eighth and tenth groynes (from the east), and the western section (**Figure 5-9**, Section 3).

**FIGURE 5-9: CHARACTERISTICS ALONG THE SANDALS MONTEGO BAY**

The erosive nature of Section 1 shoreline corresponds with the relatively higher wave along this section under the dominant ENE and NE incident wave conditions. Section 3 wide beach benefits from the westward longshore sand transport and the protection from the barrier reef, resulting in relatively wide beach. The rate of the westward longshore transport is difficult to estimate because it is controlled by not only the wave conditions but also by the availability of the sand along the beach and in the nearshore. In addition, the longshore transport is confined by the groynes. However, based on the westward increasing trend of beach width, the pre-2017 groynes allowed some of the westward longshore sand transport to move through. This was likely the reason that the groyne field was reinforced in 2017-2018.

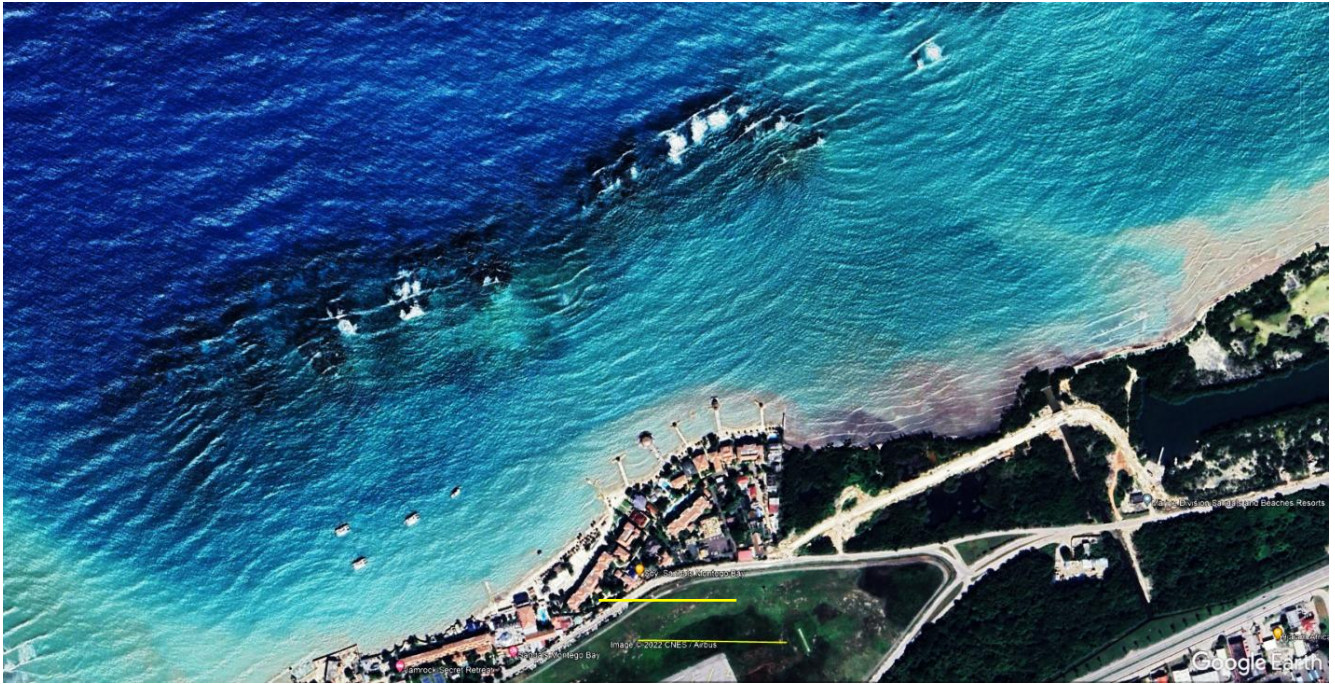
**FIGURE 5-11: WAVE BREAKING OVER THE SHALLOW BARRIER REEF AND WAVE PROPAGATION THROUGH THE GAPS . YELLOW LINE = 200 M.**

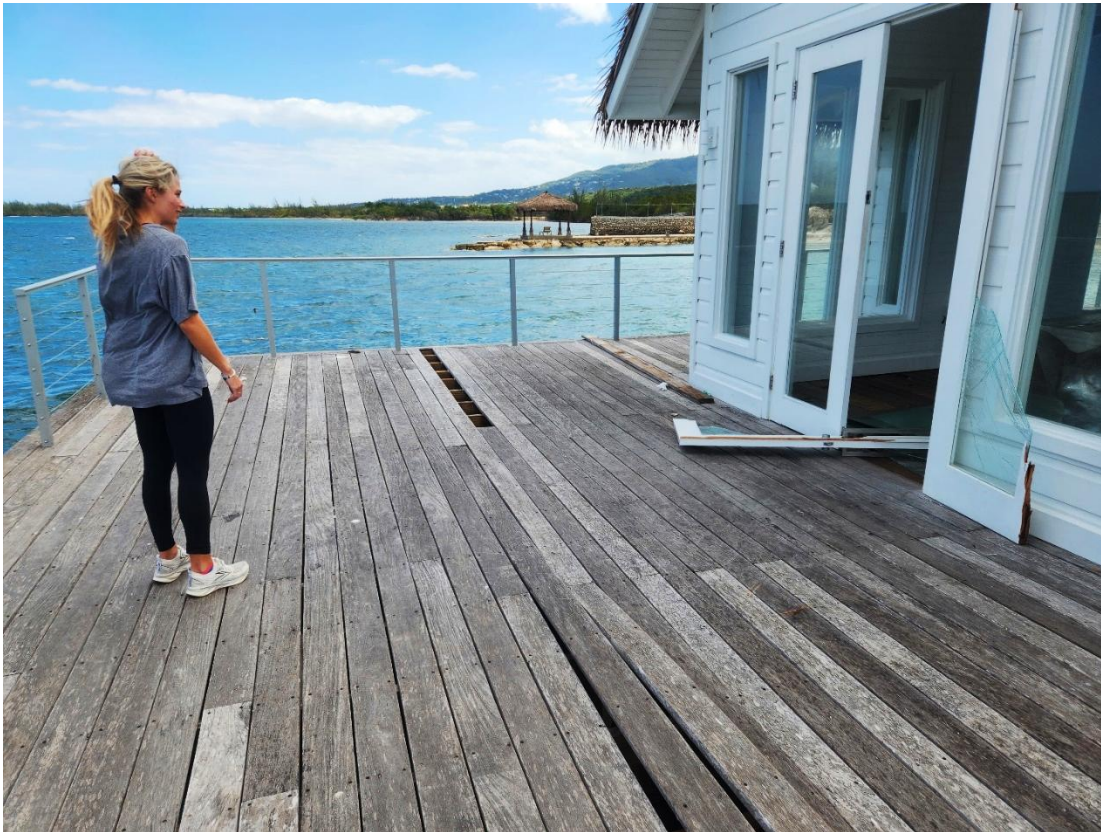
FIGURE 5-50: UPPER PANEL: THE WOOD PIER (3RD FROM THE EAST) WAS DAMAGED BY THE SEVERE WINTER STORM IMPACTED JAMAICA ON FEBRUARY 6, 2024. THE WOOD BOARD WAS DETACHED BY THE WAVE IMPACT FROM UNDERNEATH. THE DECK IS ROUGHLY 1.3 M FROM MEAN SEA LEVEL. LOWER PANEL: SIDE VIEW OF THE WOOD PIER. PHOTO WAS TAKEN ON FEBRUARY 11, 2024 ABOUT 5 DAYS AFTER THE STORM.

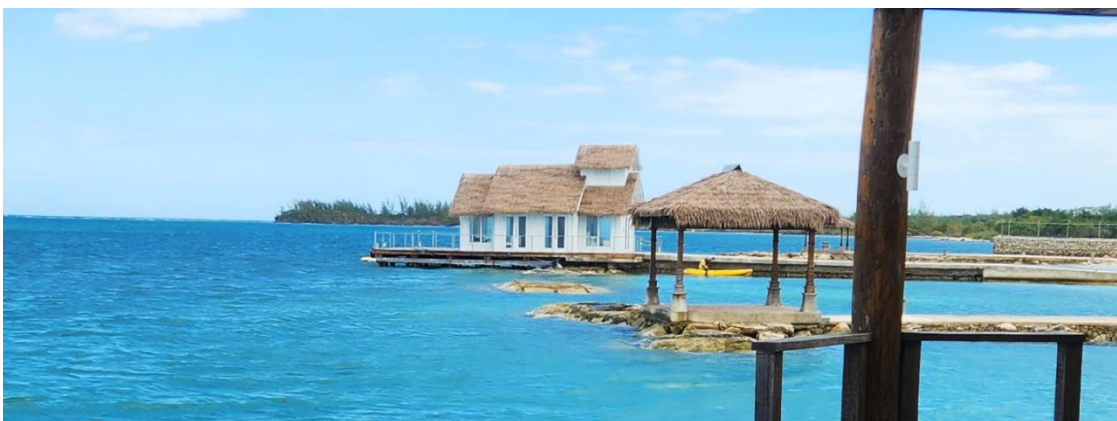
A very energetic winter storm impacted the Sandals Montego Bay Resort on February 6, 2024. Damage along the sandy beach was observed during the field investigation on February 11, 2024. Here, we focus on the infrastructure damage with the goal of using this information to evaluate the proposed design of the overwater units. **Figure 5-50** illustrates the condition of a shore-perpendicular wood pier serving as a boardwalk. This pier is the 3rd from the east as shown in **Figure 5-49**. Several pieces of the board were detached from the frame, likely caused by the strong upward forcing generated by waves crashing from underneath overcoming the nails. The housing structure, likely used for party gathering, was also damaged

(Figure 5-51 and Figure 5-52). The broken door (Figure 5-50) was likely caused by strong wind. The glass bottom inside the house was lifted from the floor, likely by the strong wave forcing from underneath. Similar types of damage were observed at other nearby structures installed on pilings (Figure 5-50 lower panel).

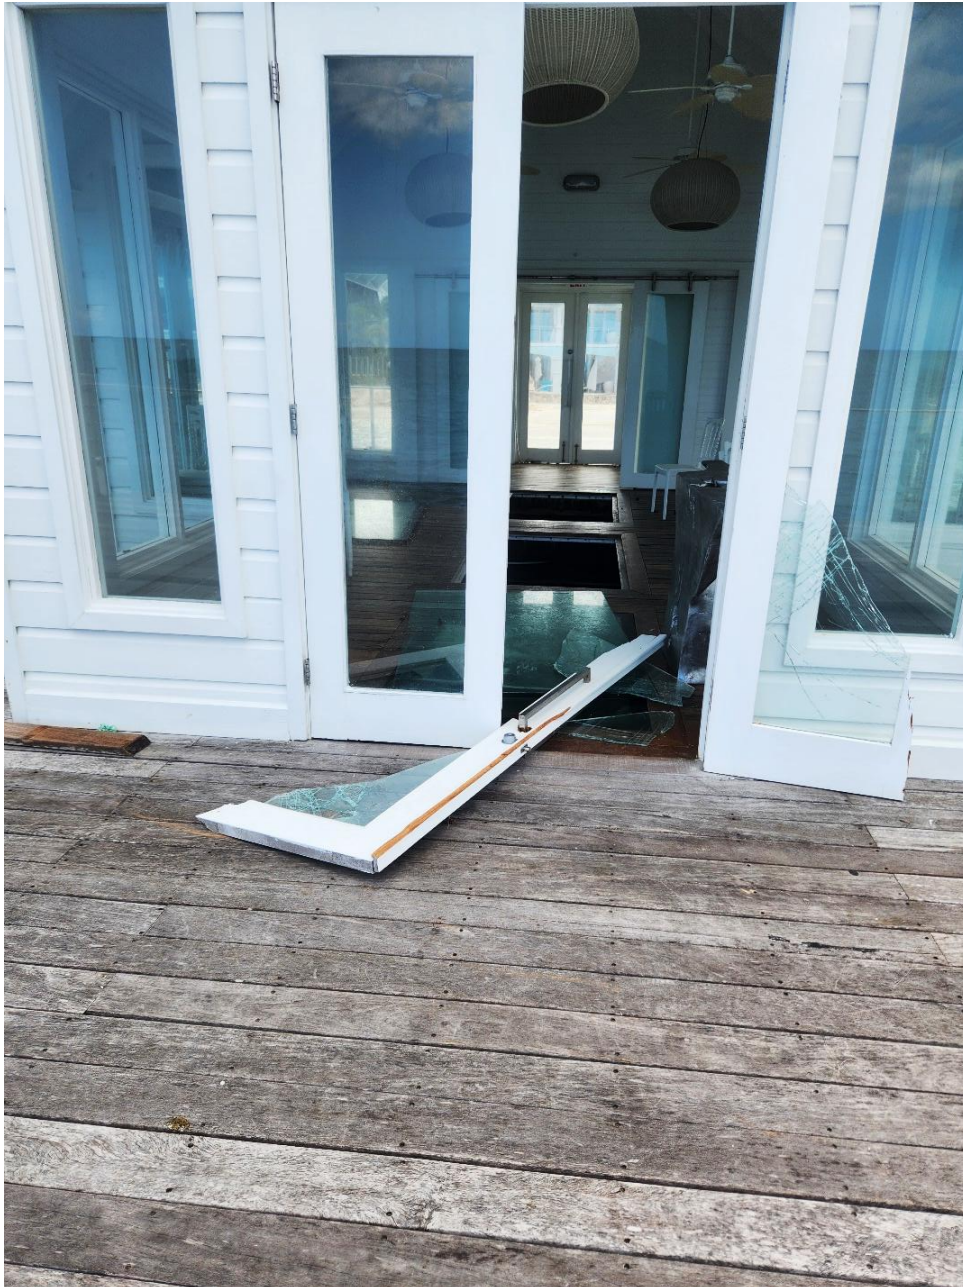
**FIGURE 5-51: THE HOUSE OVER THE WOOD PIER (2ND FROM THE EAST) WAS DAMAGED BY THE SEVERE WINTER STORM IMPACTED JAMAICA ON FEBRUARY 6, 2024. THE GLASS BOTTOM WAS DETACHED BY THE WAVE IMPACT FROM UNDERNEATH. THE DECK IS ROUGHLY 1.3 M FROM MEAN SEA LEVEL. PHOTO WAS TAKEN FEBRUARY 11, 2024 ABOUT 5 DAYS AFTER THE STORM.**

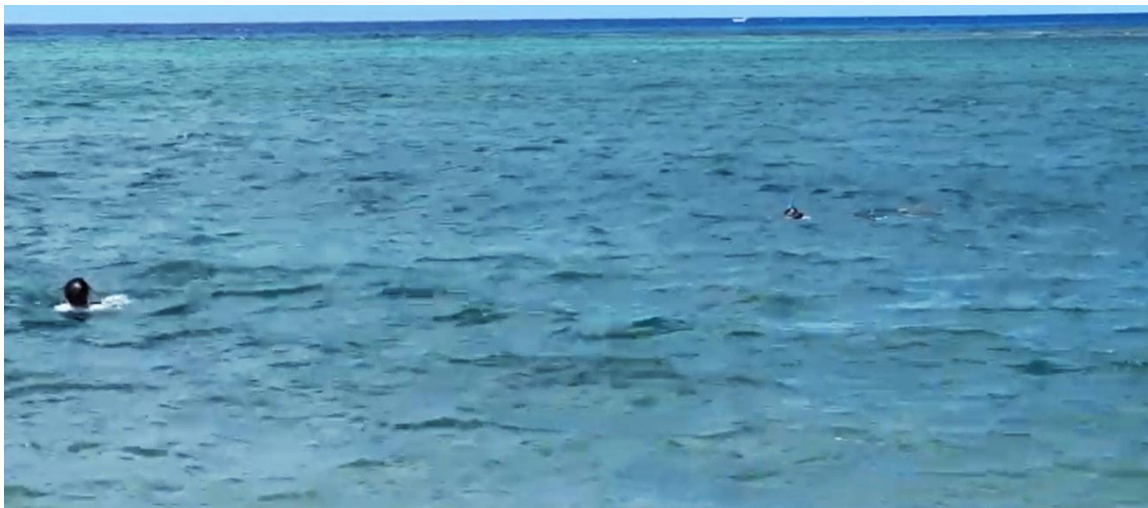
Bottom sediment samples were collected on February 11 2024 during the field investigation (**Figure 5-53** and **Figure 5-54**). An approximately 5-cm long core sample was collected from the bed to ensure a representative bottom sediment. A plastic cup was used by divers to collect the bottom sediment.

FIGURE 5-54: SEDIMENT SAMPLING AT THE OVERWATER UNIT SITE. THE BOTTOM SEDIMENT IN THIS AREA IS MOSTLY SANDY. THE BARRIER REEF IS VISIBLE SEAWARD OF THE SAMPLING SITE.

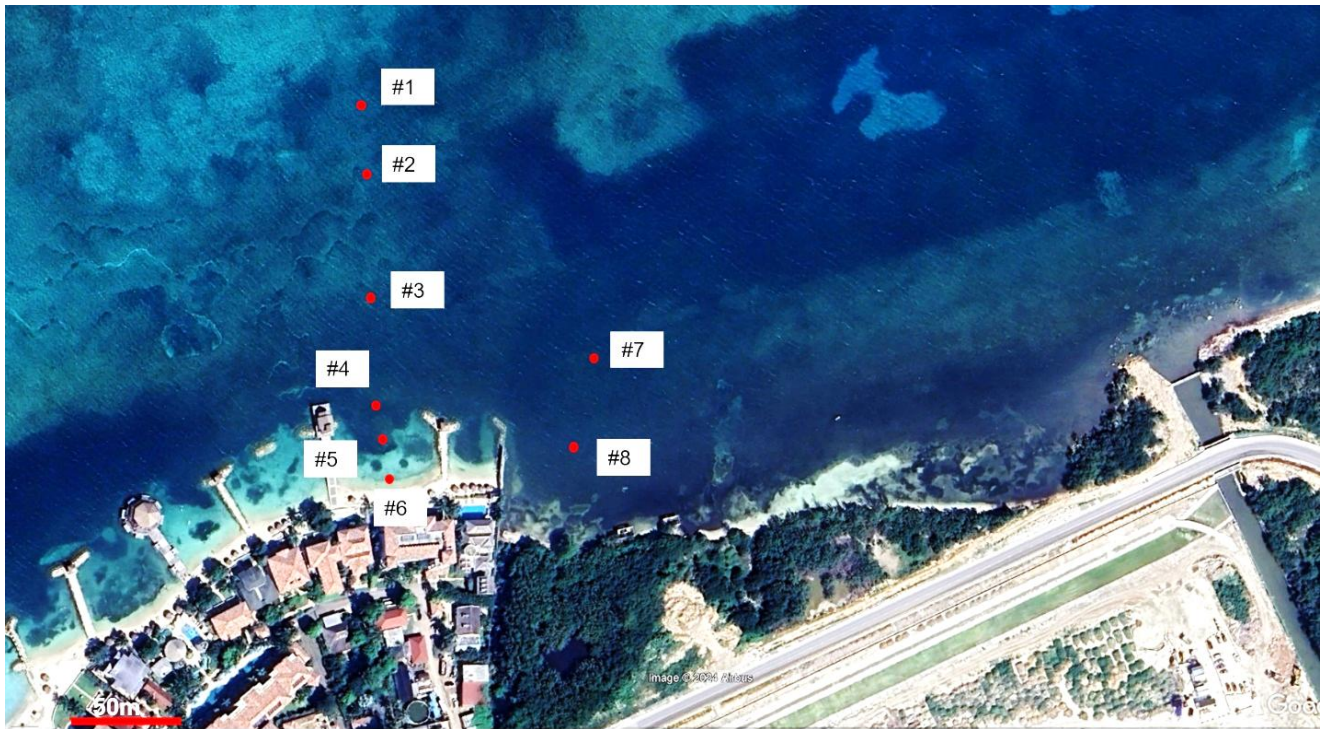
A total of 8 bottom sediment samples were collected (**Figure 5-55**). Six bottom sediment samples were collected along a shore-perpendicular transect extending from the sandy beach to the overwater units' site. In addition, two sediment samples were collected in the nearshore area to the east of the project site. These samples should provide an adequate representation of the bottom sediment characteristics.

**FIGURE 5-55: LOCATIONS OF THE FIELD SEDIMENT SAMPLING**

Considerable grain-size variation was measured in the cross-shore direction. From landward to seaward, the sandy beach (Sample #6, **Figure 5-61**, with sample location shown in **Figure 5-55**) is composed of clean well-sorted medium sand, as expected, with minimal muddy sediment. A patch of muddy sediment was identified seaward of the wave-breaking zone at sample locations #4 and #5. Location #5 has the highest mud content of nearly 51%. The mud content decreases seaward to slightly less than 16% at location #4. Further seaward at the location of the overwater units, the mud content decreased to 5.3% at location #3,

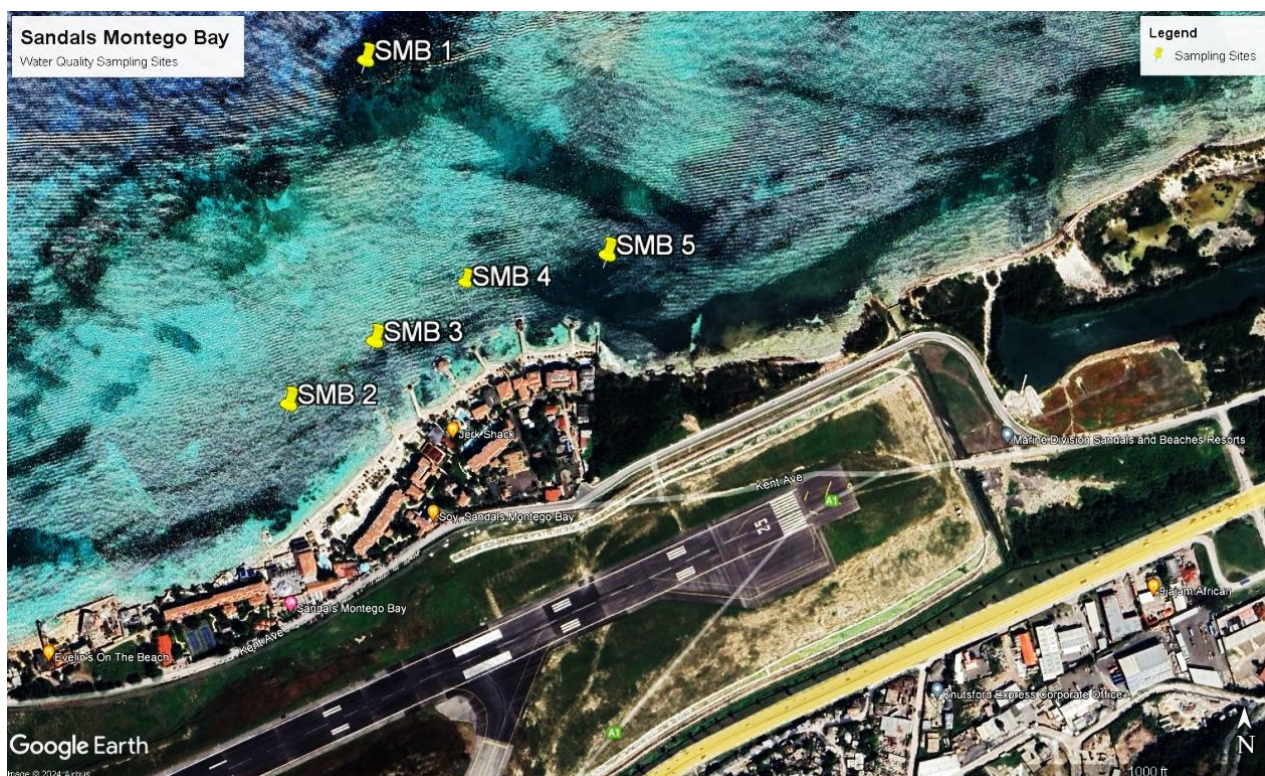
Samples were collected from five sampling sites (**Figure 5-70**) during the wet season on October 10, 2022, October 18, 2023 and October 25, 2023 and dry season on January 31, 2023, February 11, 2024 and March 11, 2024 to reflect background conditions (outside the reef) and baseline conditions within the footprint of the proposed development. Coordinates are shown in **Table 5-4**. These data sets are considered to be representative of wet and dry season baseline.

**FIGURE 5-70: WATER QUALITY SAMPLING SITES**

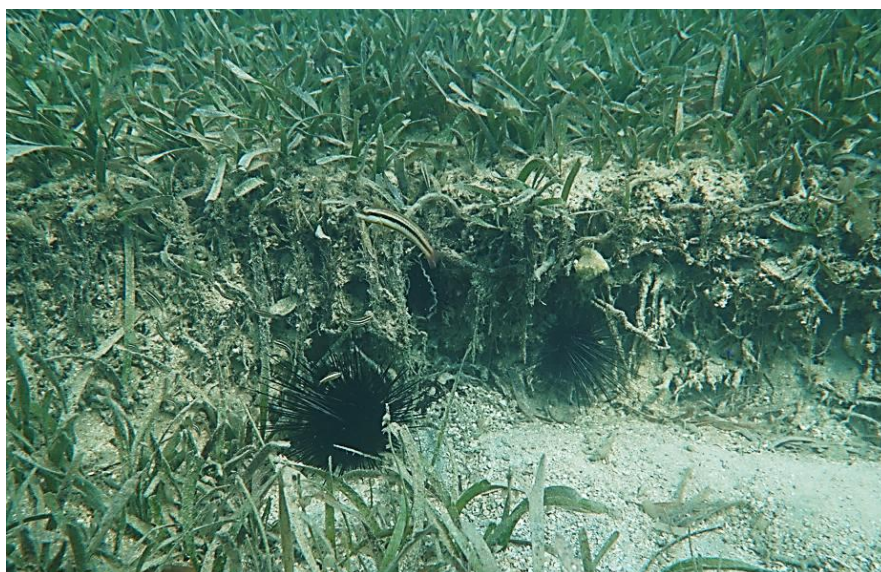
Several crescent-shaped blowouts of variable size are apparent in the seagrass beds. Blowouts are bare or sparsely vegetated open areas in established seagrass beds (Patriquin 1975), caused by wave disturbances that erode the sandy sediment and expose a vertical edge of seagrass root matrix (i.e., rhizomes) (Macia and Robinson, 2005) (**Figure 5-77**). The resulting unvegetated area of the blowout is deeper than the surrounding seagrass bed. Over time and under favorable conditions, blowout scars can ‘heal’ through succession growth, whereby one species is replaced by another. Natural recovery (i.e., succession growth) was apparent in certain blowout areas where Manatee Grass (*Syringodium filiforme*), a pioneer species, has colonised the bare sandy substrate, which, over time, will contribute to trapping sand along the blowout edges and paving the way for recolonisation by *T. testudinum*.

**FIGURE 5-77: EDGES OF BLOWOUTS PROVIDE SHELTER FOR FISH AND DIADEMA ANTILLARUM.**

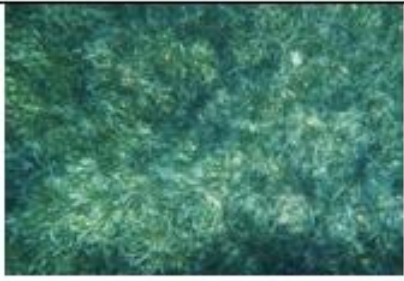
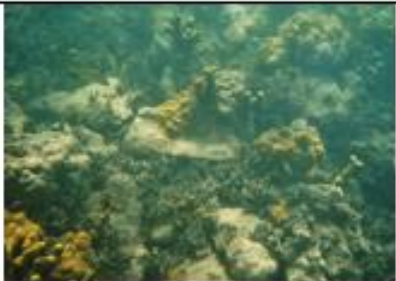
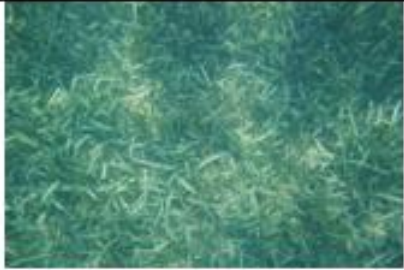
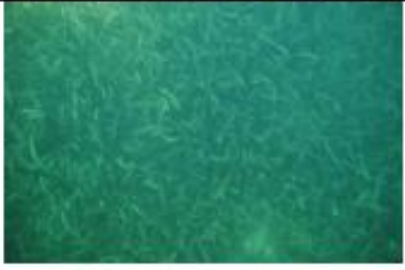
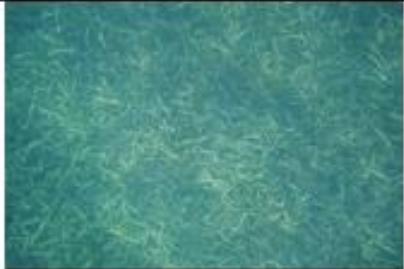
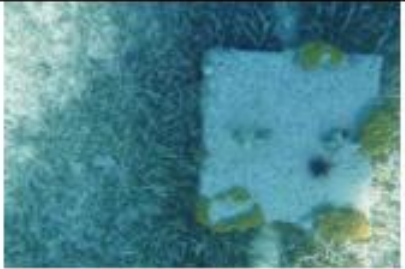
**FIGURE 5-80: GROUND-TRUTHING REVEALED EXTENSIVE SEAGRASS MEADOWS AND A VIBRANT REEF CREST AREA.**

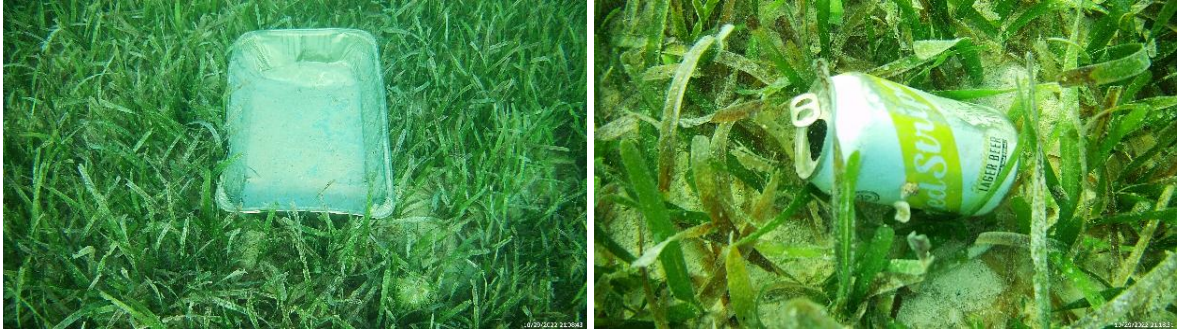
Anthropogenic impacts observed in the marine areas included solid waste pollution (e.g., single-use and other plastics, discarded fishing gear etc.) and high sedimentation, especially in nearshore areas. **Figure 5-92** below shows examples of some anthropogenic impacts observed in the project area.

**FIGURE 5-92: SOLID WASTE POLLUTION OBSERVED**

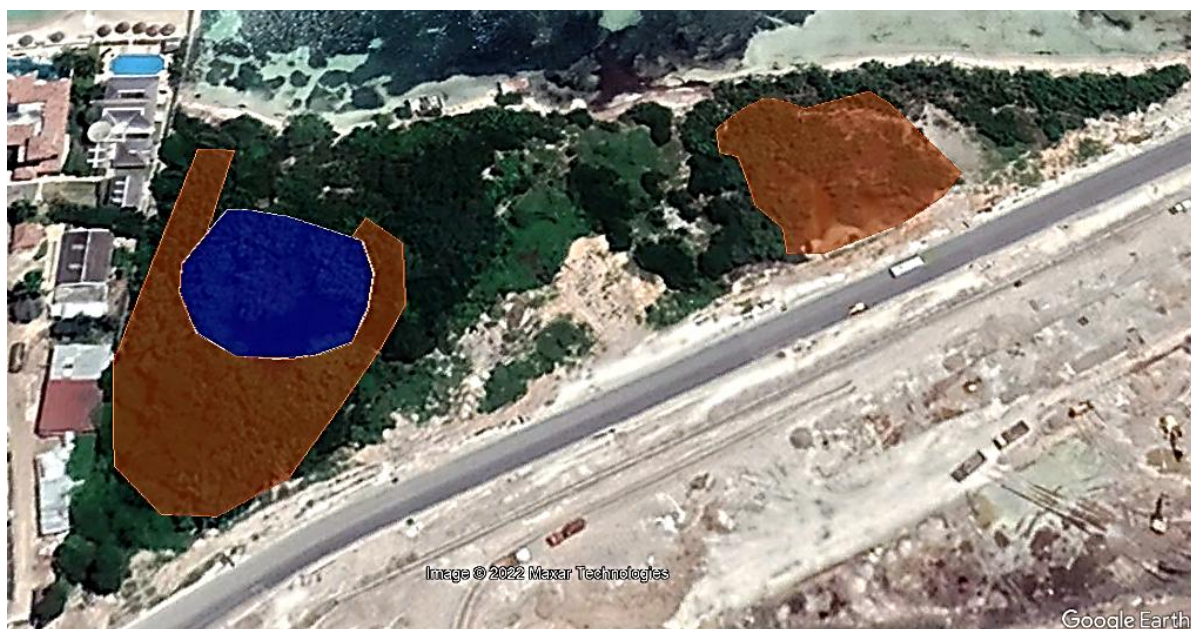
A review of aerial images in conjunction with ground truthing of the property revealed that the project area has 2 wetland areas: one degraded mangrove/salina area to the east; and another buttonwood dominant wetland toward the west, with no standing water but surrounding a concrete pond. **Figure 5-100** below shows the outline of the pond (blue shaded region) and the approximate footprint of the 2 identified wetland areas (brown shaded regions). The remainder of the forested areas is considered coastal forest and disturbed secondary forest dominated by non-wetland species. The wetland areas that would potentially be impacted within the project area are the western buttonwood forest (approximately 2,543 m<sup>2</sup> area) and the eastern mangrove/salina (~1866 m<sup>2</sup>).

**FIGURE 5-100: BUTTONWOOD WETLAND (BROWN HIGHLIGHTED AREA ON LEFT) AND MANGROVE/SALINA WETLAND (AREA ON THE RIGHT); CONCRETE POND/POOL ALSO INDICATED (BLUE)**

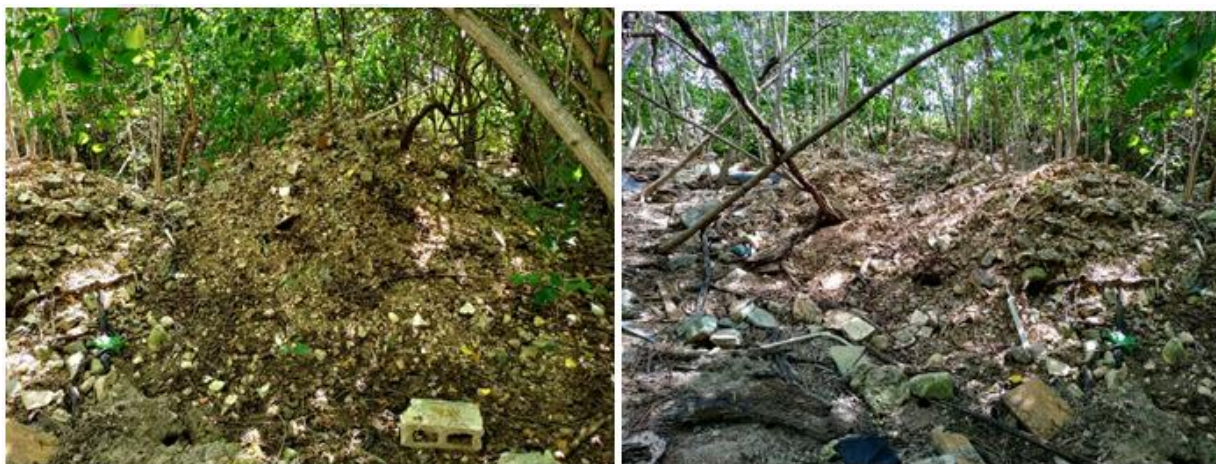
**FIGURE 5-104: LARGE MOUNDS OF CONSTRUCTION AND POSSIBLY DREDGE/FILL MATERIAL OBSERVED IN SOME AREAS (E.G., T2)**

This area can be considered as a coastal (as opposed to wetland), secondary forest- as indicated by the absence of mangroves in conjunction with the dominance of dry, compact soil and non-wetland flora such as lead trees (*Leucaena sp.*), seaside mahoe (*Thespecia sp.*) and morning glory (*Ipomea sp.*). Multiple mounds of construction/fill material, as well as other forms solid waste pollution (e.g. plastics) were observed in this area (Figure 5-104).

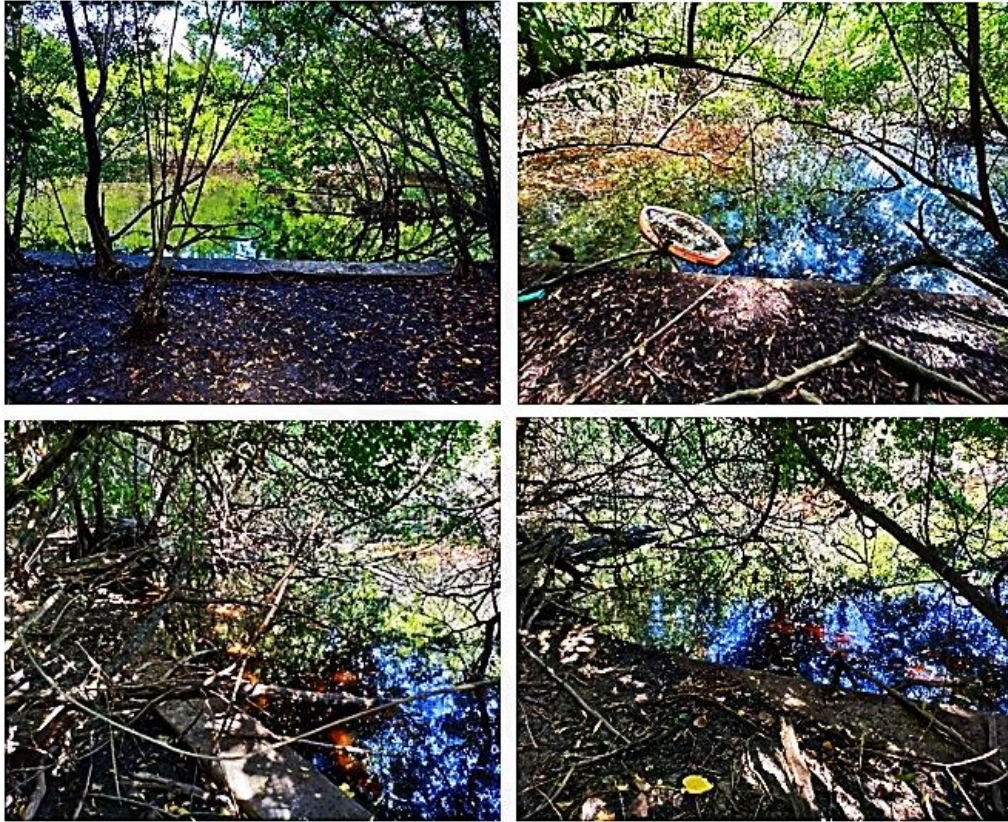
FIGURE 5-105: ARTIFICIAL (CONCRETE) POND LOCATED NEAR T<sub>3</sub> AND T<sub>4</sub> (SALINITY READING= 4 PPT)

T3 is a wetted area dominated by buttonwood trees, mixed with other mangrove associates such as coin vine (*Dalbergia ecastaphyllum*) and seaside mahoe. Like T1, this area is seemingly elevated above the central pond (**Figure 5-105**) to which water may drain into from these wetted areas. No mangrove seedlings were observed in T3; however, a large abundance of hermit crabs was observed (**Figure 5-106**), which could help explain the lack of seedlings (i.e., due to large abundance of hermit crabs feeding on seedlings).

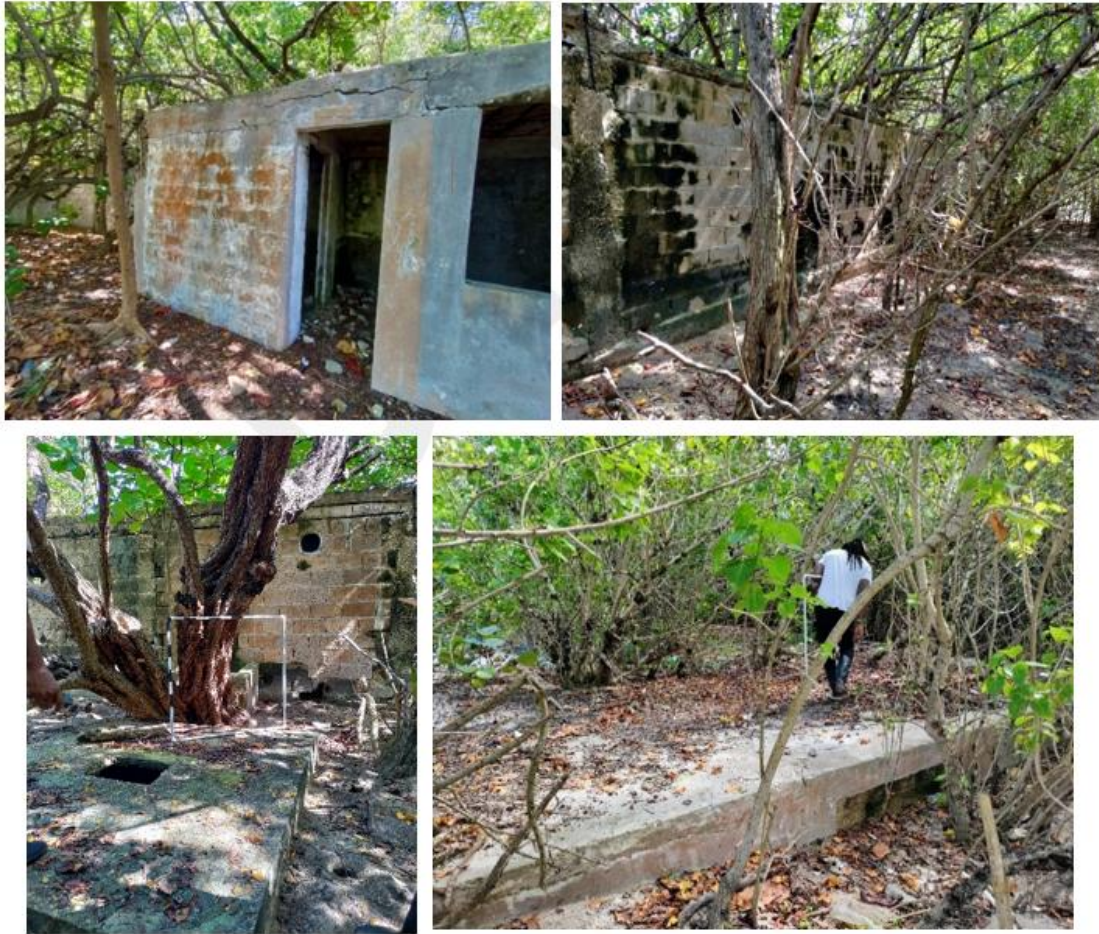
**FIGURE 5-108: ABANDONED, SINKING BUILDINGS RANGING FROM BATHHOUSES WITH SOAK-AWAY PIT AND OTHER MULTI-USE BUILDINGS, TO CONCRETE PLATFORM/POSSIBLE PREVIOUS STAGE AREA (LOCATED NEAR T<sub>3</sub>)**

This area can also be considered coastal forest as indicated by the dominance of species like seaside Mahoe and lead trees. Solid waste (mostly plastic pollution) was also observed in T4 (**Figure 5-107**) and there was evidence of forest clearing in the area (coal kilns observed). This area of the forest is likely used as a wood source for charcoal production and/or other uses. T4 was also located in relatively close proximity to the concrete pond (**Figure 5-105**), as well as two (abandoned) building structures (**Figure 5-108**).

This area contained mounds of marl-like material, rubble, and sand, from which secondary, coastal vegetation emerged. Two abandoned, sinking buildings **Figure 5-107** as well as **Figure 5-108** are also located in this area.

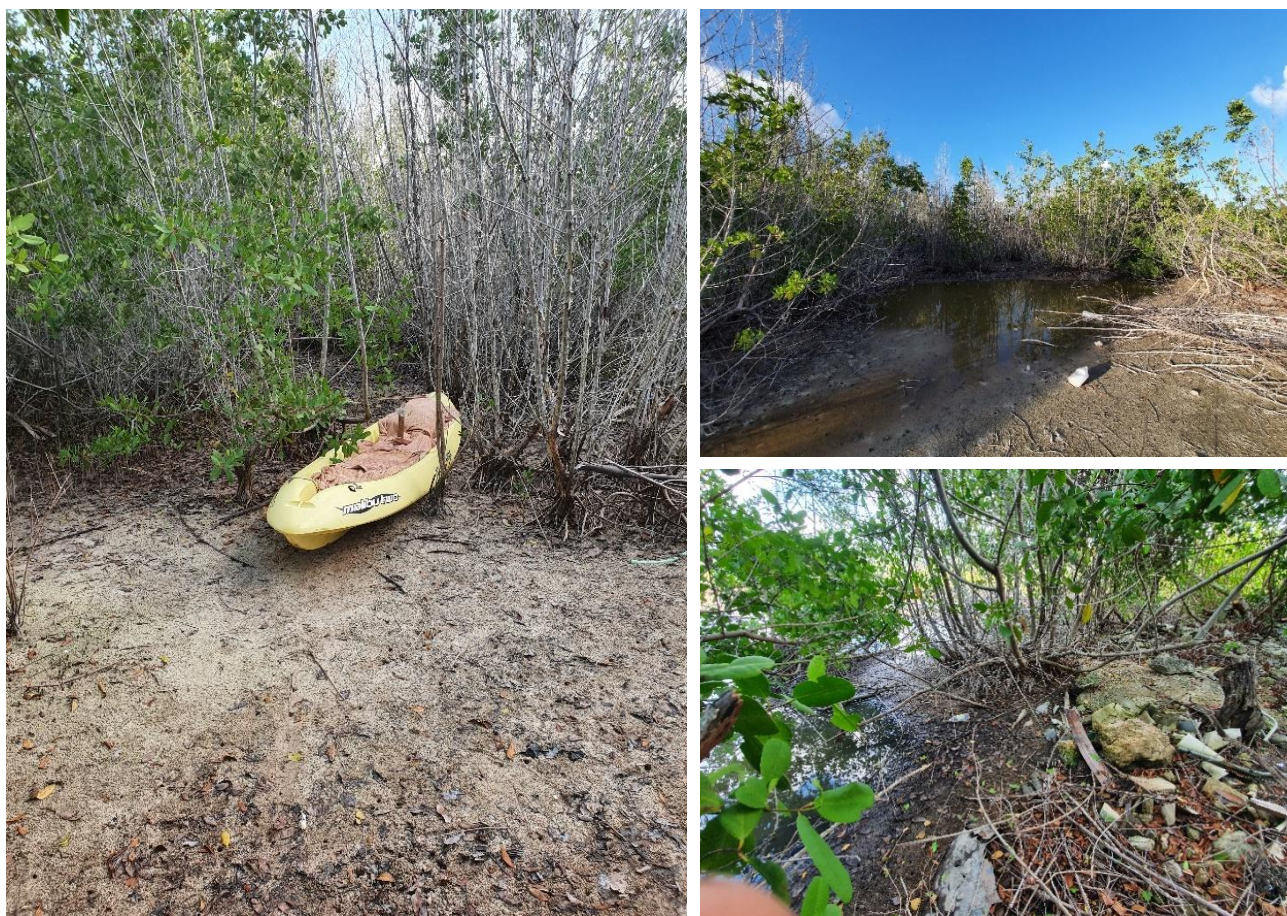
**FIGURE 5-110: DISTURBED SECONDARY FOREST IN T6**

This area is an extremely impacted mangrove forest, which appears to be transitioning into a salt flat/salina (**Figure 5-110**). There was stagnant water present which was hypersaline (~50 ppt) and mostly dead (mangrove) trees, with some stands of living white mangroves (*Laguncularia racemosa*). The mangroves in this location will likely not survive as the area has been changed drastically since the re-alignment of Kent Avenue. Based on past aerial images and previous studies, this wetland area appears to have been sustained by freshwater (from Kent Ave.) coupled with tidal water inflow from the north. Under current conditions, water may only enter during high tide and will subsequently be trapped and subject to evaporation. This explains the hypersaline conditions observed.

As we know the wetland areas at the site were already highly impacted - historically and more recently by the expansion. From the photos (**Figure 5-110**), it was evident that the wetland area was transitioning into a pioneer forest. This means the carbon and fisheries values applied here are over estimates given that the global values are based on healthy functioning mangroves.

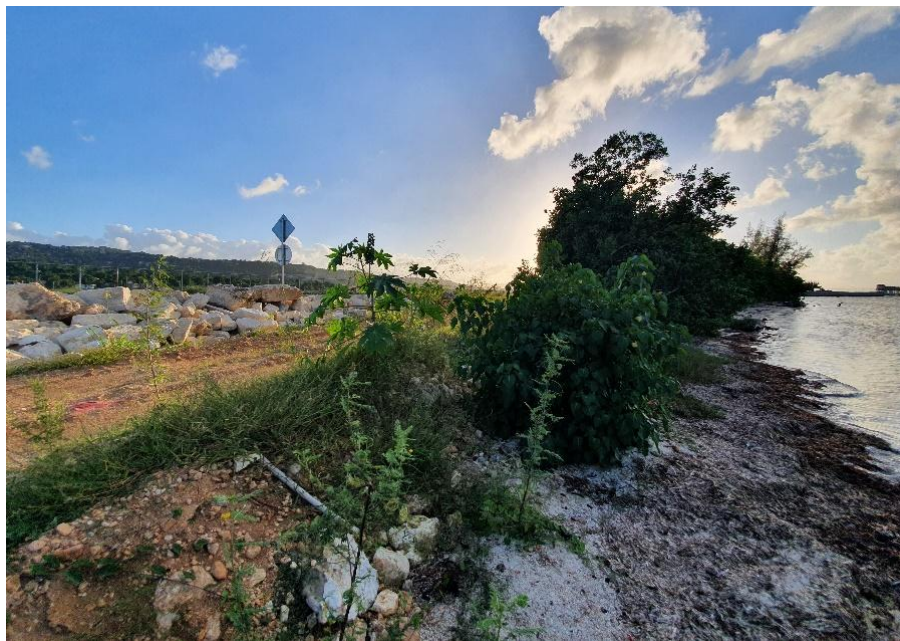
FIGURE 5-112: COASTAL FOREST AND RUBBLE (T8)

The vegetation in T8 was similar to that observed in T7, however the area contained a significant volume of dumped material (rubble and boulders) - most likely from the recent roadway works (Figure 5-112).

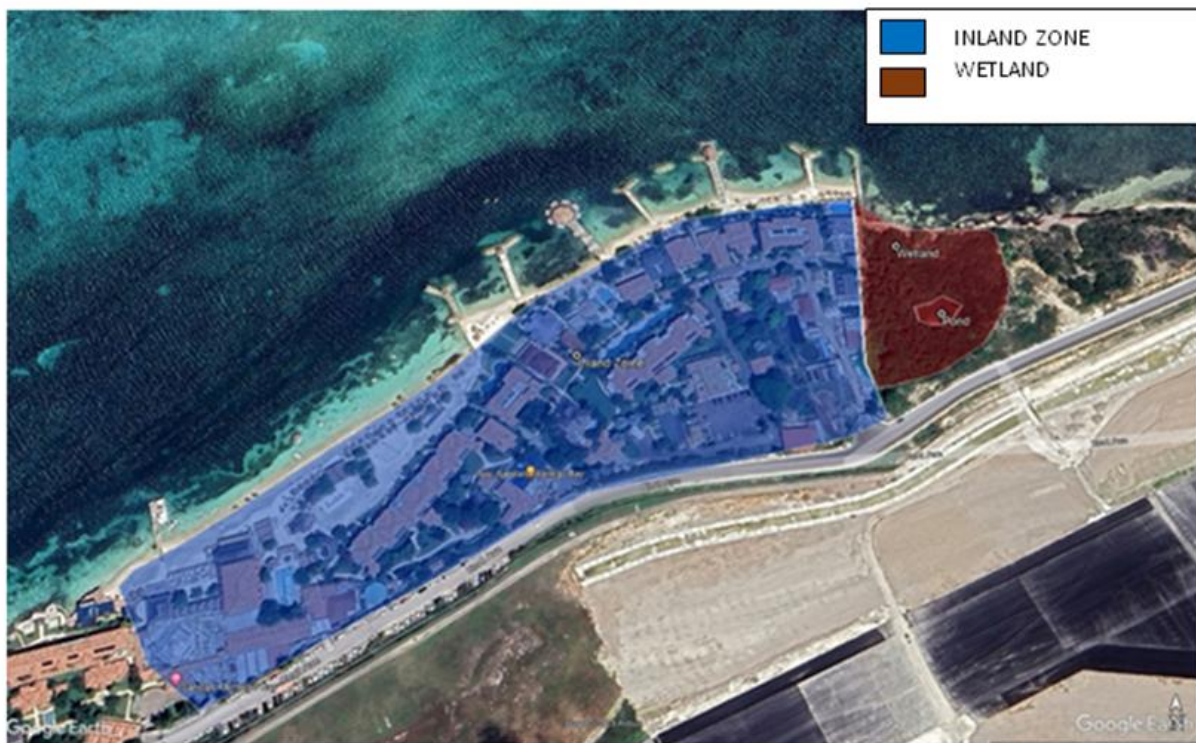
FIGURE 5-113: THE ZONES USED FOR THE FAUNAL SURVEY OF THE PROPERTY

The faunal assessments were conducted at selected sample points placed throughout the study area, including along the trails and footpaths to and within the sample sites (**Figure 5-113**). The surveys were carried out over 5 days and 3 nights using the methods listed below. A DAFOR scale of relative abundance was used to rank the species for both the fauna and flora identified; Dominant ( $\geq 20$ ), **A**bundant (15-19), **F**requent (10-14), **O**ccasional (5-9) and **R**are ( $<4$ ).

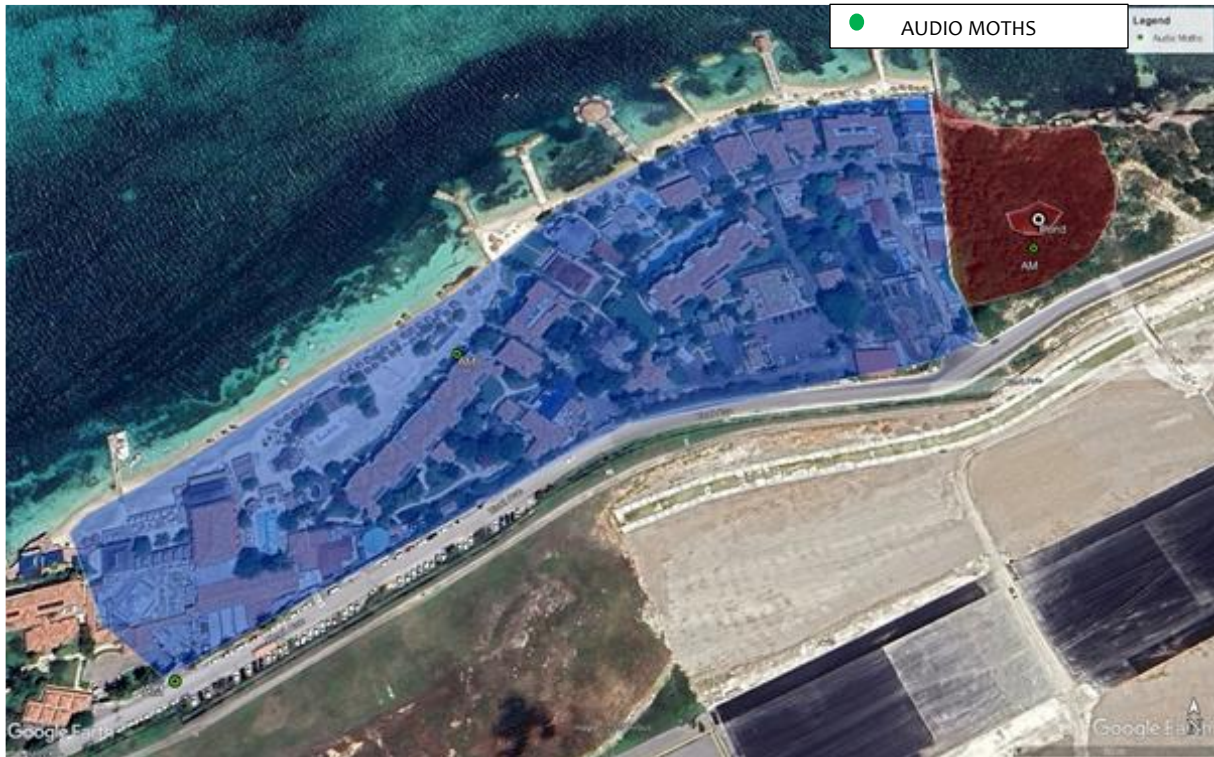
**FIGURE 5-118: THE LOCATION OF THE AUDIOMOTHS DEPLOYED IN THE STUDY**

Three AudioMoth® acoustic recorders were deployed in selected areas on the property (Open fields and Riverine Habitat) as shown in **Figure 5-118**. The AudioMoth detectors were recording duration was for 5 seconds configured to start recording from 18:30 to 06:00 for 3 nights.

The sample rate was 384 kHz, and the gain was set at medium. The sleep duration was 5 seconds, and the the devices were deployed at least 2m above the ground, primarily on trees. The Kaleidoscope Pro® software was used to process and ID the bat calls from all acoustic devices. Please note that the software can only auto-ID ten of Jamaica's 21 species of bats. The other species were identified using a call library from Windsor Research Center and internet resources.
