**REPORT  
ENVIRONMENTAL IMPACT ASSESSMENT  
FOR  
SANDALS MONTEGO BAY  
(OVERWATER BUNGALOWS & VILLAS)**

March 18, 2025

Document No.: TEMN-ESL/SRI-2024-01

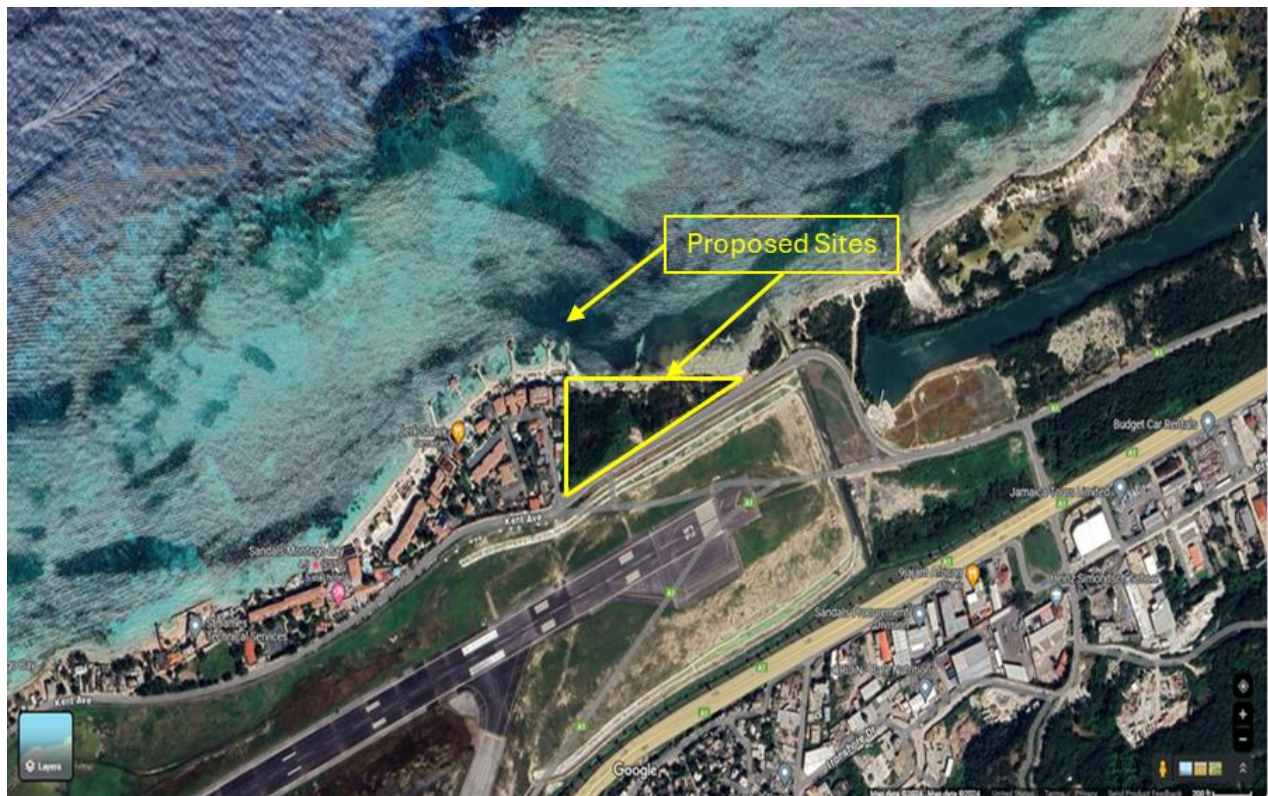
FIGURE 6-1: PROPOSED PROJECT SITE - OCEAN AND VACANT LOT

**Land Use Findings – Onsite** – The land use of the proposed site for the villa-style bungalows consists of a 2-ha vacant parcel of land that is covered in secondary coastal forest with two wetland areas and a concrete pool, while the site of the overwater bungalows is the Caribbean Sea (Figure 6-1). Access

to the overwater bungalows extends from the eastern boundary of the existing Sandals Montego Bay Resort (resort land use category). The site is bordered to the west by a drainage gully beyond which is vacant land. To the north of the site is the Caribbean Sea, while the roadway – Kent Avenue borders the site to the south. Beyond Kent Avenue is the western end of the runway of Sangster International Airport.

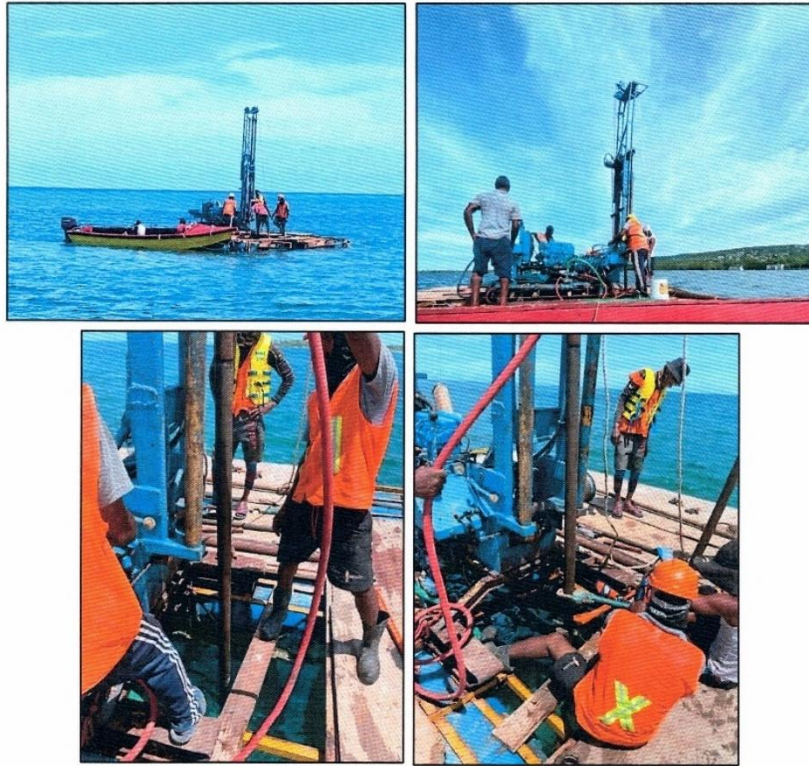
*Plate 3-1: Offshore borehole drilling at Sandals, Montego Bay using a Barge mounted Drill Rig*

The boreholes were advanced with a rotary drill, equipped with a split-spoon sampler and auger stem attachment (**Plate 3-1**). Disturbed samples were collected at varying intervals of 0.3m (1 ft), 0.5m (1.5 ft), 0.6m (2 ft), 0.8m (2.5 ft), or 0.9m (3 ft) up to a depth of 3m (10 ft). Beyond this depth, samples were taken at 1.5m (5 ft) intervals to the borehole's termination depth.

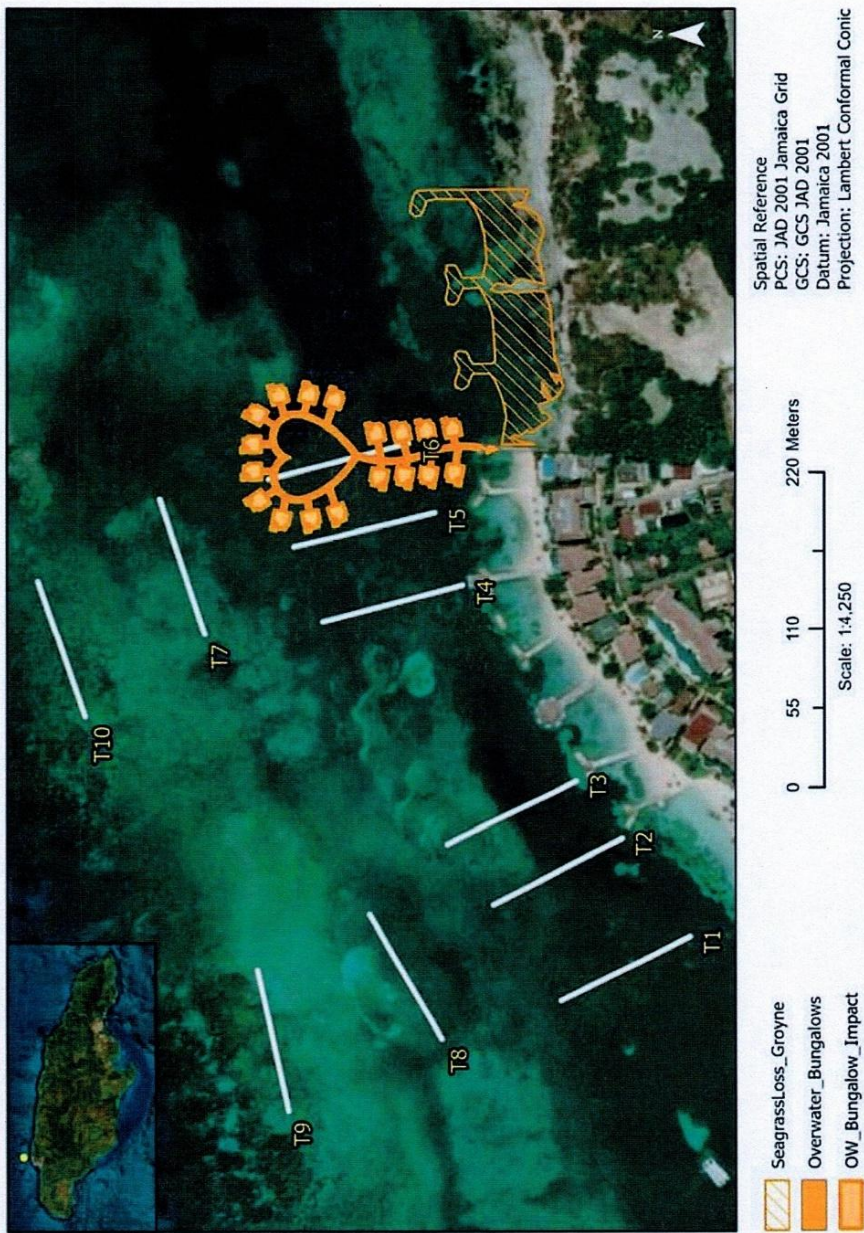
Plan 2: Location of the Benthic Survey at the Sandals Montego Bay Location (Courtesy of Sandals Resorts International)

The proposed project will involve coastal modifications aimed at enhancing the beach and will feature the construction of a sea wall, rock groynes, a rock revetment on the property's eastern side and the expansion of the beach area through the addition of sand fill.

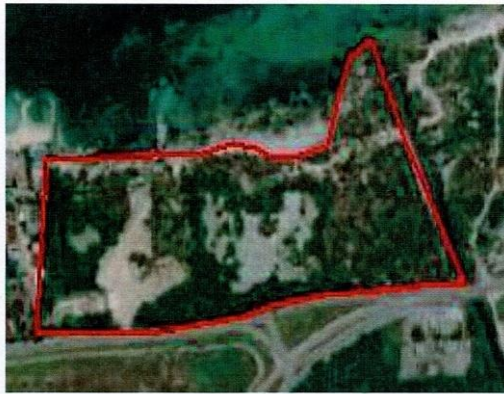
**Satellite Imagery 1:** Google earth image showing coastline prior to 2010

The area is a relatively narrow piece of land with a maximum width of about 124m, the area narrows moving eastward with lows of 9.7m. The proposed development area has been impacted by major wave action in the past causing erosion and the loss of sections of the beach. Satellite imageries 1 and 2 below show how the eastern segment of the land parcel has deteriorated over time due to climate change impacts, leading to the current rugged features and narrow coastline appearance.

The aesthetic of the coastline has changed overtime and now displays coastal damage with washed up refuse and exposed rocks. It was observed that Satellite imagery 1 displayed two large distinctive ponds whereas the on later Satellite imagery 2 the ponds are not as evident because of the existing vegetation that has covered the area.

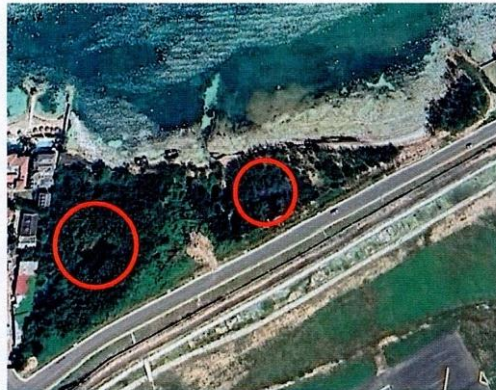
**Satellite Imagery 2:** Google earth image showing more recent image of the coastline dated February 23, 2024

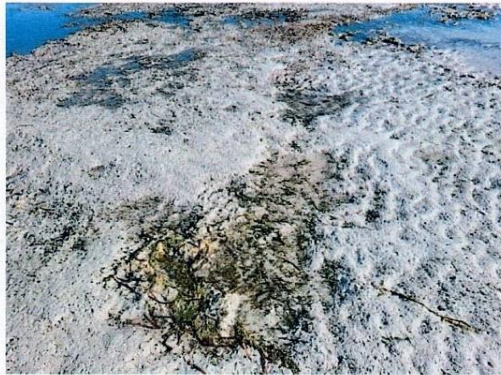
**Plate 12: Sea grass exposed during low tides**

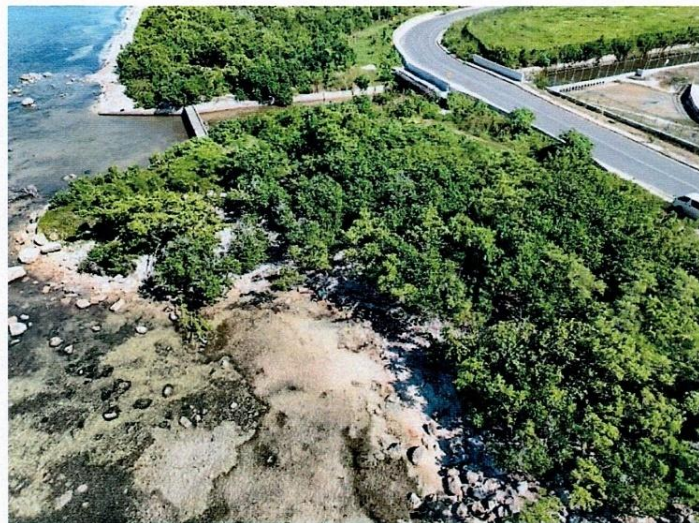
The area appears to have been artificially altered in the past, as boulders seem to have been brought in and deposited there. This may have been an effort aimed at supporting the revetment. To the east of the proposed development area is the airport canal/channel, which take excess water from the airport runway and discharges it into the sea.

**Plate 14: An overview of the coastline, featuring boulders and stones**

However, while some boulders were transported from elsewhere, there is evidence of natural deposits as well. These natural deposits of large rocks and boulders were observed closer to the shoreline and within the receding waterline.

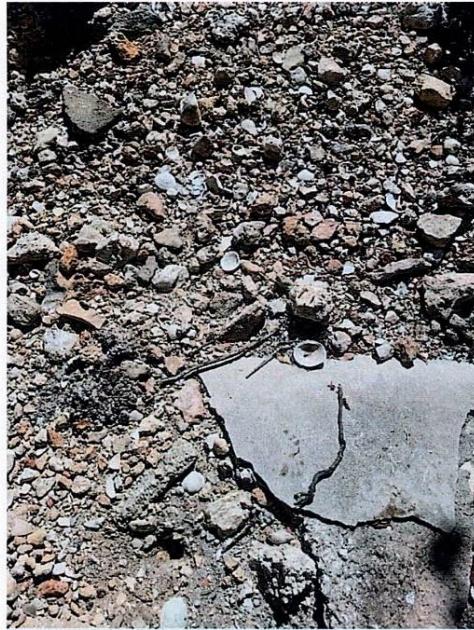
**Plate 19: Displaced concrete foundations**

Uplifted concrete slabs are also observed at various sections throughout the property. The displacement of these slabs suggests that some building foundations may have been located within the vicinity.

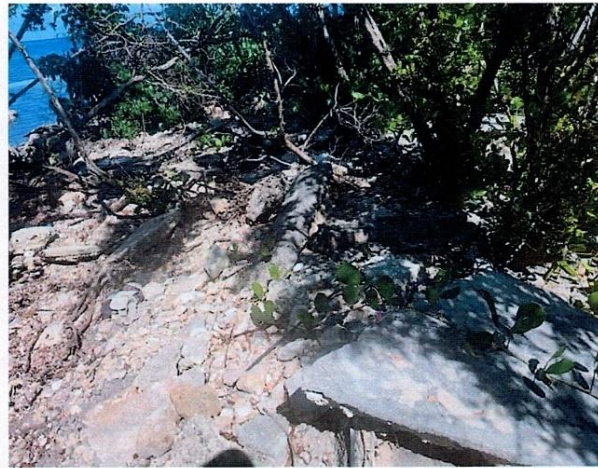
**Plate 20: Uplifted concrete foundation**

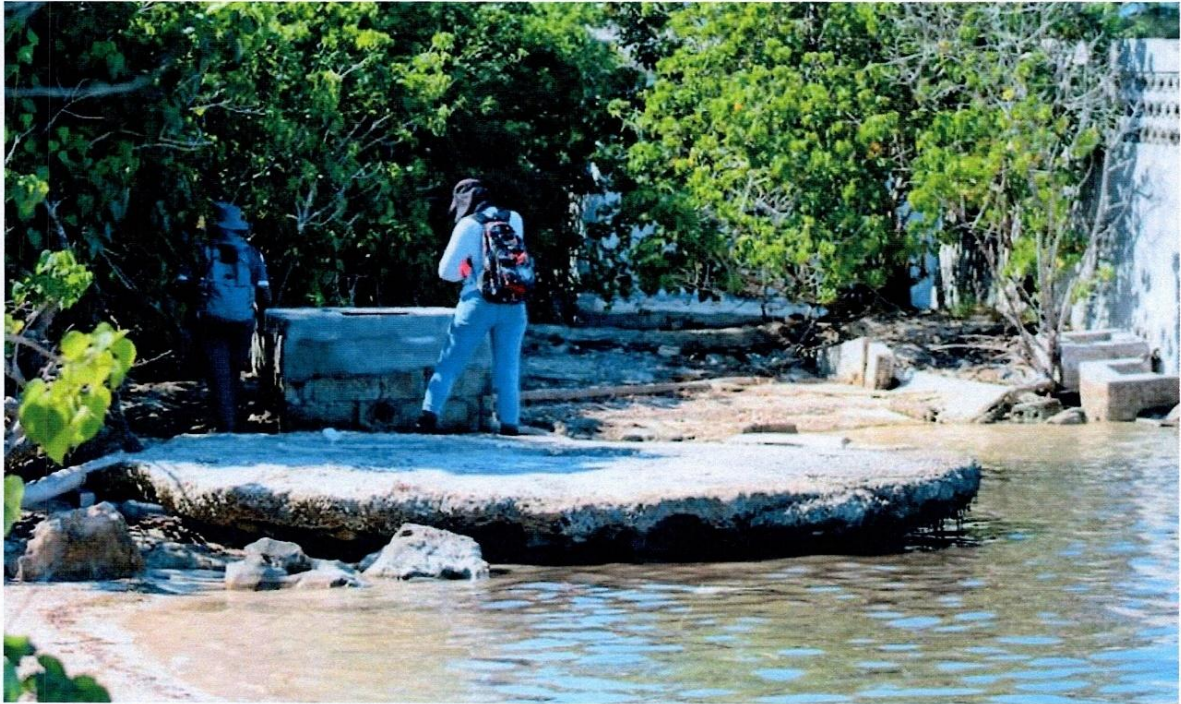
Several abandoned concrete structures were identified, which were once used as public beach changing rooms and possible restrooms. Over time, land reclamation by the sea and constant wave action have eroded these buildings, causing some of the concrete foundations to be lifted and displaced.

**Plate 37: Uplifted concrete foundation with cistern nearby**

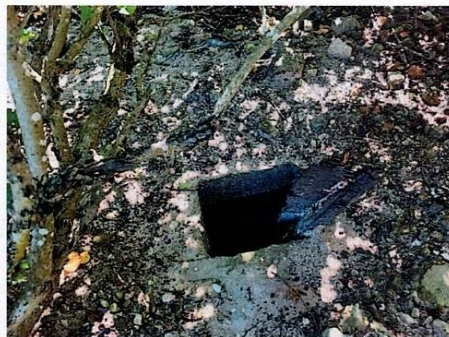
In addition, there are visible electrical conduits and old pipes still present. Notably, a strong stench emanates from this area, suggesting the presence of a nearby sewage system. It is evident that the sewage system is contaminating the seawater, particularly during high tides.

**Plate 38: An exposed manhole**

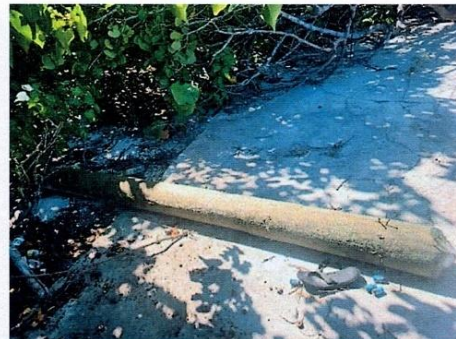
**Plate 39: Fallen light post**

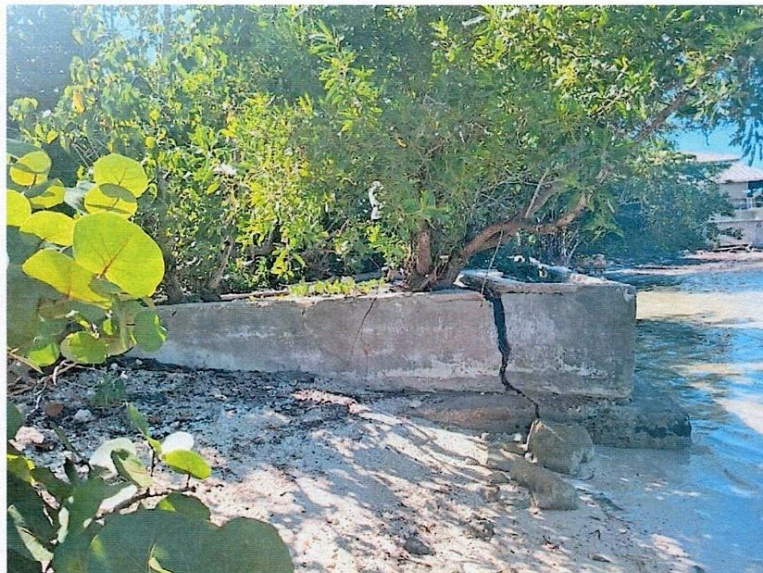
**Plate 42: A tree was observed growing through the concrete, causing it to crack**

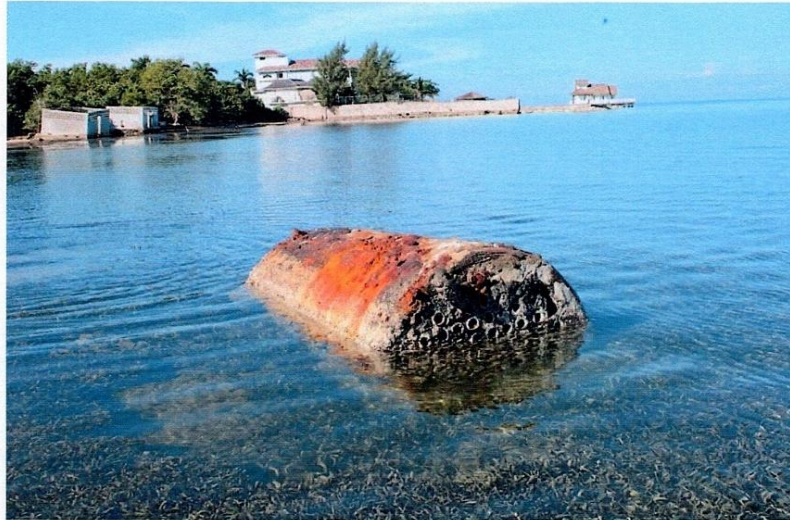
A metal cylindrical object was observed several meters offshore, approximately 152.8 feet from the shoreline. Local fishermen believe the object holds little value and is likely debris from a ship. One fisherman mentioned that it has been in the area for over twenty years.

**Plate 49: Cylindrical object located offshore**

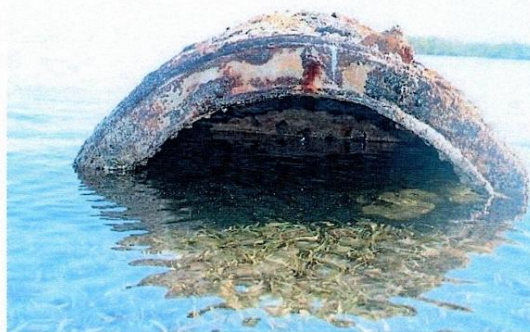
The object features an opening with a diameter of 4 feet 6 inches and a length of 8 feet. Additionally, there are perforations at its base.

**Plate 50: Opening of the cylindrical object**

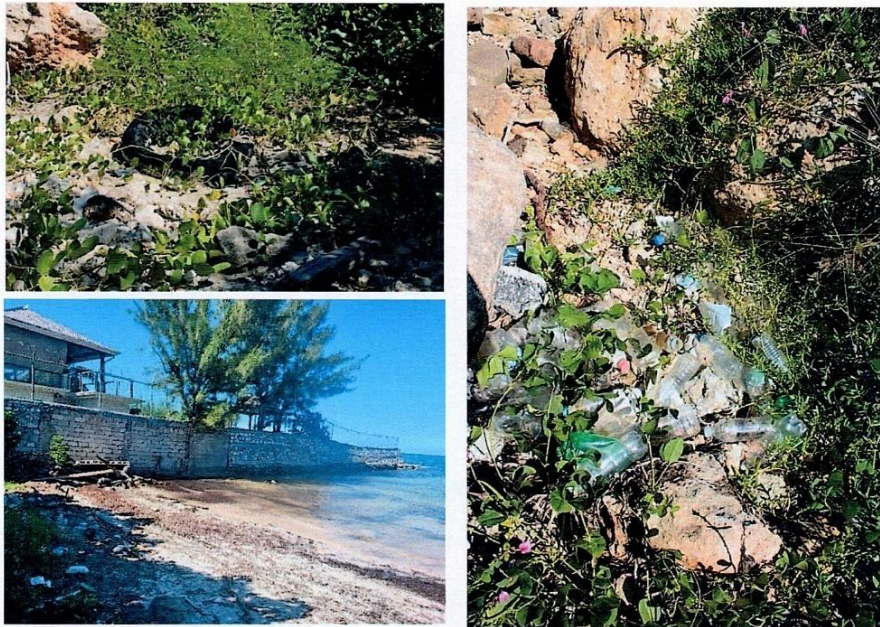
Several waste materials have been observed throughout the site, including areas along the shoreline and in the swamp regions. There is also a build-up of debris washed ashore by high tides. Some of the waste materials observed included plastic bottles, tyres, Styrofoam boxes amongst other materials. Additionally, tiles, old pipes, and wires were seen within the interior sections, scattered among the concrete foundation, which likely would have been part of the flooring.

**Plates 51-53: Waste materials seen along the beach**

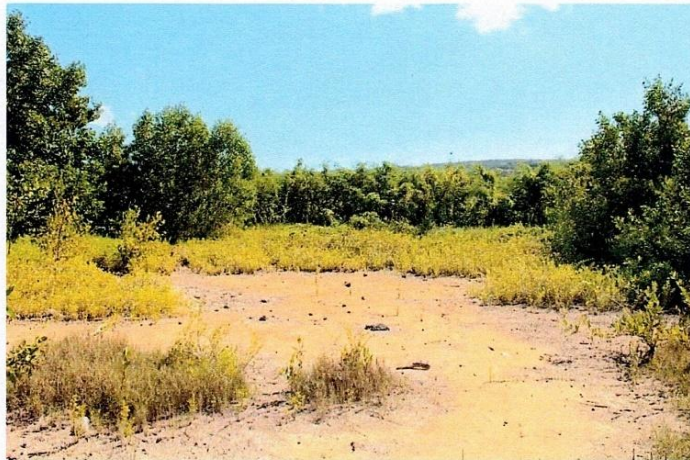
There are some dry areas and muddy sections, but the fishermen pointed out that whenever it rains or during high tides, the water in this area takes several days to recede to normal levels.

**Plate 55: This area was covered in mud**
