DUNE RESTORATION MONITORING REPORT 2
FOR
AMERICAN AIRLINES 331 ACCIDENT SITE

Submitted to:
AMERICAN AIRLINES

Prepared by:
C.L. ENVIRONMENTAL CO. LTD.
22 Fort George Heights
Kingston 9
Jamaica, WI

DECEMBER 2010

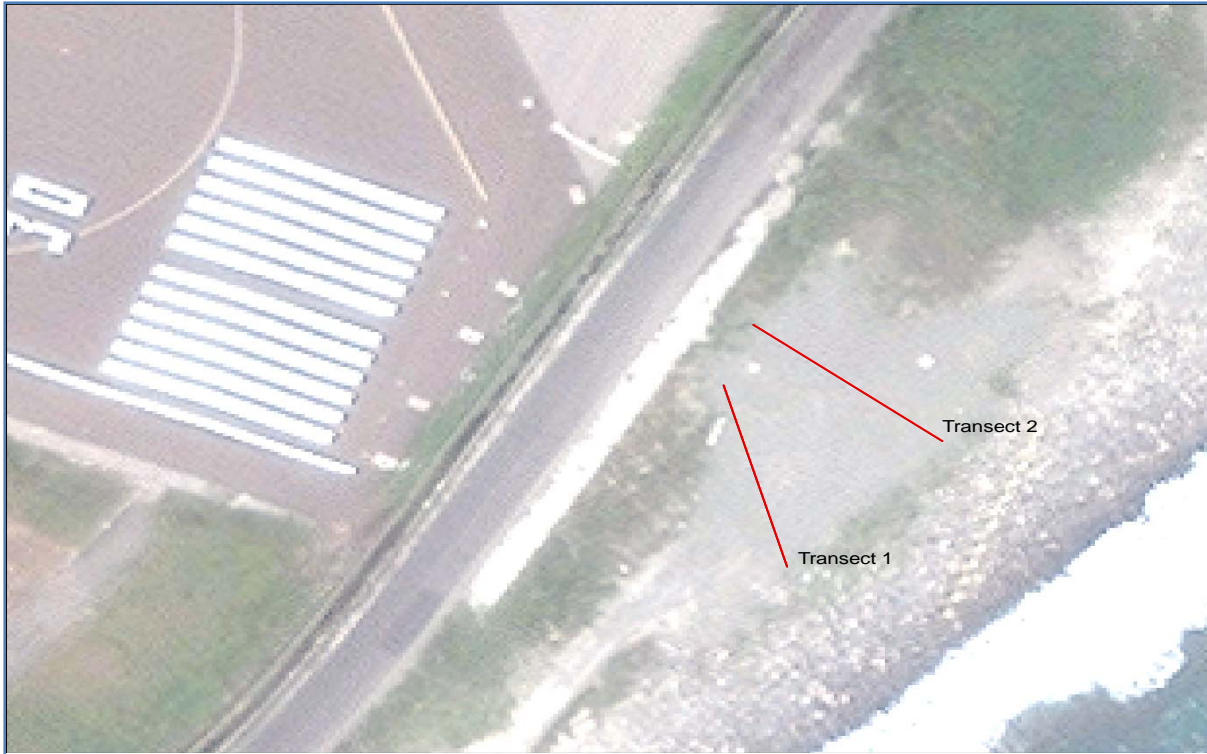
Figure 1 Map showing locations of belt transects at dune restoration site

Two belt transects which were two meters wide by thirty-two meters long, previously established at the restoration site, were used to determine both growth and survivorship. The transect began at the southern end (seaward) of the area at the edges of the replanted site and ran diagonally across the area ending at the western edges of man-holes close to the roadway (Figure 1) (Plates 2-3).
