ENGINEERING GEOLOGICAL SURVEY REPORT (ABRIDGED VERSION)

JAMAICA NORTH SOUTH HIGHWAY PROJECT SECTION 1A

CAYMANAS TO LINSTED REALIGNMENT

(CAYMANAS INTERCHANGE)

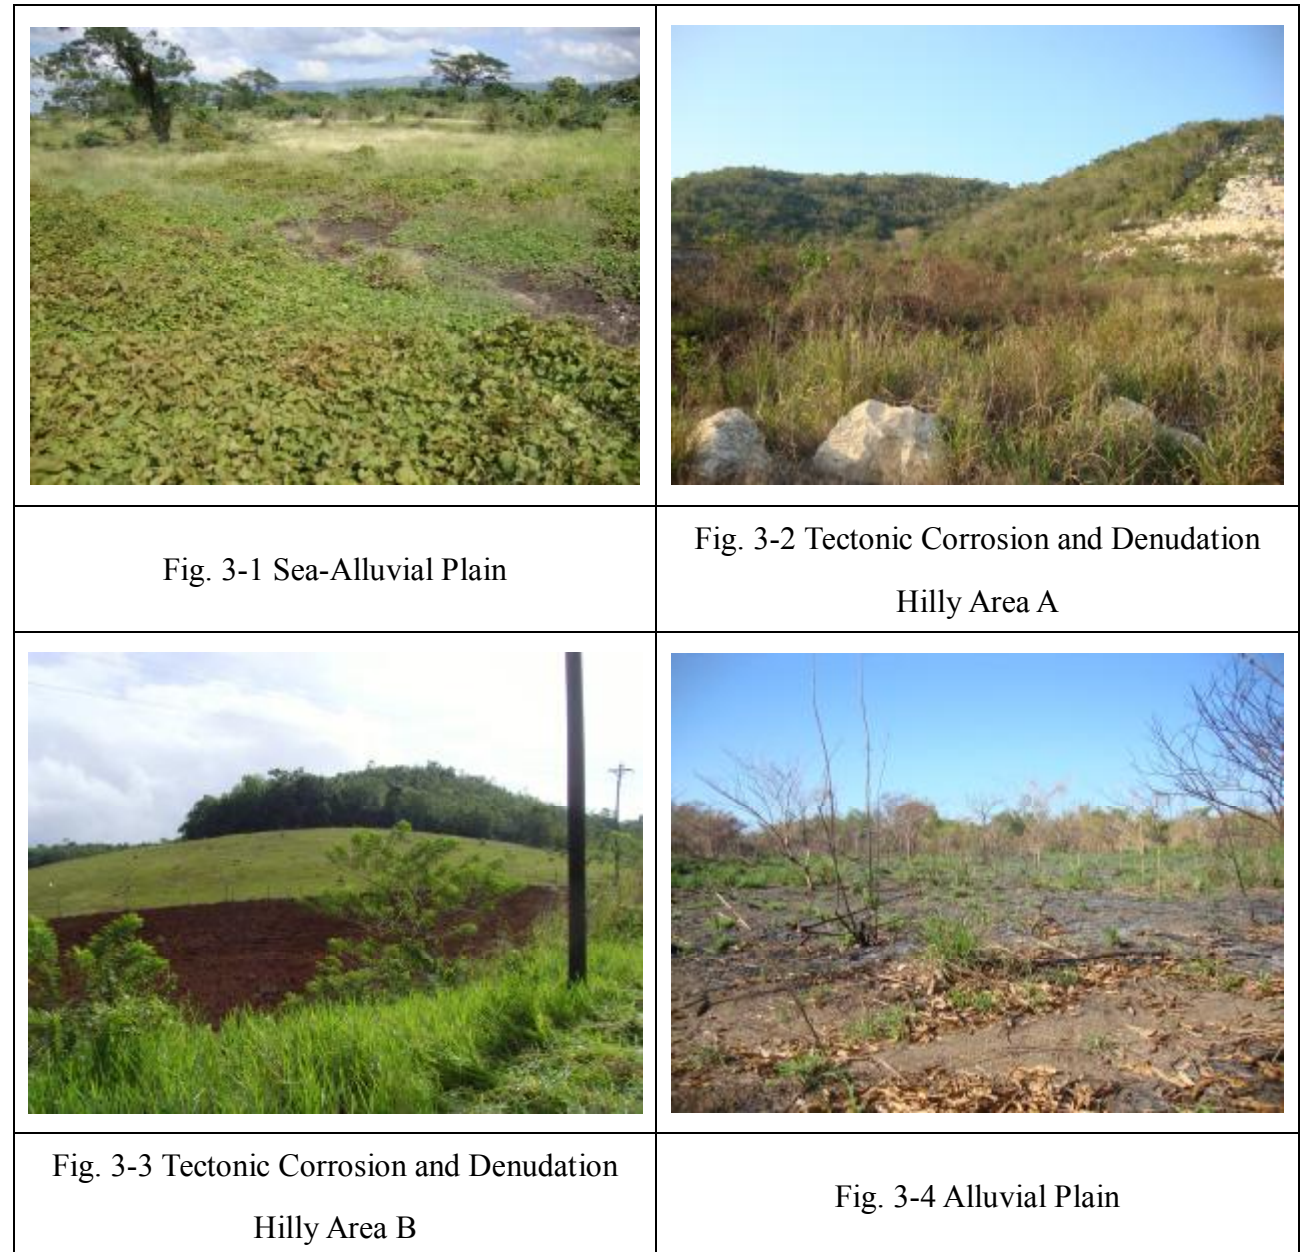
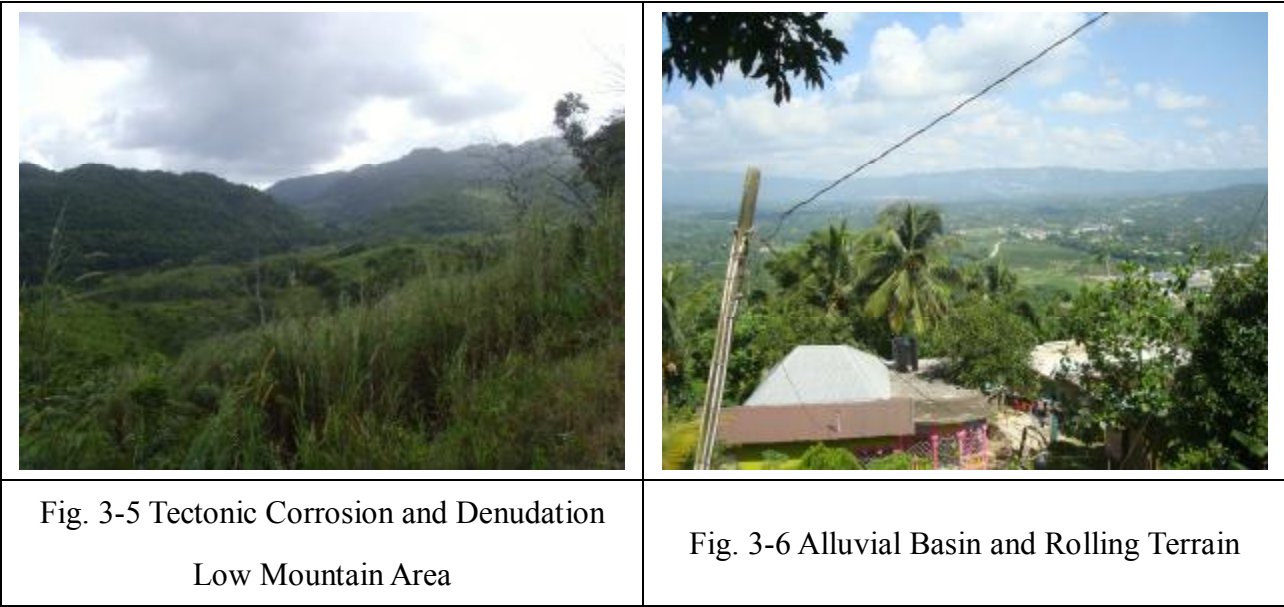
(Section K23+600-K25+600), it is rolling terrain and the terrain is undulating but smooth in general. The covering layer is thick in the basin; the overburden layer in the tiny hillock area varies greatly and the bedrock exposes in some parts. The overburden layer is alluvial clay formed long before and it is hard plastic and solid in general. The mechanical property of the clay in valley area of the river and in low-lying places is poor; the expansibility of the clay layer is at moderate and strong level; the exposed bedrock is gray limestone group in the Tertiary layer. The engineering geological conditions in this area are ordinary (Fig. 3-6).

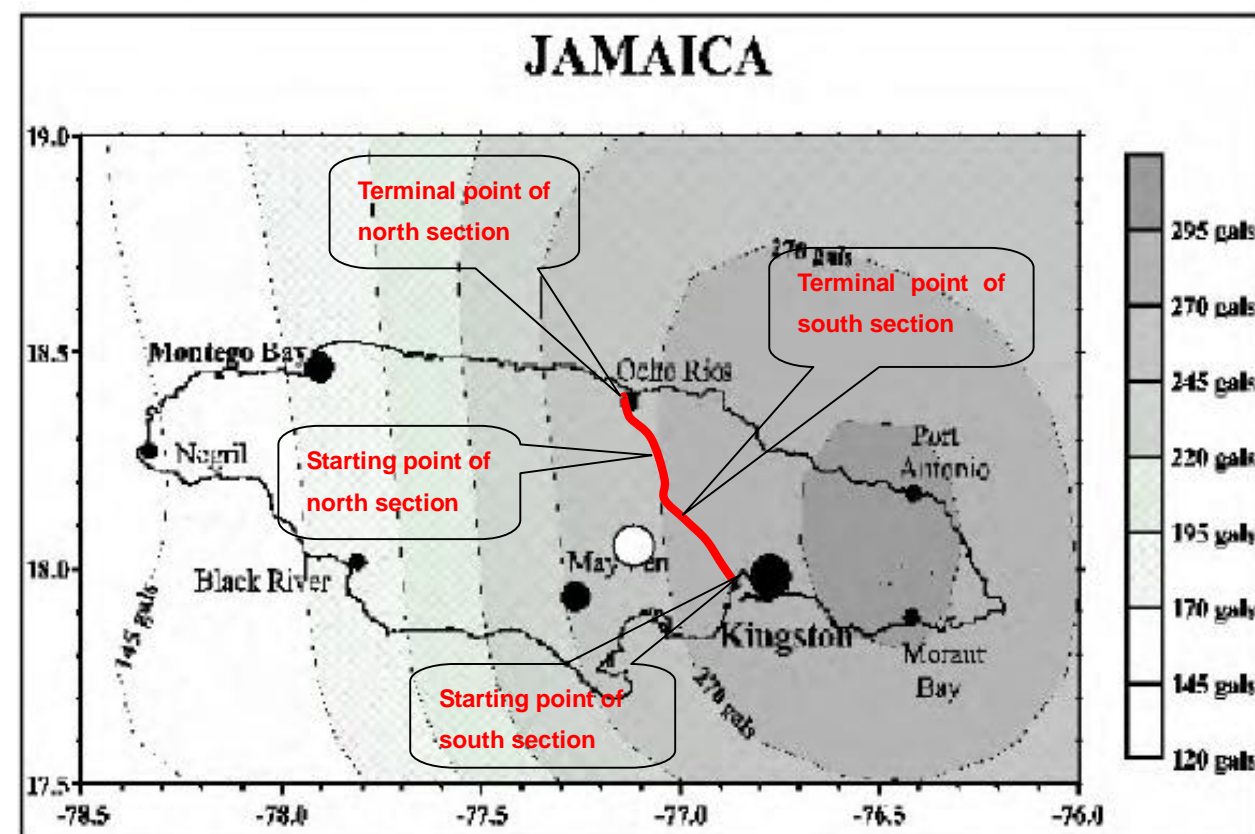
Fig. 3-11 Jamaica Seismic Parameters

Figure 4-48 - Horizontal ground acceleration with 10% probability of exceedence in fifty years (Shepherd et al. 1999 in CDMP 2001), Contour interval is 25 gals (2.5%g). Modified from CDMP 2001. White spot is location of the Rio Cobre Gorge bypass

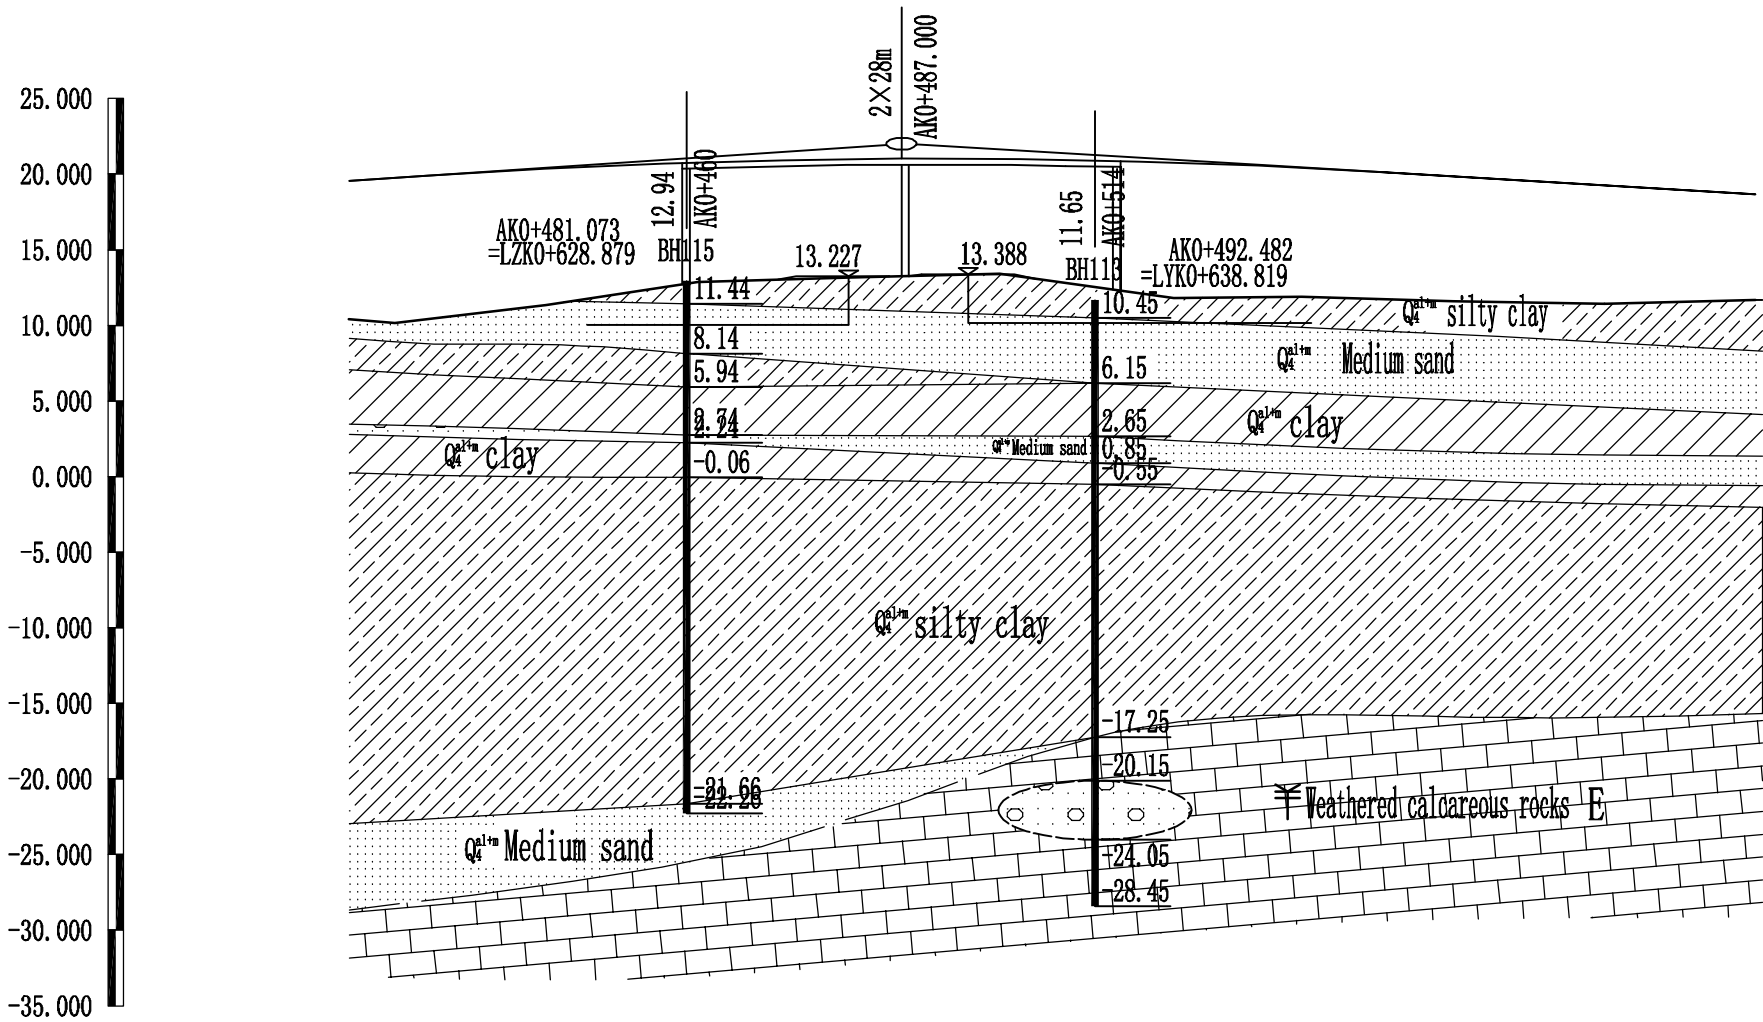
垂直比例尺 1:500
水平比例尺 1:1000

Ground elevation	10.16	11.35	12.86	13.17	13.40	11.82	11.90	11.57	11.41	11.67
Mileage stake number	AKO+420.000	AKO+440.000	AKO+460.000	AKO+480.000	AKO+500.000	AKO+520.000	AKO+540.000	AKO+560.000	AKO+580.000	AKO+600.000
