ENVIRONMENTAL ASSESSMENT

Jamaica North South Highway - Caymanas to Linstead Realignment

Date: **December 2014**

JAMAICA NORTH SOUTH HIGHWAY – CAYMANAS TO LINSTAD REALIGNMENT

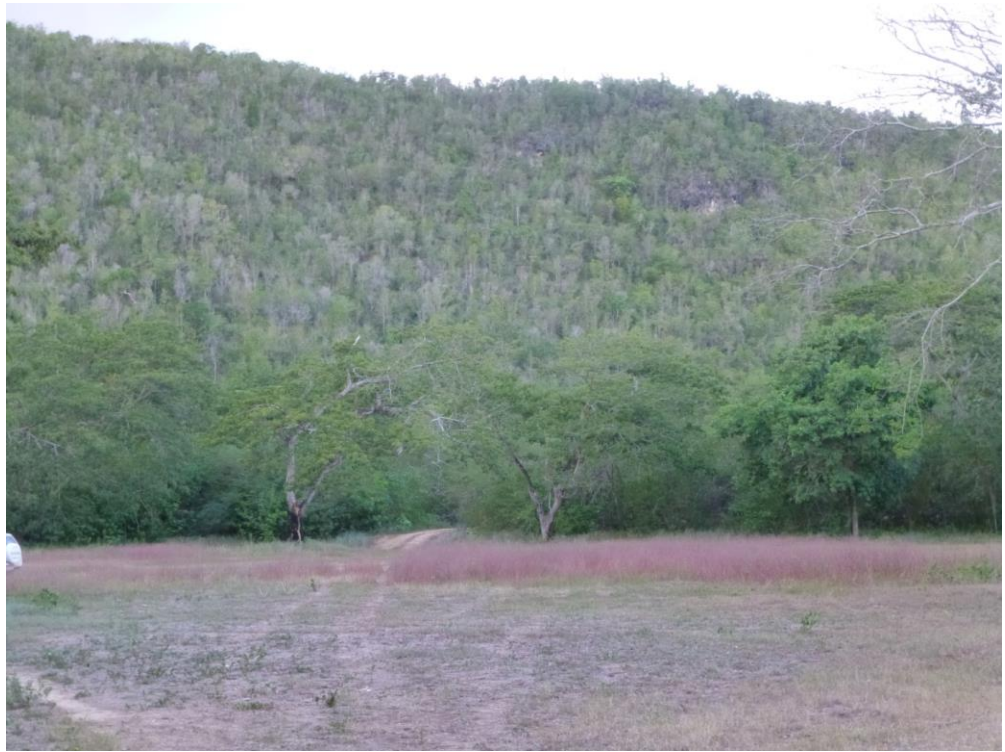
Plate 1 Caymanas Fault Escarpment

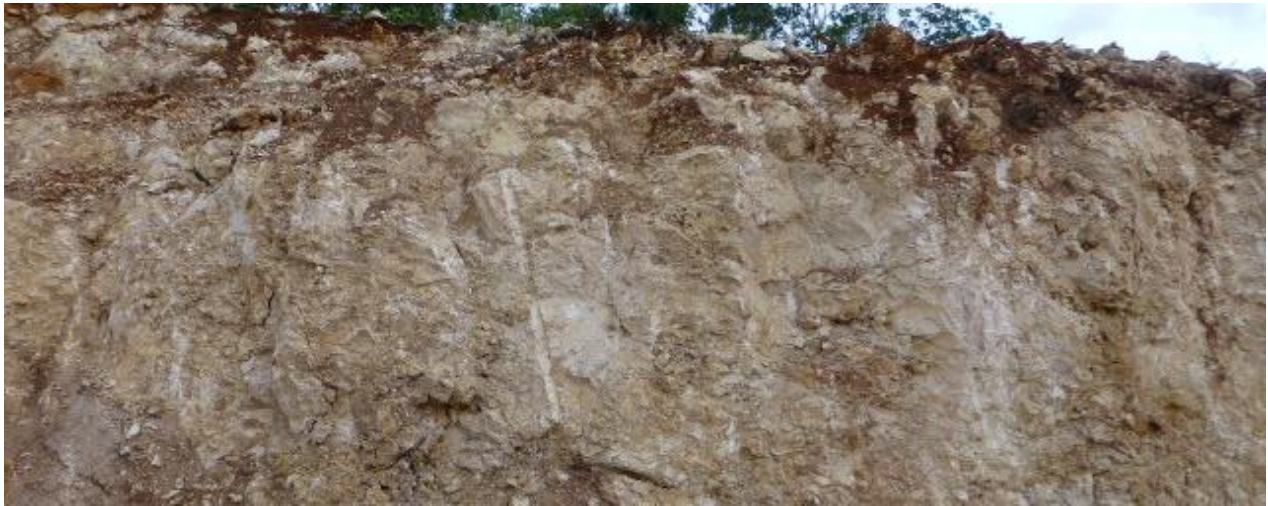
Plate 2 Typical Limestone (Walderston) Outcrop

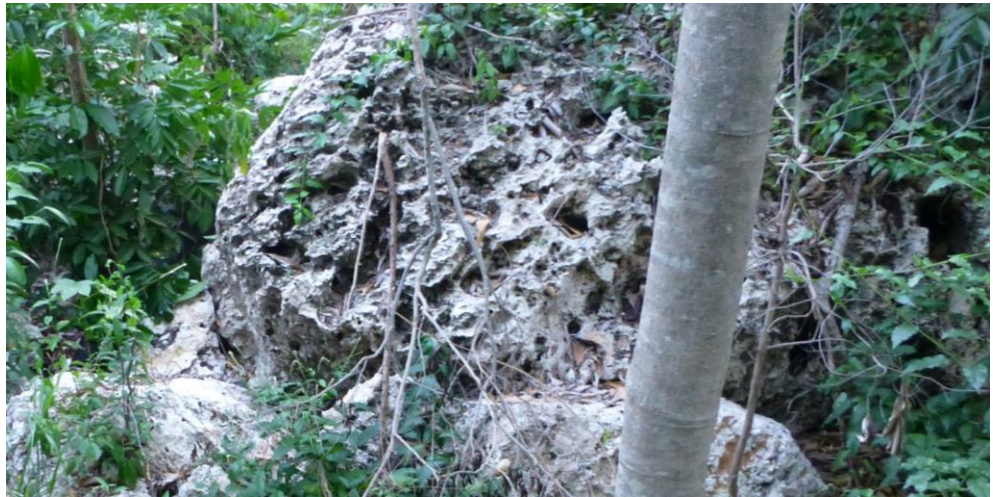
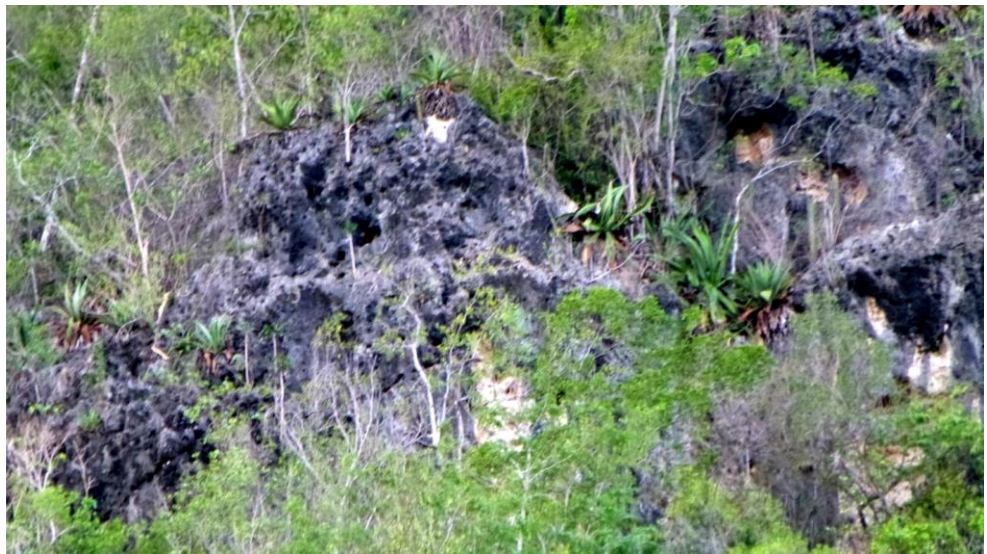
Plate 3 Limestone Outcrop in the Fault Escarpment

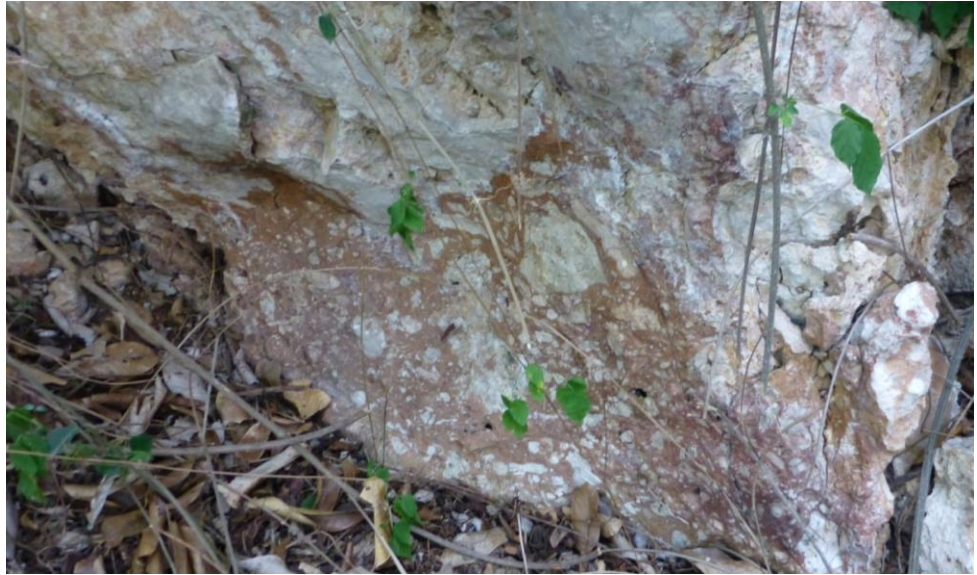
Plate 4 Outcrop with re-cemented laterite and scree

Much of the new alignment traverses a fault zone, which marks the contact between the limestone block and the alluvial plain. The main fault along the alignment route trends to the north-north east. Movement along the fault is likely to have altered the original marly limestone lithology to breccias within the zone of movement with a talus apron forming along the foot of the fault scarp (Plate 3). This may result in higher levels of secondary porosity as well as instability. However, the high level of purity in this limestone often results in rapid re-cementation of scree and infilling of voids by more crystalline calcium carbonate (Plate 4).

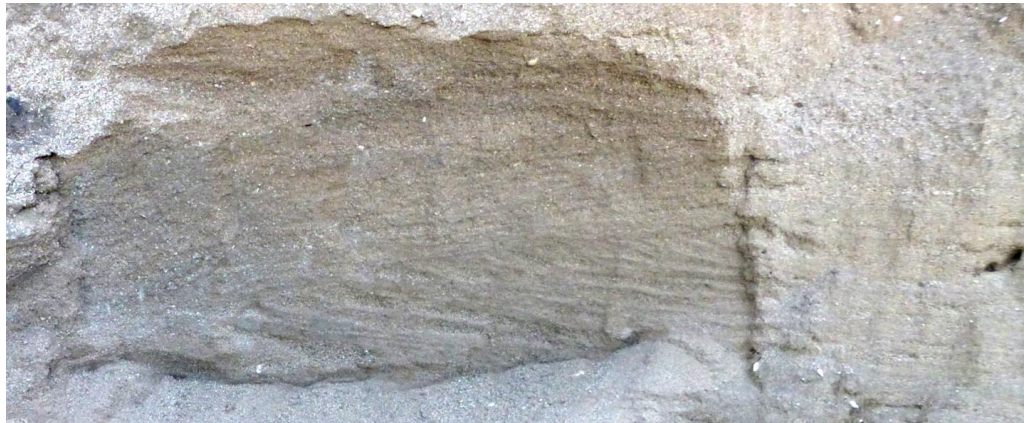
Plate 5 Coarse Alluvium with fluvial bed-forms

The Caymanas Alluvial Series (Sandy and Clay Loams) is a relatively thick (>1 m), fertile soil developed on Recent alluvium associated with the Rio Cobre floodplain (Plate 5). It is characterized by very gentle slopes (0 to 2 degrees). Internal drainage depends on the presence of clay lenses. Sandier areas can be expected to have very good infiltration capacity and high permeability. The top soil tends to be dark grey brown, becoming paler and coarser with depth.

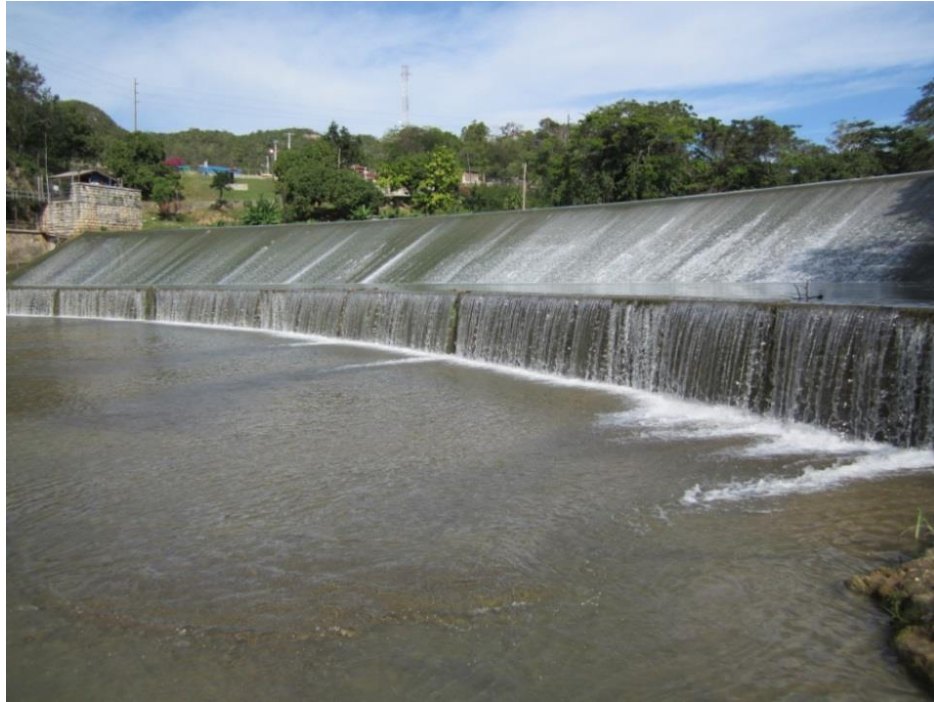
Plate 6 Rio Cobre Dam situated downstream of the proposed alignment crossing

The Rio Cobre originates north of the alignment and flows south-east. It collects flows from the rivers aforementioned in the Bog Walk area and eventually discharges these flows into the sea. Having the largest area, the catchment associated with the Rio Cobre measures 46,140 hectares. A dam is located downstream of the proposed alignment (Plate 6).

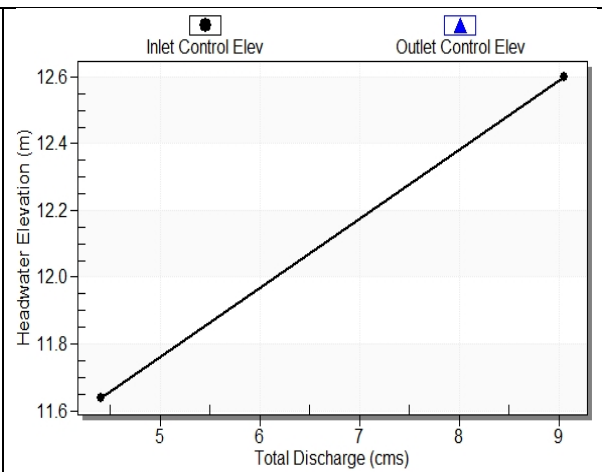
Figure 18 Performance curve for culvert during 1:10yr rainfall event using one (1) 2m culvert pipe.

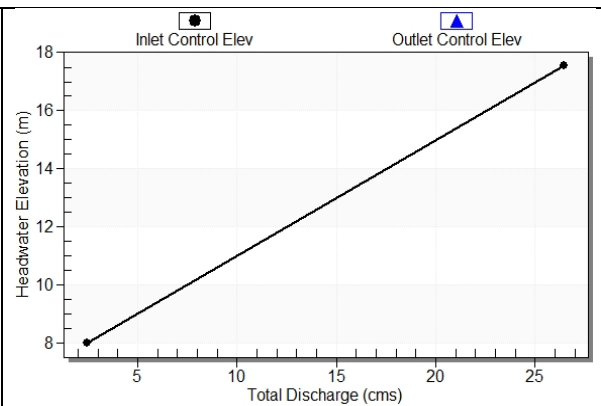
Figure 28 Performance curve for culvert during 1:10yr rainfall event using one (1) 2m culvert pipe.

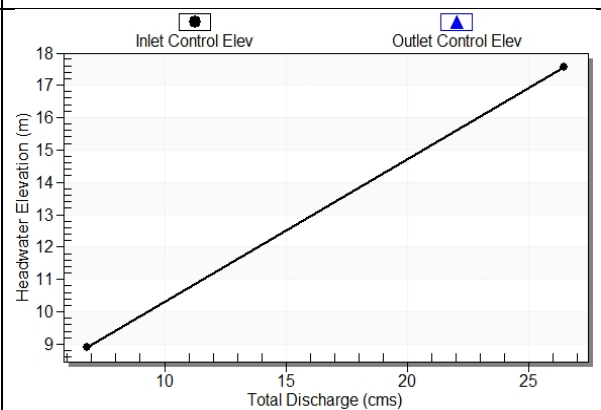
Figure 30 Performance curve for culvert during 1:100yr rainfall event using one (1) 2m culvert pipe.

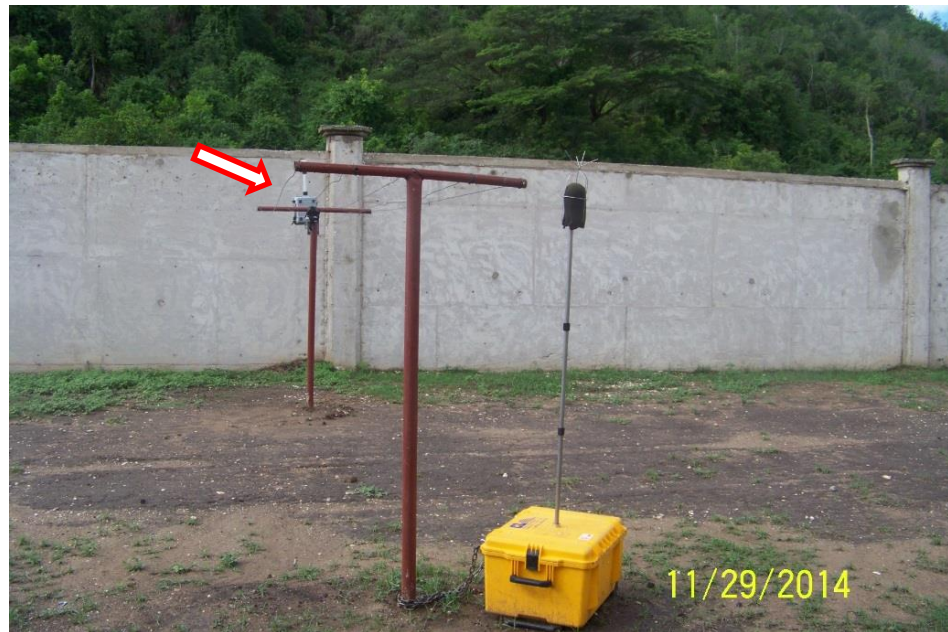
Plate 7 Photo showing noise meter at Station N1 (foreground) and particulates pump in the background (P1)

A windscreen (sponge) was placed over the microphone to prevent measurement errors due to noise caused by wind blowing across the microphone. The noise monitoring outdoor kit and the particulate pump are shown in Plate 7.

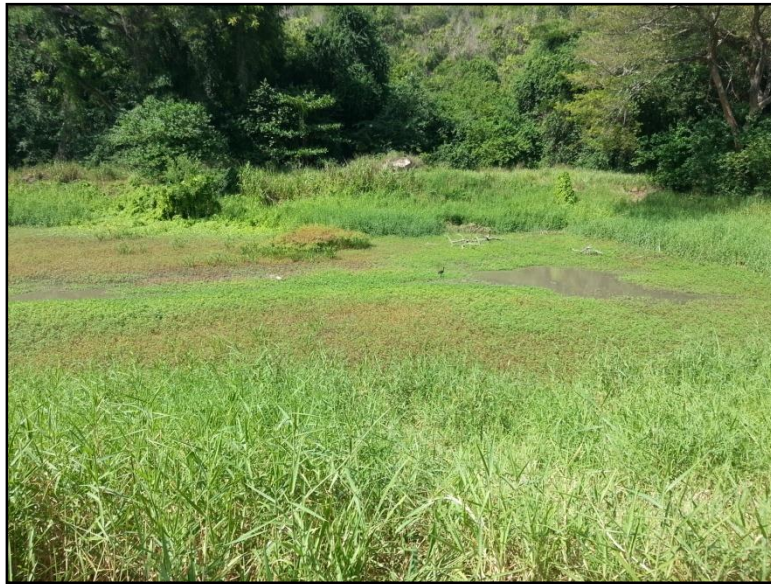
Figure 67 Pond behind Kingston Polo Club

The current rights-of-way should take the highway development nearby/through a pond system that (according to local reports) was fed by subsurface runoff and rainwater (Figure 67). The dominant plant species in this community was *Pistia stratiotes* (Water Lettuce). Bordering the pond were primarily sedges (*Cyperus* spp.).

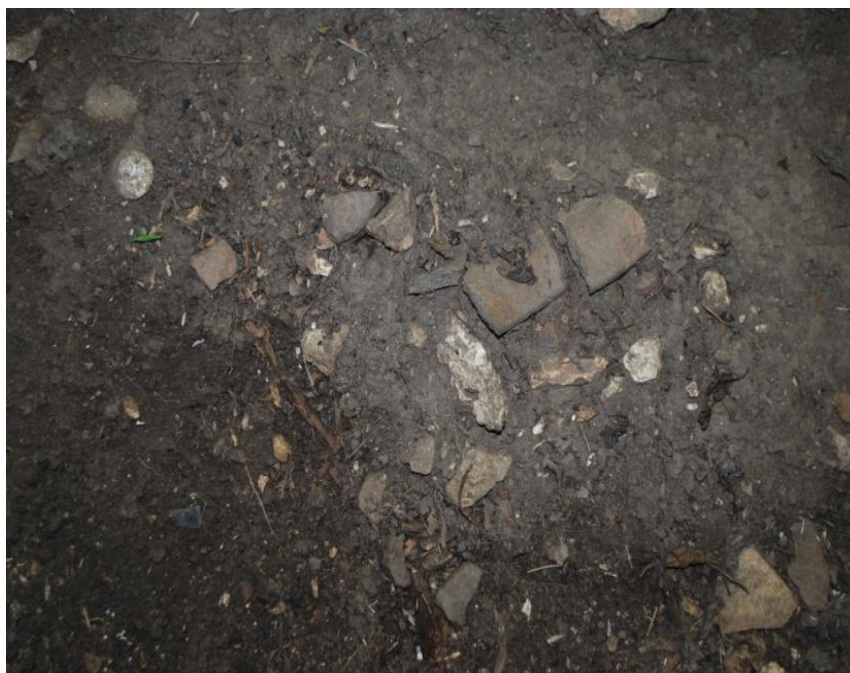
Plate 10 Showing assemblage of artefacts in situ in the Ellis Slave Village

At grid reference point 18Q0297298, 1993632 in the Slave Village area a number of artefacts were recovered (Plate 10).

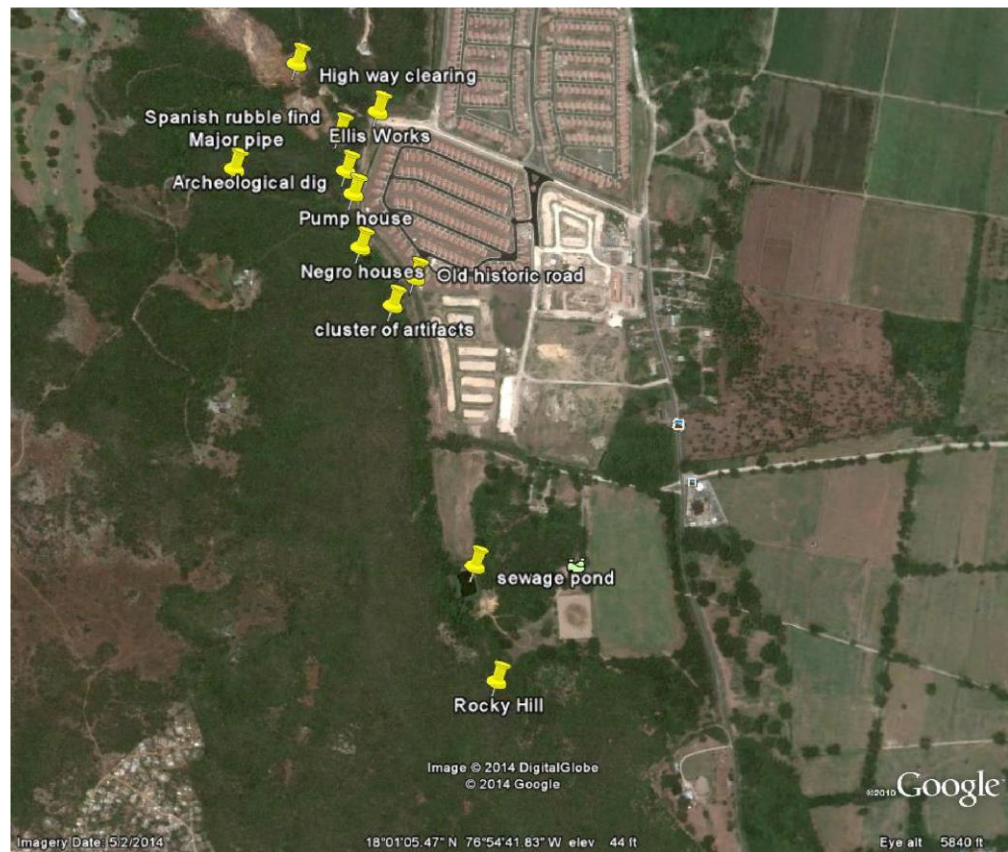
Figure 72 Satellite image showing points of interest

The JNHT have identified points of interest along the proposed realigned Jamaica North South Highway between metering 0+000 to 4+200 (Figure 72).
