Environmental Impact Assessment

Blue Mountain Renewables 34 MW Wind Farm Project Malvern, St. Elizabeth

February 2014

Environmental & Engineering Managers Ltd.

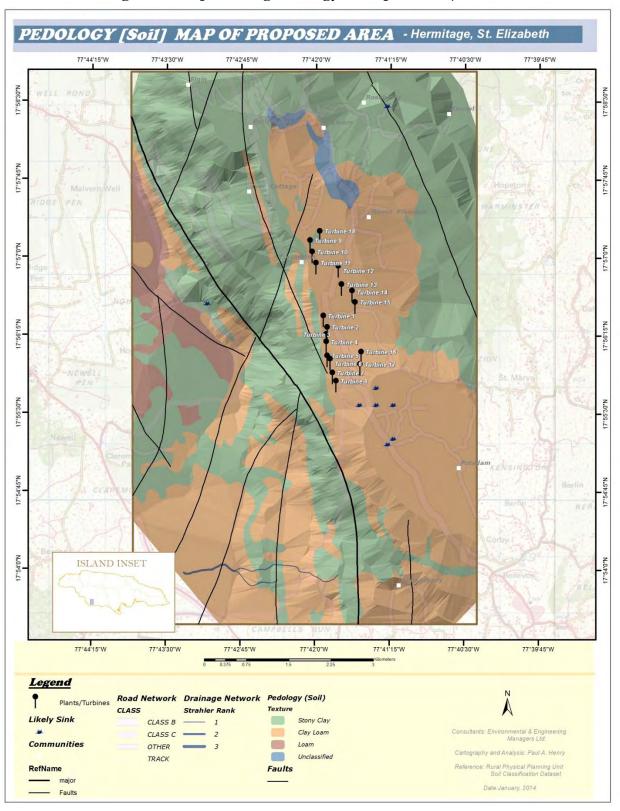
Figure 15: Map Showing Pedology of Proposed Project Area

Marked localisation is seen with loam textured soils being found exclusively on the planar lowlands. This could be as a result of a combination of the availability of surface water and biogenic factors. Additionally there is a small lens of unclassified soils found in a northwest-south east trending valley on the highland plateau. This notable spatial distribution again, could be as a result of soil infiltration rates being different in the valley reaches.

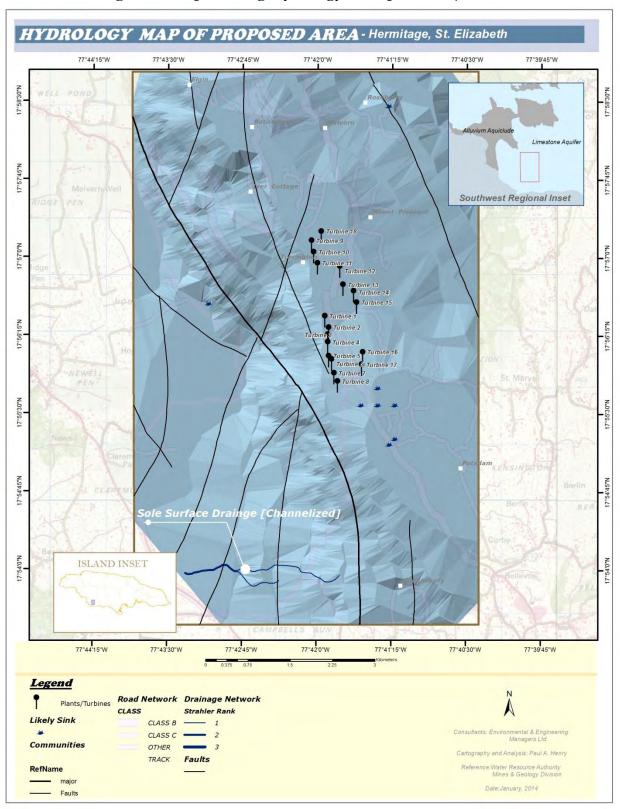
Figure 16: Map Showing Hydrology of Proposed Project Area

The hydrology map (Figure 16) indicates the presence of wells to the west of the base escarpment. These are areas where the aquifer has realised specific yield (capacity to store water).

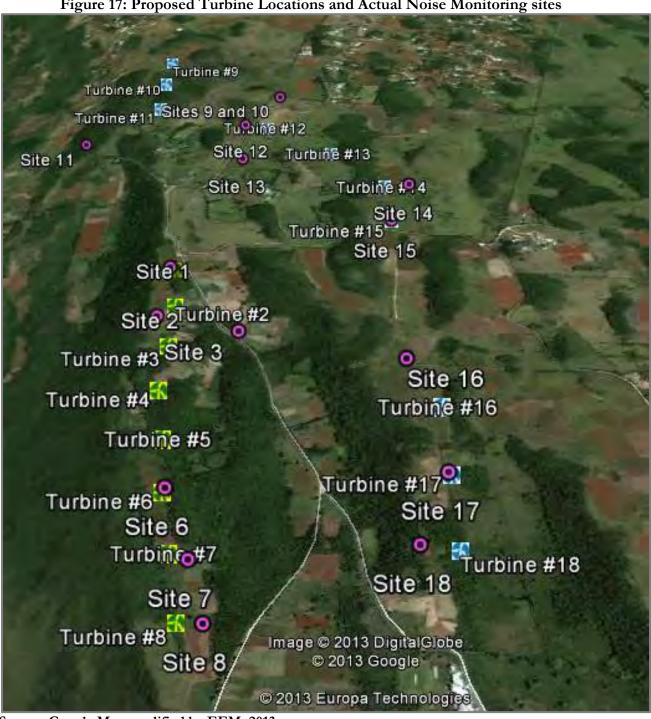
Figure 17: Proposed Turbine Locations and Actual Noise Monitoring sites

Figure 17 shows the Google Map image of these locations and highlights the proximity of the noise monitoring sites to the proposed turbine locations.

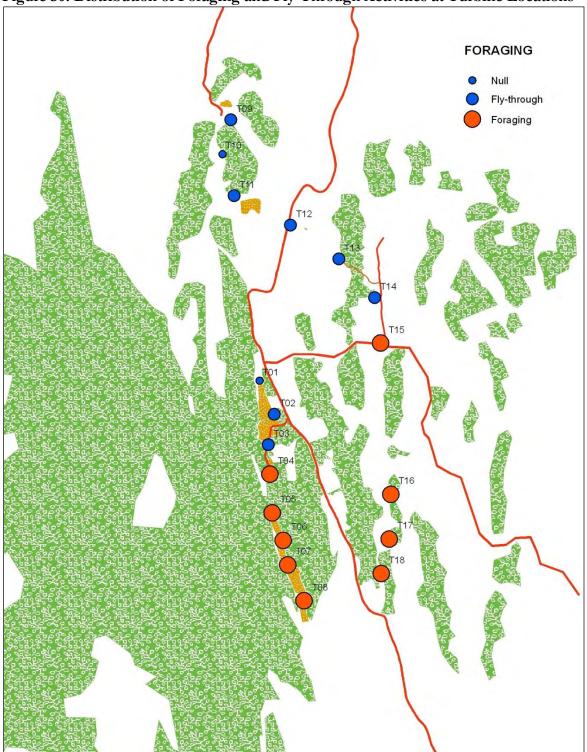
Figure 30: Distribution of Foraging and Fly-Through Activities at Turbine Locations

The behaviour of bats within forested areas was also reinforced by their foraging behaviour. Figure 30 shows that foraging activities were greatest within forested areas. Foraging information was recorded at each site, which included bat circling and the hawking of insects. The observed trends were plotted on a topographic map of the project area, which also highlighted a correlation between proximity to forest and foraging.

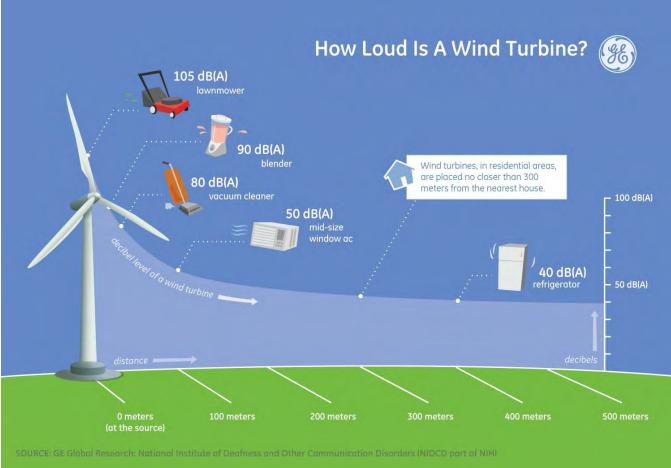
Figure 43: Noise Levels from Wind Turbines at different distances

The final design of the wind farm by the supplier Vestas has determined the locations for the wind turbines to eliminate or minimise the potential noise impact on receptors.

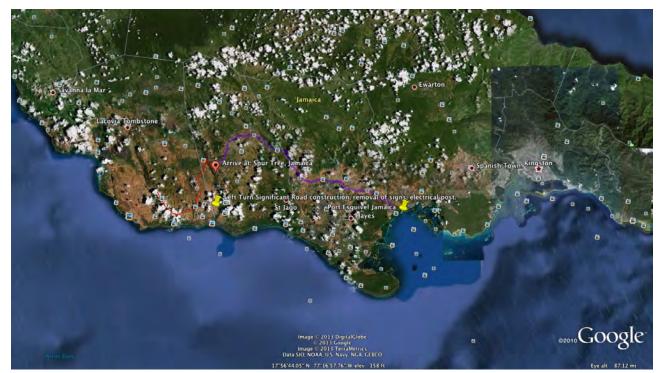
Fig1. Route overview from Port Esquivel to Blue Mountain Wind Farm

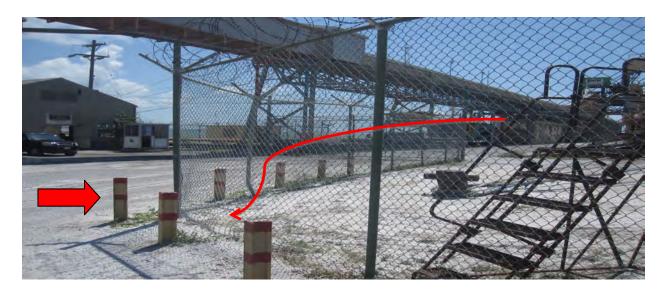
Fig 4a. Rail line barriers and fence to be removed and replaced.

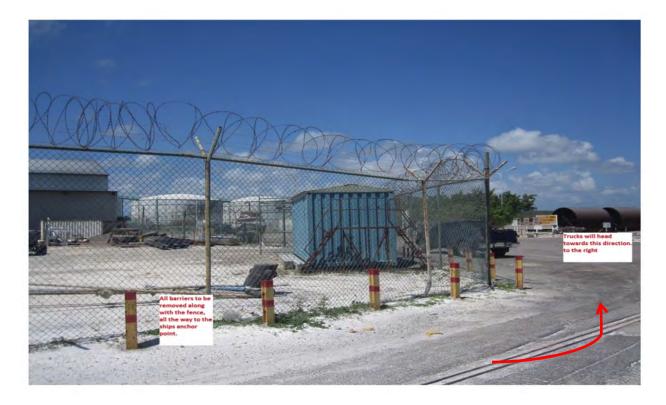
Fig 5. Container, Fence Post, Guard Rails to be removed.

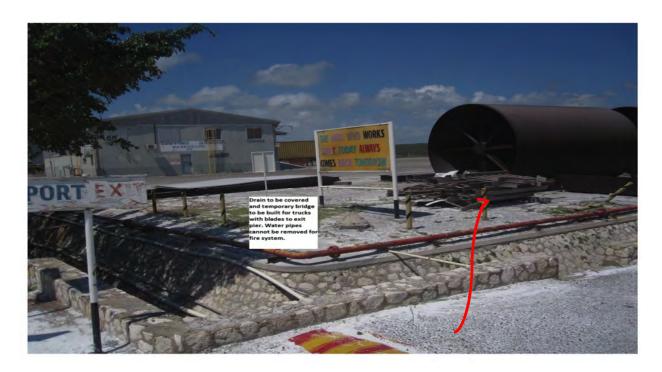
Fig 7. <u>Option for clearance to allow exit of blades from port</u> - A temporary bridge must be constructed to pass over an existing waterway and the removal and replacements of signs.

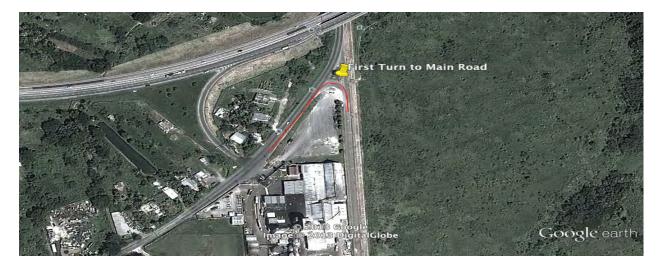
Fig 14. U turn from aerial view, ample space for making corner. No obstruction for overhanging towers. Few signs to be removed and replaced.

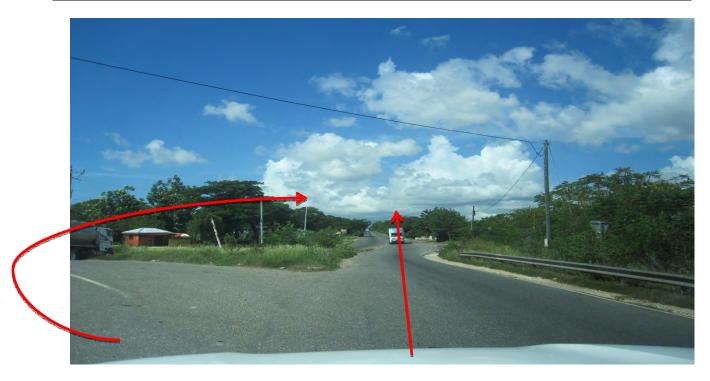
Figure 21. Intersection from A2 to T1. Braking one way to keep straight.

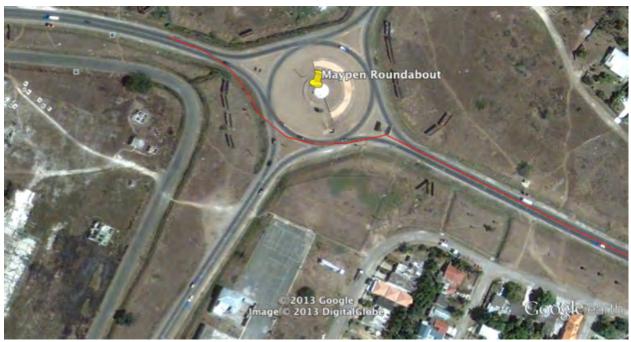
The turning radius of the roundabout is fairly wide and the curbs are low. The grass area of the roundabouts can be utilized to make the turns in which has to be repaired when the project is complete. Rear Steer Trailers can avoid climbing on the grass area.

Fig 30. Maypen Roundabout Aerial View.

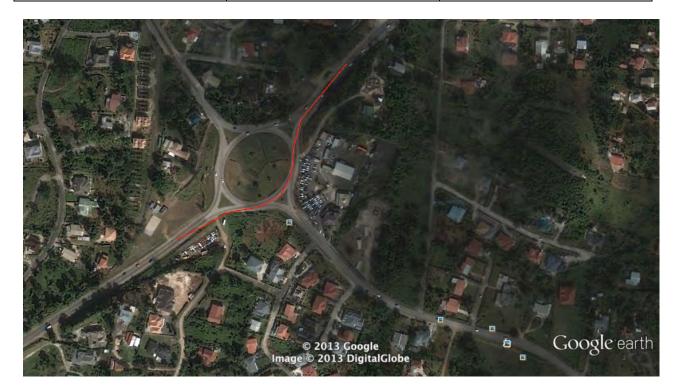
Fig 79. The Green vale Roundabout is wide and the curb walls are short. Additional turning radius is possible with climbing on the grass areas.
