Environmental Impact Assessment
**CONSTRUCTION OF TWO BREAKWATERS
AT LONG BAY, NEGRIL, WESTMORELAND**

Report Version: **FINAL**

Date: **April 2014**

**ENVIRONMENTAL IMPACT ASSESSMENT FOR
THE CONSTRUCTION OF TWO BREAKWATERS
AT LONG BAY, NEGRIL, WESTMORELAND**

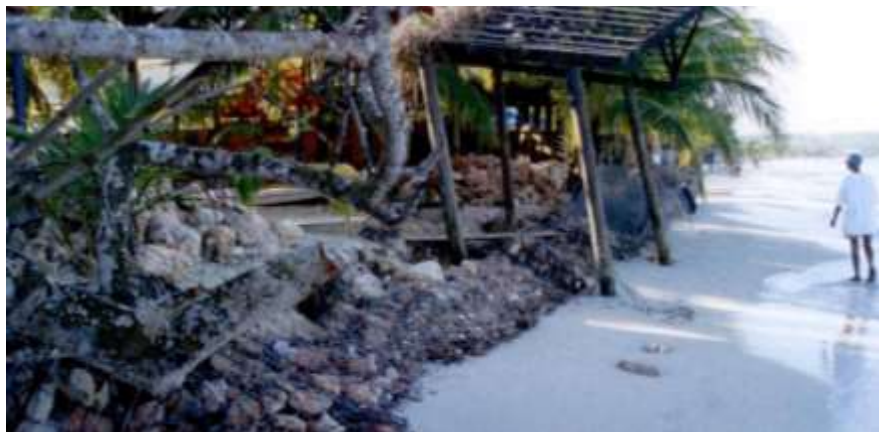
Plate 1-2 Photographic comparison between November 2004 eroded beach (top) and November 2005 recovery period (bottom) at same stretch of beach within central section of Long Bay

The erosion trend along the Negril beach, Long Bay, Westmoreland and Hanover is well known and documented (Plate 1-1 through to Plate 1-4). It is stated that erosion rates are between 0.5 metre and 1.0 metre per annum, with sections of the shoreline having lost between 20 and 55 metres of beach in this period, with some sections losing more than 70 metres. This 40-year problem facing Negril has attracted numerous studies focused on studying the causes of the beach erosion and researching various mitigation measures. Studies included those undertaken by the University of the West Indies (UWI) (2002), Smith Warner International Limited (SWIL) (2007) and the United Nations Environment Programme (UNEP) in collaboration with the Planning Institute of Jamaica (PIOJ) (2010). Prior to these, a comprehensive study on Long Bay was undertaken by Hendry (1982).

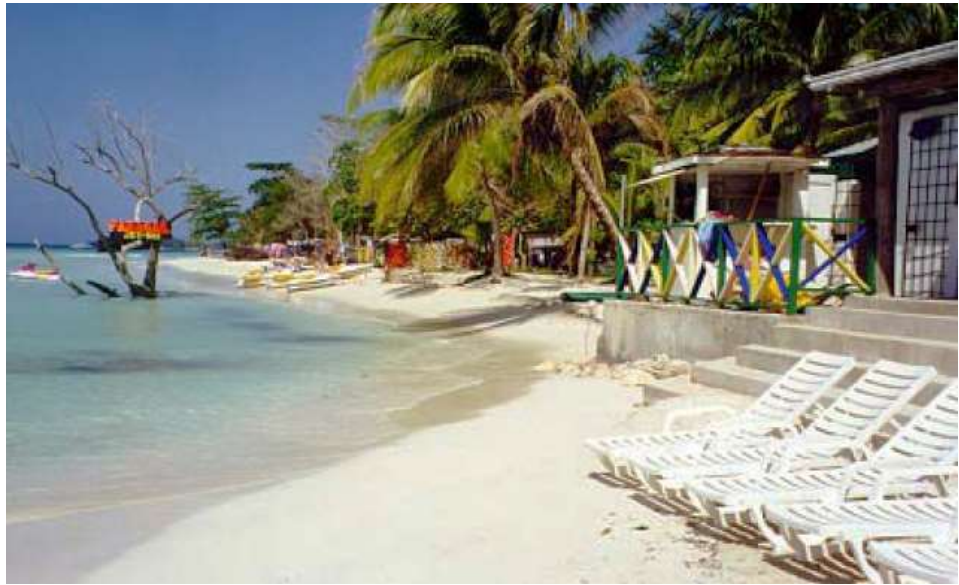
Plate 1-3 Erosion along central part of Long Bay as a result of damage from Hurricane Ivan, 10 November, 2004

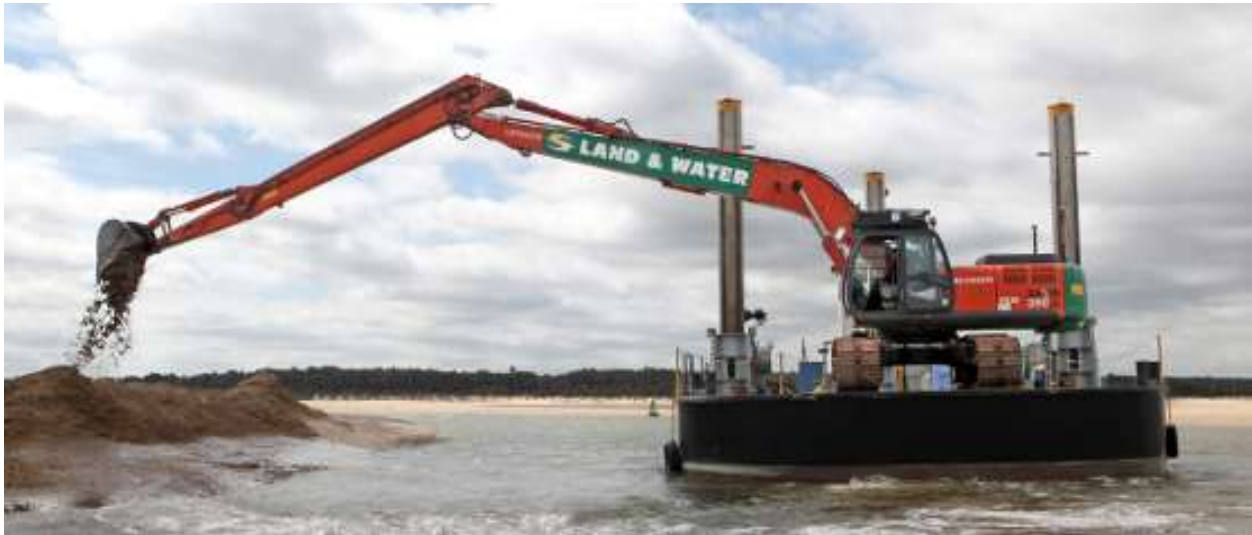
Plate 3-4 Example of a long-reach excavator with shaping bucket

The camp site wearing surface will be finished with crushed aggregate or the river fill (if adequate) to ensure a practical driving surface for the trucks with boulders. Site office for the engineer, resident engineer, and supply and placement contractor will be established likewise in container offices. Sewage services will be provided by way of portable toilets and temporary on site disposal methods. The stormwater generated on site will be collected and sent to a sediment basin, followed by an oil water separator before being discharged into the Negril River.

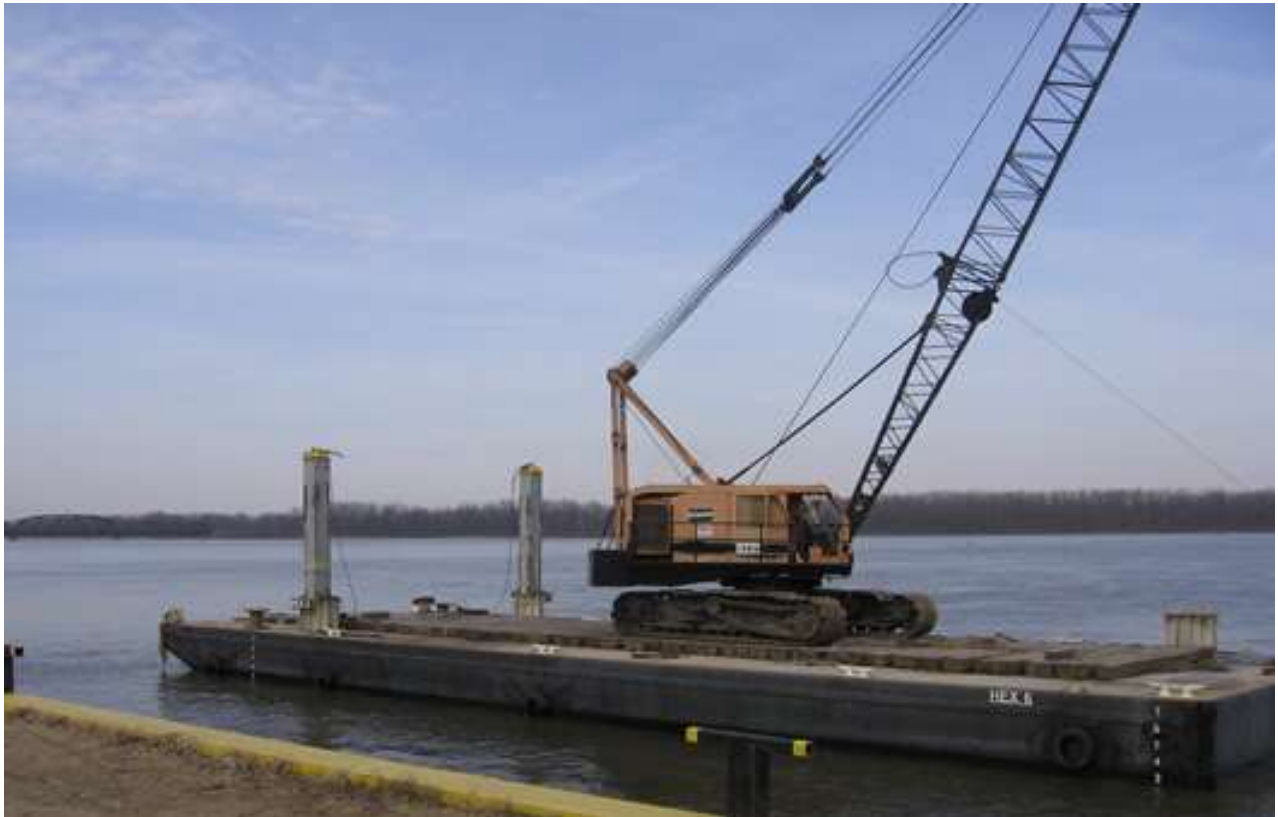
Plate 3-6 Spudded barge with crane

- 1) Retrieve boulders from supply barge
- 2) Place boulders on seafloor
- 3) Move placement barge with spud traveller or tug if needed
- 4) Continue placement of filter stones for 30 to 50 metres
- 5) Survey placement
- 6) Retrieve primary armour from supply barge, and repeat process 2 to 5 for crest armour as well.

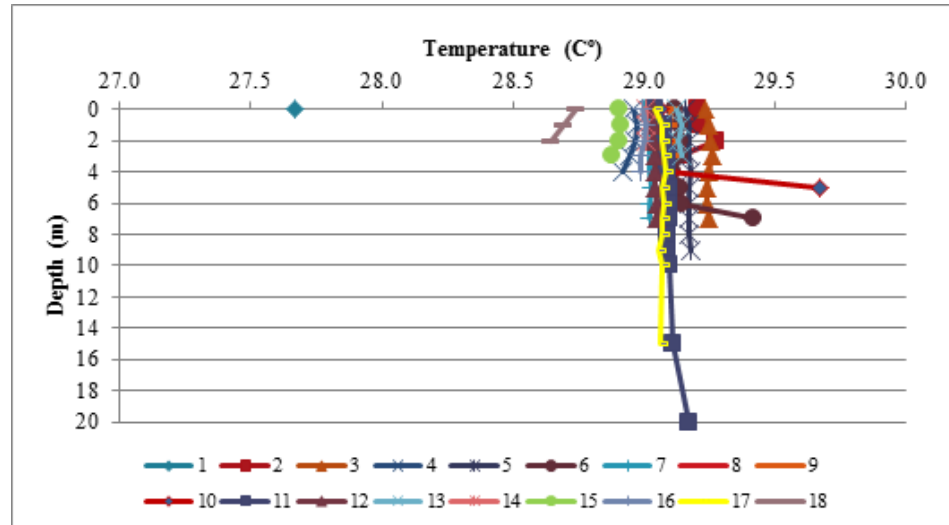
temperature observed at station 1 would be due to the outflow from the South Negril River located at the south end of the Bay.

Figure 4-2 Average Temperature variation across sampling stations

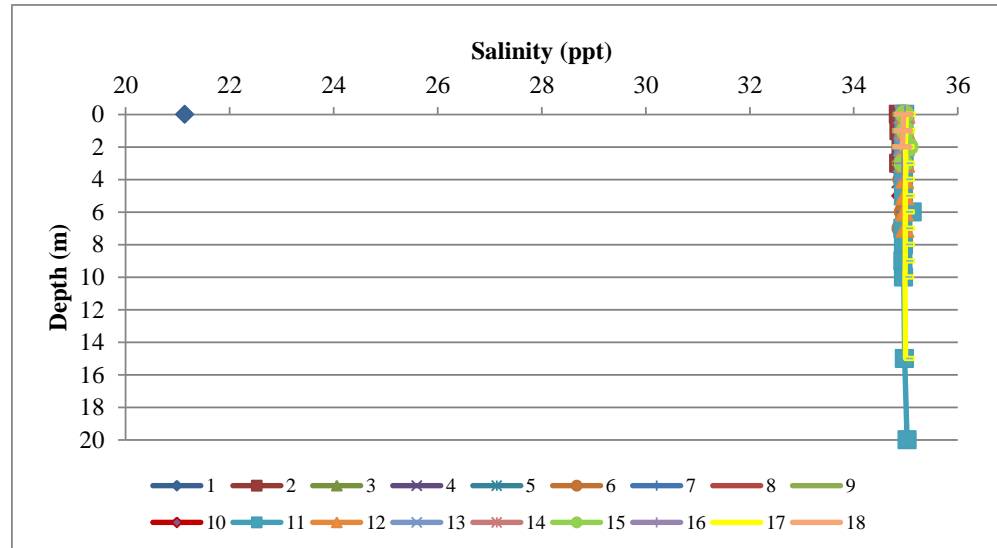
Average salinity values varied little across the stations ranging from 21.14 – 35.12ppt. Station 1 reported the lowest value and the highest value was observed at station 11. When compared to depth, the values showed little variation at all stations (Figure 4-4). Station 1 had low salinity, which was expected, due to its location near to the river mouth. This trend was also observed in the temperature and conductivity for station 1.

Figure 4-4 Average Salinity variation across sampling stations

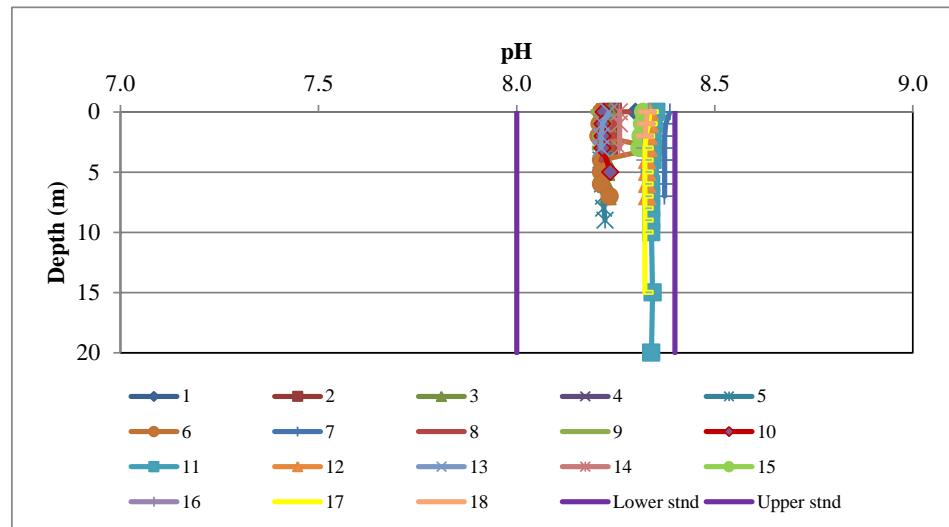
Average pH values varied little across stations ranging from 8.21 – 8.39. The lowest pH value was reported at stations 5, 6, 9 and 13 while the highest value was observed at station 7. When compared to depth the pH values at each station showed little variation

Figure 4-5 Average pH variation across sampling stations

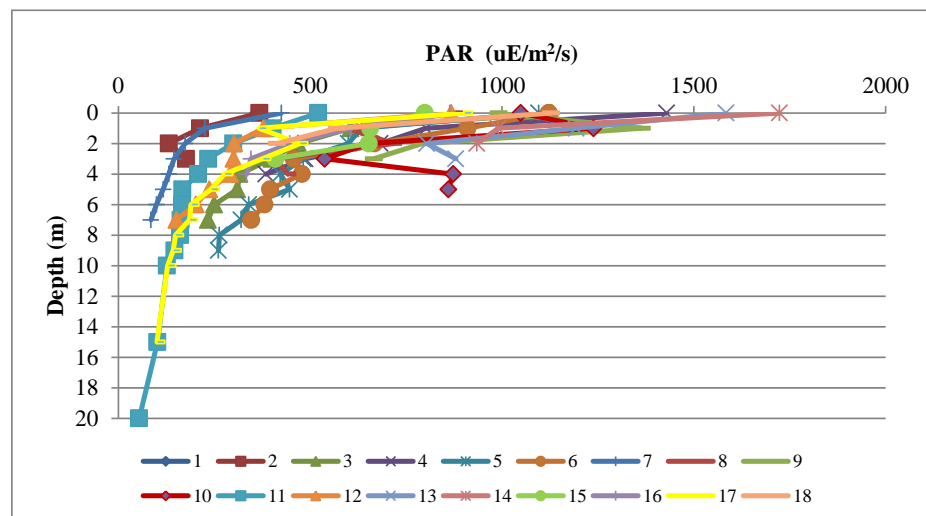
Average PAR varied greatly across stations ranging from 54 – 1723.33 $\mu\text{E}/\text{m}^2/\text{s}$. The highest PAR value was observed at station 14, and the lowest value was reported at station 11. When compared to depth, the PAR values showed a general decrease at each station except at station 10 (Figure 4-6). The decrease in PAR is expected, as less light is able to penetrate with increasing depth. Cloud cover, time of day, and the presence of organic and inorganic material also affect the amount of PAR available.

Figure 4-6 Average PAR variation across sampling stations

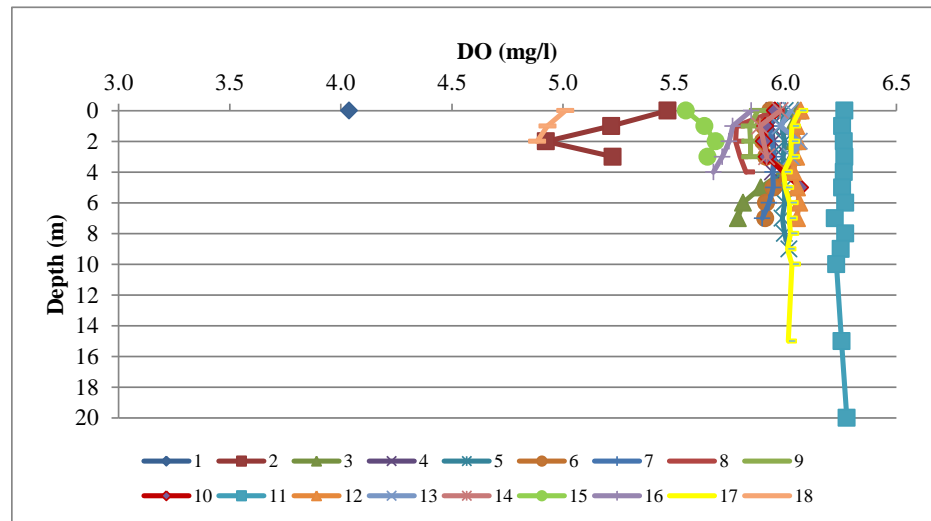
Average dissolved oxygen values varied across the stations ranging from 4.04 – 6.28mg/l. The highest DO values were reported at station 10 and the lowest values were at station 1. When compared to depth, the DO levels varied at each station with station 2 showing the largest change with depth (Figure 4-8). The low DO values at station 1 and 2 could be due to elevated levels of decaying organic matter flowing from the river.

Figure 4-8 Average D.O. variation across sampling stations

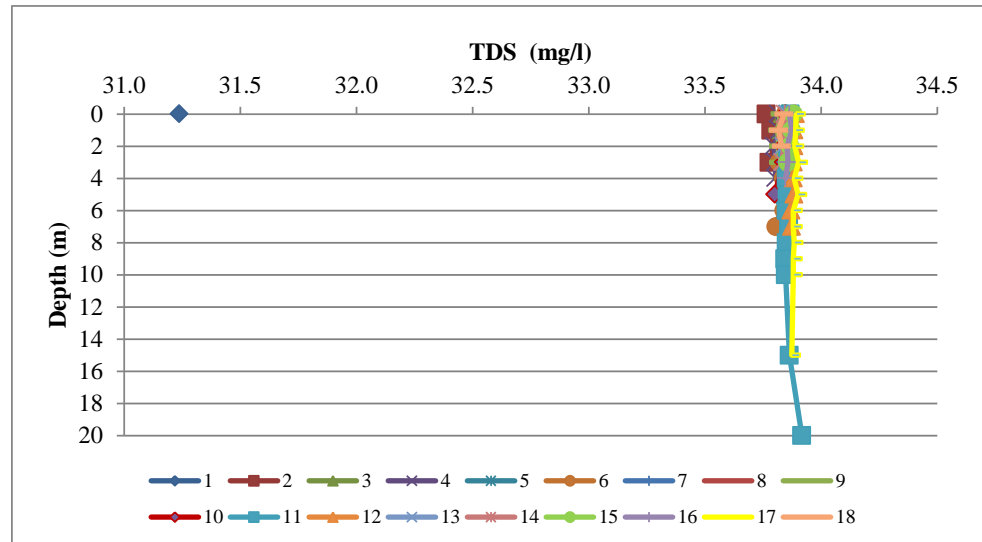
Average TDS varied little across the stations ranging from 31.24 – 33.92g/l. Lowest TDS value was reported at station 1 and the highest value was observed at station 11. When compared to depth at each station, the values showed little variation (Figure 4-10).

Figure 4-10 TDS variation across sampling stations

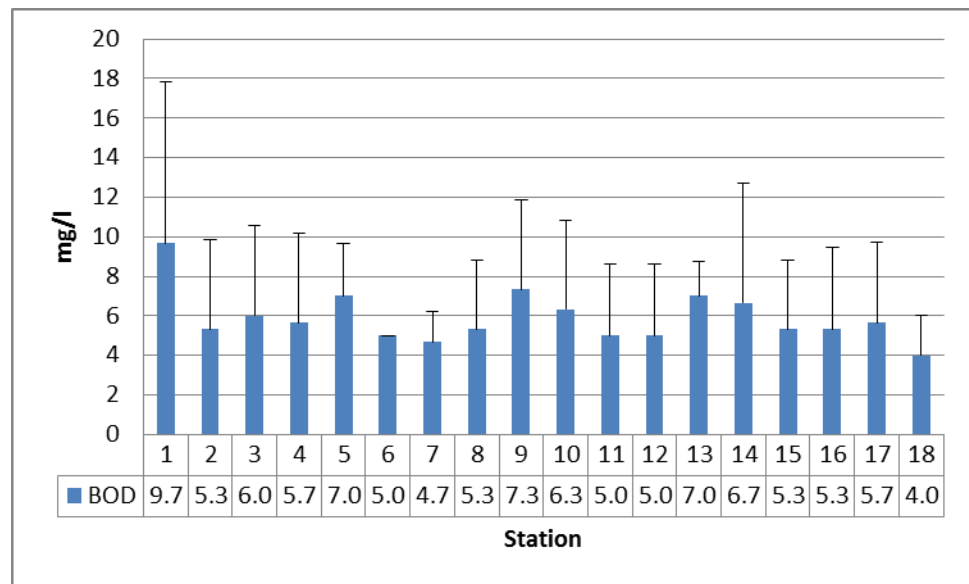
Average BOD varied across stations ranging from 4.0 – 9.7mg/l (Figure 4-11). The highest average was observed at station 1 and the lowest value was observed at station 18. The elevated BOD value observed at station 1 could be due to the influence of the river, which contains organic matter. In comparison, Kingston Harbour a known eutrophic harbour had maximum levels of >35mg/l due to the organic loading from the numerous gullies and rivers that empty into the Harbour (D. F. Webber and Kelly 2003). All stations were above the NEPA standard for seawater of 1.16mg/l.

Figure 4-11 Average BOD variation across sampling stations with standard deviation

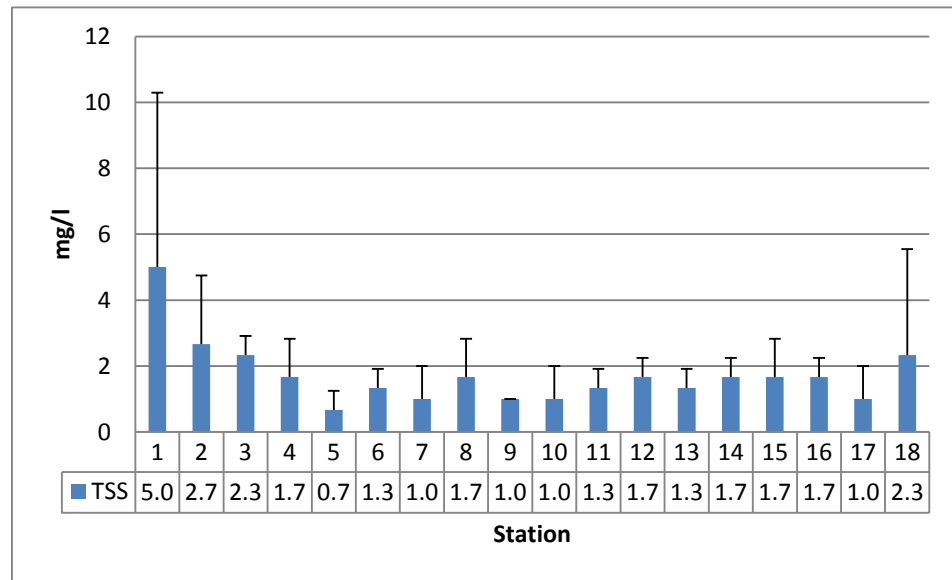
Average TSS values varied across the stations ranging from 0.7 – 5mg/l. Station 1 reported the highest value and the lowest value was observed at station 5 (Figure 4-12). These concentrations are considered to indicate clear water as they are below 20mg/l. Station 1, located near the mouth of the river, and was expected to have the highest value due to the presence of debris and sediment flowing outwards. However, it should be of note that this is episodic due to tidal features and periods of heavy rainfall.

Figure 4-12 Average TSS variation across sampling stations with standard deviation

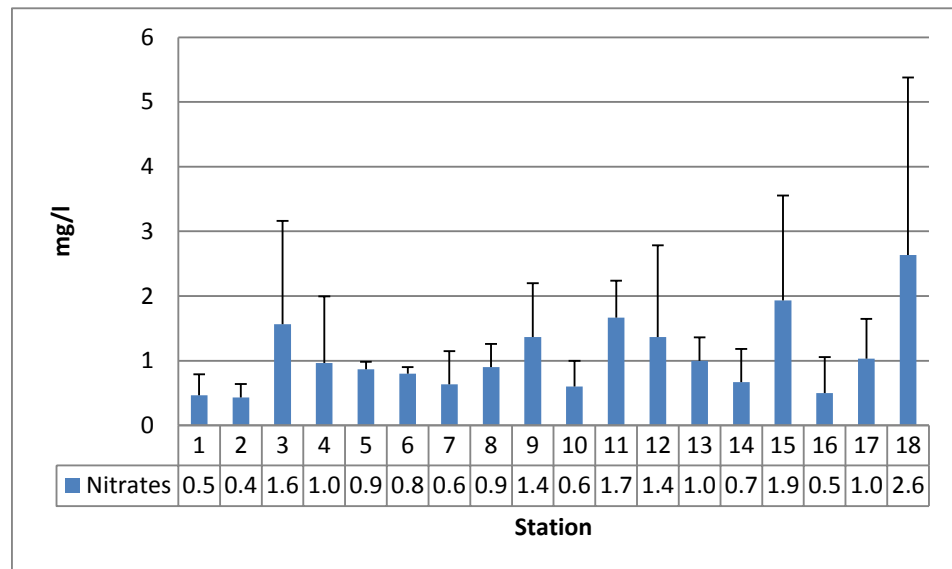
Average nitrate values varied across the stations ranging from 0.4 – 2.6mg/l. The lowest nitrate value was reported at station 2 and the highest value was observed at station 18 (Figure 4-13). All stations were above the NEPA standard for Seawater for nitrates of 0.007 – 0.014mg/l.

Figure 4-13 Average Nitrate variation across sampling stations with standard deviation

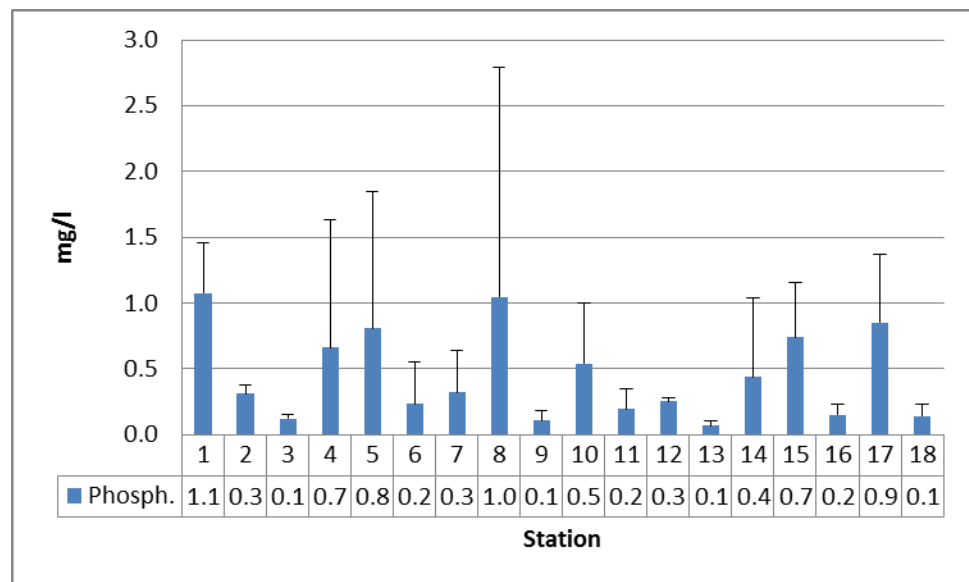
Phosphate values varied across the stations ranging from 0.1 – 1.1mg/l. Highest phosphate value was reported at station 1 whereas the lowest value was observed at stations 3, 9 13 and 18 (Figure 4-14). All stations were above the NEPA Standard for Seawater for phosphates of 0.001 – 0.003mg/l. Lapointe et al. (2011) reported elevated levels of soluble reactive phosphorus (SRP) in Negril waters, with higher concentrations towards the “West End”. However, in the present study elevated phosphate levels were observed throughout the bay.

Figure 4-14 Average Phosphate variation across sampling stations with standard deviation

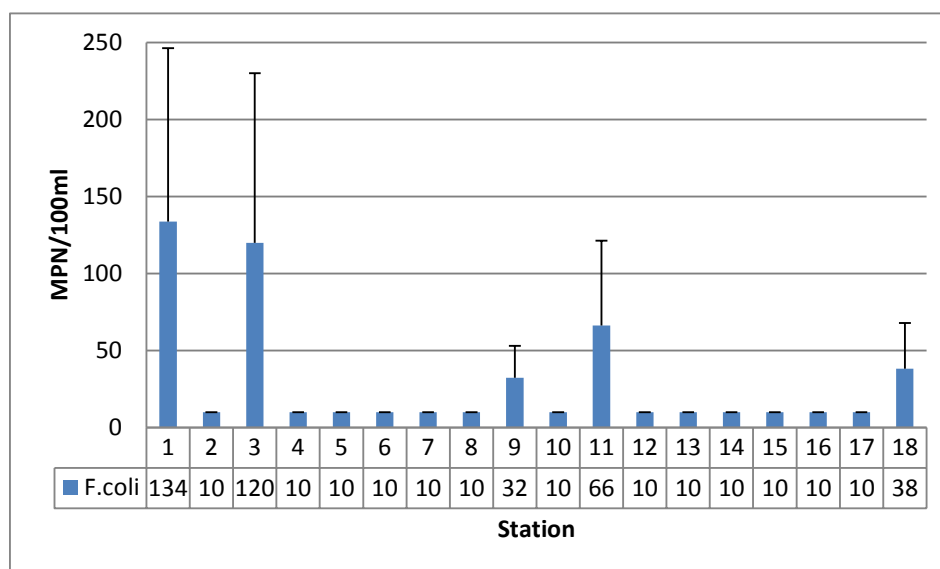
F. coliform values varied across the stations ranging from <11 - 134MPN/100ml. The presence of faecal coliform can be used as an indicator of sewage contamination. Station 1, the southernmost sample, had the highest value (Figure 4-15). Most stations were below the NEPA standard for seawater of 13MPN/100ml except stations 1, 3, 9, 11 and 18. These stations were located close to shore with the exception of station 9.

Figure 4-15 Average Faecal Coliform variation across sampling stations with standard deviation

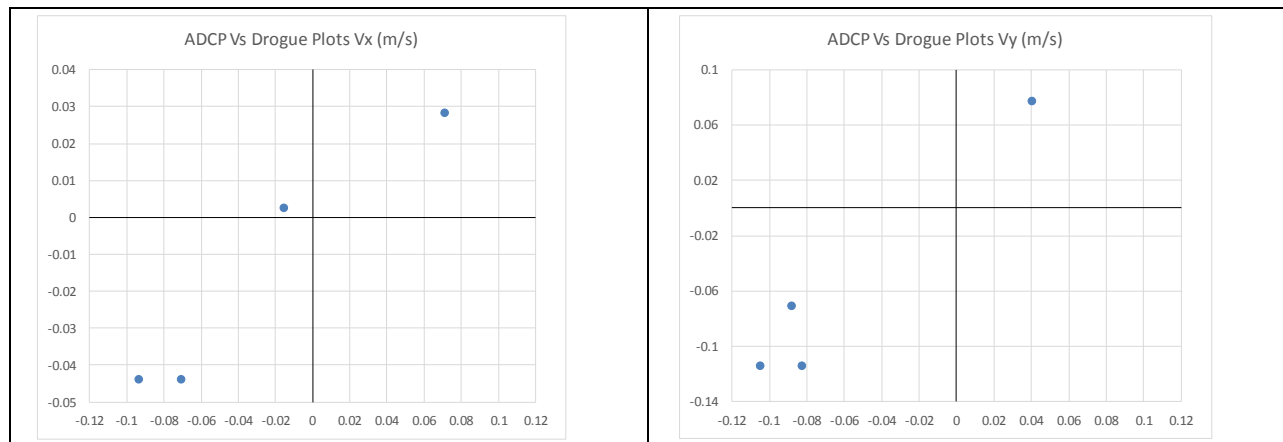
Table 4-9 Comparison Plots for the X and Y components of velocity for the Drogues and ADCP deployed in Long Bay

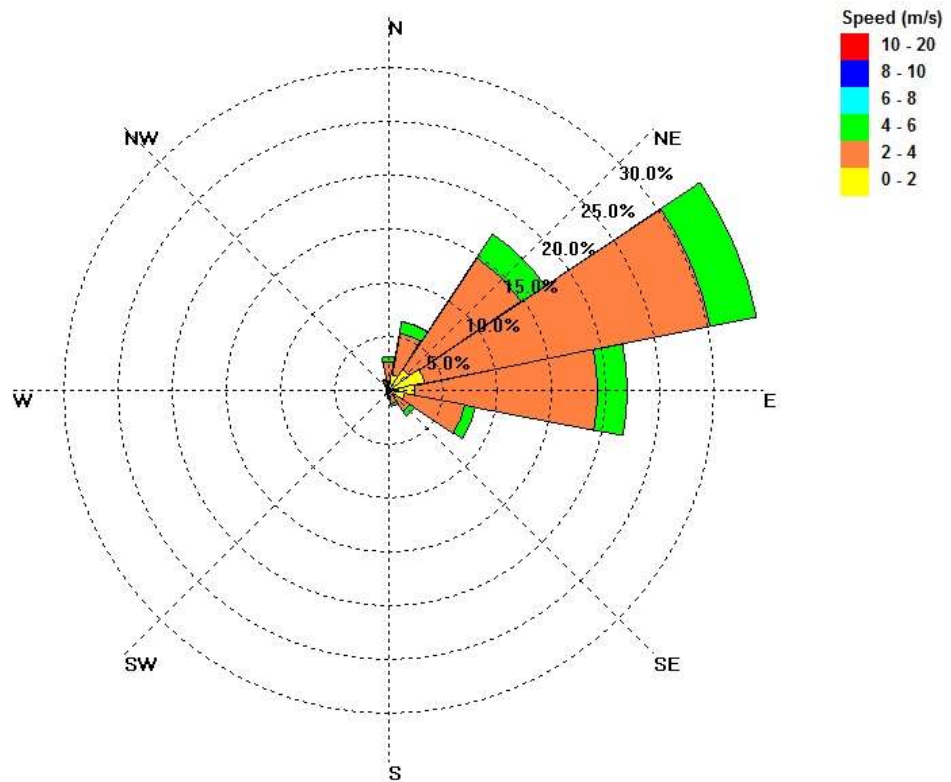
The analysis revealed that the winds have directions predominantly of NE to E direction with wind speeds of 20 m/s or less approximately. North to North West and southerly wind directions were noted to occur but rarely. Overall the average wind speed and direction is between 2 to 4m/s from the ENE.

Figure 4-26 NOAA Long term wind data for Negril offshore node Spanning 1999 to 2007

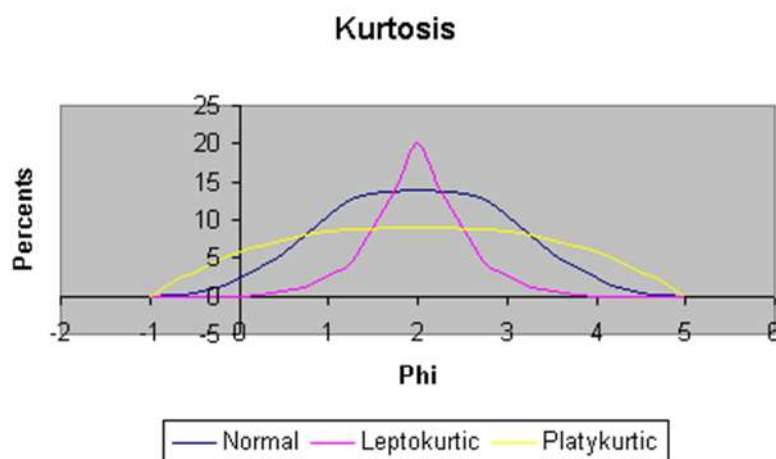
quantitative measure used to describe this departure from normality. It measures the ratio between the sorting in the "tails" of the curve and the sorting in the central portion. If the central portion is better sorted than the tails, the curve is said to be excessively peaked or leptokurtic; if the tails are better sorted than the central portion, the curve is deficiently or flat-peaked and platykurtic.

Figure 4-35 Typical kurtosis curves

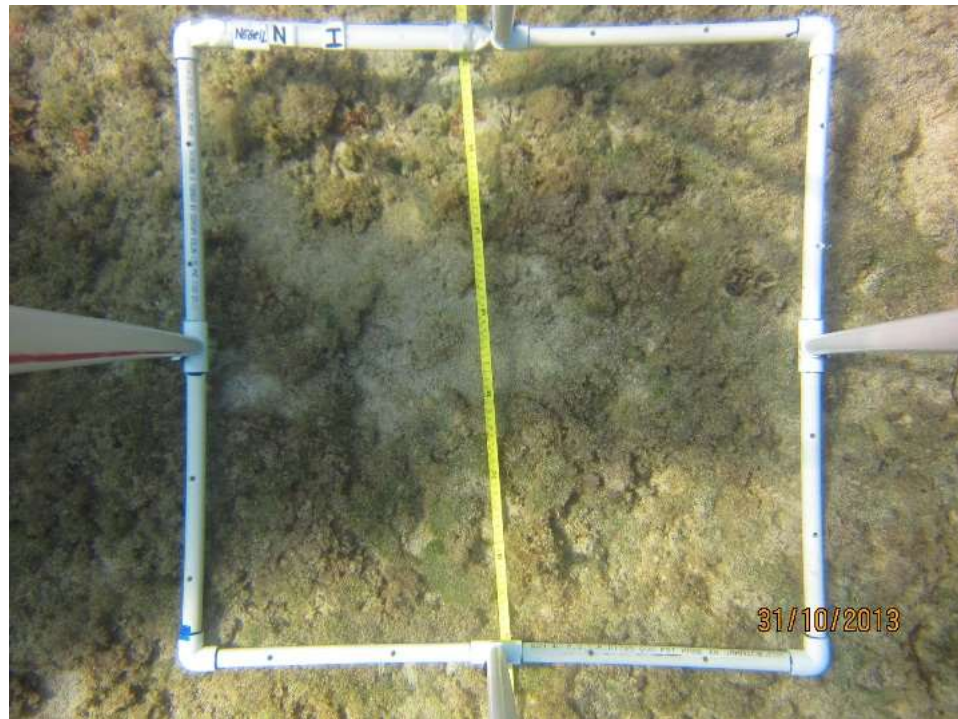
The substrate was assessed during biophysical surveys to be primarily pavement throughout the footprint of the structures (Plate 4-2). Wherever sands were observed, the layers were generally less than 0.6 metres thick.

Plate 4-2 *Hard bottom in footprint of breakwater*

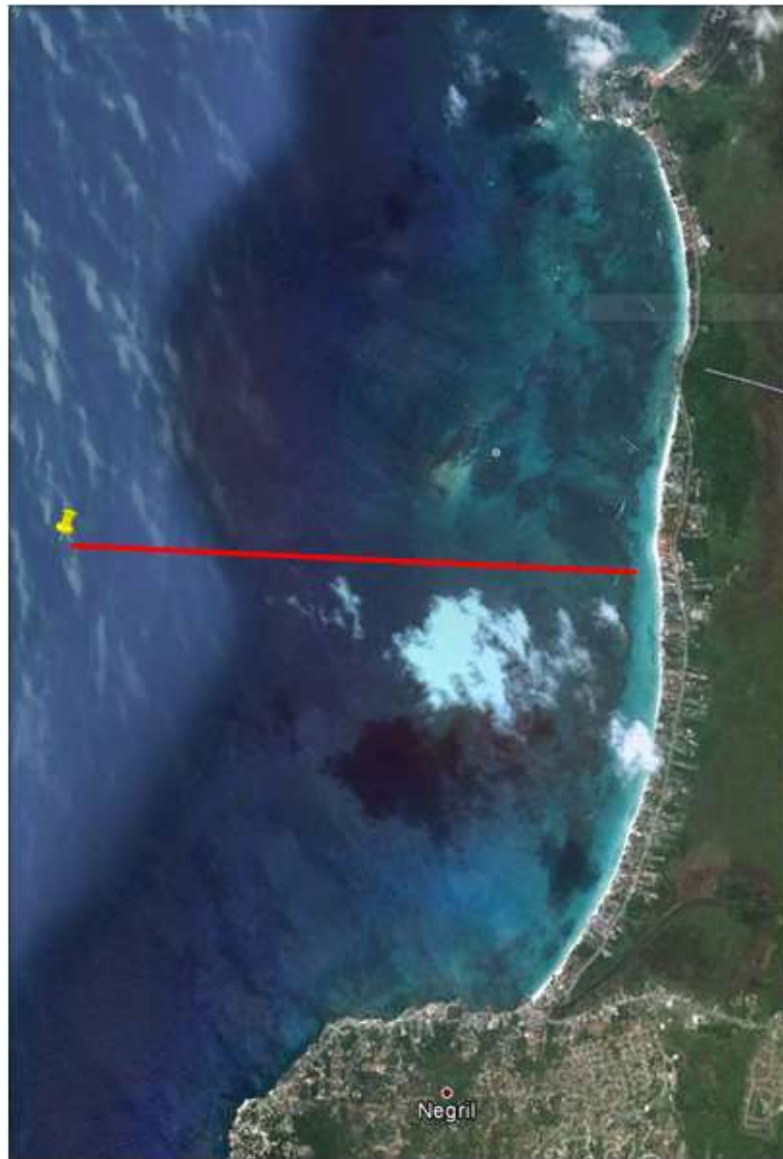
The National Hurricane Center (NOAA) database of hurricane track data in the Caribbean Sea was utilized to carry out a hindcast, wave breaking (along two tracks) followed by a statistical analysis to determine the hurricane waves, wind and set-up conditions. The database of hurricanes, dating back to 1886, was searched for storms that passed within a 300km radius from an offshore point approximately 4.5km west of the Long Bay shoreline. The following procedure was carried out:

Figure 4-39 Offshore point used for storm surge analysis

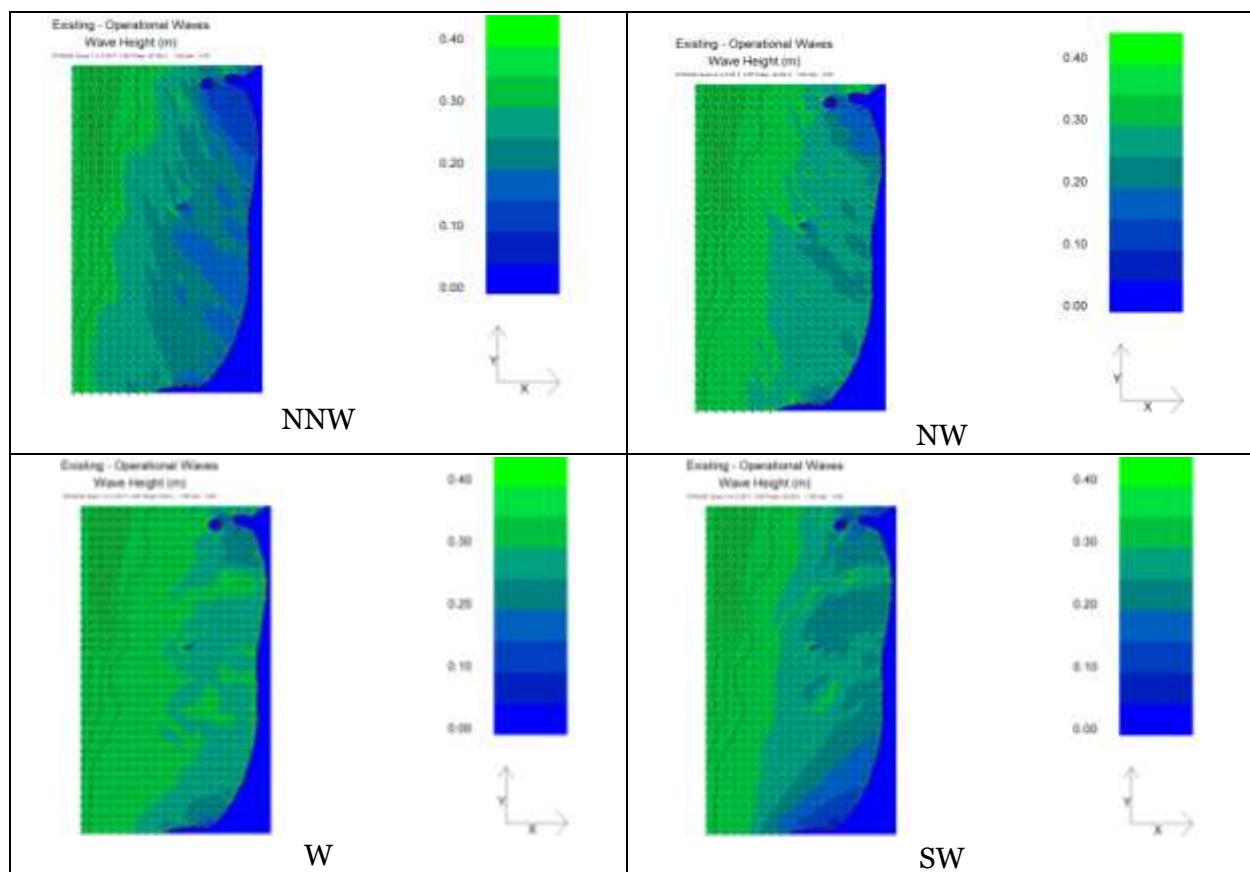
Table 4-25 STWAVES resultant plots of operational waves for various directions

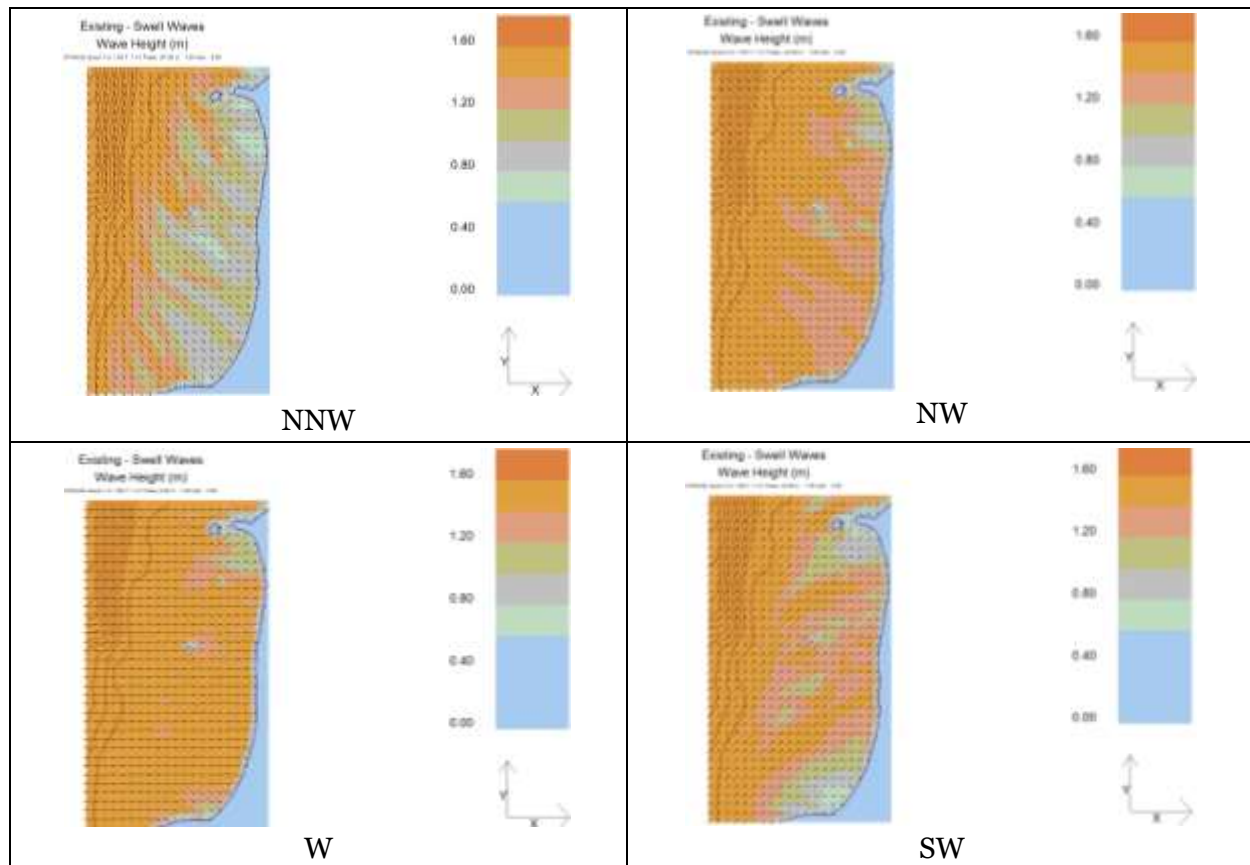
Table 4-26 STWAVES resultant plots of Swell waves entering Long Bay Negril for various directions

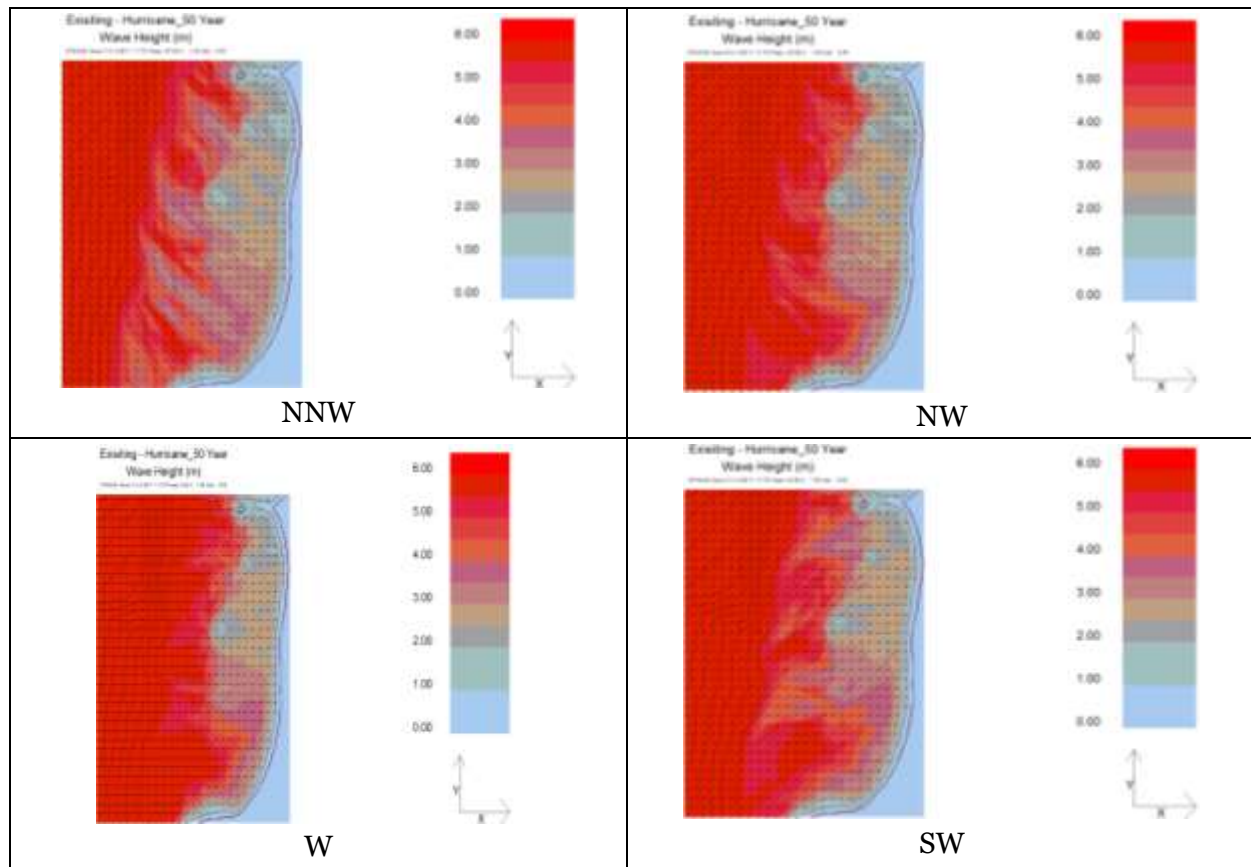
Table 4-27 STWAVES resultant plots of Hurricane waves (50 year) for various directions (Pre-Project)

- *Pre-Project Scenario* - Wave plots generated from the model showed that during hurricane conditions, wave heights of up to 3.1m and 3.6m reaches the shoreline from the NNW, NW, W and SW directions for 50 and 100 year return periods respectively.
- *Post-Project* - The implementation of the two breakwaters resulted in a reduction in the magnitude of hurricane waves reaching the shoreline to 1.5 to 2.5m and 1.6 to 2.8m for the 50 and 100 year return period respectively. The smallest wave heights observed reaching the central and northern section of the bay.
- *Future Climate* - Hurricane waves (50 and 100 year return periods) had impacts on the shoreline as wave setup increased from 1.15m and 1.25m to 1.29m and 1.39 m for the 50 and 100 year return period respectively.

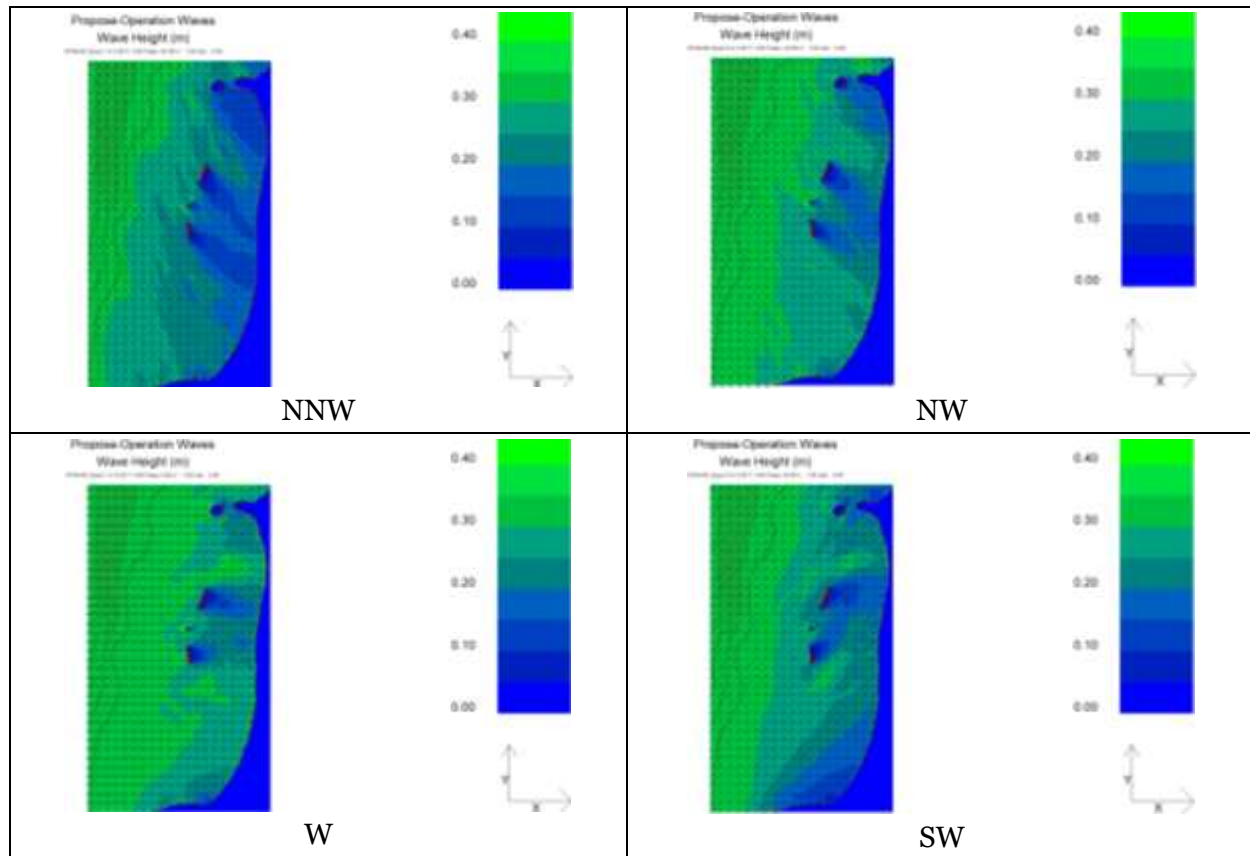
Table 4-29 STWAVES resultant plots of operational waves for various directions (Post project)

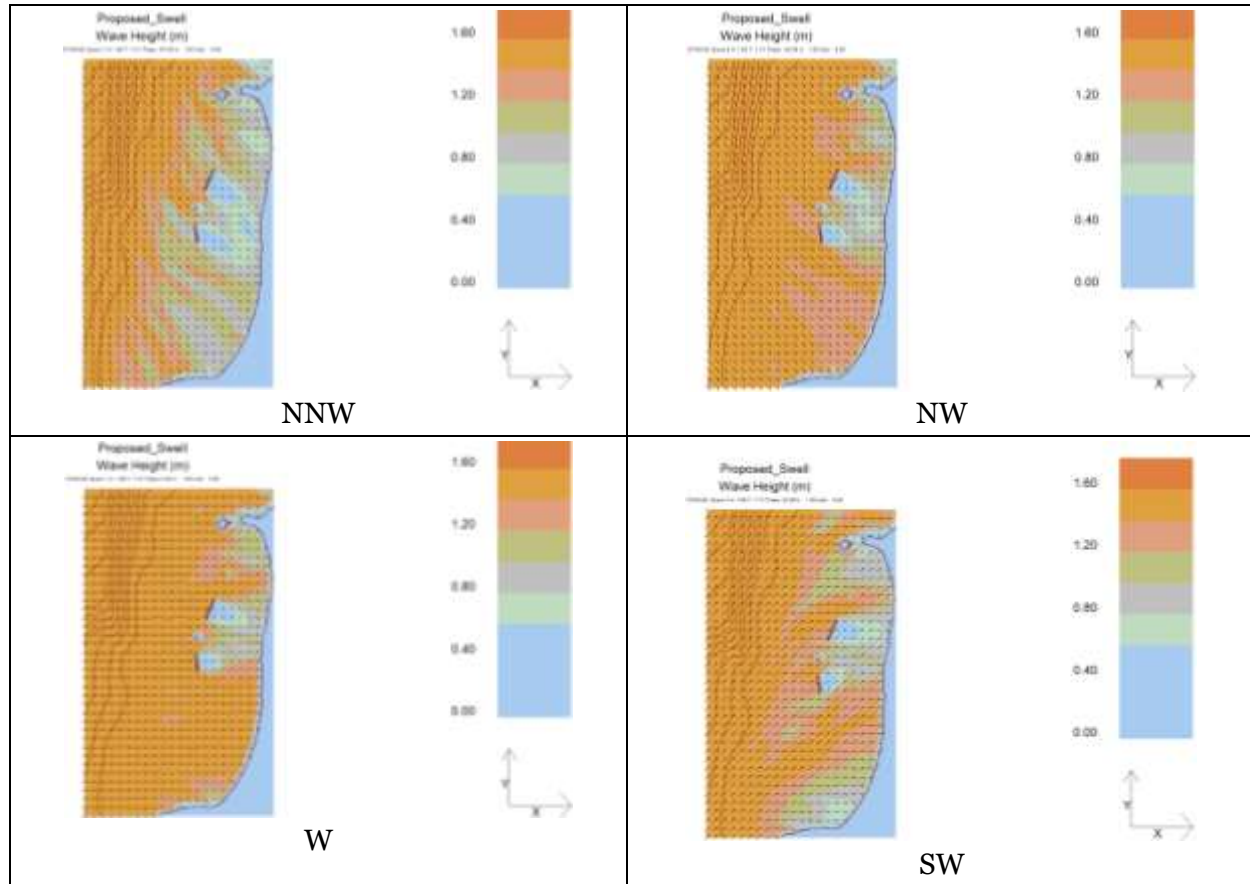
Table 4-30 STWAVES resultant plots of operational waves for various directions (Post Project)

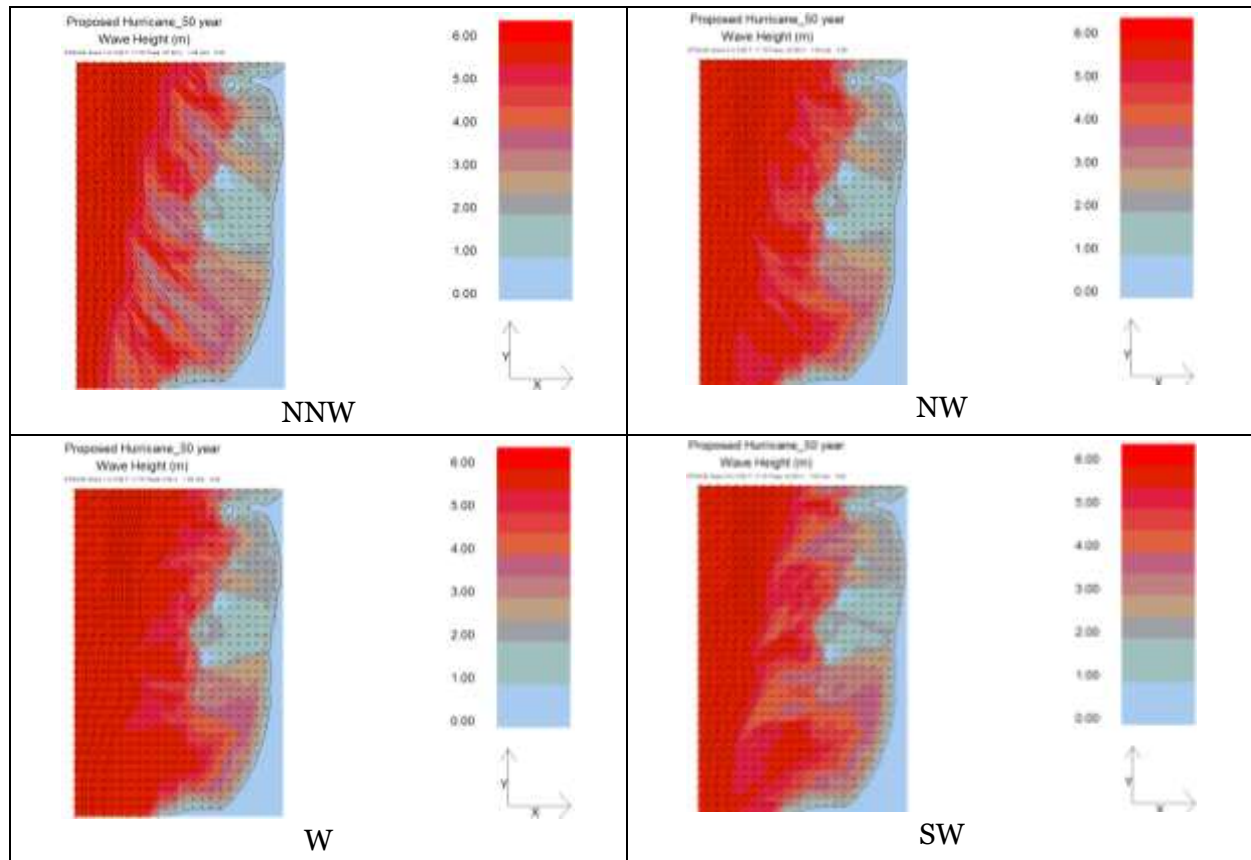
Table 4-31 STWAVES resultant plots of Hurricane waves for various directions (Post Project)

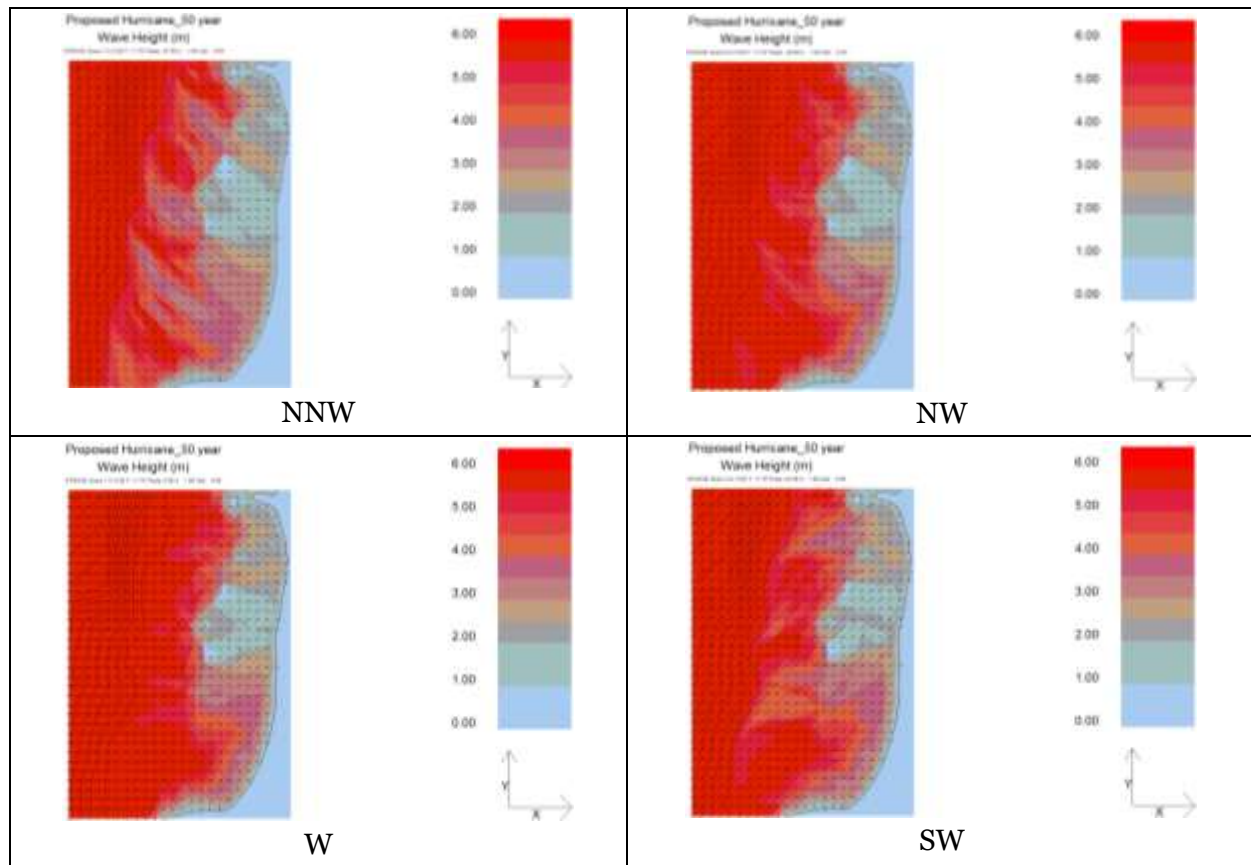
Table 4-37 STWAVES resultant plots for future climate Hurricane waves (100 year) for various directions (Post Project)
