Environmental Impact Assessment
**CONSTRUCTION OF TWO BREAKWATERS
AT LONG BAY, NEGRIL, WESTMORELAND**

Report Version: **FINAL**

Date: **April 2014**

**ENVIRONMENTAL IMPACT ASSESSMENT FOR
THE CONSTRUCTION OF TWO BREAKWATERS
AT LONG BAY, NEGRIL, WESTMORELAND**

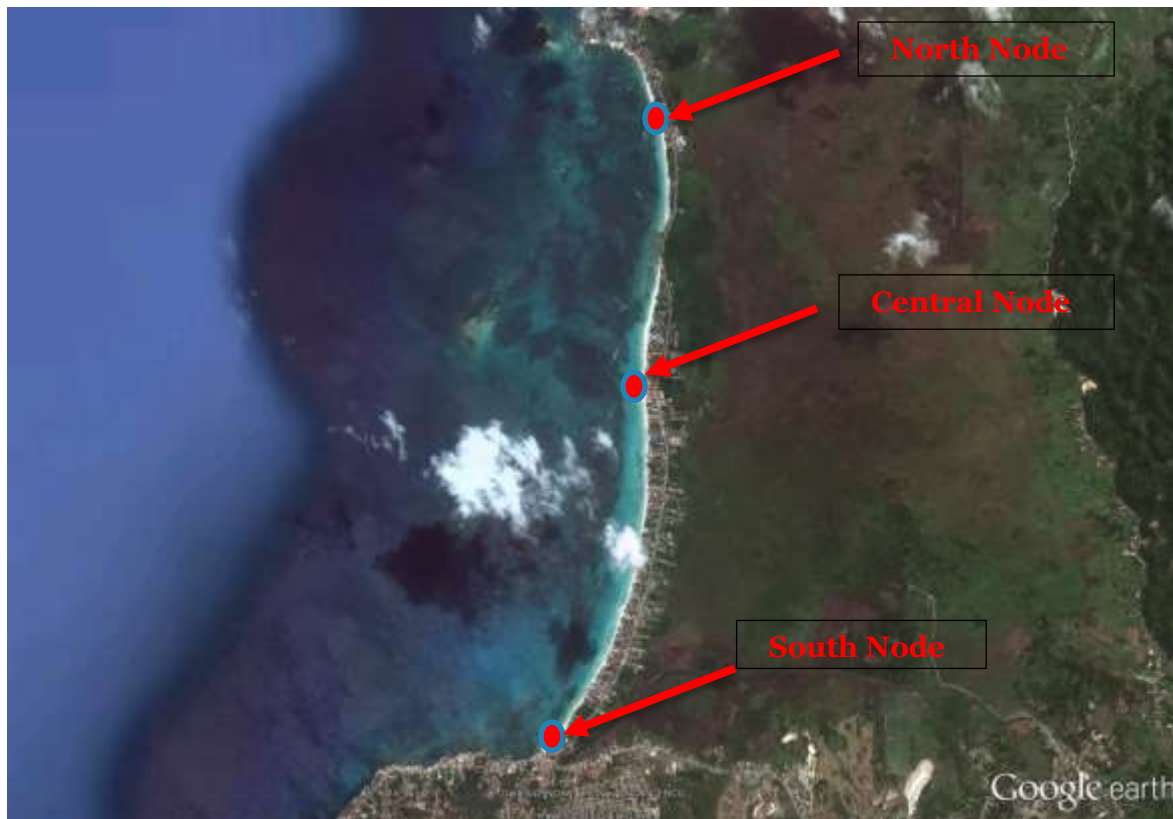
Figure 4-47 Location of the profile nodes used in the storm surge model

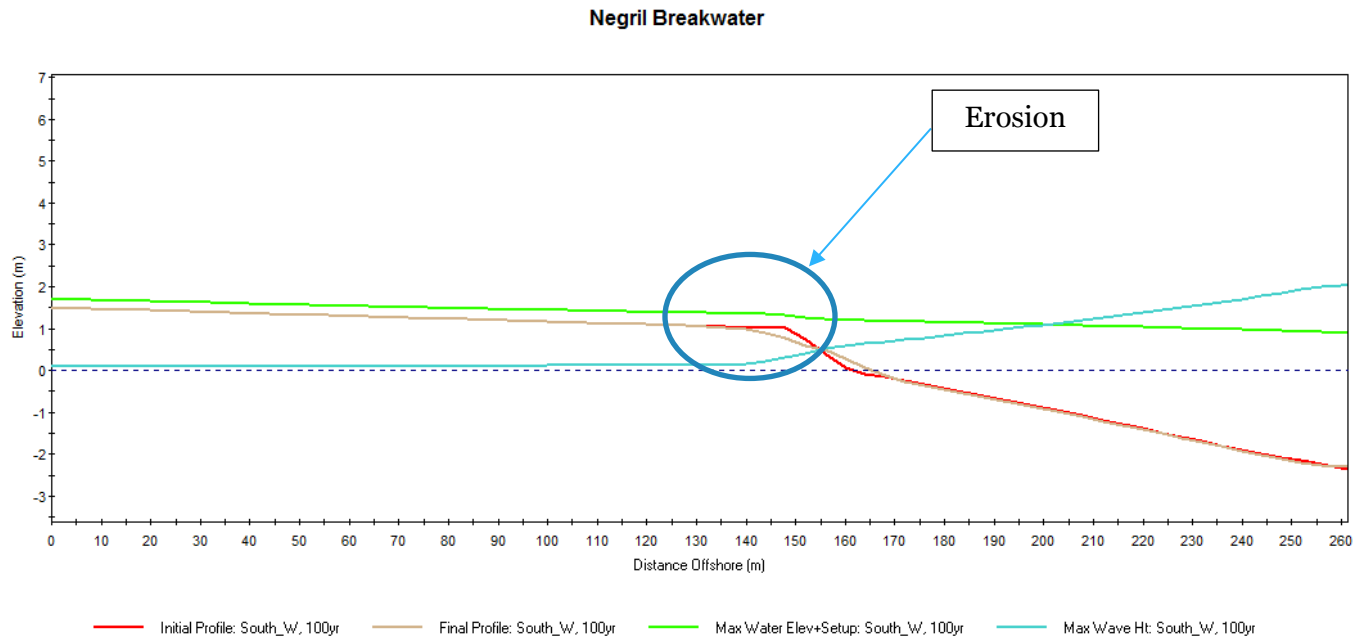
Figure 4-48 BEACH results showing the southern node experiencing erosion along the shoreline for 100 return period storm event

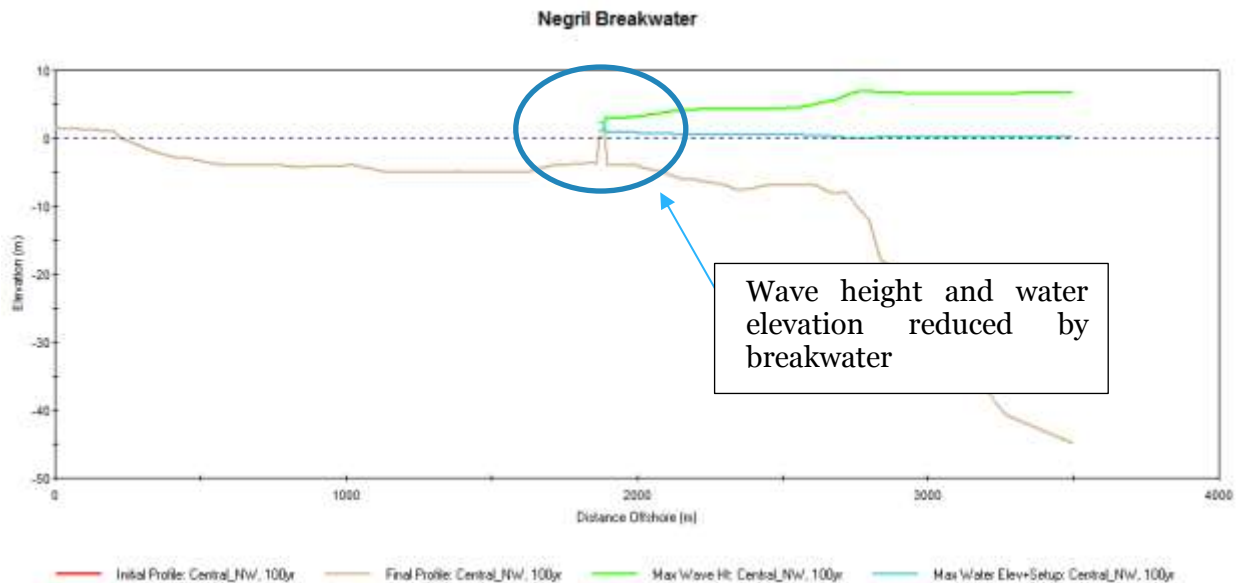
Figure 4-51 SBEACH results showing that at the central node under the projected climate conditions with the breakwaters in place the breakwaters greatly reduced the amount of storm waves brought to the shoreline

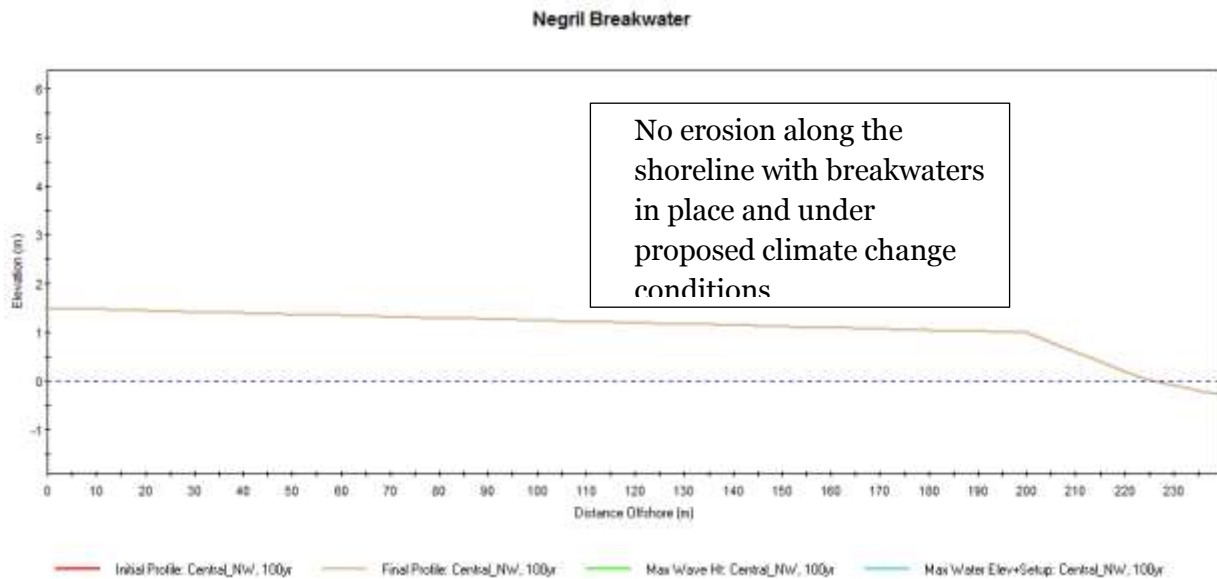
Figure 4-52 SBEACH results showing that at the central node under the projected climate conditions with the breakwaters in place the breakwaters no erosion takes place along the shoreline

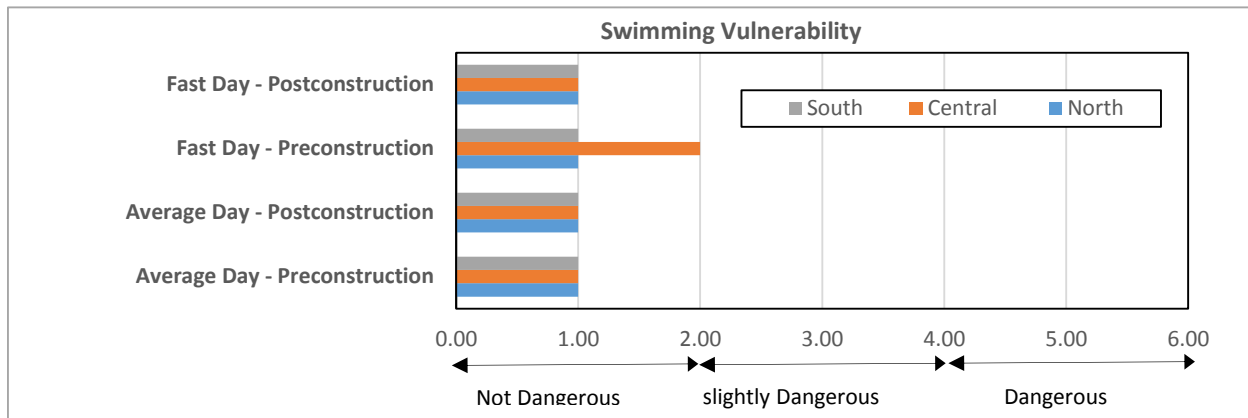
Figure 4-62 Assessment of the vulnerability to drowning for Long Bay Negril. A rating of 0-2 meant the area is considered dangerous, 2.0 to 4.0 is considered slightly dangerous and 4.0-6.0 is considered dangerous

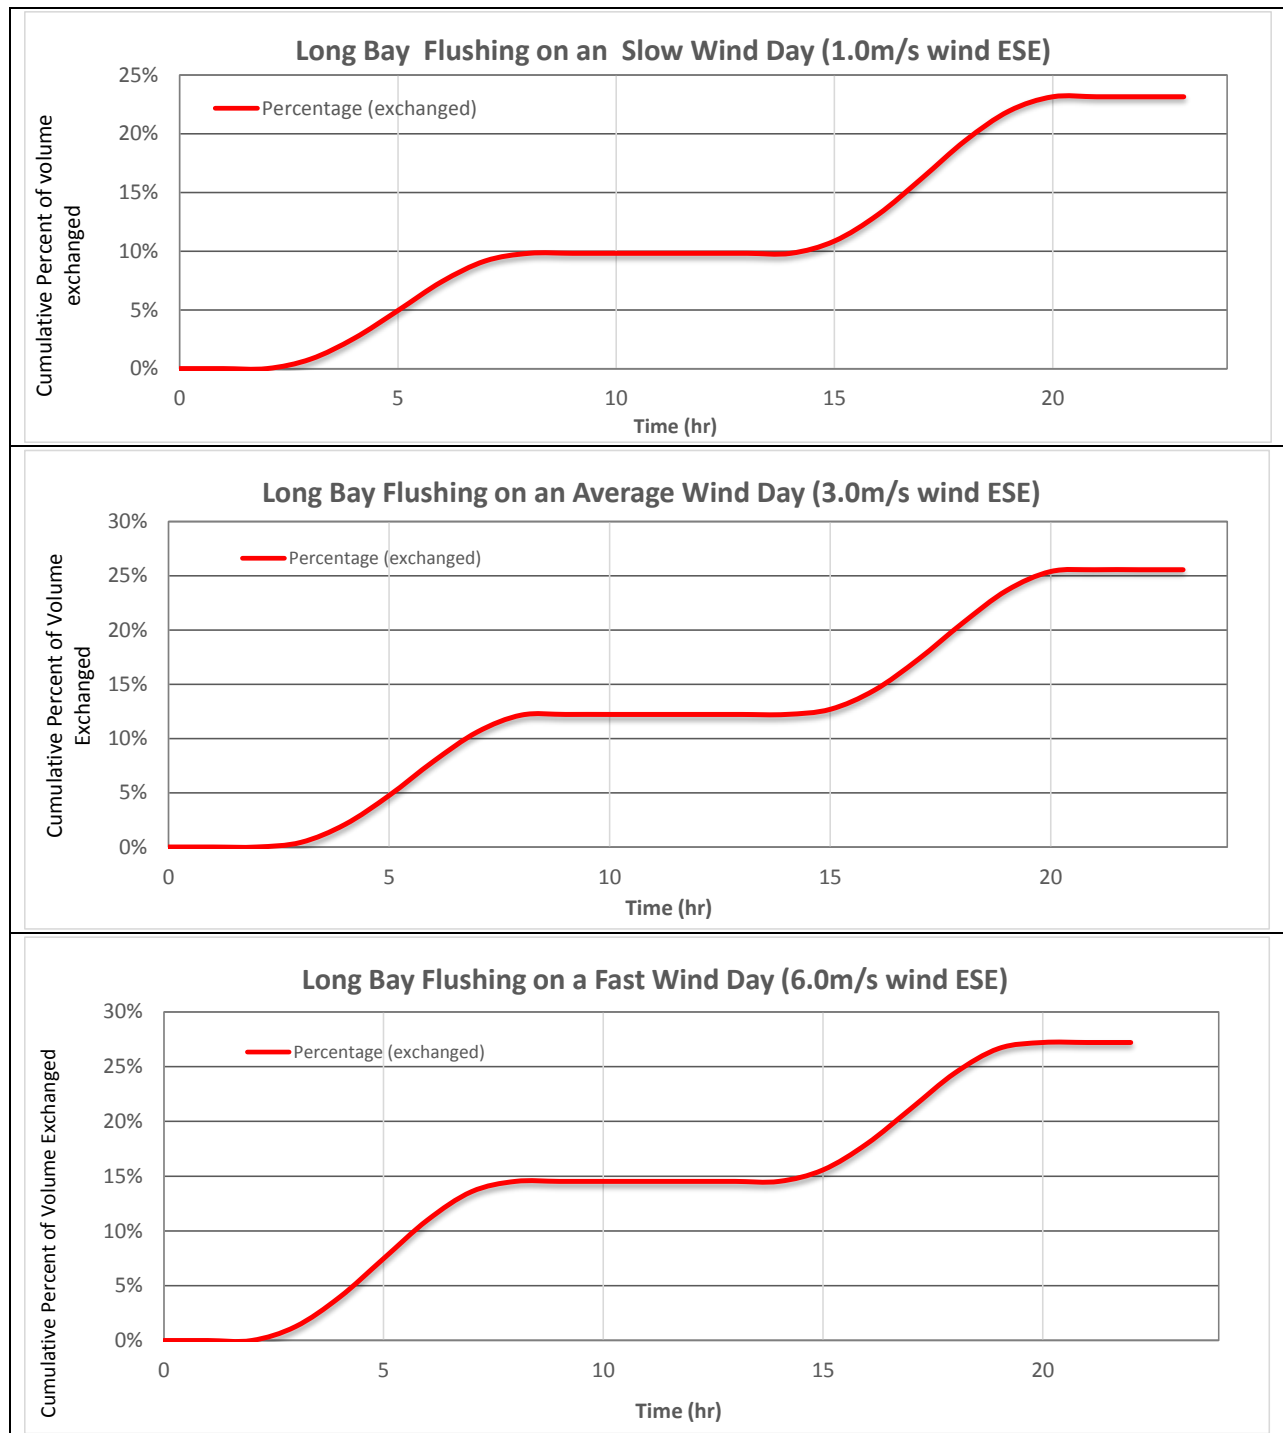
Table 4-58 Graphs of percent volume exchanged (flushing) over time on a slow average and fast wind days for winds from the NW during the pre-construction scenario

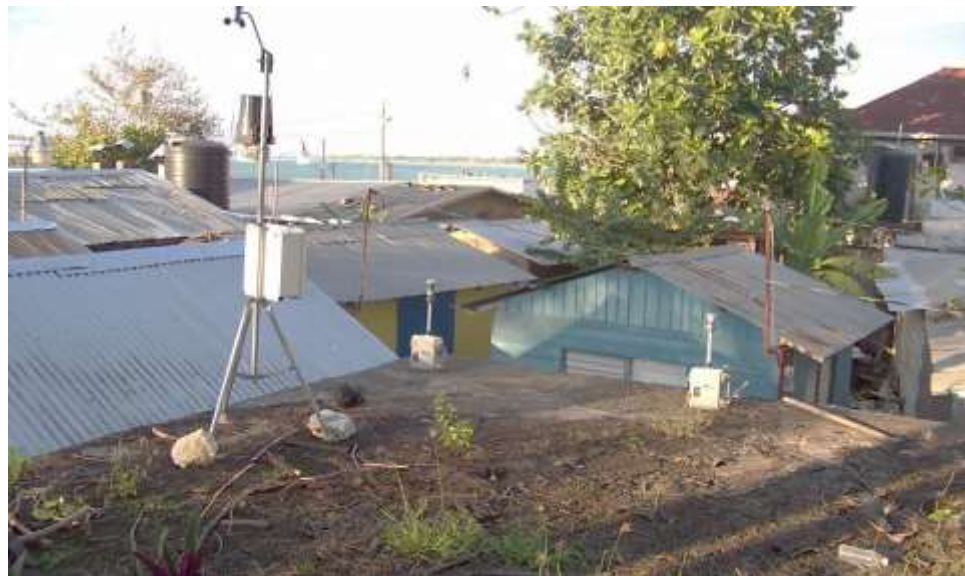
Plate 4-7- Weather station deployed on roof of commercial area building along West End Road

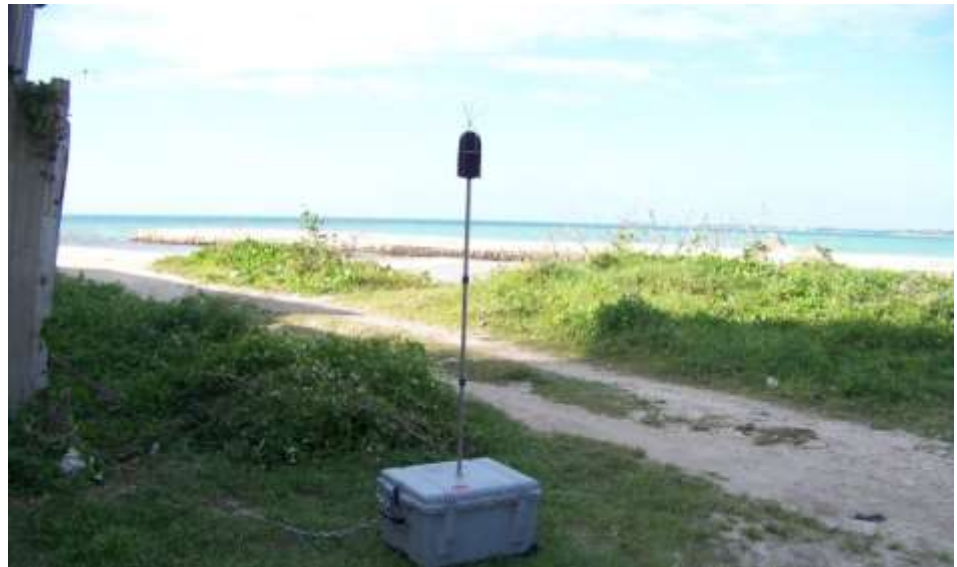
Plate 4-9 - Photo showing noise meter behind Burger King

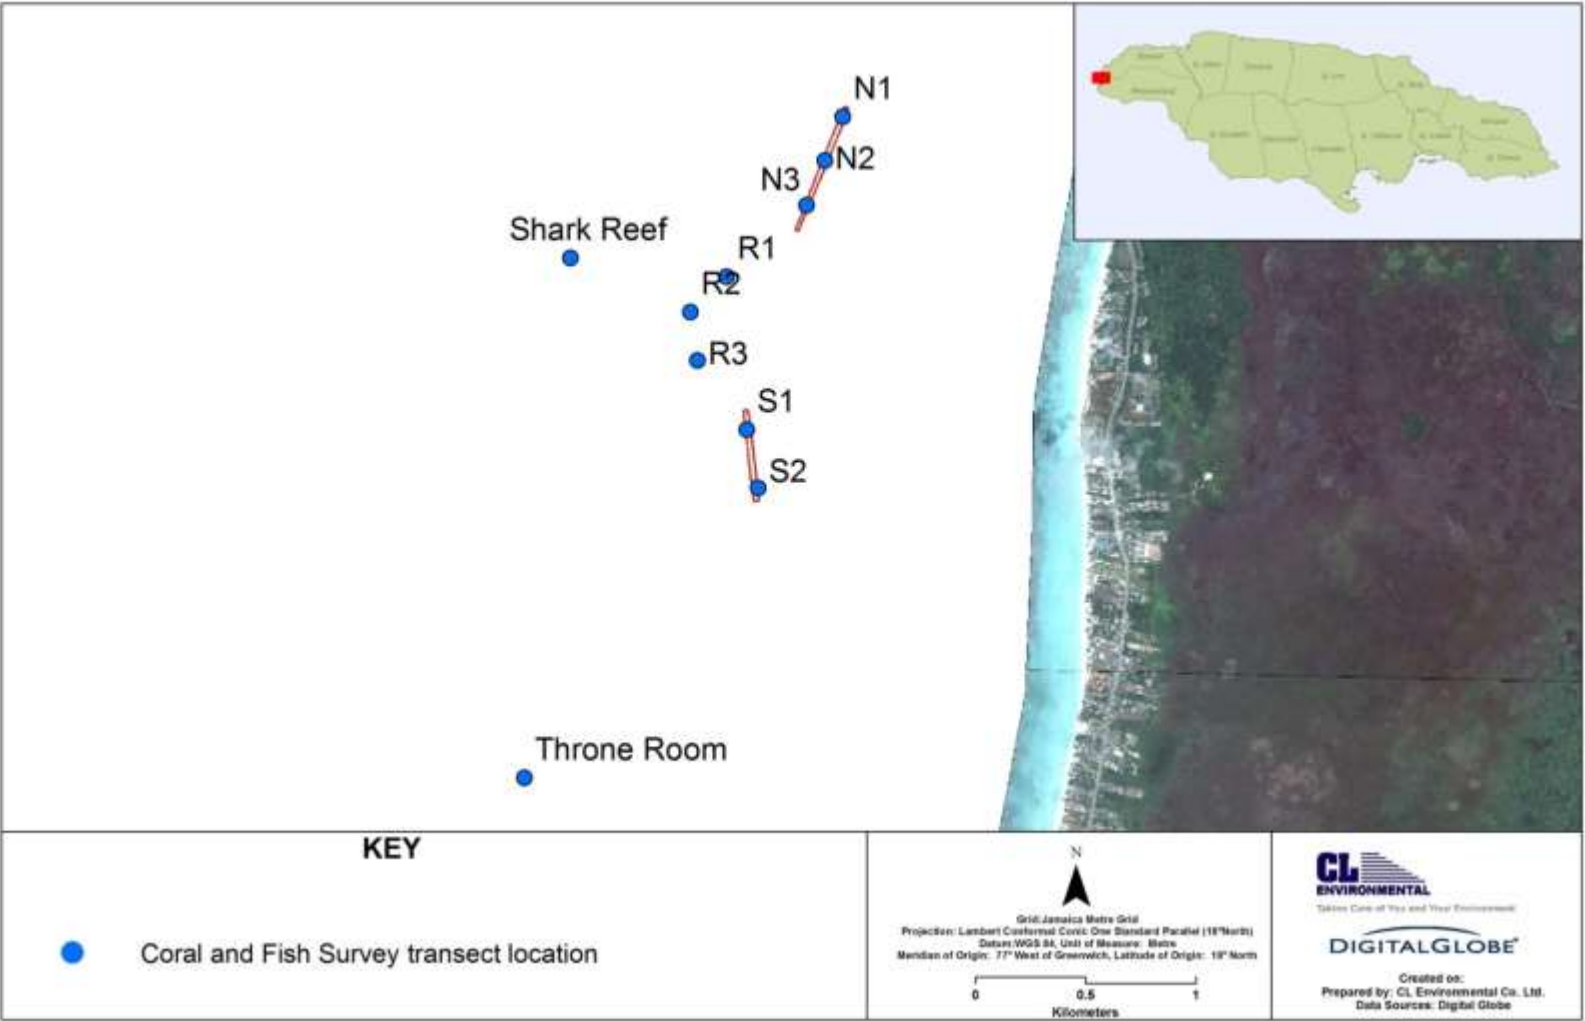
Figure 4-77 Location of benthic transect lines

Benthic surveys were conducted using 100m long transect line with a 0.7 x 0.7 m photo quadrat (0.5m² area). Pictures were taken every metre along the line and analysed using CPCE. A total of 3 transect lines in the northern breakwater (150 m²), 2 in the southern (100 m²), 3 in-between (reef crest/forereef) and 1 at each dive site was conducted. The proposed locations of both the northern and southern breakwaters occur in pavement zone areas. The low-relief, high wave action, heavy usage by divers and fishermen along with other natural and anthropogenic stresses have caused this community to be dominated by macroalgae, with low coral species diversity and few other invertebrates. The algal community is composed of fleshy macroalgae and turfs, with little calcareous (Halimeda) or coralline algae present. The CPCE analysis indicates a coral community with a percent cover less than or equal to 1% in both breakwater footprints. The coral community is dominated by small encrusting colonies of *Siderastrea* sp. Both soft corals (various species of seawhips and fans) as well as the sponge community are also located with holdfasts and bases on pavement.

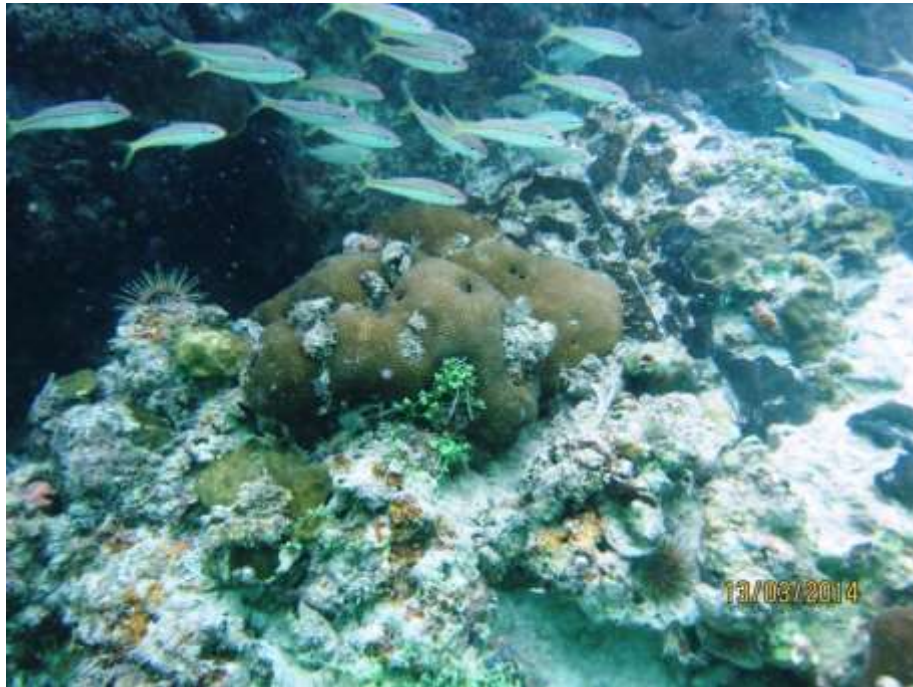
Plate 4-23 Photo showing Siderastrea colony along groyne

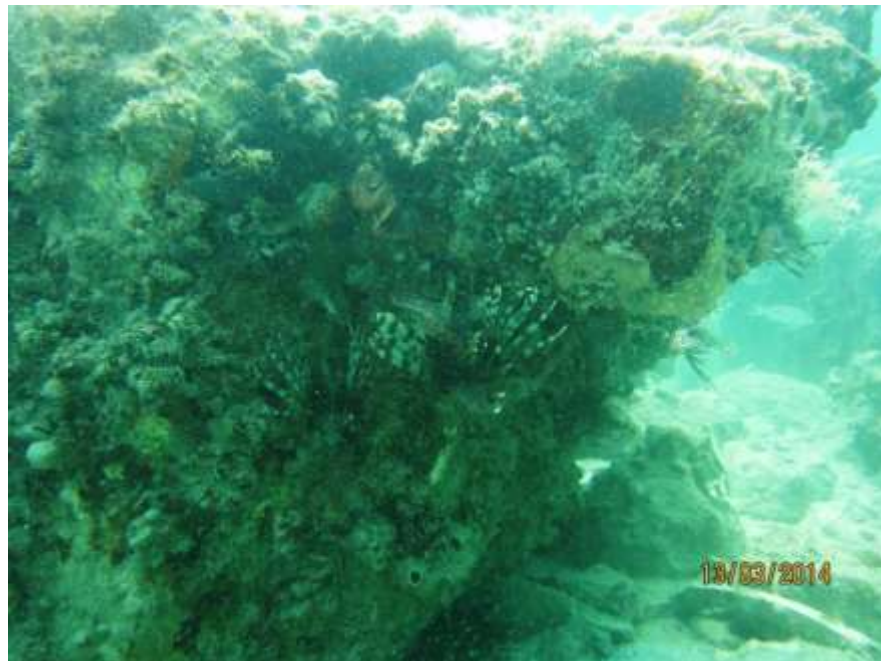
Plate 4-28 Photo showing numerous lion fish found along the groyne

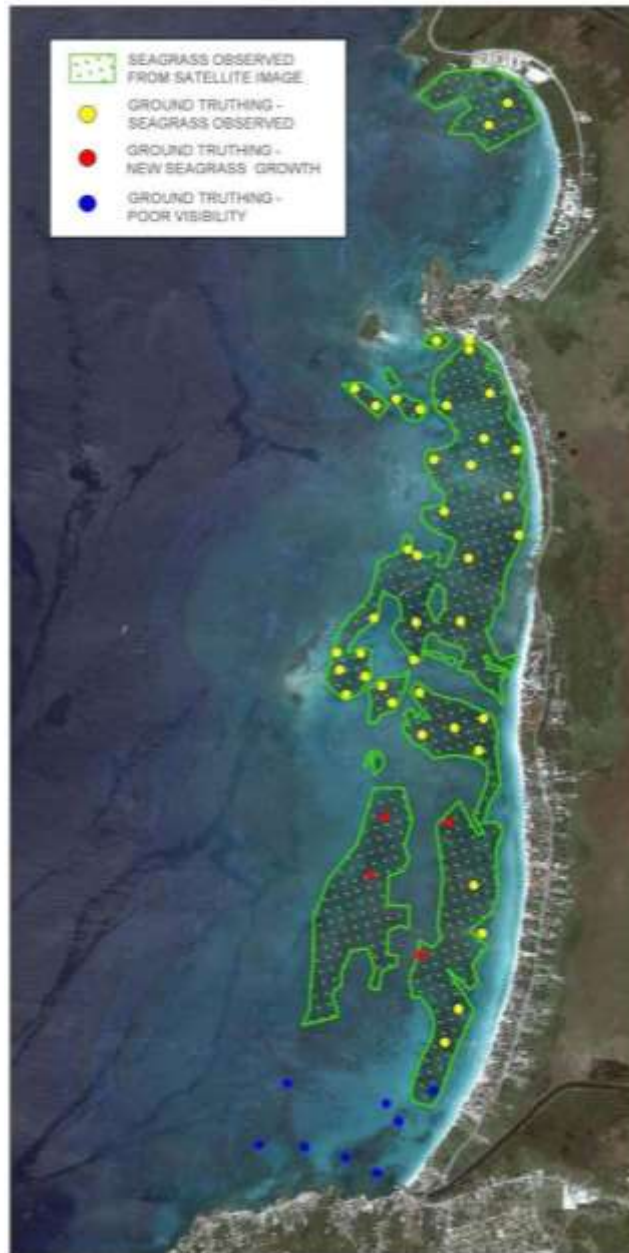
Figure 4-87 Seagrass beds within Long Bay (taken from *Erosion Negril Beach*, 2006)

Seagrass beds of varying densities were located within the backreef and consisted mainly of *Thalassia* sp. and *Syringodium* sp.. Areas of mixed beds were also observed in close proximity to the reef crest. This area was also covered with algae and had several patch reefs behind the crest.

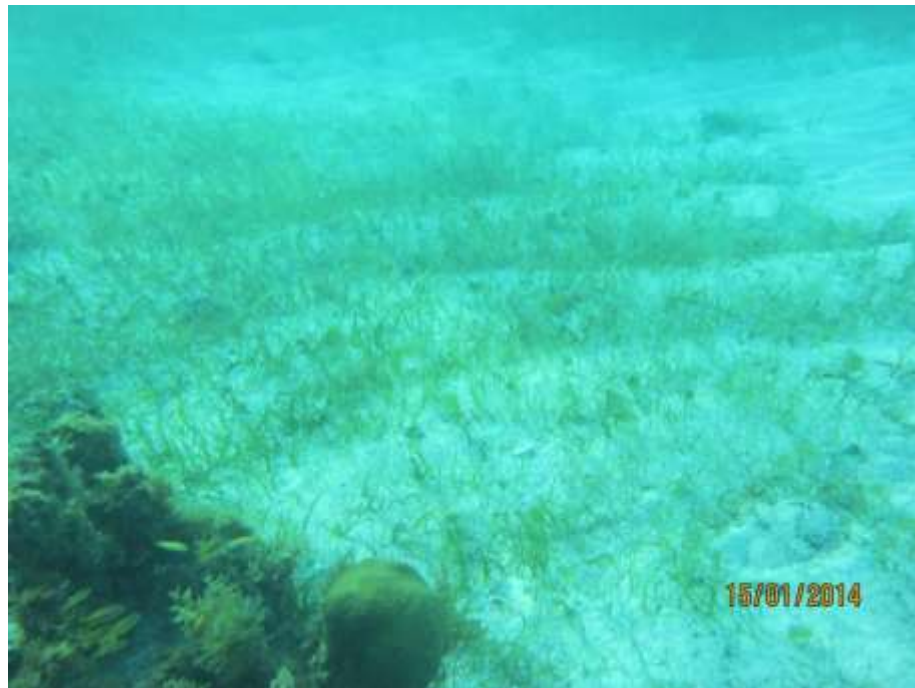
Plate 4-29 *Syringodium* bed in the backreef

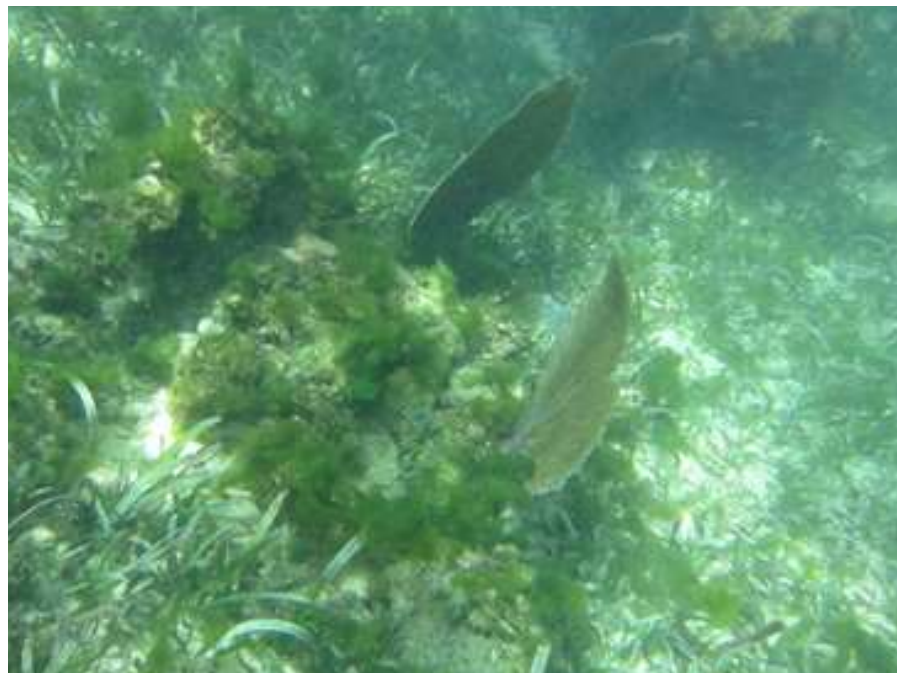
Plate 4-33 Fleshy macroalgae in the seagrass bed

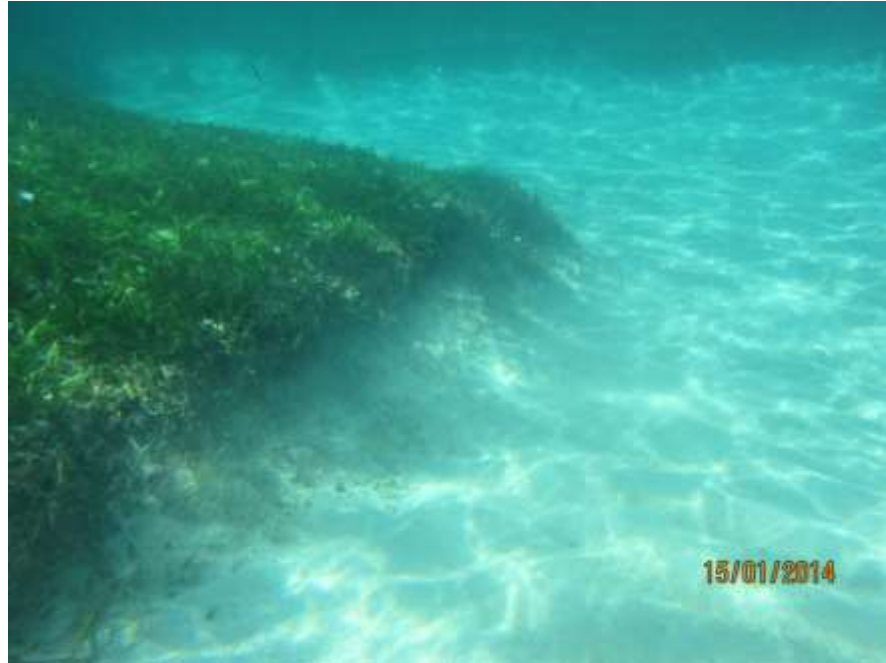
Plate 4-34 Seagrass bed showing erosion edge.

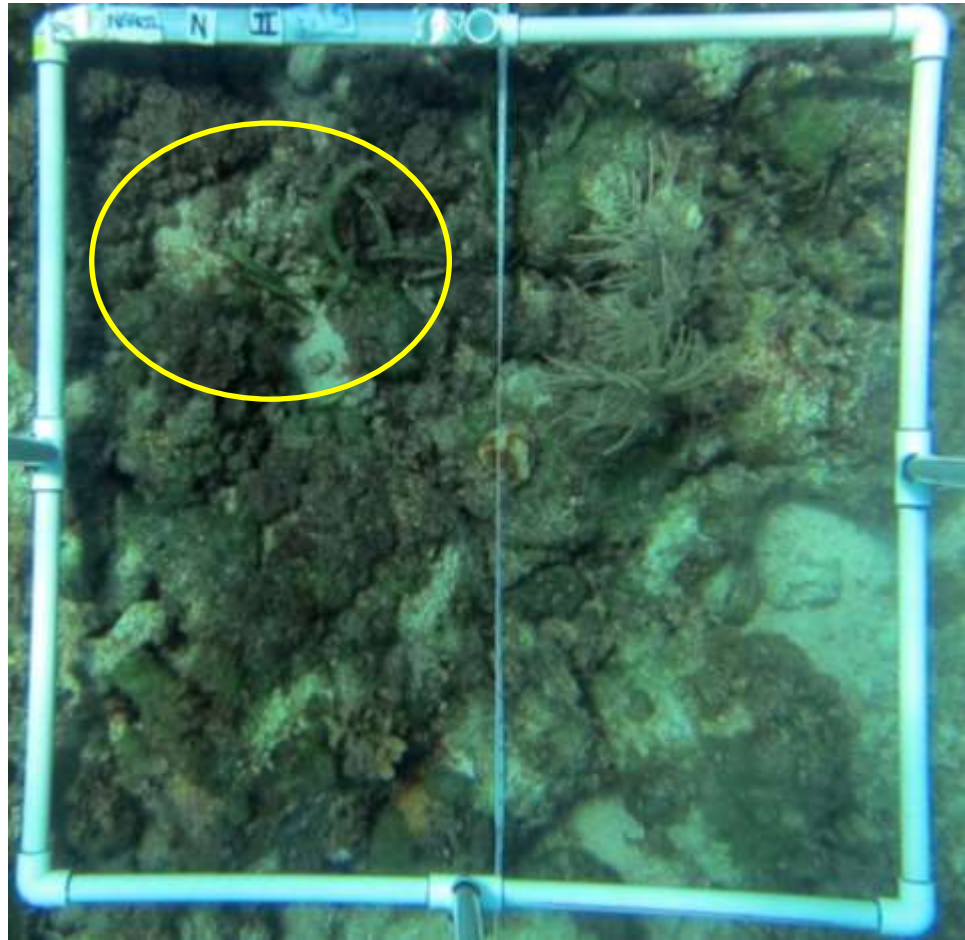
Plate 4-35 *Sparse seagrass within the footprint area growing on a rocky substrate*

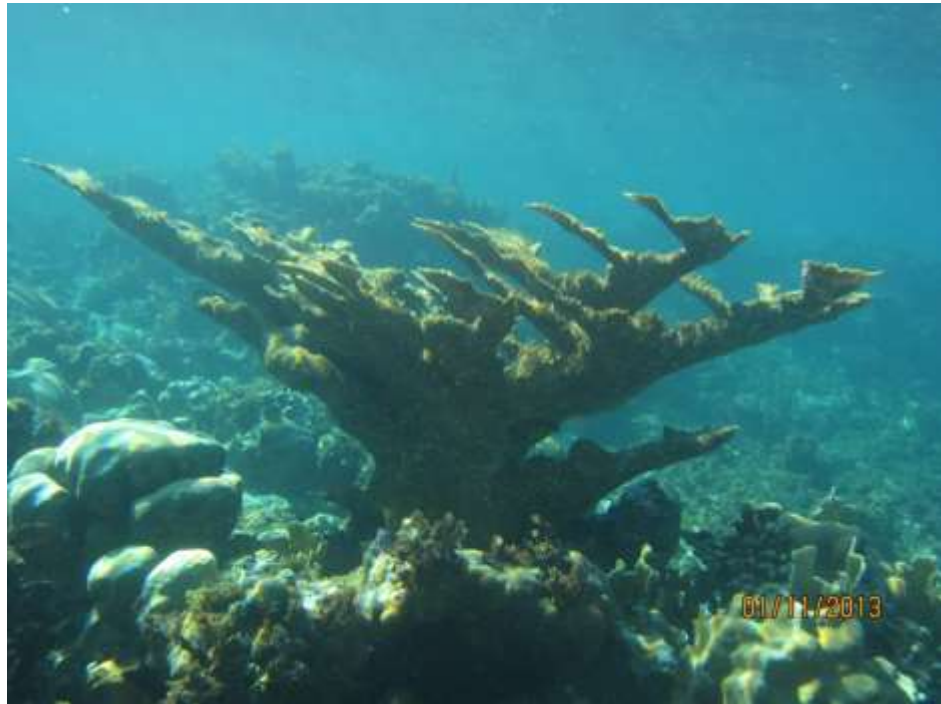
Plate 4-36 *Large A. palmata colony*

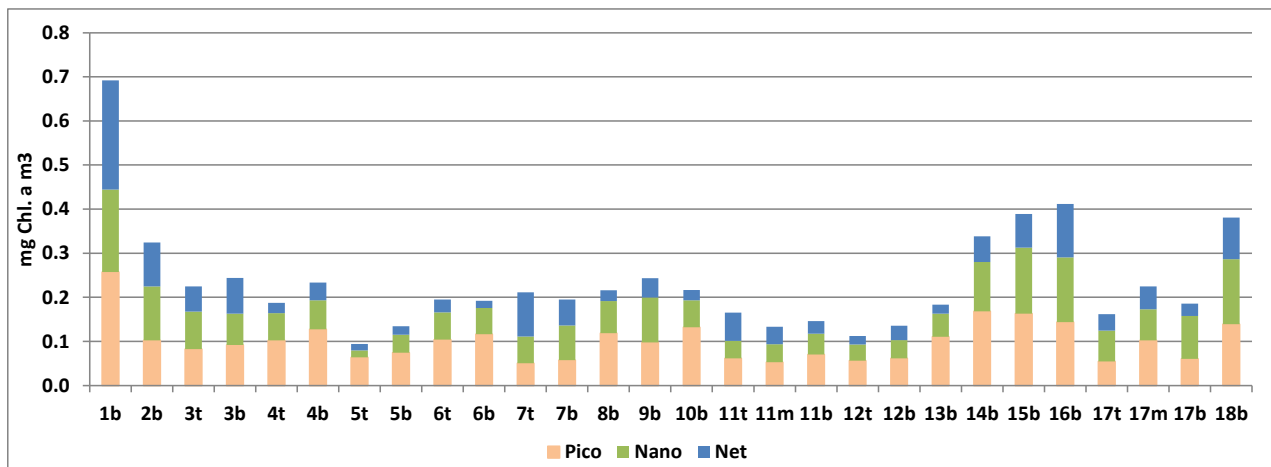
Figure 4-88 Phytoplankton biomass as chlorophyll *a* values across stations for different size fractions

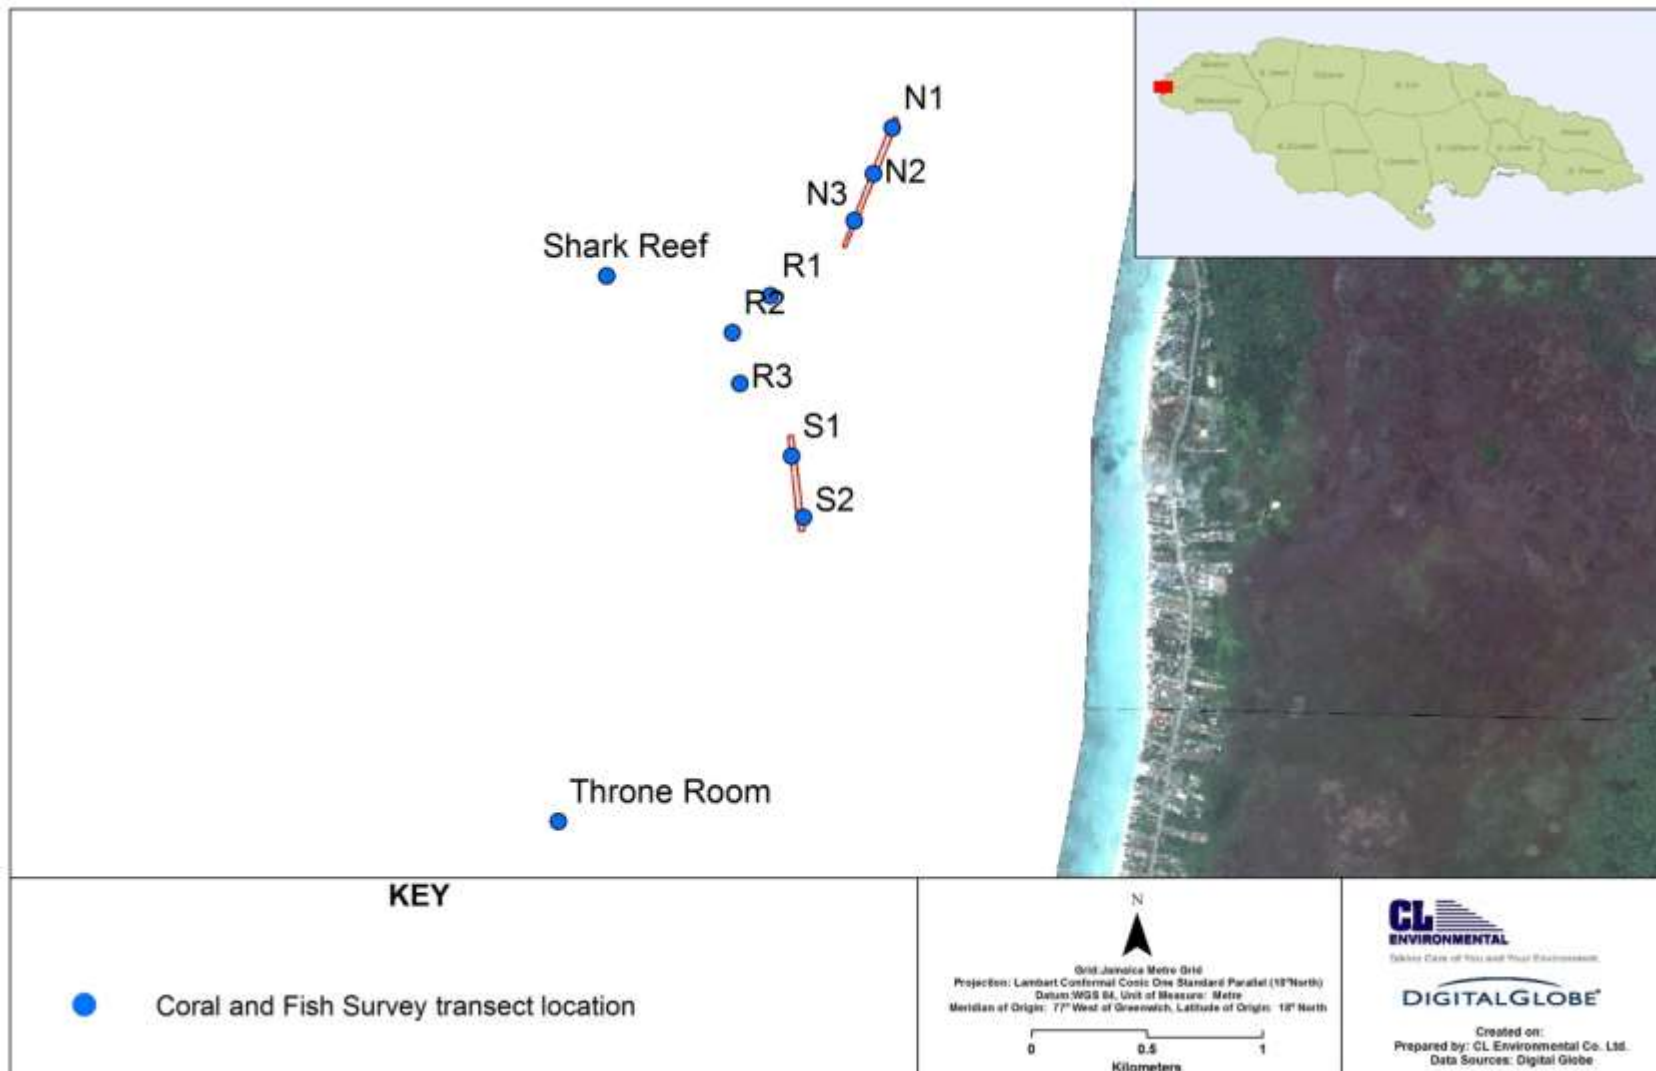
Figure 4-89 Locations of the fish and coral surveys

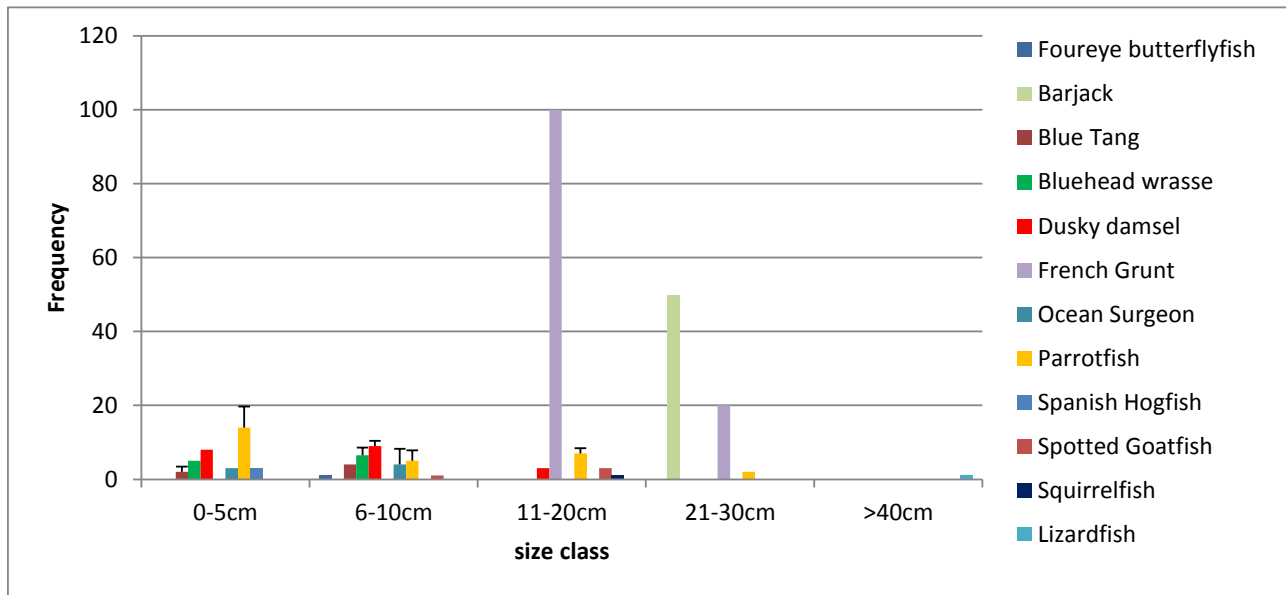
Figure 4-90 Average number of fish observed in the North breakwater location with standard deviation

Fish counts were conducted at each dive transect location using roving fish count methods defined for the Atlantic Gulf Rapid Reef Assessment (AGRRA) protocol. The lowest numbers of fish species (10 species) were observed within the North and South breakwater area. In comparison, the recreational dive sites, Throne Room and Sharkreef, showed the highest species diversity of 23 and 25 respectively. Within the North breakwater area, the dominant fish was the French Gruntfish with the majority within the 11-20cm size class. Barjacks, Parrotfish and Damselfish were also numerous with most being on the smaller size classes. Barjack dominated the area for the South breakwater within the 6-10 cm size class. The richness of each species was generally low at these two sites with the exception of barjacks, which had high numbers at both areas.

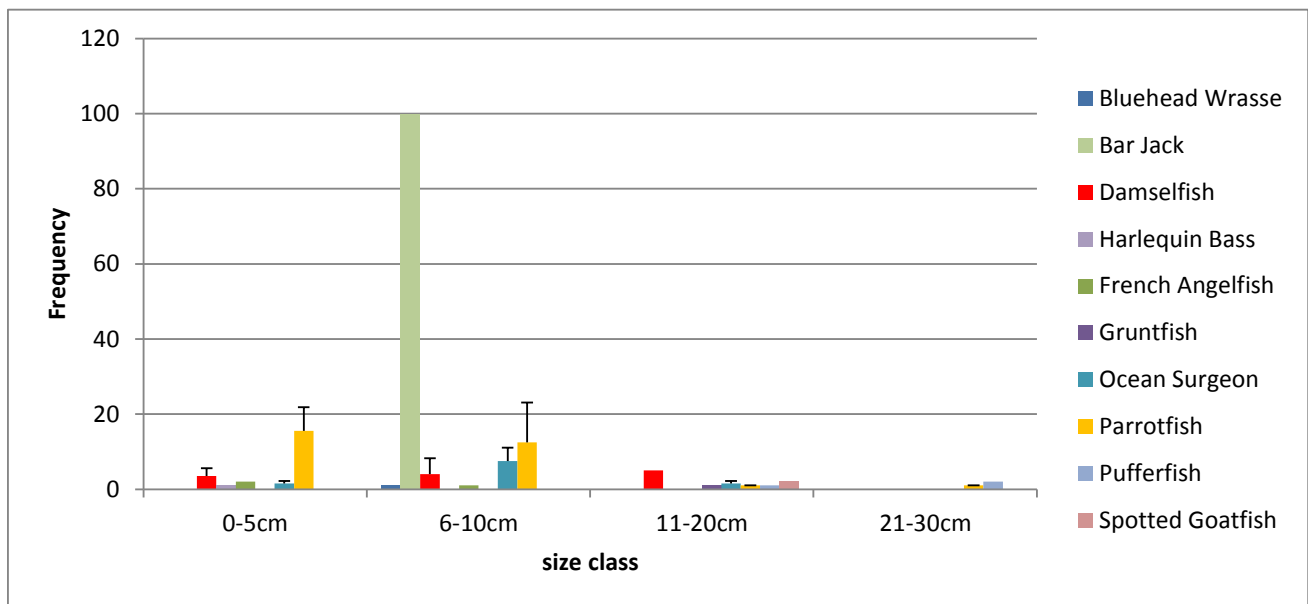
Figure 4-91 Average number of fish observed in the South breakwater location with standard deviation

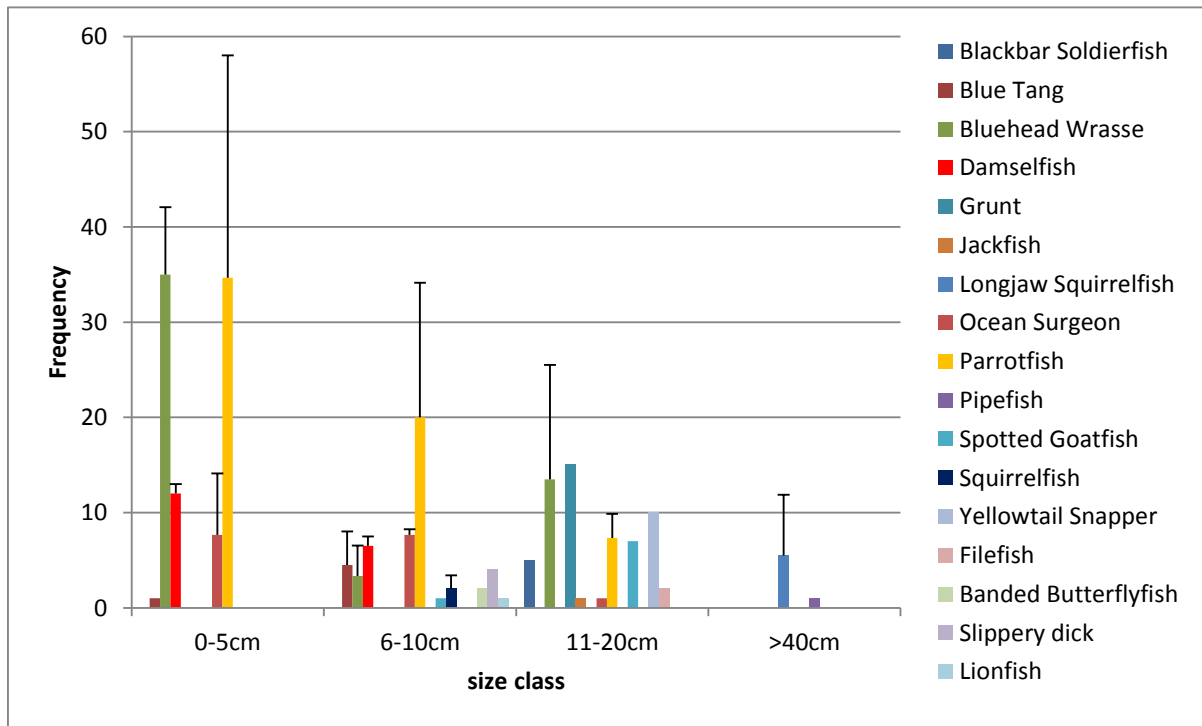
Figure 4-92 Average number of fish observed along the reef crest with standard deviation

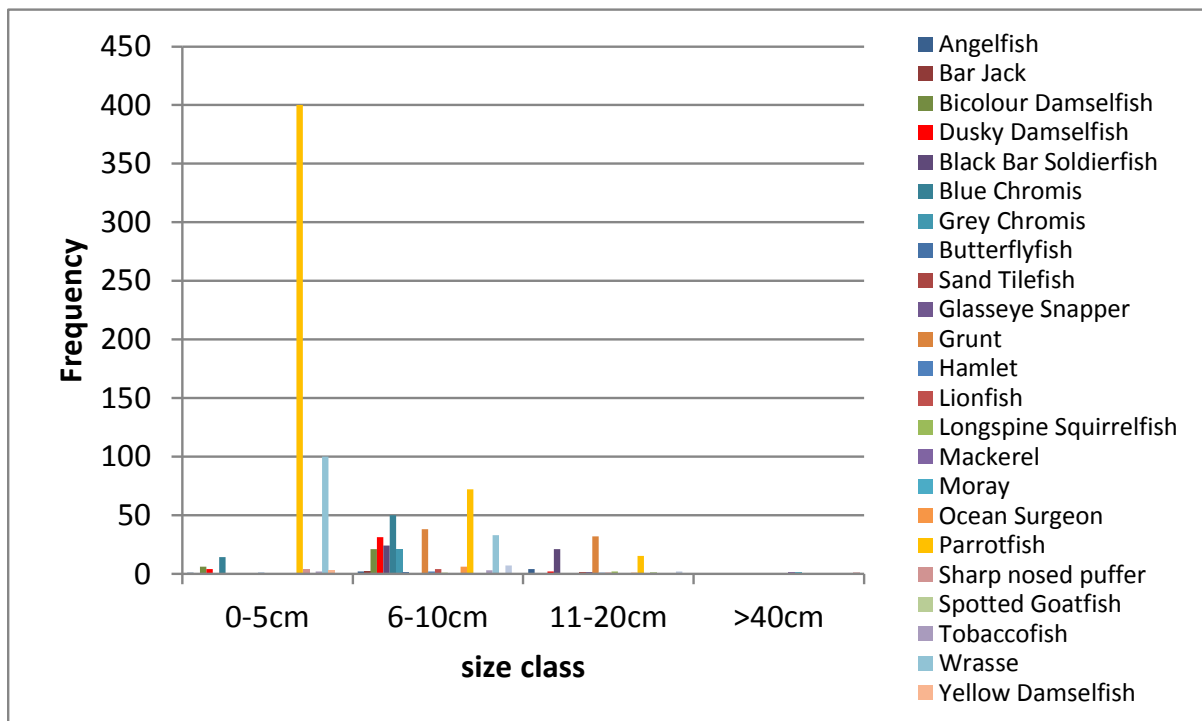
Figure 4-93 Number of fish observed at Throne Room site

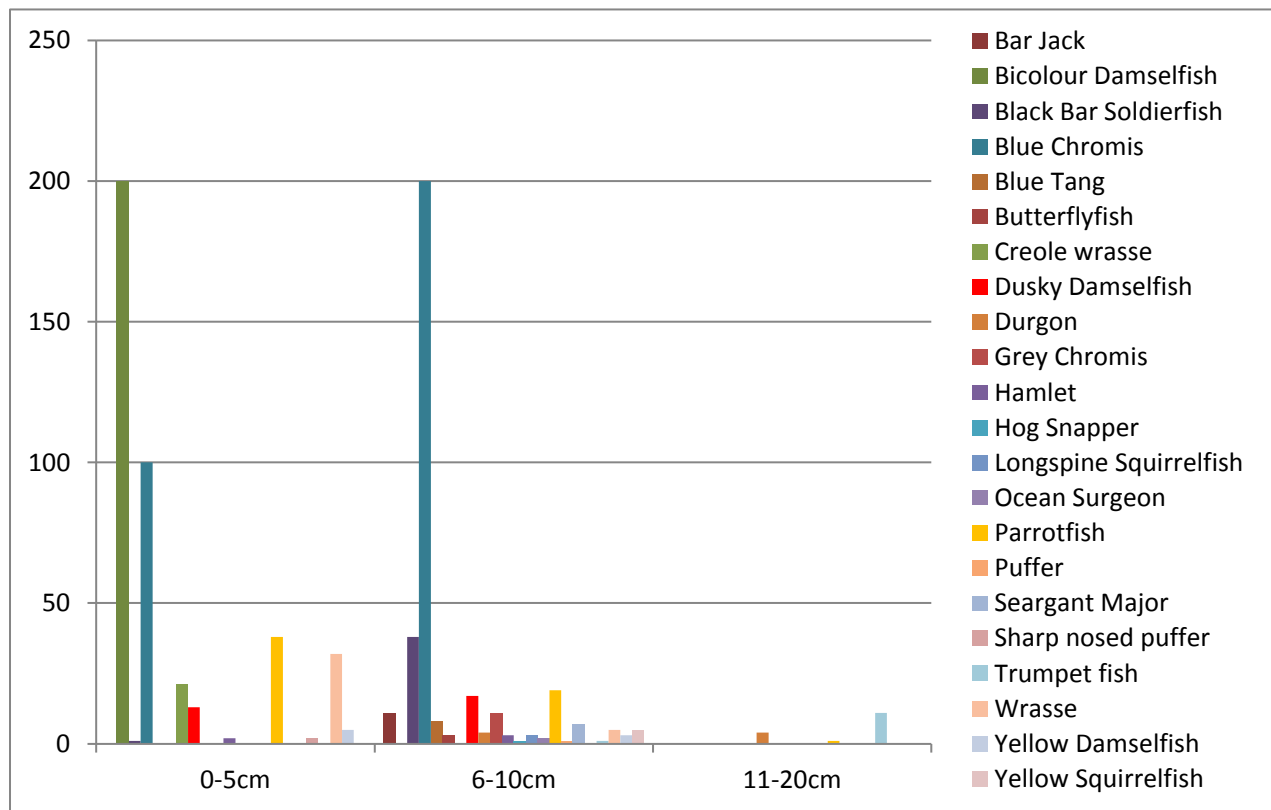
Figure 4-94 Number of fish observed at Shark Reef site
