Environmental Impact Assessment
**CONSTRUCTION OF TWO BREAKWATERS
AT LONG BAY, NEGRIL, WESTMORELAND**

Report Version: **FINAL**

Date: **April 2014**

**ENVIRONMENTAL IMPACT ASSESSMENT FOR
THE CONSTRUCTION OF TWO BREAKWATERS
AT LONG BAY, NEGRIL, WESTMORELAND**

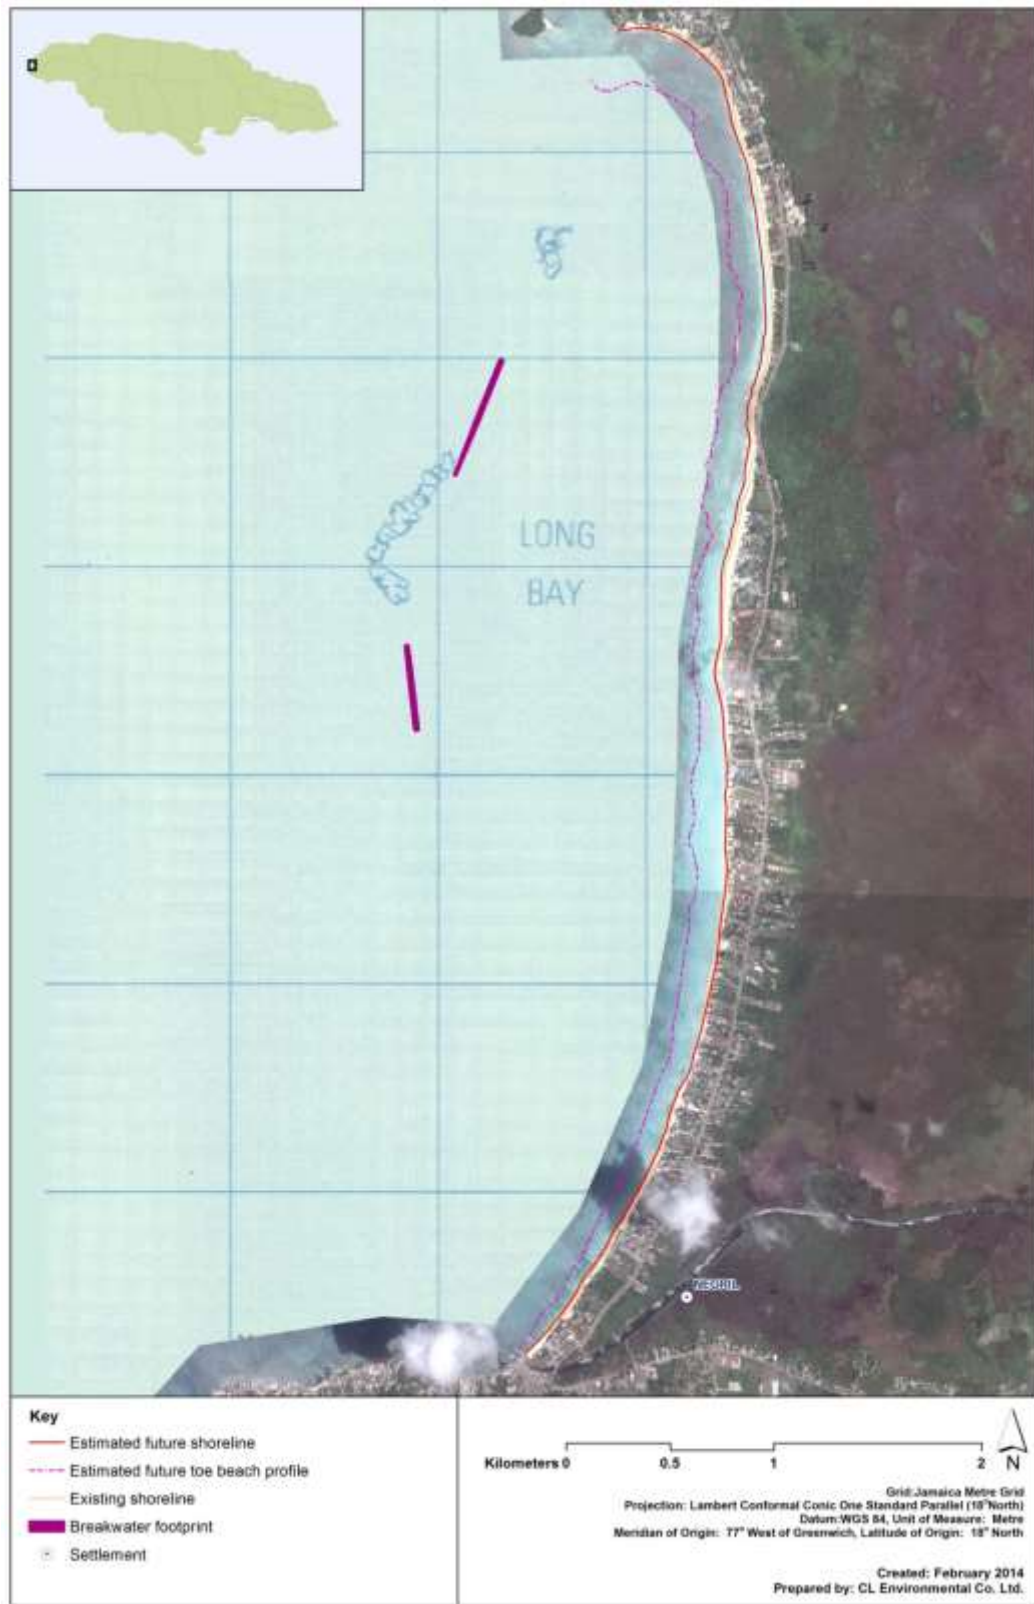
Figure 5-15 Estimated future beach shoreline and toe beach profile for 2050, Long Bay

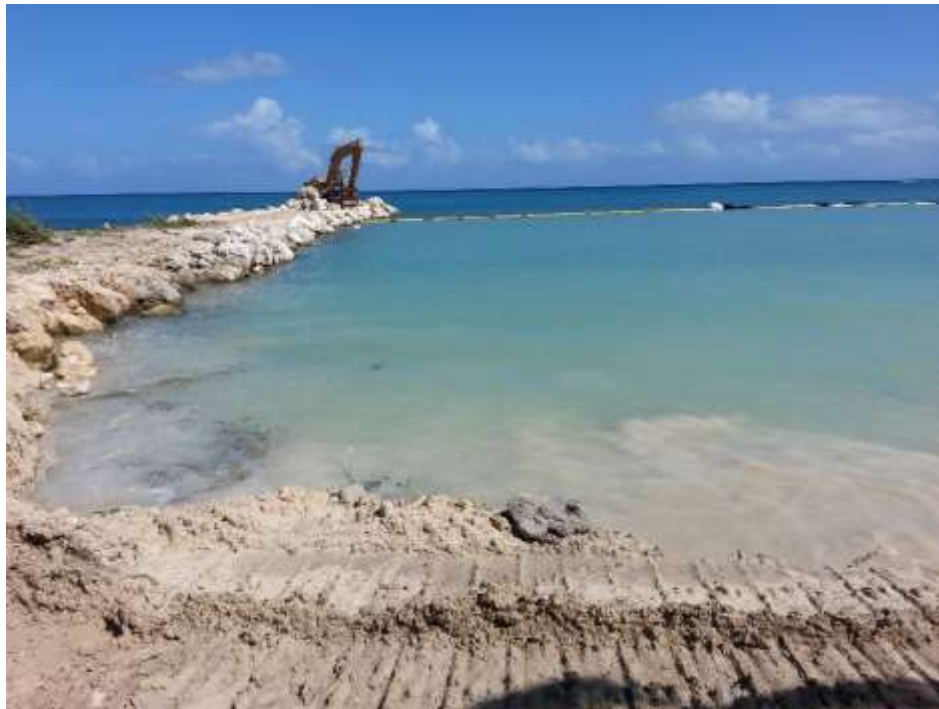
Plate 7-1 Example of a turbidity barrier being used to mitigate against a declining water quality during construction

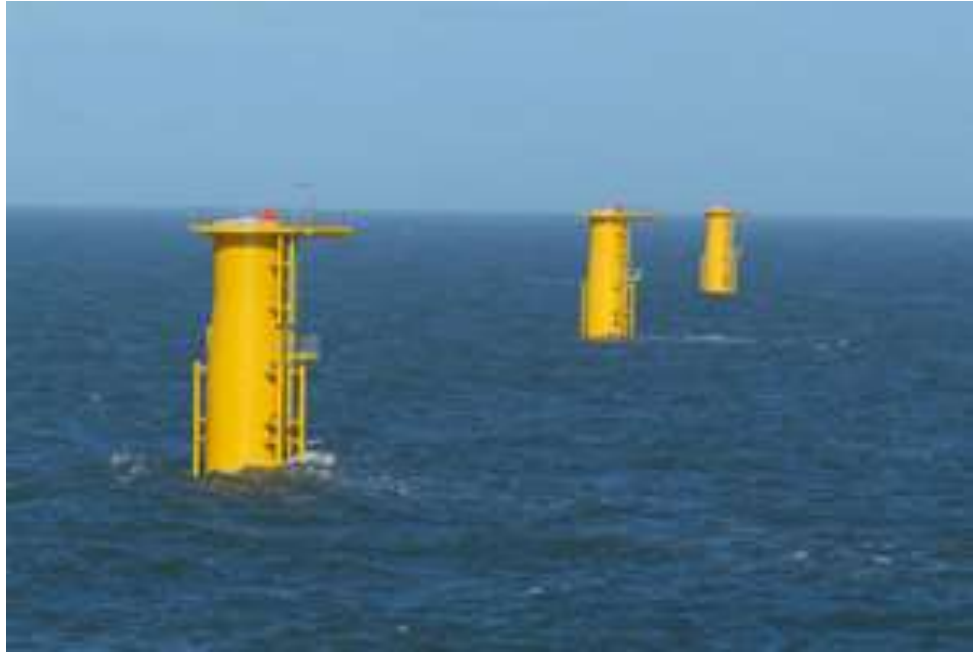
Plate 7-2 Buoys being used as navigation aids
